Steel Hull Corrosion of USS Arizona with Applications to Submerged Resources

The USS Arizona Preservation project is a multi-year, interdisciplinary and cumulative effort with each discipline contributing to basic research required to make informed management decisions for long-term preservation. Three significant issues include: (1) USS Arizona is a grave site for 900 or more Navy and Marine personal lost with the USS Arizona when Japanese forces attacked Pearl Harbor on Dec 7, 1941. (2) Minimizing environmental hazard from a potential fuel oil release of an estimated 500,000 gallons remaining in fuel bunkers or compartment overheads. A cross section view of the ship and bunkers before and after the attack is shown in Fig. 1. (3) Over 1.5 million visitors a year consider the vessel a national icon. Research and any solution to the oil issue incorporates a minimum impact approach. The primary goal of the project is to characterize complex deterioration processes and utilize finite element modeling (FEM) to predict stability in the context of a variety of interdisciplinary inputs including geology, oceanography, microbiology, oil analysis, structures, environmental parameters and c

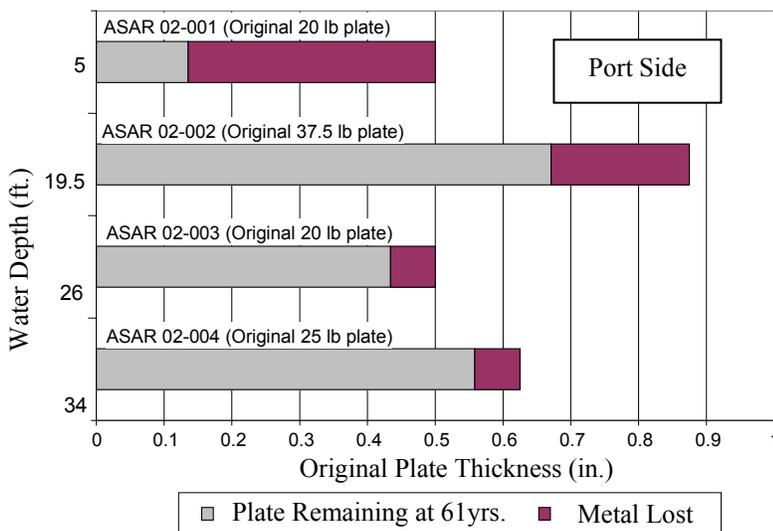
Eight 10 cm (4 in) diameter hull samples (coupons) were removed, four each from port and starboard sides near midship, at vertical positions from 5 ft (1.5m) to just below the mudline at 34 ft (10.4m). Corrosion rate was determined by subtracting final thickness from original thickness and dividing the difference by the submerged time interval, 61 years. Fig. 3 is a port side bar graph of hull plate thickness as a function of water depth [2]. At 5 ft (1.5m), the metal loss is over 50% of original thickness due to fresh seawater exposure on both sides. At 19.5 ft (6m), the loss is less than 25%, at 26 ft (8m) and lower, the loss is less than 15%. Corrosion rate varies from 2.7 mpy (0.07mmpy) near the surface to 1.2 mpy (0.031mmpy) at the mudline. USS Arizona's complete structural deterioration and eventual release of oil inside the hull is, by all indications, not imminent.

Fig 3. Plate loss as a function of water depth.
