# Underground Water Problem at Chadron, Nebraska: Causes and Solution

### UNDERGROUND WATER PROBLEM AT CHADRON, NEBRASKA: CAUSES AND SOLUTION

Arthur W. Struempler

Chemistry Department  
Chadron State College  
Chadron, Nebraska 69337

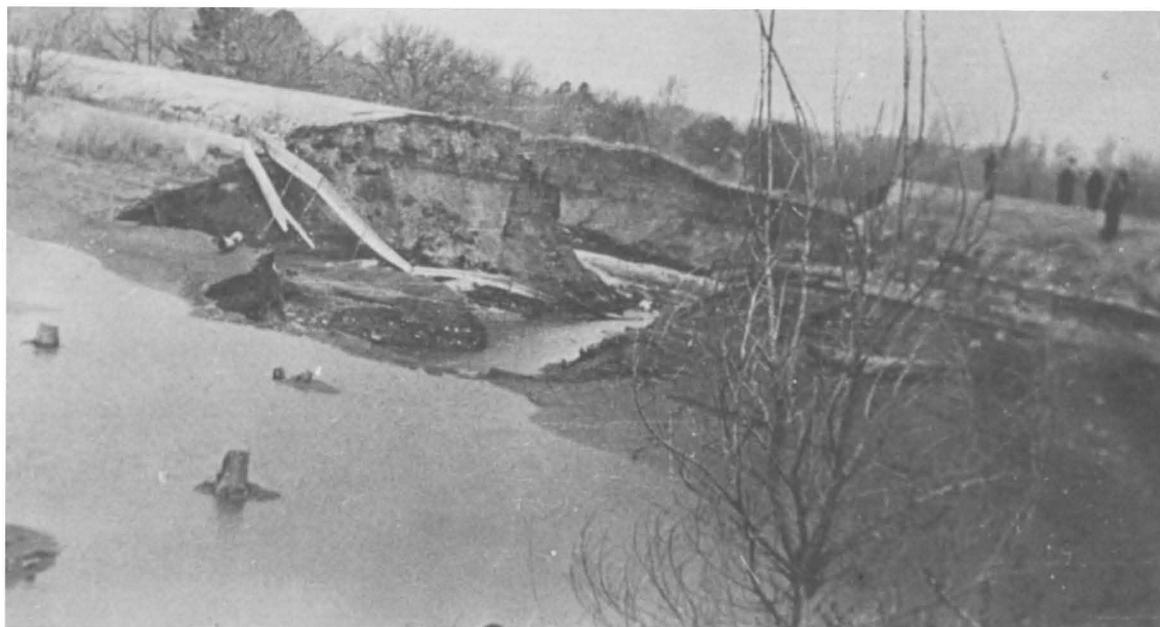
In 1930, the dam was once again destroyed by a flood (Fig. 1), and was again rebuilt. In 1960, another storage reservoir was constructed on Chadron Creek, doubling the water storage capacity. Bids later were let for a one-million-gallon steel reservoir, which was placed on C-Hill south of the College campus.

FIGURE 1. Destroyed Chadron reservoir dam on Chadron Creek, April 1930. (Photo by Billy J. Smith)

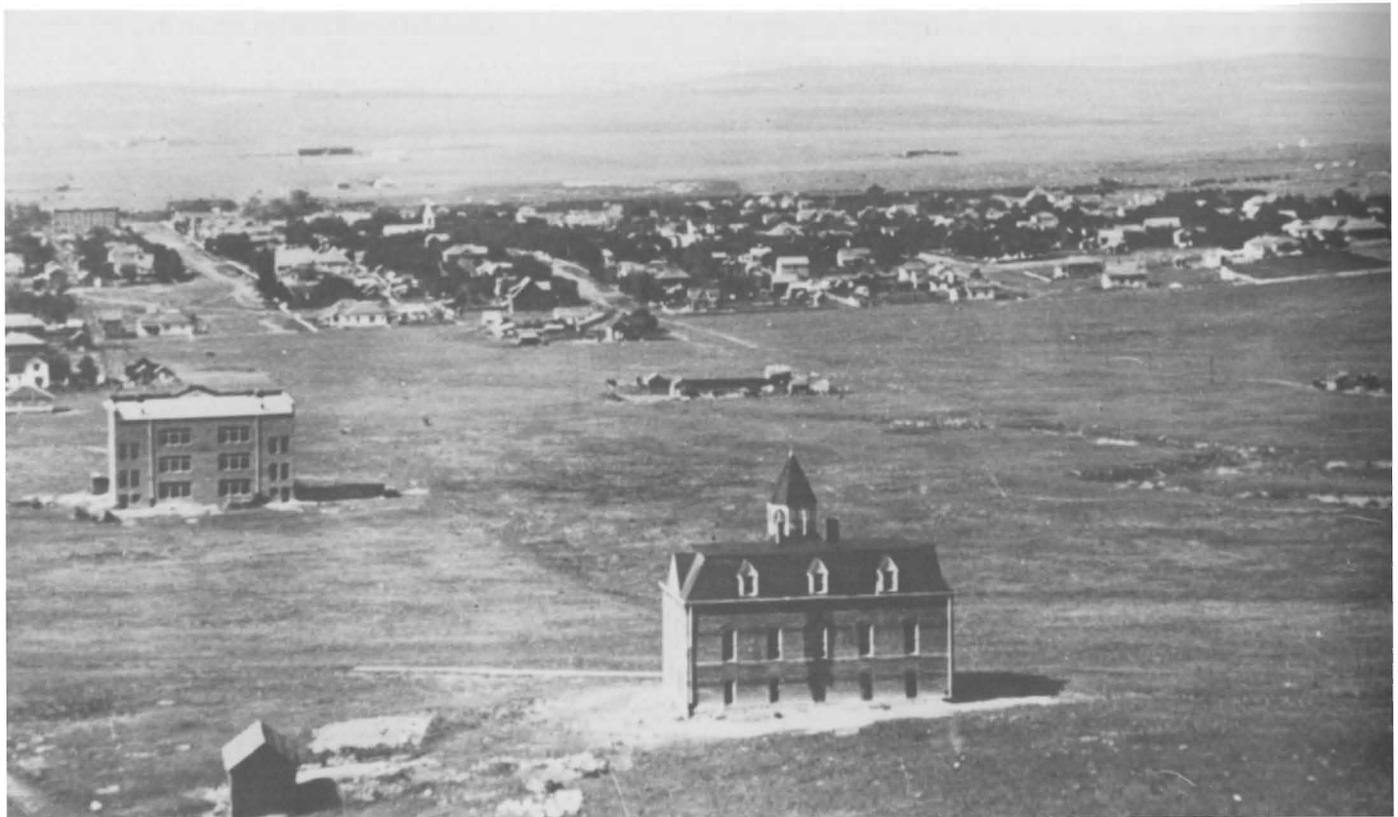
An early photograph of Chadron (Figure 3) provides a clue of the surface drainage patterns. This photograph, taken about 1912 from C-Hill, and viewing north-northeast, shows the Chadron Congregational Academy in the foreground and the middle portion of the Administration Building, built in 1910–1911, behind it. A drainage pattern is shown in the middle-right of the photo and is assumed to be the drainage area near the present Armstrong Gymnasium.

FIGURE 3. Looking north-northeast, about 1912, from C-Hill. The Chadron Congregational Academy is in the foreground and the middle section of the Administration Building in the left foreground. (Con Marshall photo)

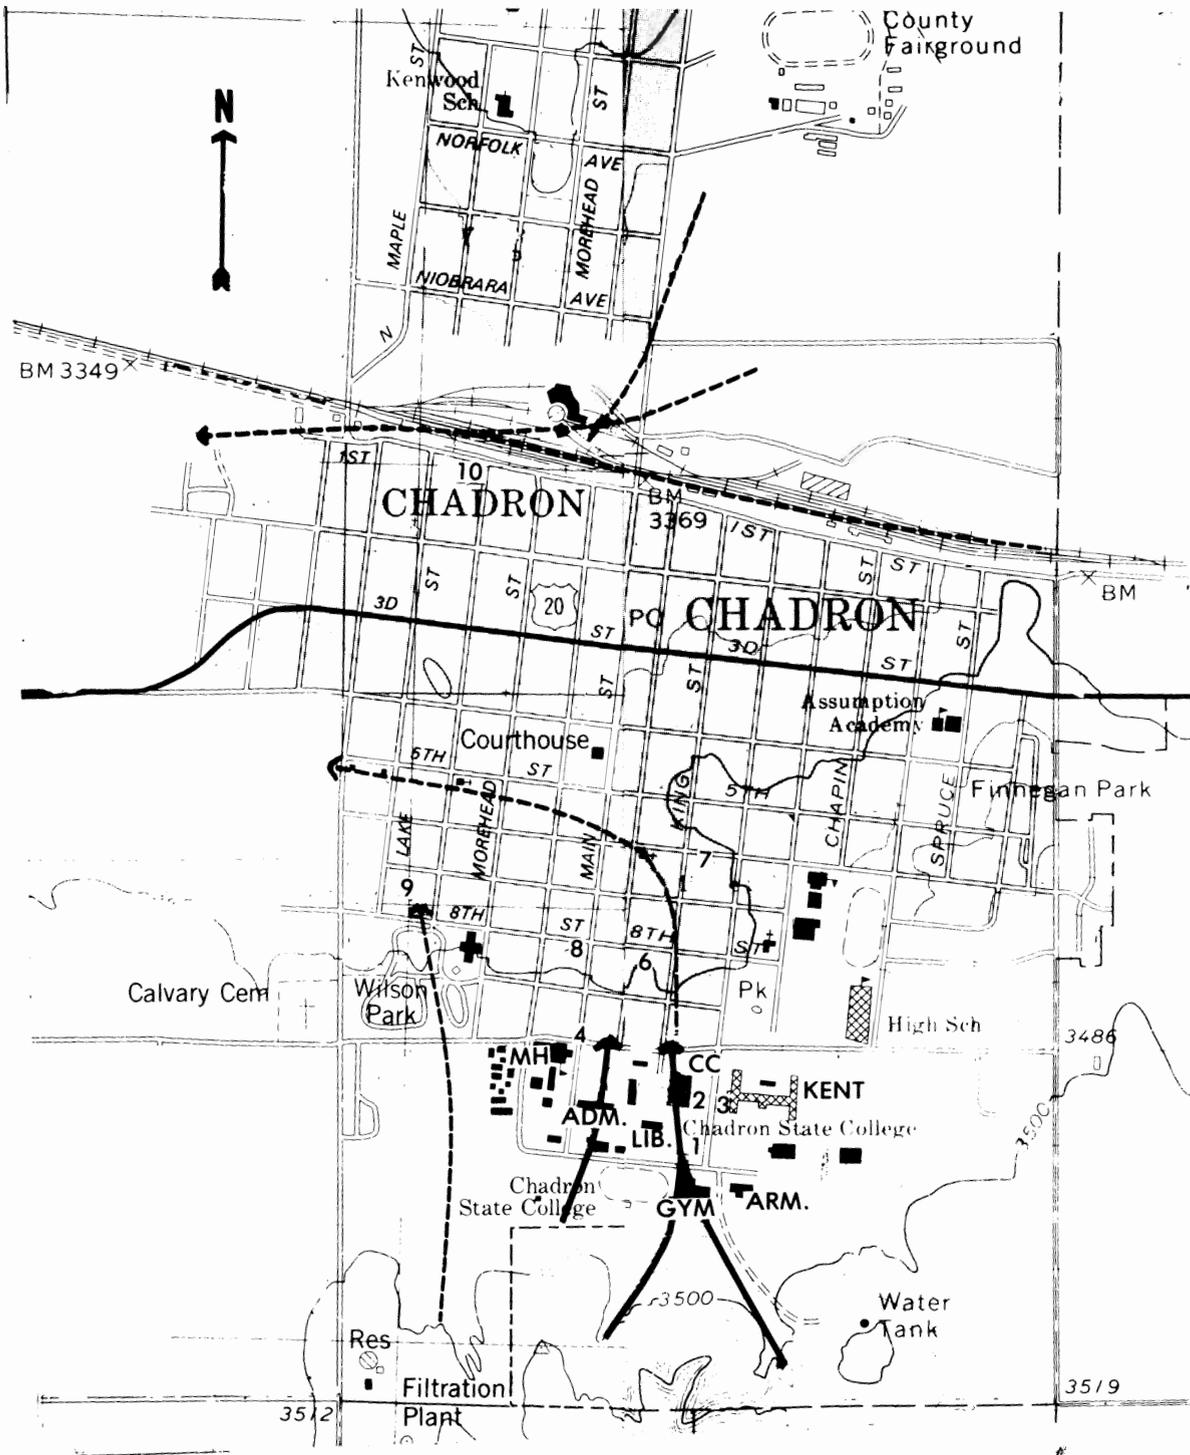
FIGURE 4. Modified U.S.G.S. topographic map of Dawes County, 7.5 series, of Chadron East (1970) and Chadron West (1967). Solid lines indicate the buried drainageways based on test borings. The slashed lines indicate surface drainage patterns. Caption: CC = Campus Center, ARM = Armory; GYM = Gymnasium; LIB = Library; ADM = Administrative Building; MH = Memorial Hall; KENT = Kent Hall.

lines in Figure 4 indicate the surface drainage patterns. These drainage areas are reasonably certain and are mostly based on topographical maps. The solid lines show the buried drainageways as determined by photographs and test borings on the Chadron State College campus. Again, the locations of these lines are reasonably certain (engineering report prepared for Chadron State College by Francis-Meador-Gallhaus, Inc., 1823 West Main, Rapid City, South Dakota, 57701, November, 1980).

Also, in recent years street deterioration and structural damage in homes are increasingly evident in an area north and northwest and down gradient from the campus. Damage appears to be most pronounced in an area down King Street following the assumed drainage area (slashed line) shown in Figure 4, then veering northwest and west along Sixth Street. Waste wells and pumps have or are being installed in many basements and outside locations to alleviate the rising water problems in basements.

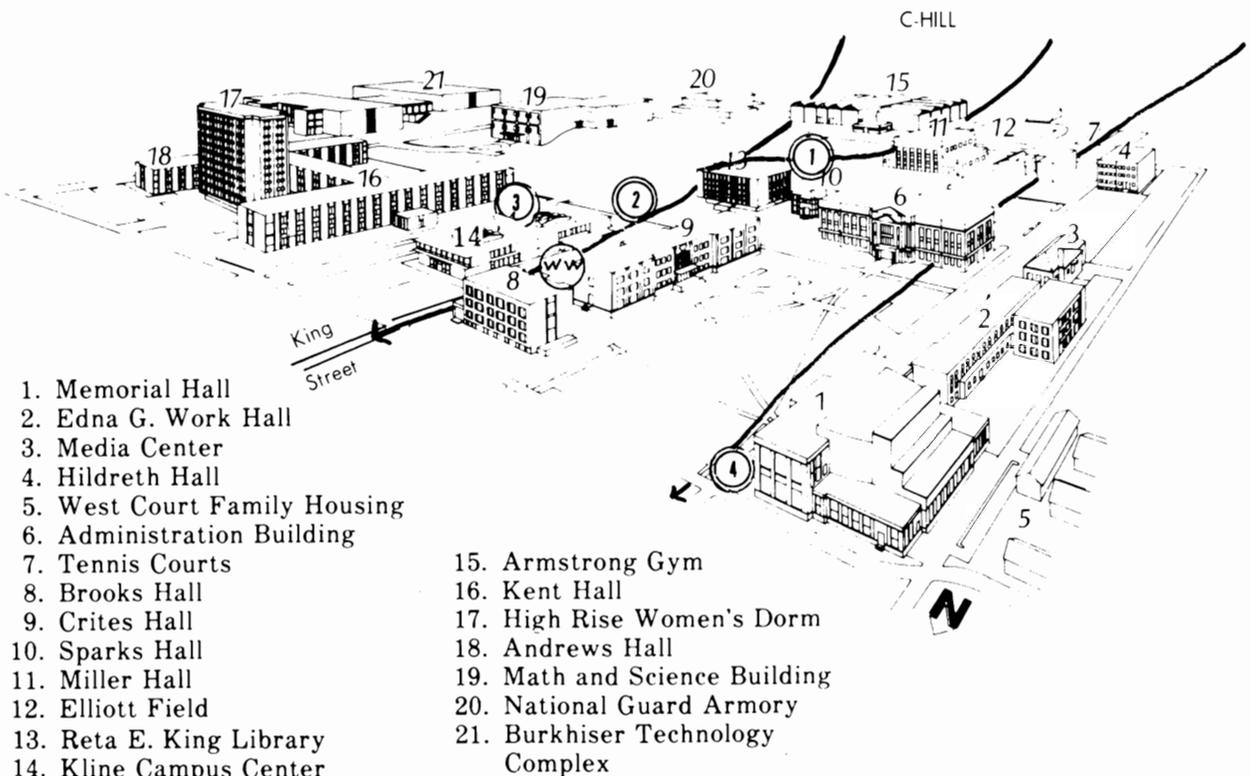
Figure 5 shows a more detailed map of the assumed drainageways through the campus in relationship of the College's buildings. It also shows the locations of the four test wells and the waste (desaturation) well.

FIGURE 5. Location of wastewater (desaturation) well (WW) and test wells 1-4. Solid lines indicate underground drainageways.

Older buildings not located near the old drainageway, and recently showing settlement problems, include Crites Hall located about 30 m (100 ft) west off the Campus Center (Fig. 5); the Administration Building located about 60 m (200 ft) southwest of the Campus Center; and the east part of Brooks Hall.

In the spring of 1986, a wastewater well was installed between the west side of the Campus Center and the southeast corner of Brooks Hall (Fig. 5), and the wastewater is discharged in the storm sewer. It has pumped continuously since its installation at the rate of 22 gallons per minute. As shown in

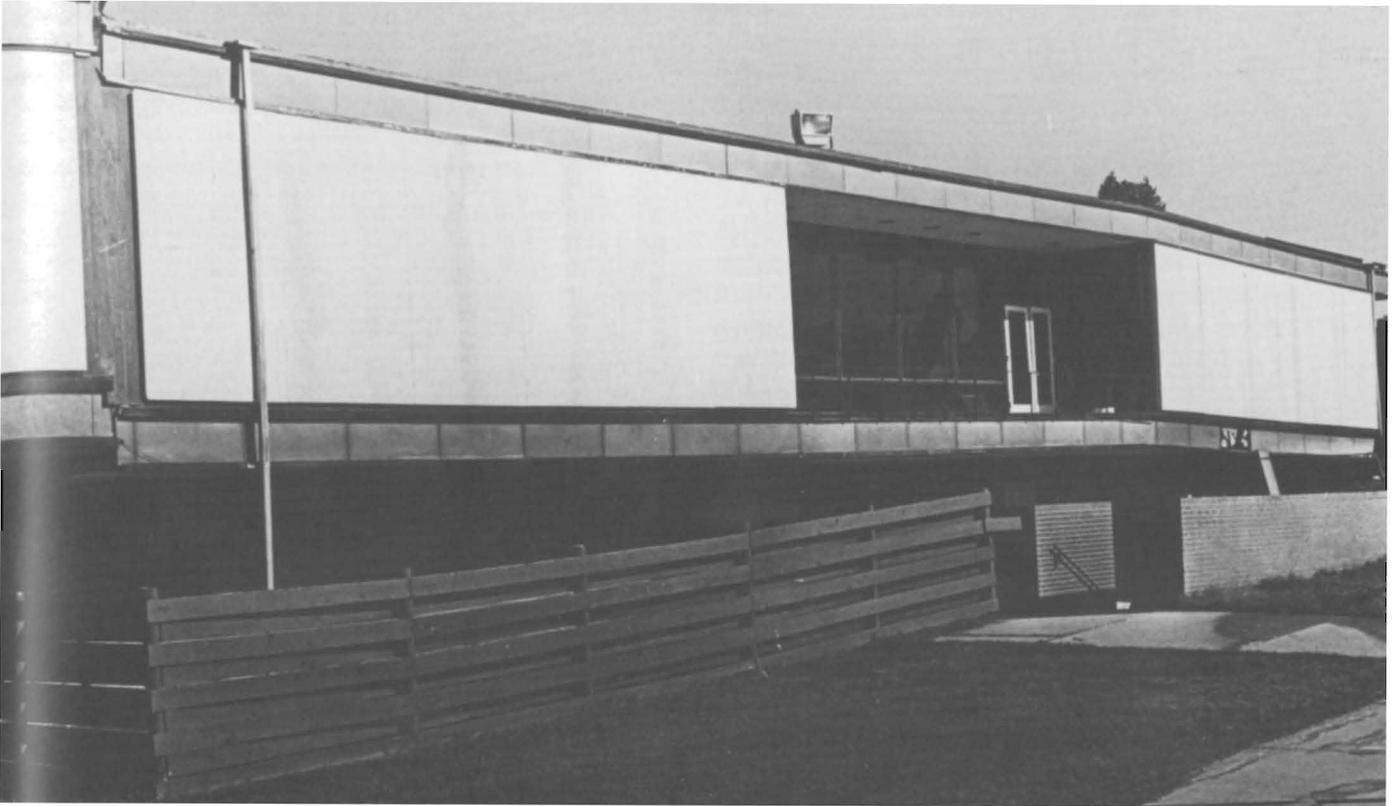
Settling problems of buildings on the Chadron State College campus were identified as early as 1964 (letter to F. Clark Elkins, President of Chadron State College, from E. Albin Larson, Secretary of the Board, regarding settling problems of the Kline Campus Center, dated December 22, 1964) and also in an engineering report for the College; the latter reported groundwater at 13.2 m (43.5 ft) below ground surface at the southwest side of the Campus Center (letter to Clark & Enersen, Olsson, Burroughs & Thomsen from Western Laboratory, Inc., 1630 Q Street, Lincoln, Nebraska, February 18, 1965). The settling problems now appear to be most pronounced on buildings constructed since 1960 on spread-footing foundations, and located on or near the assumed underground drainageway running down gradient (north) of the Armstrong Gymnasium. These include: (1) the north half of the Campus Center, constructed in 1967 and built on pier-type foundations, the main floor now showing settlement problems possibly related to the rising underground water levels, wetting, and compressibility of the soil; (2) Armstrong Gymnasium; (3) National Guard Armory; and (4) the south half of the Kline Campus Center, built in 1961, and condemned in 1979 because of structural differential sinking of 5 to 30 cm (2 to 12 in) (Fig. 6). Since 1971, many thousands of dollars have been spent on remedial repair of

FIGURE 6. Differential cleavage of 10 inches between the north half of the campus center constructed on pier-type foundations (extreme left) and the south half of the campus center built on spread-type footings. (Photo by Con Marshall)

buildings (Agenbrood, 1979). At the time of this writing (September, 1987) the south half of the Campus Center is soon to be demolished at a cost of nearly \$400,000.00.

On the basis of the foregoing considerations, I suggest: (1) the College install a limited number of strategically located wastewater wells to further prevent structural damages to existing campus buildings; removal of campus underground water would also prevent its downward flow into the residential areas of the City; (2) concurrent with pumping, water levels be monitored for changing underground water levels; (3) the College and High School manage irrigation water so that the earth is not saturated below plant root depth.

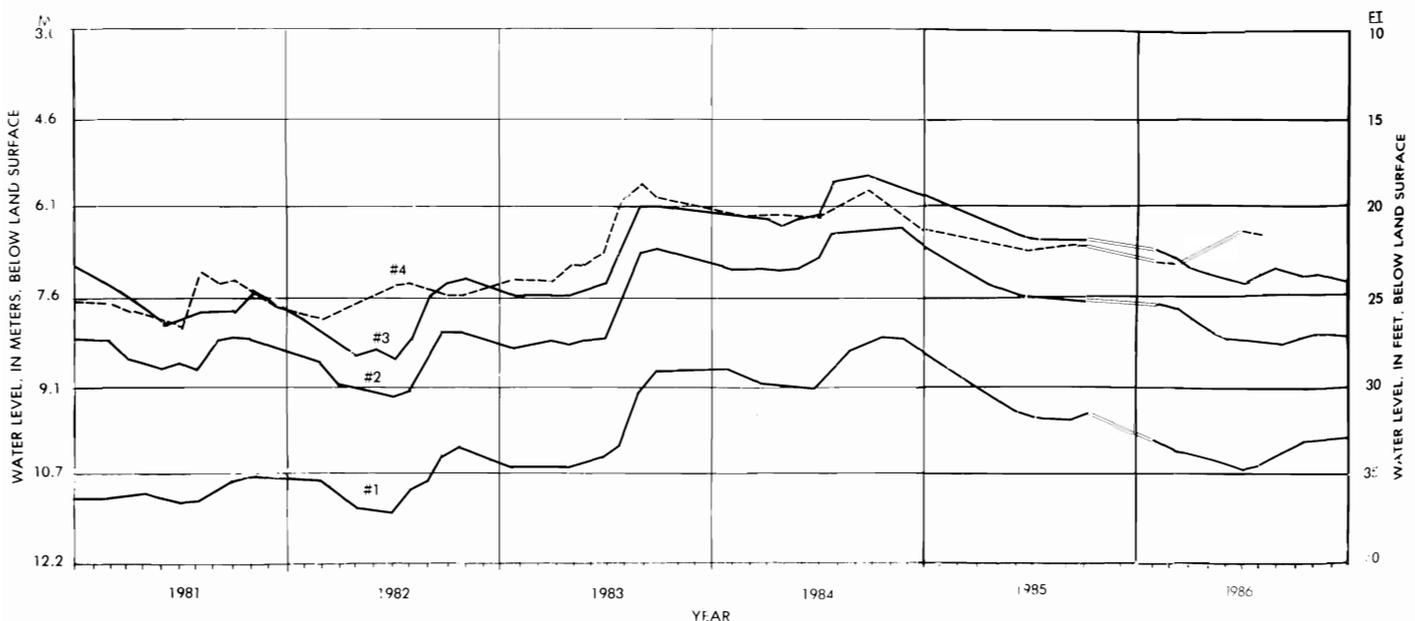
(Fig. 4). Well 1 is located north of the Armstrong Gymnasium, well 2 is south of the Campus Center, and well 3 is adjacent to the southwest corner of Kent Hall (east of the Campus Center). These three wells are in line with the old assumed drainageway. The underground water levels for wells 1–4 for years 1981–1986 are shown in Figure 7. Note the synchronous seasonal cyclic patterns of the wells for the 1981–1984 period. In each case, a buildup of water occurs in late summer, followed by a slight decrease in the spring months. The overall trend, however, is up. The rate of increase (slope) for wells 1, 2, and 3 is approximately 67 cm (2.2 ft) per year. These three wells are subject to upgradient supplemental campus lawn watering.

Figure 7, a notable decrease in groundwater levels is noted during the 1985–1986 period, especially for wells 1, 2, and 3. The double lines between the November 1985–February 1986 time period represent extrapolated data because the wells were not measured due to snow cover. Well 4 caved in during the summer of 1986 and its data are terminated at that point. The decline in groundwater during the 1985 season is probably due to the drought experienced in Chadron during the year (27.66 cm or 10.89 in). The continued decline during 1986 appears to be linked to the pumping influences of the wastewater well since 1986 was a wet year (63.65 cm or 25.06 in). Although not shown in Figure 7, this decline in water levels has continued into 1987 at the time of this writing (September, 1987), again probably linked to the discharge of saturated water into the storm sewer.

FIGURE 7. Depth in meters and feet to underground water on the campus.

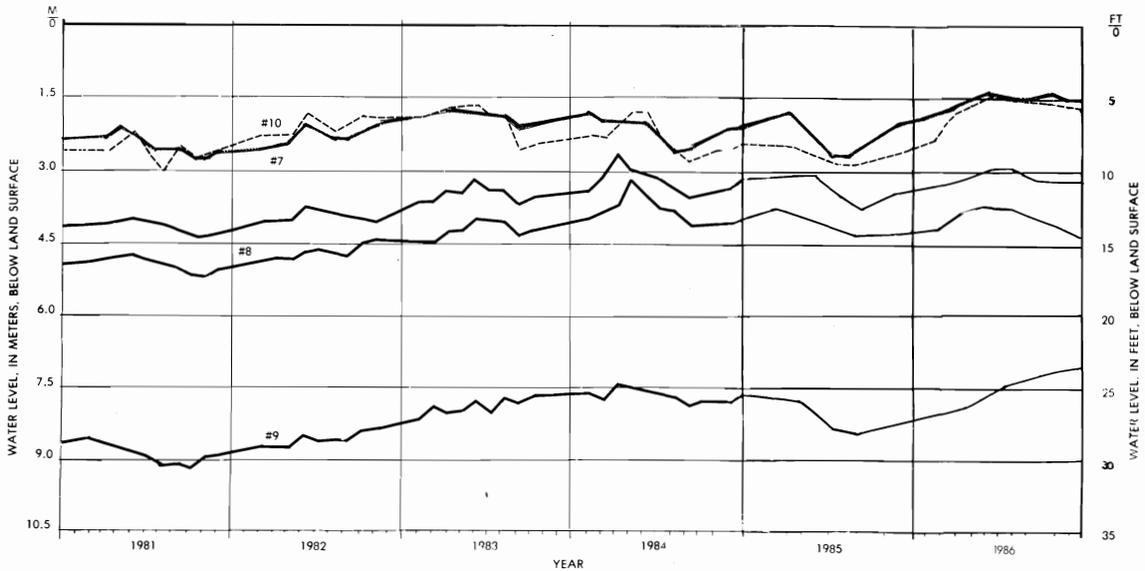
For the 1981–1984 period the underground water levels from all wells 6–10 follow the same seasonal synchronous and phase patterns (Fig. 8). During this period water levels tend to fall during the summer months and tend to increase slightly during the winter months, resulting in a slight net gain until 1984. In 1984, the water levels tended to remain static. The lowering of groundwater levels during the summer months appears to be related to the use of these wells for irrigation purposes. In 1985, a decline in groundwater levels is noted in

all the wells, probably related to the drought and the need of increased pumping for lawn-irrigation purposes. The increase in water levels during 1986 may be related to the abundant rainfall during 1986.

FIGURE 8. Depth in meters and feet to underground water in the city.

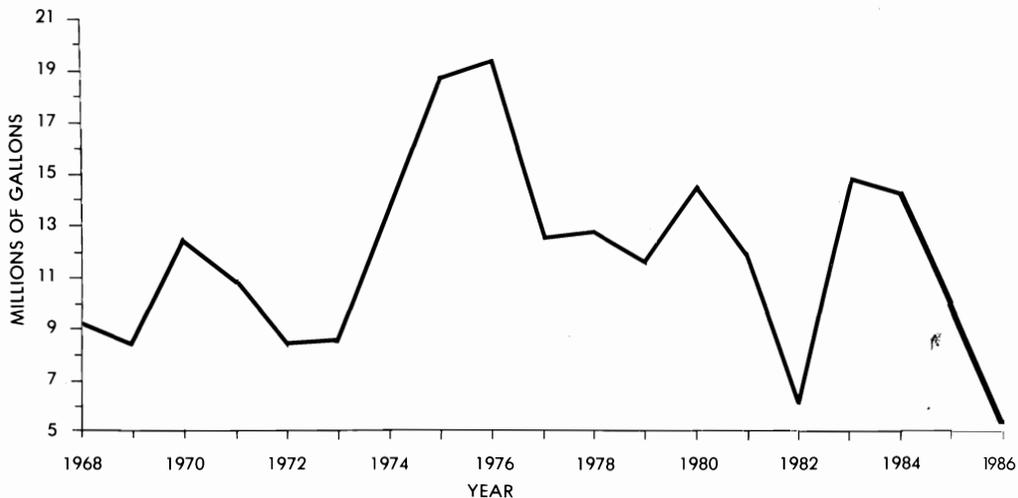
Chadron State College is the largest single user of water within the City. A view of the College's use of water for irrigation purposes on the campus is shown in Figure 9. Only taps serving irrigation purposes are used in the data. Two exceptions, however, are made: (1) water usage from the baseball field has been deleted because the field has not been used in recent years and is located away from the area of study; (2) water usage has been estimated for the area between the Gymnasium and Campus Center based on an equivalent area usage of the football field; this area is not on a tap supplying irrigation water only, yet it has been an important consumer of irrigation water. Unfortunately, complete data of campus usage could not be obtained for years before 1969, which would have added to a broader data base prior to the deep-well system. The data, however, indicate that on the average, for the last 18 years, approximately 12,300,000 gallons of water have been used by the College annually for lawn purposes from taps used exclu-

sively for irrigation for an estimated area of 5.5 ha (13.6 acres). Generally, water consumption is inversely related to precipitation patterns; the exception is the 1985 season. It is noteworthy that a wastewater discharge of 22 gallons per minute equates to eleven million gallons of water in one year, or about the same volume applied for lawn purposes each year.

FIGURE 9. Water usage for lawn beautification at Chadron State College.

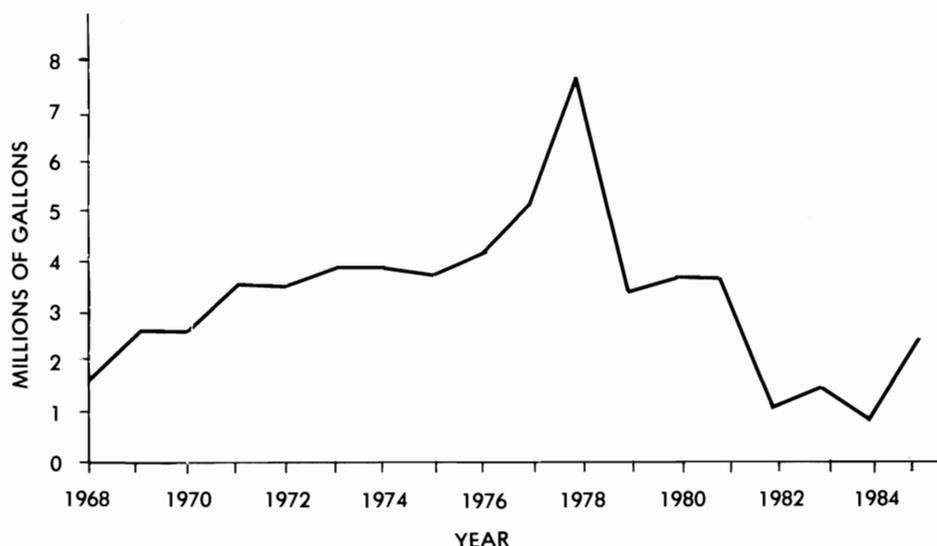
Seepage from the swimming pool has been suggested as a possible source of rising underground water. Figure 10 shows the usage of water from the Armstrong Gymnasium, where the pool is located, for a 18-year period. The data indicate increased water usage in 1976, 1977, and 1978, suggesting leakage. Perhaps as many as four million gallons of water may have leaked from the pool and entered the old drainage pattern. It was repaired in 1978, and water consumption in the Gymnasium has now been reduced.

FIGURE 10. Water usage for Armstrong Gymnasium.
