# Evaluating the Impact of Bridge Deck Removal Method on the Performance of Precast/Prestressed Concrete I-Girders

EVALUATING THE IMPACT OF BRIDGE DECK REMOVAL METHOD ON  
THE PERFORMANCE OF PRECAST/PRESTRESSED CONCRETE I-GIRDERS

Shaddi A. Assad

A THESIS

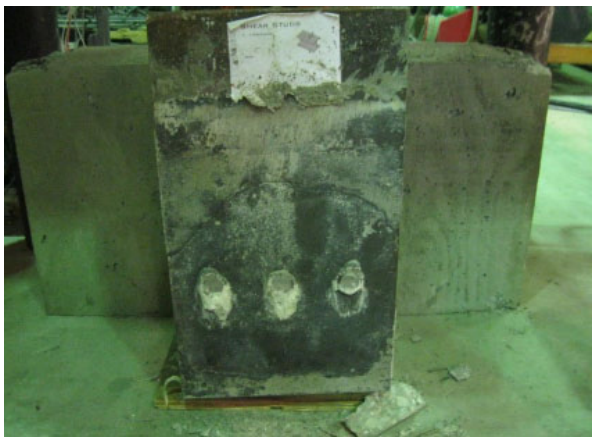
FIGURE 2-5: SHEAR STUD CONNECTOR FAILURE MODE (COURTESY OF ISU BRIDGE CENTER)

Specimen failure mode is shown in Figure 2-5. All of the shear connector types had the same resultant failure mode, which is shearing off the connector at the deck to girder interface.

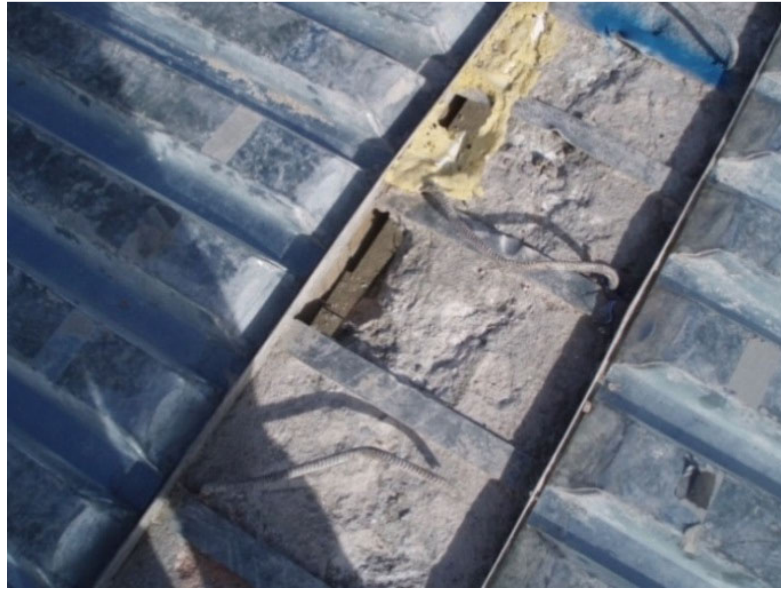
FIGURE 3-23: DAMAGED SHEAR CONNECTORS AND TOP FLANGE OF THE GIRDER

Damage occurred with the use of the large jack hammer mounted to the excavator. Figure 3-23 shows the minor damage that occurred to the top flange of the girders, as well as a half dozen shear connectors. The broken straps between the stay-in-place forms will be replaced before casting the new deck. This operation totaled 1300
