# Evaluation of Critical Flare Rates for the Midwest Guardrail System

*Midwest States' Regional Pooled Fund Research Program  
Fiscal Years 2003-2005 (Years 14 and 15)  
Research Project Number SPR-3(017)  
NDOR Sponsoring Agency Code RFPF-04-03 and RFPF-05-05*

# **EVALUATION OF CRITICAL FLARE RATES FOR THE MIDWEST GUARDRAIL SYSTEM (MGS)**

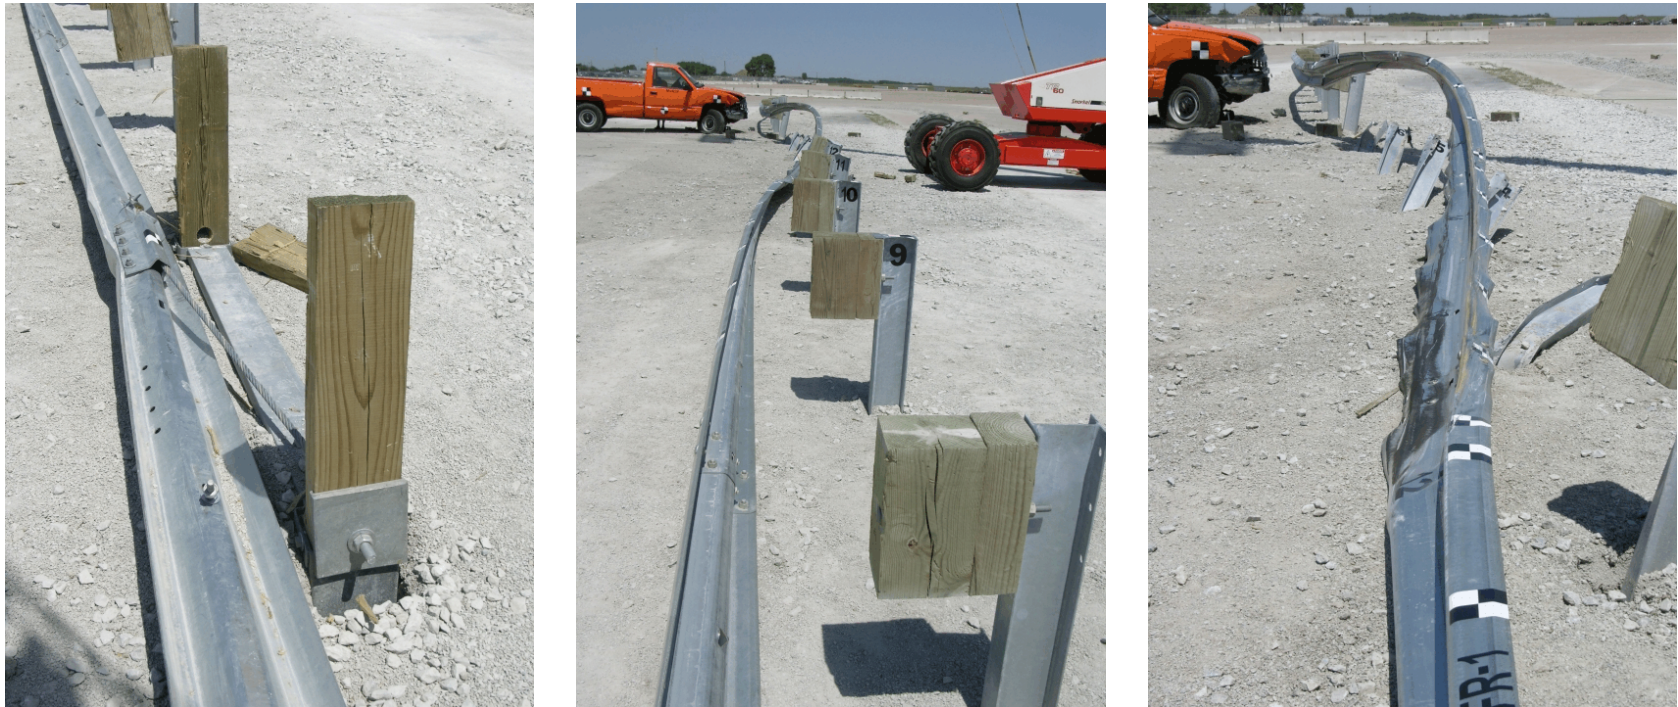
Figure 39. System Damage, Test FR-1

Barrier damage was moderate, as shown in Figures 39 through 44. Barrier damaged consisted of deformed guardrail posts, deformed W-beam rail, deformed and disengaged blockouts, and contact marks on a guardrail section. The length of vehicle contact along the system was approximately 11.4 m (37 ft - 6 in.), which spanned from the centerline of post no. 12 through the centerline of post no. 18.

The permanent set of the barrier system is shown in Figure 39. The maximum lateral permanent set rail and post deflections were 1,140 mm (44.875 in.) at the midspan between post nos. 15 and 16 and 813 mm (32 in.) at the centerline of post no. 13, respectively, as measured in the field. The maximum lateral dynamic rail and post deflections were 1,684 mm (66.3 in.) at the centerline of post no. 15 and 853 mm (33.6 in.) at the centerline of post no. 13, respectively, as determined from high-speed video analysis. The working width of the system was found to be 1,794 mm (70.6 in.).

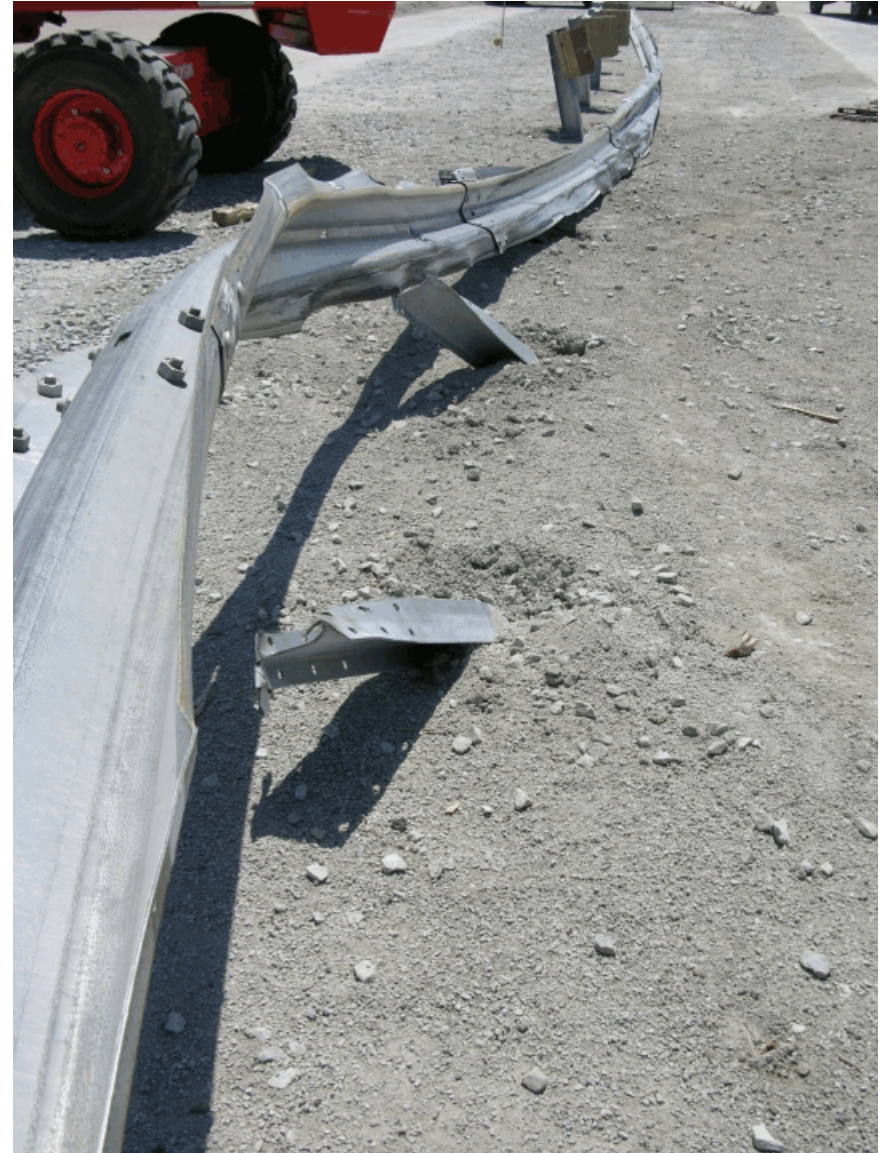
Figure 40. System Damage, Test FR-1

Moderate deformation and flattening of the impacted section of W-beam rail occurred between post nos. 12 and 18. Contact marks were found on the rail between post nos. 12 and 18. The guardrail buckled at nearly every post location between post nos. 12 and 18. Major buckling of the guardrail occurred at the upstream side of post no. 19. The W-beam was pulled off of post nos. 1 through 19. The W-beam rail sustained significant yielding around the post bolt slots at post nos. 1 through 11, 13, 14, 18, and 19. Minor tearing of the W-beam rail occurred around the post bolt slots at post nos. 12 and 15, while the tearing of the W-beam rail around the post bolt slots at post nos. 16 and 17 was very significant. No significant guardrail damage occurred downstream of post no. 20.

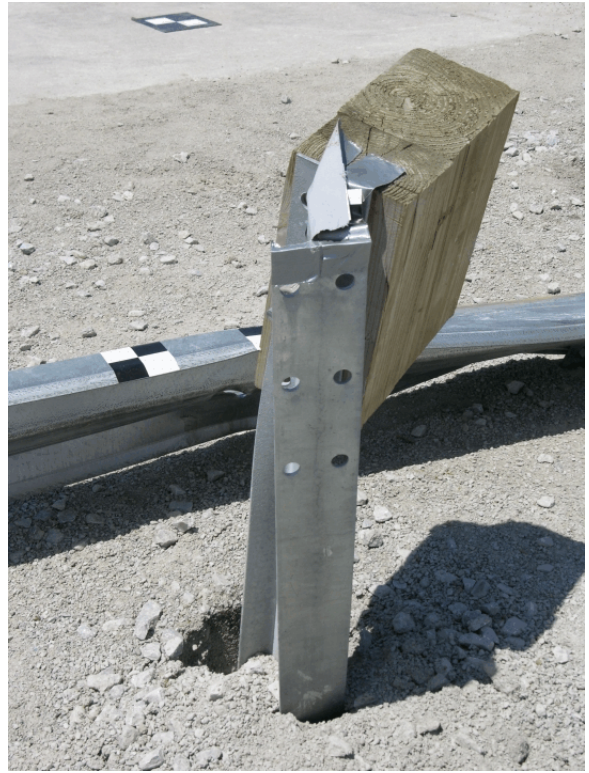
Figure 41. Post Nos. 11 and 12 Damage, Test No. FR-1

The wooden blockouts at post nos. 3 through 10 and 19 rotated slightly while still attached to the post. The wooden blockouts at post nos. 11, 12, and 18 encountered damage on the front face due to W-beam rail contact, but remained attached to the posts. The wooden blockouts at post nos. 13 through 17 were fractured and removed from the posts.

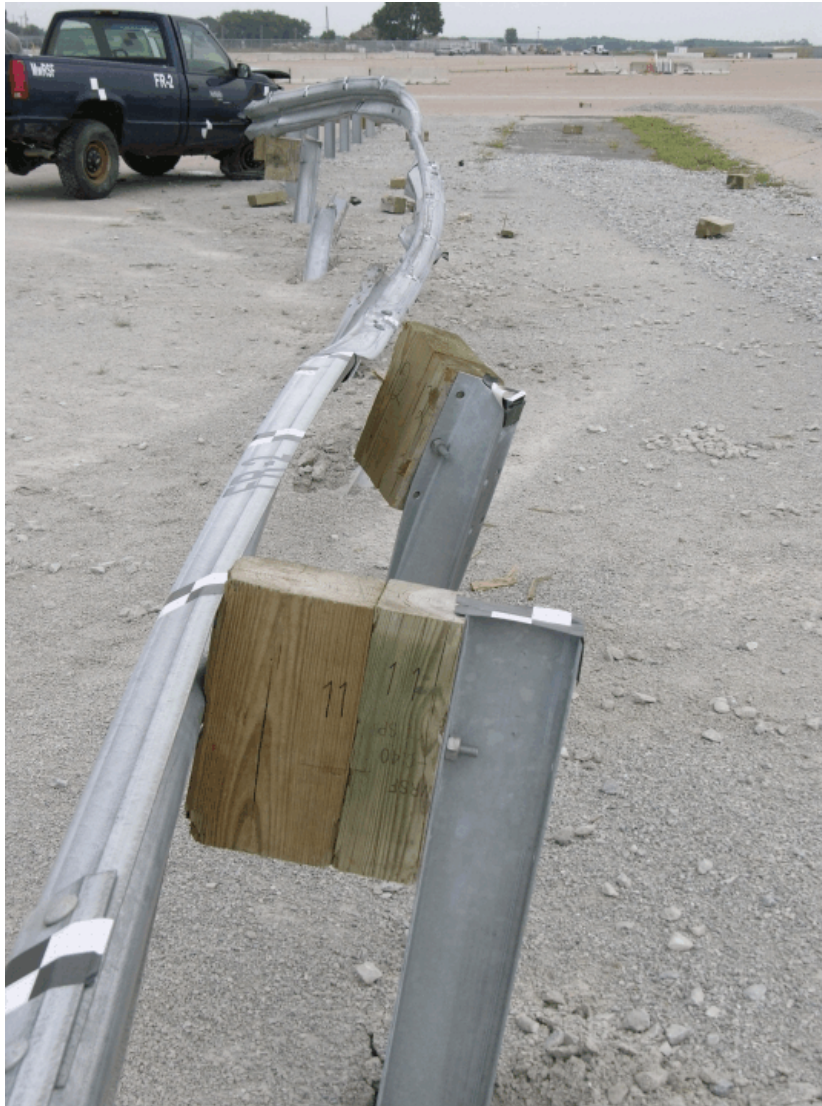
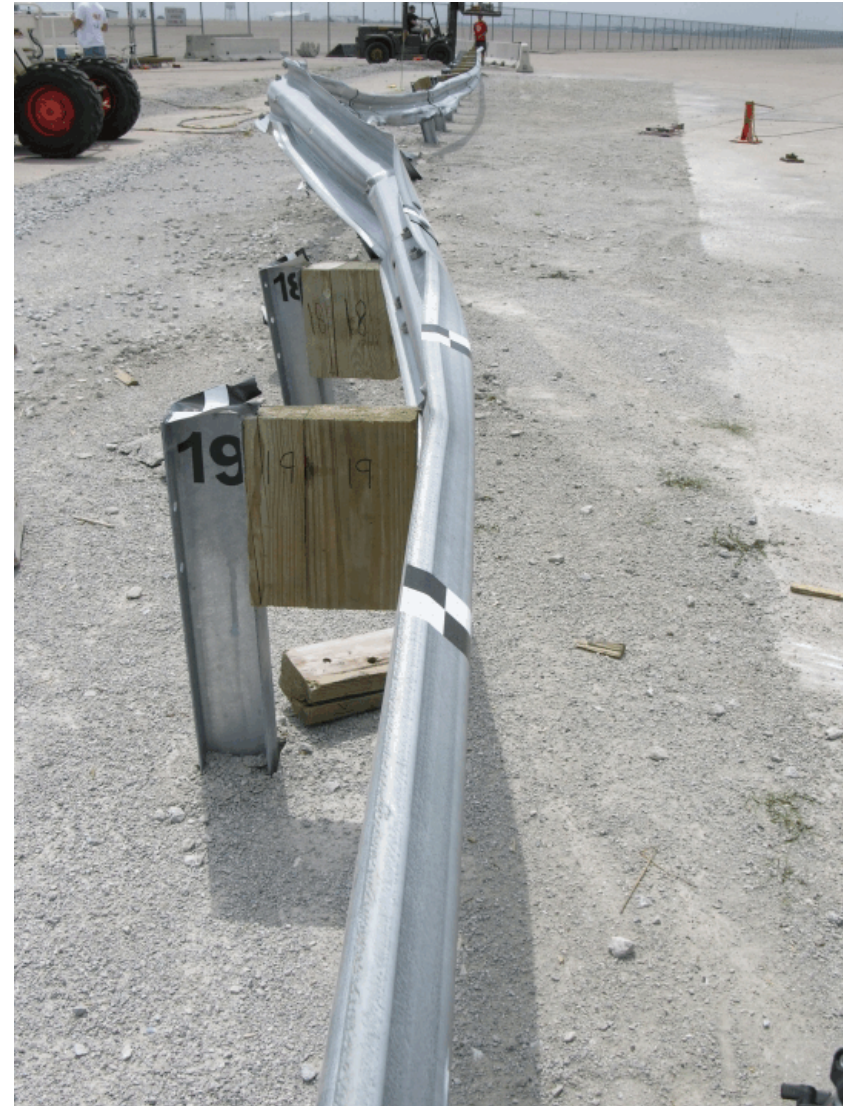
Figure 62. System Damage, Test FR-2

Damage to the barrier system was moderate, as shown in Figures 61 through 69. Barrier damage consisted of deformed guardrail posts, deformed W-beam rail, deformed and disengaged blockouts, and contact marks on a guardrail section. The length of vehicle contact along the system was approximately 16.3 m (53 ft - 6.75 in.), which spanned from 451 mm (17.75 in.) upstream from the centerline of post no. 12 through 635 mm (25 in.) downstream from the centerline of post no. 20.

Contact marks were found along the length of vehicle contact with the system. Minor guardrail deformation was found between post nos. 21 and 28. The W-beam rail was deformed and flattened between post nos. 13 and 17. The guardrail buckled at post nos. 2 and 17 through 19 and at the midspan between post nos. 11 and 12. Other guardrail buckle points were found at 432 mm (17 in.) upstream of post no. 19, 470 mm (18.5 in.) downstream of post no. 19, 203 mm (8 in.) upstream of post no. 21, and at post no. 28. The W-beam rail pulled off of post nos. 12 through 24 and 26. The W-beam rail sustained major tearing and significant yielding around the post bolt slots at post nos. 12, 15, and 26, while only minor yielding occurred around the post bolt slots at post nos. 13, 14, and 16 through 24.

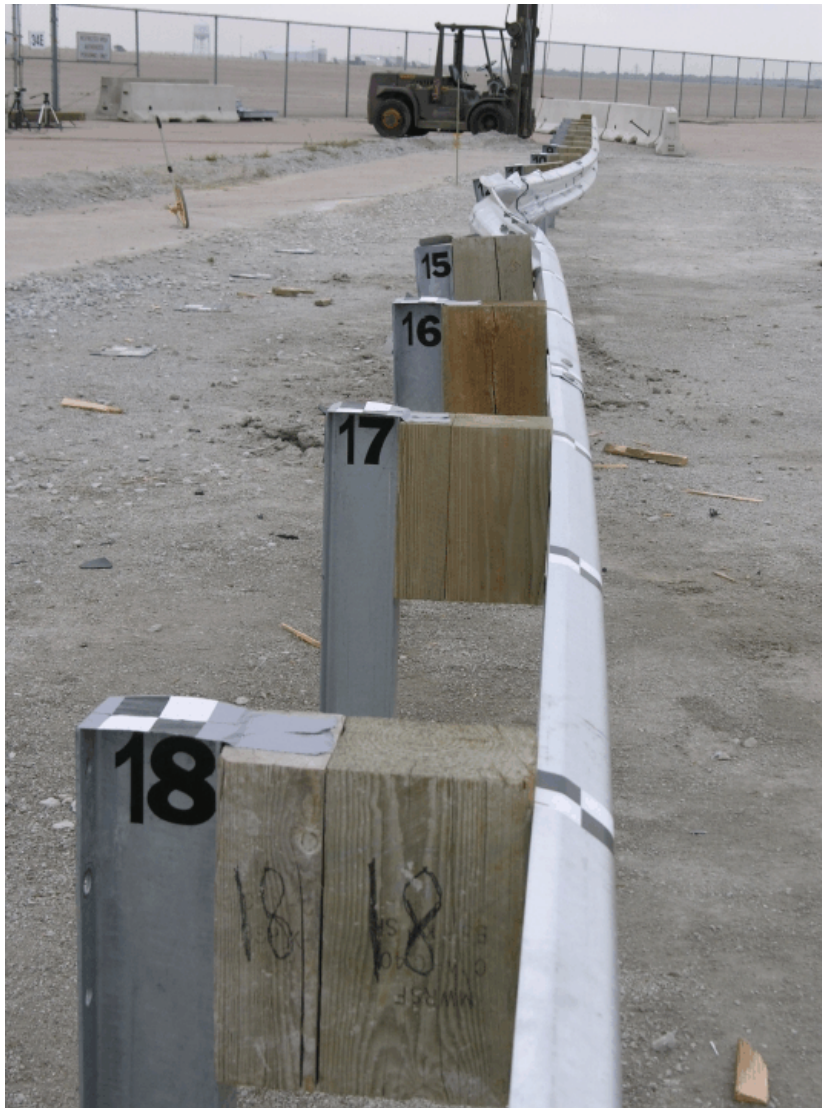
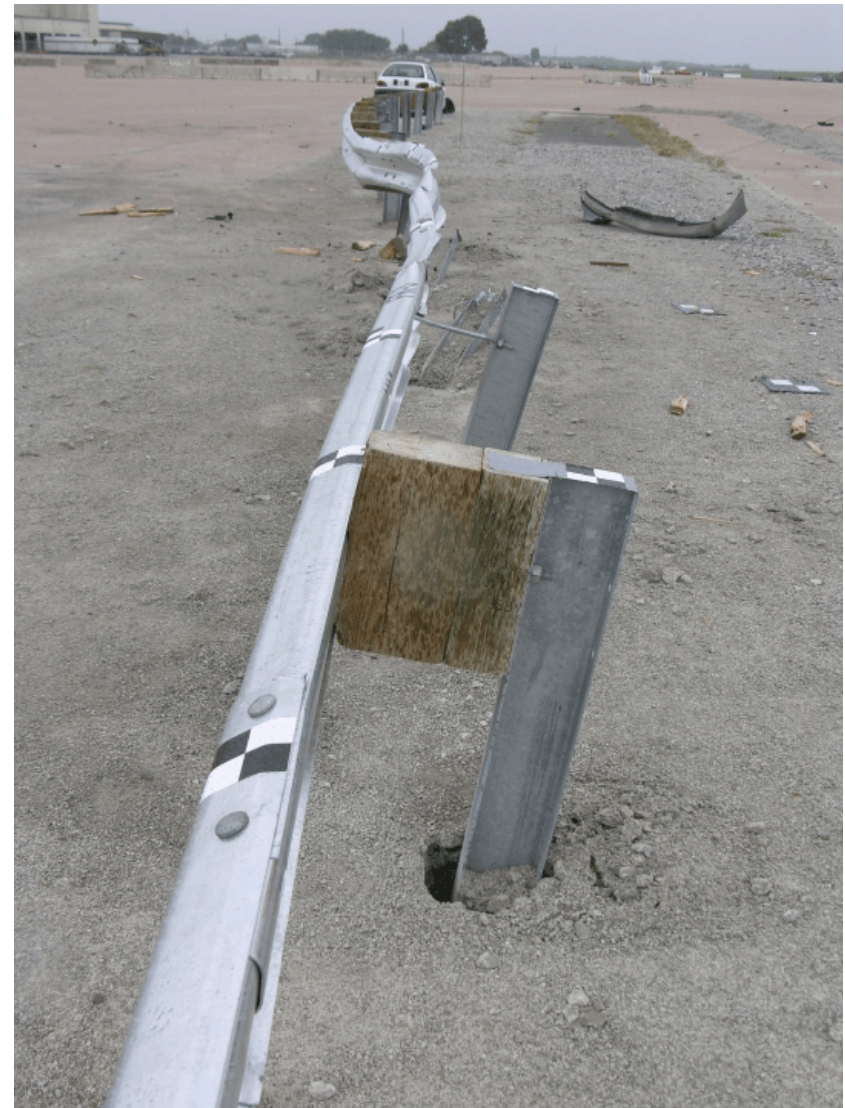
Figure 83. System Damage, Test FR-3

Barrier damage was moderate, as shown in Figure 83. Barrier damage consisted of deformed guardrail posts, deformed and disengaged blockouts, deformed W-beam guardrail, and contact marks on a guardrail section. The length of vehicle contact along the system was approximately 9.6 m (31 ft - 4.1875 in.), which spanned from 849 mm (33.4375 in.) downstream upstream from the centerline of post no. 12 through 1,086 mm (42.75 in.) downstream from the centerline of post no. 16.

Contact marks were found along the length of vehicle contact with the system. The W-beam rail was deformed and flattened between post nos. 11 and 15. The guardrail buckled at the midspan between post nos. 10 and 11, at post nos. 12 and 15, and at the midspan between post nos. 13 and 14. The guardrail also buckled at 648 mm (25.5 in.) downstream of post no. 12, at 254 mm (10 in.) and 356 mm (14 in.) upstream of post no. 13, and at 191 mm (7.5 in.) and 419 mm (16.5 in.) downstream of post no. 13. Guardrail buckle points were also found at 227 mm (9 in.) upstream of post no. 14, at 286 mm (11.25 in.) and 184 mm (7.25 in.) upstream of post no. 15, and 483 mm (19 in.) downstream of post no. 15. The W-beam was pulled off of post nos. 13 and 14. Minor yielding occurred around the post bolt slots at post nos. 12 through 15. No significant damage occurred downstream of post no. 16, except for slight deflection and minor contact marks between post nos. 25 and 28 due to the secondary vehicle contact with the system before coming to rest.

Post nos. 3 through 11 encountered minor twisting downstream, and post nos. 9 through 17 rotated backward in the soil. Post nos. 13 and 14 were also bent longitudinally downstream. The upstream and downstream end anchorage systems moved longitudinally approximately 13 mm (0.5 in.) downstream and 13 mm (0.5 in.) upstream, respectively, and the posts deflected downstream. However, all four wood BCT posts remained undamaged. The blockouts at post nos. 12 through 14 were fractured and removed from the system.
