**Field Demonstration Report**  
**Enhancing Direct Assessment by Inspection through**  
**Coatings and Buried Regions of Non-Piggable Pipelines**

23 August 2007

Contract DTPH56-06-T-0009

Prepared for:  
US Department of Transportation  
Pipeline and Hazardous Materials Safety Administration

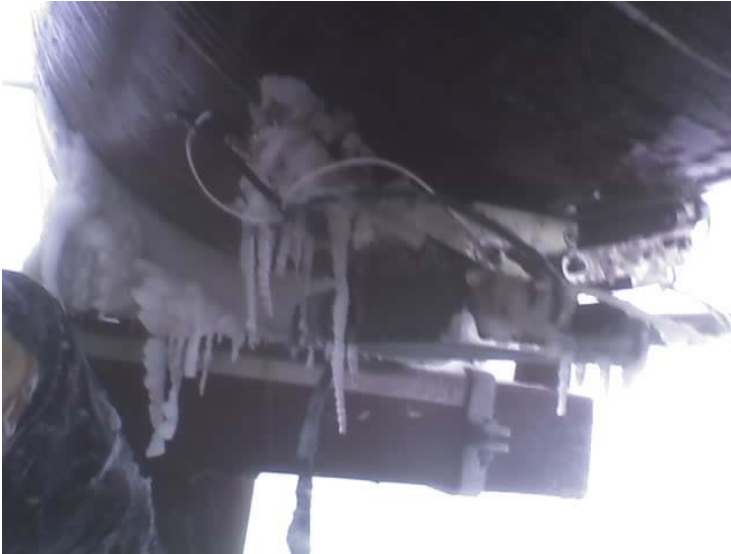
1. During the beginning of this R&D Project, in August of 2006, there was a major petroleum line in Prudhoe Bay Alaska shut down due to internal pitting corrosion. The 34" oil transit line was responsible for approximately three percent (3%) of the petroleum supply to the lower 48 states. This shutdown immediately became highly visible to the environmental groups, jurisdictional authorities and even the national media. Approximately 10 miles of insulated pipe had to be inspected for internal corrosion as soon as possible. Any applicable NDE technique was mobilized to attach this monumental task. The USDOT and DOE became involved to evaluate the effectiveness of these techniques because conventional Ultrasonic Testing, UT, and Automated UT, AUT, was simply too slow to be practical. To make matters worse most of this line was

insulated which required a significant effort to remove the coating and prepare the surface sufficiently for conventional UT. The Non-Contact EMAT CIRC tool was prepared to inspect this pipe through the tape wrapped coating and after extensive qualifications by the DOT and DOE the method was determined to be the “Preferred Screening Tool for Coated Pipelines”. The Sonic Sensors EMAT CIRC tools were the only EMAT tools and they completed the entire exam before Thanksgiving of 2006 where the extreme cold of the North Slope posed great hardships for the equipment and operators. The inspection performance for this pipeline required a 100% probability of detection, POD, for a 50% deep pit. The EMAT CIRC tool proved a 100% POD for a 25% deep pit in uncoated pipe and a 30% deep pit in the tape wrapped coated pipe.

**Figure 2: EMAT CIRC Scanner with icicles scanning the bottom of the 34” oil transit line in Prudhoe Bay Alaska.**

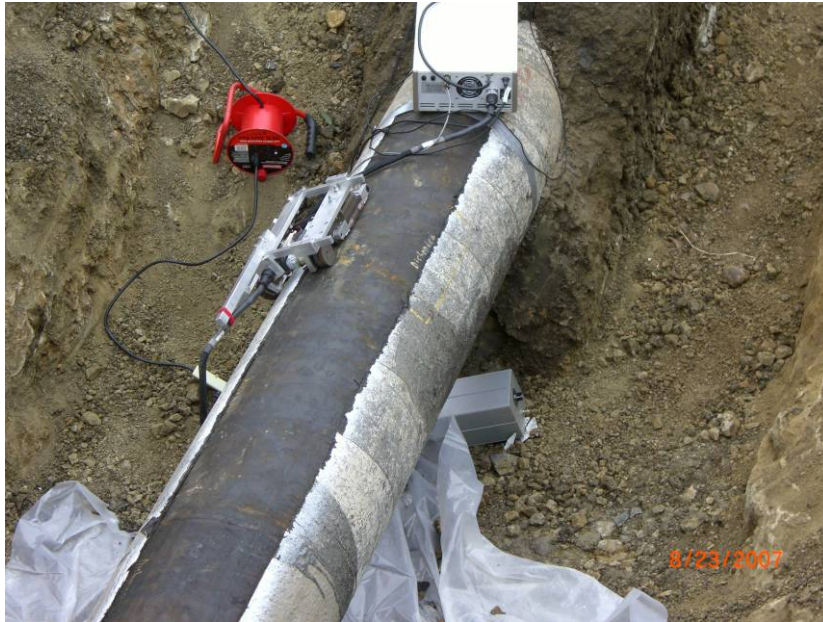
**Figure 3: Field demonstration at an ECDA dig on a 20" asphalt coated pipe. The scanner is shown half on the 1/4" coating and half on the bare pipe. The inspection instrument is on the pipe at the top of the photo.**

A 20 inch pipeline was completely excavated exposing approximately 10 feet of the pipe. The asphalt coating was approximately 1/4 inch thick and was too thick for the thin coating tool. A 12 inch wide strip of the coating was removed from the top surface of the pipe as shown in Figure 3. One scan was performed on the exposed bare metal surface of the pipe and the other scan was half on the coating and half on the bare pipe. The results of both scans were identical and effectively proved the pipe free of internal corrosion as well as external corrosion without removing the remaining 80% of the asphalt coating. The integrity of the coating was also evaluated and a previous coating repair 14 inches to one side and including the girth weld was bonded significantly better than the original coating. This was apparent on the scan.

The inspection was verified by removing the remainder of the coating exposing no visible external corrosion. The EMAT CIRC scan was repeated on the bare pipe for verification and no corrosion was detected but an insignificant “Stable” long seam variation was detected and visually confirmed.
