DEVELOPMENT OF A TL-3 F-SHAPE TEMPORARY CONCRETE MEDIAN BARRIER

MIDWEST ROADSIDE SAFETY FACILITY

IOWA DEPARTMENT OF TRANSPORTATION

MwRSF Research Report No. TRP-03-64-96 December 1996

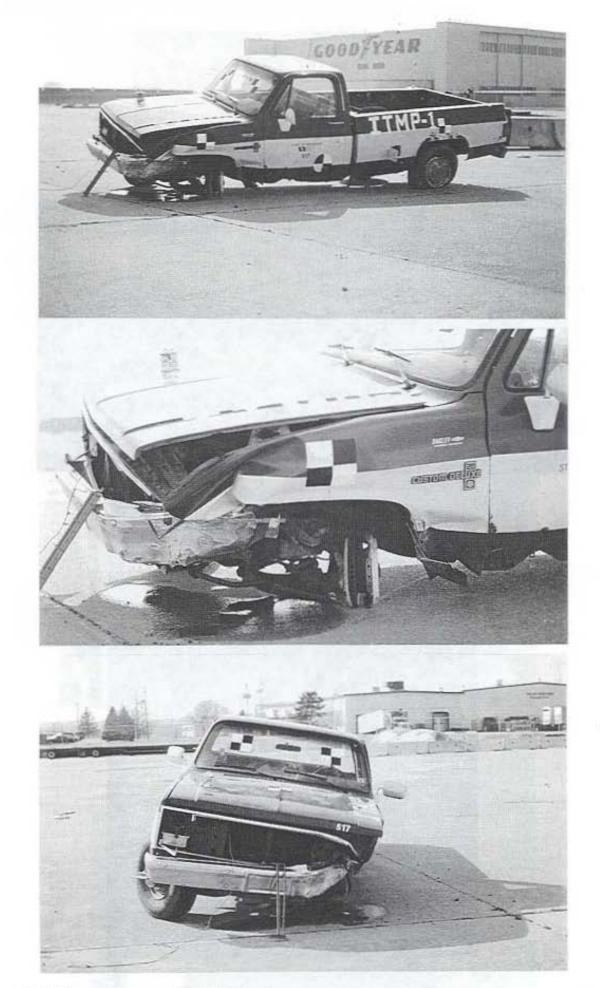
Figure 18. Vehicle Damage, Test ITMP-1

Vehicle damage was moderate, as shown in Figure 18. The front bumper and left-front quarter panel were crushed inward. The left-front wheel assembly was dislodged during the impact as the outer steel rim fractured from the inner region attached to the wheel hub. The steel frame was slightly bent inward near the front with a slight twist along its length from front to rear. Maximum occupant compartment deformations to the floorboard were 127 mm of longitudinal displacement near the center firewall region and a vertical displacement of 32 mm and 51 mm near left-side floorpan and center hump, respectively. The deformations to the floorboard were judged insufficient to cause serious injury to the vehicle occupants.

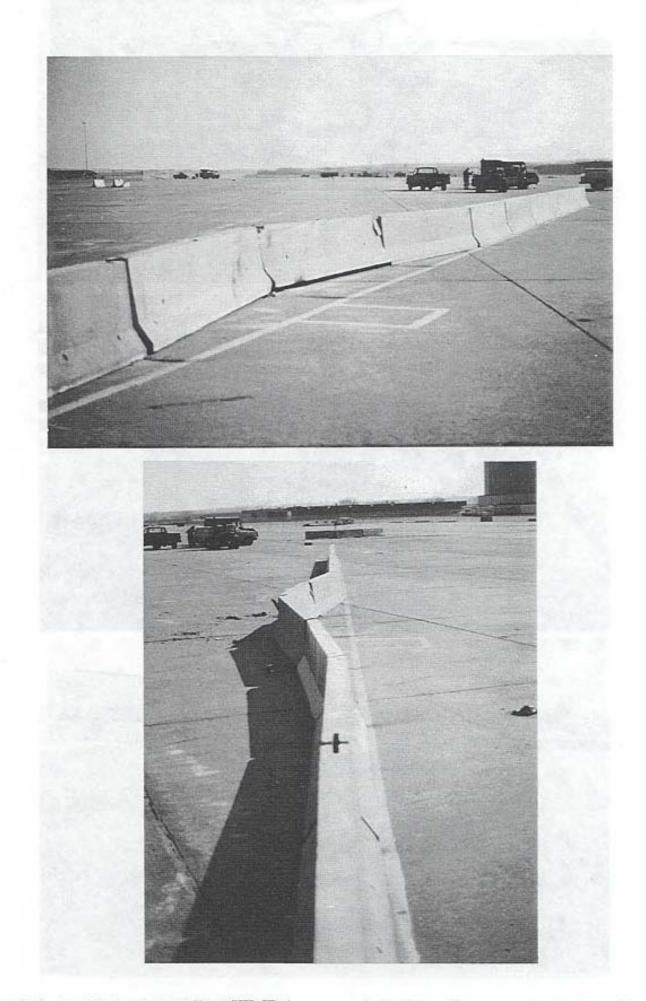
Figure 19. Barrier Damage, Test ITMP-1

Barrier damage was extensive, as shown in Figures 19 through 22. Concrete damage consisted of tire marks, scrapes, gouges, spalling, and fractured concrete pieces. The ends of barriers nos. 7 through 10 were cracked and fractured at various locations, and two cracks were also observed to extend through barrier no. 9. Ten of the steel connector pins were also deformed, ranging from slight to extensive. The maximum permanent set deflection of the barrier was 0.99 m.

Following the unsuccessful crash test on Design No. 1, it was necessary to determine the cause of the poor barrier performance so that design modifications could be made to the system. A careful examination of the damaged barrier system revealed that considerable damage occurred at the barrier joints, most likely resulting from the inherently weakened recessed areas located at the top end of each barrier. It is believed that the recessed areas weakened the pin and rebar connection causing the rebar loops to deform significantly during the impact, thus allowing for excessive joint rotations and barrier uplift. This joint and barrier movement led to increased vehicle climbing and penetration over the barrier system.

In order to reduce the joint rotations between barrier segments as well as to prevent barrier uplift, it was necessary to strengthen the barrier ends by eliminating the recessed areas. This retrofit was completed in a three step process, as shown in Figures 23 and 24. First, concrete was removed at the top end of each barrier to expose both the vertical shear and longitudinal reinforcement. Second, vertical holes were drilled in the exposed concrete region at each end of the barrier. Two U-shaped steel bars were then epoxied into the holes to close the tops of the two end-stirrups. Finally, concrete was placed at each end to return the barrier to its original shape. In addition, it was deemed necessary to reduce pin deformations by decreasing the clearance between the bottom of the lower rebar loop and the top of the bottom plate. This 25-mm reduction in clearance was achieved by shortening the 31.8-mm diameter steel pin and repositioning the 12.7-mm diameter hole near the base, as shown in Figure 23. A photograph of the modified pin and rebar connection is shown in Figure 25.

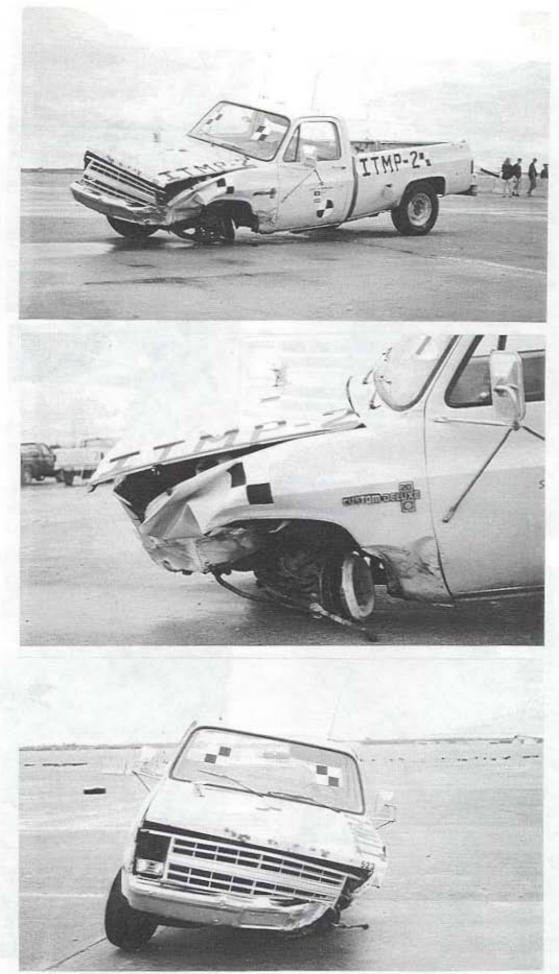
Figure 31. Vehicle Damage, Test ITMP-2

Vehicle damage was moderate, as shown in Figure 31. The front bumper and left-front quarter panel were crushed inward. The left-front wheel assembly was dislodged during the impact as the outer steel rim fractured from the inner region attached to the wheel hub. The steel frame was bent inward near the front with a significant twist along its length from front to rear. Maximum occupant compartment deformations to the floorboard were 55 mm of lateral displacement near the firewall and both a vertical and longitudinal displacement of 38 mm near the center hump behind the gear shift. The deformations to the floorboard were judged to be insufficient to cause serious injury to the vehicle occupants.

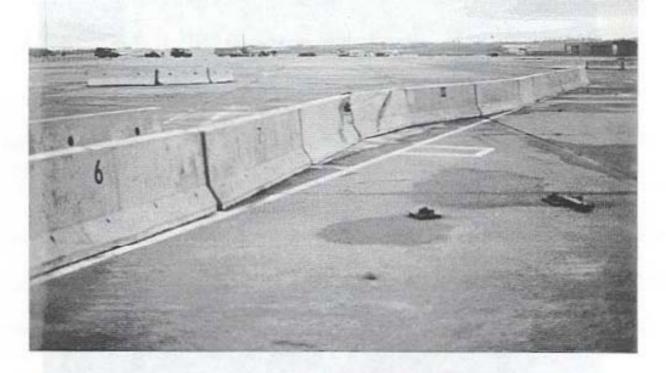
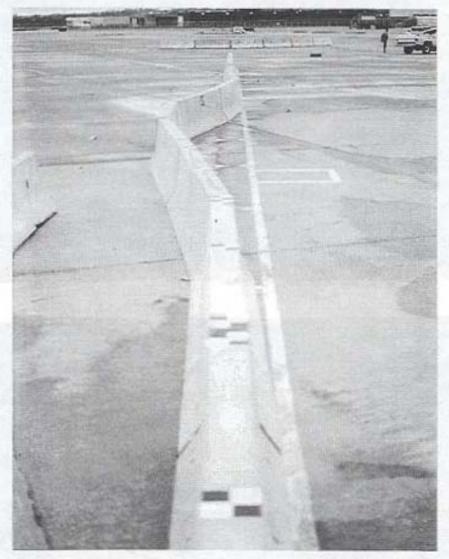
Figure 32. Barrier Damage, Test ITMP-2

Barrier damage was minor, as shown in Figures 32 through 34. Concrete damage was mostly cosmetic, consisting of tire marks, scrapes, gouges, and minor spalling. Nine steel pins were also deformed, ranging from slight to extensive. The maximum permanent set deflection of the barrier was 1.14 m.
