# Post-Fire Damage Geospatial Assessment via Point Clouds of a Highway Bridge Structure

**ABSTRACT:** This paper discusses the quantitative post-fire damage assessment of a steel girder bridge via point clouds. In this case study, the point cloud was collected using light detection and ranging (lidar) for a detailed geometric and shape analysis. The out-of-plane deformation was analyzed to locate and quantify buckling across the length of the steel girders.

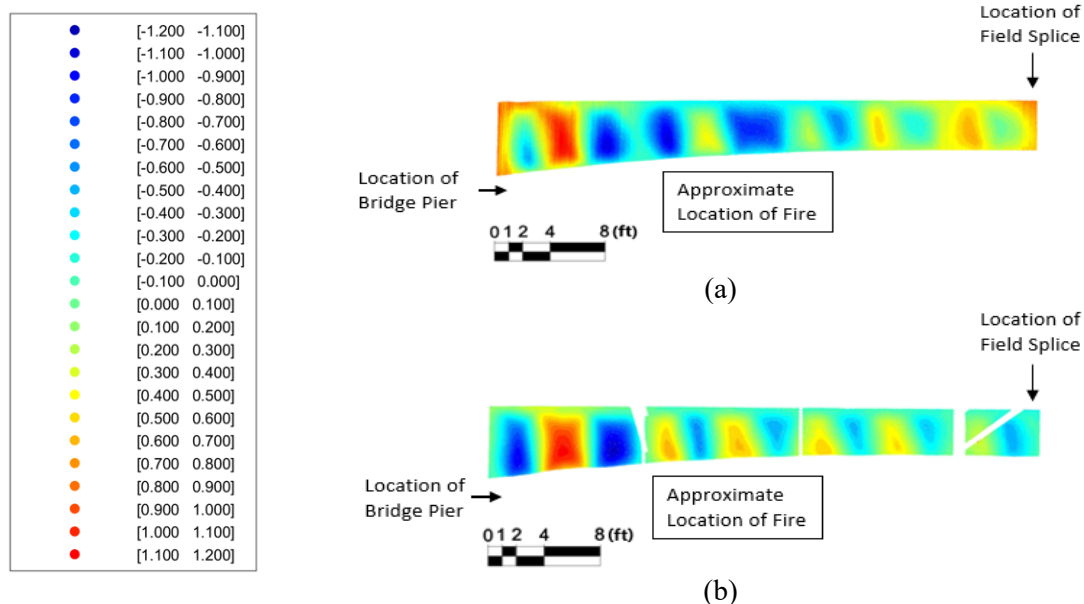
The visualization of the depth-map analysis enables the identification of the locations of maximum and minimum out-of-plane-deformation as well as its distribution throughout the girder web. As shown in Figure 2, the two girders underwent a severe deformation due to the elevated temperatures, where they experienced a total deformation (range from the minimum to the maximum) in excess of 2.2 inches approximately at the distance of 3.5 ft from the pier, respectively. In addition, the depth-map visualization indicates that second eastmost sustained additional localized deformations with maximum magnitudes in excess of 1.1 inches throughout its length up to the field splice in both out-of-plane directions. The eastmost girder sustained a localized out-of-plane deformation with a maximum magnitude of 1.2 inches, with respect to the reference plane, in the vicinity of the pier with additional localized deformation near the field splice. Similar analysis and results were detailed on other girders in both the eastbound and westbound lanes as well as select cross-frames [1].

Figure 2. Depth map analysis results (in inches) on the westbound span (a) eastmost girder, (b) second eastmost girder.

Point clouds are an emerging data format that can be widely applied to various infrastructure. This case study presents the precise quantification of the out-of-plane deformation of bridge girders to monitor steel buckling for potential intervention. Buckling behavior as small as 0.1 in was evident in the depth maps, indicating the applicability of this approach for a variety of buckling monitoring scenarios. Based on this work and for precise quantification, it is recommended to use a single scan to avoid registration error, which introduces offsets even in tightly aligned point clouds. Furthermore, geometric information is observed to be most reliable since RGB information is inconclusive due to environmental effects (e.g., staining and power washing on the girders). Moreover, the depth map analysis incorporated only the lowest 99% of the points due to the presence of outlier points despite carefully applied filters. Inclusion of 100% of the points substantially reduces the resolution of the depth maps due to their low observed frequency of occurrence combined with the higher magnitudes of the highest 1%, which skews the color map.
