Corrosion of Steel Shipwreck in the Marine Environment: USS *Arizona*—Part 1

2006 Materials Performance 45(10), pp. 40-44

Corrosion of Steel Shipwreck in the Marine Environment: USS Arizona—Part 1

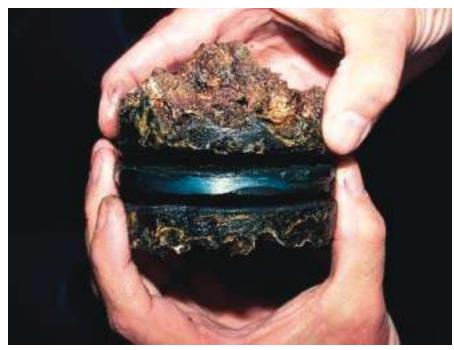
FIGURE 3

Composite interior/exterior concretion with hull metal coupon from USS Arizona; sample taken from a water depth of 5 ft (1.5 m), port side.

near amidships frame 75 (each frame represents a 4-ft [1.2-m] section of the hull, beginning at the bow with frame 1), from near the water line to just below the mudline. The ship's blueprints were consulted to ensure that no compartments containing oil would be penetrated. Figure 3 is a picture of a core sample taken at a depth of 5 ft (1.5 m) with intact concretion on

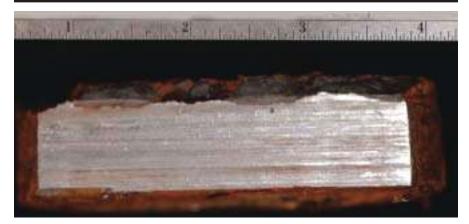
FIGURE 4

Cross section of metal coupon from USS Arizona; sample taken from a water depth of 19.5 ft (5.9 m), port side.

Multiple optical metallographic measurements were made on each metal coupon at Rail Sciences Laboratory in Omaha, Nebraska. Figure 4 shows the cross section of a typical sample taken at 19.5 ft (5.9 m) below the water surface. General corrosion was evident in this macrophotograph, as it was on the other seven samples. For comparison, the sample in Figure 3 taken near the water's surface shows severe corrosion from wave action and corrosion from both sides. The bar graphs in Figure 5 (port) and 6 (starboard) are representations of the results of this analysis in terms of metal loss as a function of original plate thickness and water depth. The original nominal hull plate thickness was identified from original cross-section drawings, amidships, at frames 75 and 93. Thicknesses in the original blueprints were expressed in terms of weight per unit area (lb/ft²). The magenta on each horizontal bar corresponds to metal lost during 61 years of seawater exposure. The direct corrosion rate is determined by subtracting the thickness of metal remaining from the original thickness, dividing the result by time (61 years), and multiplying by 1,000. The equation is given by:

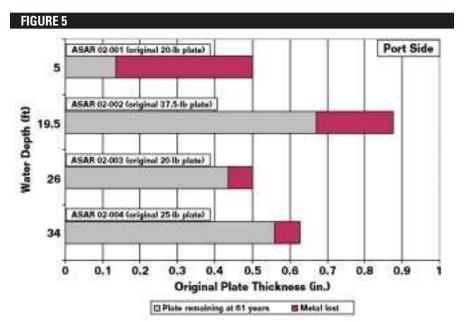
Metal loss (magenta) on USS Arizona as a function of water depth, port.

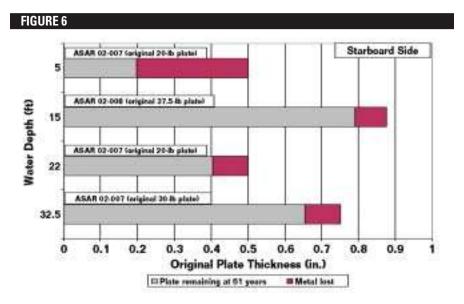
Metal loss (magenta) on USS Arizona as a function of water depth, starboard.
