Post-Earthquake Structural Damage Assessment Through Point Cloud Data

Eleventh U.S. National Conference on Earthquake Engineering
Integrating Science, Engineering & Policy
June 25-29, 2018
Los Angeles, California

POST-EARTHQUAKE STRUCTURAL DAMAGE ASSESSMENT THROUGH POINT CLOUD DATA

M. E. Mohammadi¹ and R. L. Wood²

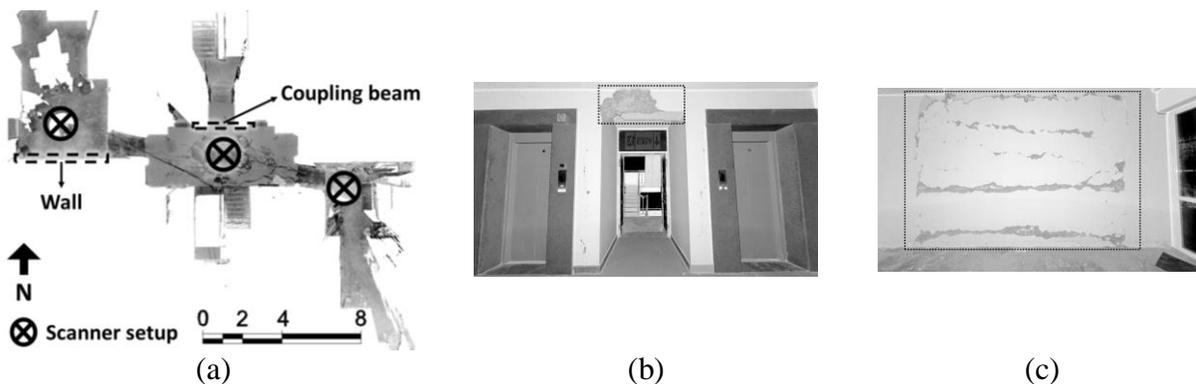
The 18-story RC apartment building sustained moderate damage as result of the main event and the following aftershocks. The damage observed in various components including nonstructural exterior and interior infill walls, separation of infill walls and adjacent columns, beam-column joint cracking, and concrete spalling and cracking within the coupling beam elements. To document the sustained damage throughout the structure the team utilized Faro Focus X-130 scanner. A phased-based scanner, Faro X-130 can collect up to 1 million points per second at range of 130 meters [26]. A total of 16 lidar scans were collected from 5 selected levels, namely the 3rd, 6th, 9th, 12th, and 15th floors. This pattern of data, allows to document damage throughout the structure and study the damage propagation and evolution as the function of building height. To achieve this objective, two common members were selected and analyzed by the damage detection method. Fig. 1a represents the typical scanner setup for each floor to scan the common members throughout the structure [11]. The first member selected was a 1.7 m long coupling beam located roughly at the center of structure (Fig 1b). The second member was a 4 m by 2.7 m (L×H) infill interior wall located at the west of the structure (Fig. 1c).

Figure 1. 18-story structure damage survey: (a) top view of floor along with typical scan placements and location of common members to investigate the damage Evolution. (b) View of coupling beam and (c) view of the interior masonry infill wall [11].

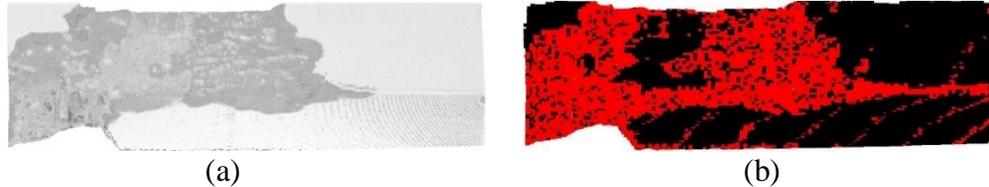
The coupling beam point cloud consists of two surfaces of beam as demonstrated in Fig. 2a. This will allow to assess the performance of the developed method for data with more complex geometries, here a coplanar surface. The analysis result of the coupling beam is illustrated in Fig. 2b. To analyze this cloud, initially the point-to-point spacing was regulated to 0.5 cm. Afterwards, the two geometrical features for each point and its 8 closet neighboring points were computed and

initial damage confidence level was set to 60%. Then, the developed method identified the significant concrete spalling and exposed rebars within the point cloud. Fig. 2b illustrates the results of the methodology. The output damage percentile after damage evaluation step was 47%. The second selected point cloud from this high-rise building is the common wall, which is a planar surface. As shown in Fig 3a, the common wall sustained significant horizontal cracking in the middle and its perimeter where it meets the beam and columns. To analyze the wall, initially the point-to-point spacing was regulated to 0.5 cm. Then, the significant cracking and other defects were identified through comparison of each surface feature and initial damage confidence level of 50% (Fig. 3b). The final damage percentile for the wall was 11%.

Figure 2. Evaluation of detected damage for the coupling beam: (a) black and white point cloud of the beam (b) color-coded point cloud where detected surface defects are shown in red (grey) [11].

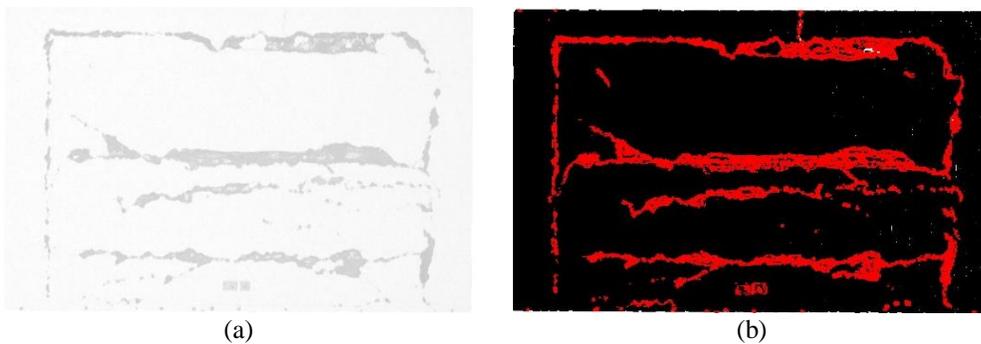
Figure 3. Evaluation of detected damage for the selected wall: (a) black and white point cloud of the wall and (b) color-coded point cloud where the detected surface defects are shown in red (grey) [11].

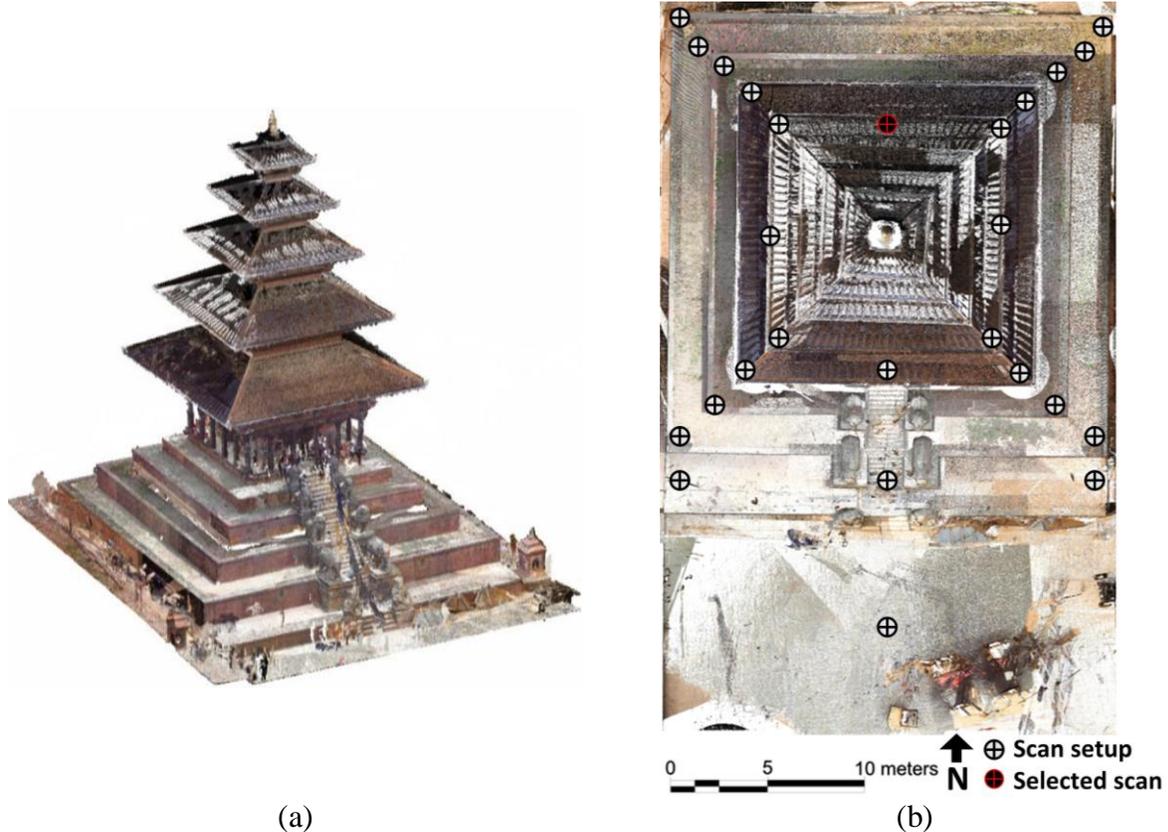
The second structure selected is the Nyatapola Temple which sustained moderate-to-severe damage during the earthquake sequence. A series of large shear cracks were observed at the base level exterior walls, in close proximity to door frames, as well as various surface defects including loss of grout and dislodged bricks throughout the structure. To survey the structure, the research team performed a total of 38 scans at various distances [27]. Fig. 4a represents the final point cloud of the Nyatapola temple. Due to various activities during the scanning sequence at the base level, architectural design of the temple, and to minimize the occlusion in the final point cloud data, a total of 26 of those 38 scans were conducted at the base level to the bottom of the tiered plinth (Fig. 4b). To evaluate the developed method for the earthen masonry wall, a single scan of the base level north wall was used as input data which contains approximately 9 million points (Fig. 5a). The location of the selected scan is highlighted in Fig. 4b. As a result, the point cloud contains various damage patterns (e.g. crack at the north wall) and occlusion due to the presence of ornate

Figure 4. Nyatapola temple structure: (a) southwest isometric view and (b) plan view of scan locations along with the location of selected scan [27].

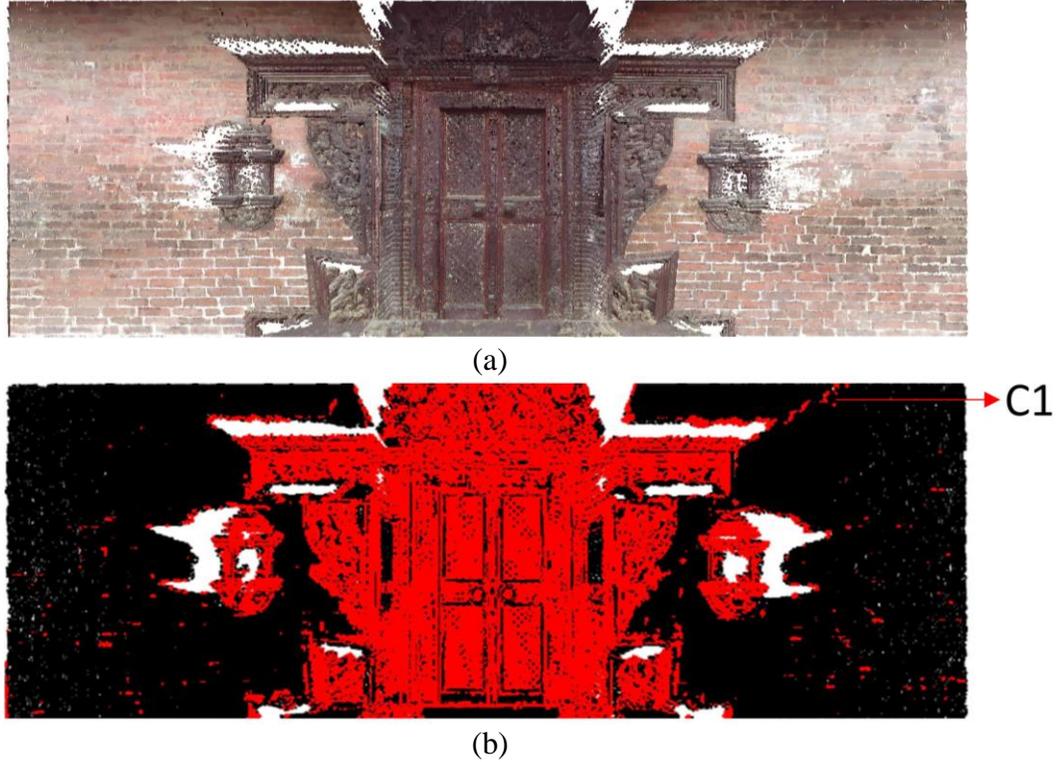
To analyze the five-story temple, the point cloud was first regulated to a point spacing of 1.25 cm. This is larger than the high-rise structure due to the large variation in point density near corners as a result of laser beam dispersion and due to the close scanner placement to the structure with a resultant high angle of attack at the corners. Then, the two geometrical features were computed for each vertex and its 8 closet neighbors. Also, the initial damage confidence level was set to 60%. Following the damage evaluation step, Fig. 5b illustrates the result of each feature classification and the identified significant cracks and other surface defects. The developed method was able to detect all surface defects and cracks with dimensions of 1.25 cm and larger. This includes the large shear crack on the top right of the entrance. Furthermore, this developed method was successful in the identification of damage near the two edges despite the occlusions in the point cloud. One drawback however, the method falsely identified a series of point as likely damage due to the ornate architectural details of the wall sculptures and door lintel. Using these results, the detected damage enabled analysts to measure the defects with a high-level confidence to characterize the structure and update a finite element model [27]. The quantification results for the significant crack on the top right of the entrance (crack C1) are presented in Table 1. To measure the crack length, the total length of the highlighted connected segments in the horizontal direction was measured. Similarly, to measure the width of the crack, multiple measurements in the vertical direction were taken and the mean width is reported.

Figure 5. North wall damage detection details: (a) RGB colored point cloud and (b) color coded point cloud where the detected surface defects are shown in red (grey).

Classification	Quantified Damage
Shear crack western side of door frame	68 cm (L) by .3.25 cm (W)
