Evaluation of Dowel Bar Inserter Practices in PCC Pavements with Magnetic Tomography Technology

Report MPMC-04

Final Report
26-1121-4027-001

December 2016

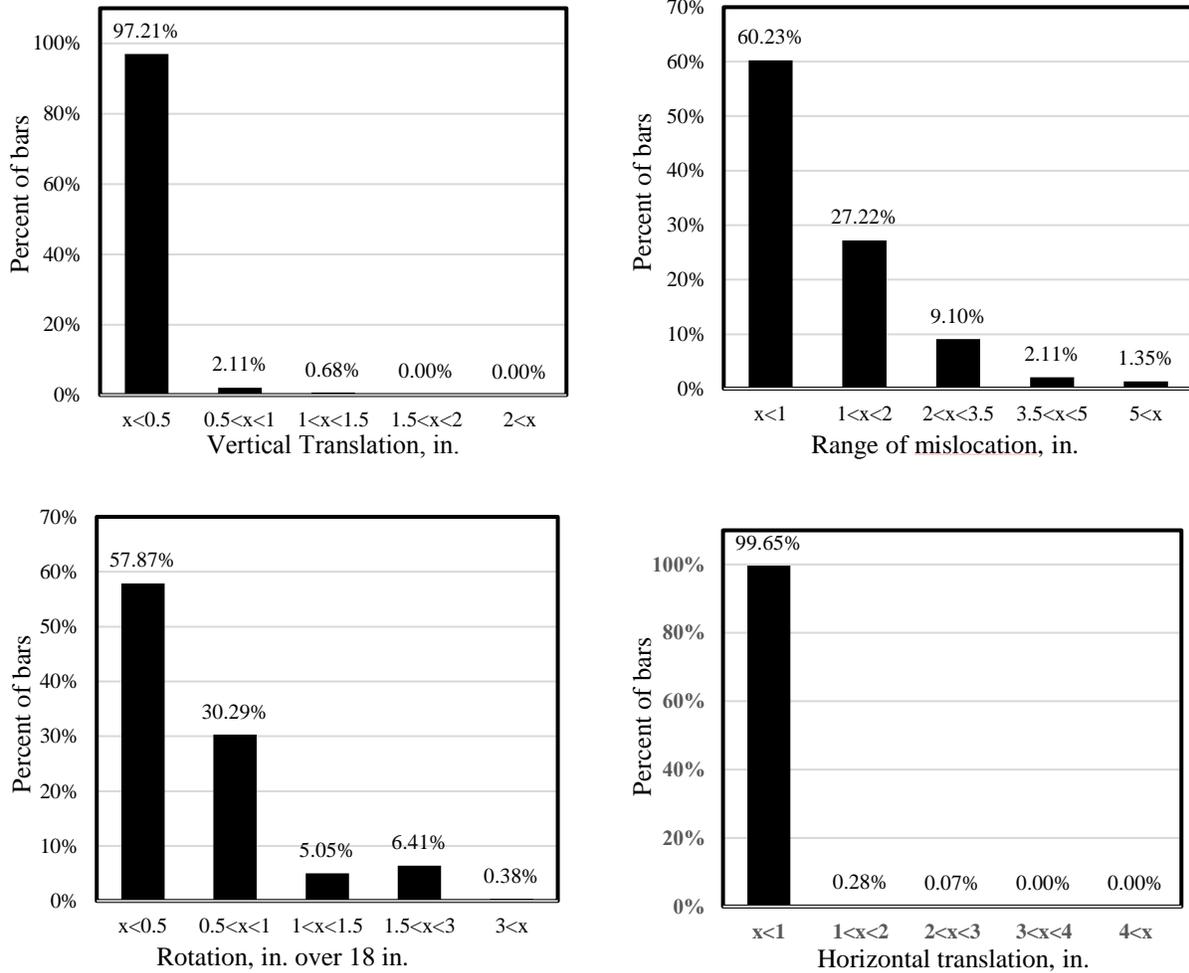
Figure 3.4 Dowel misalignment for Norfolk project

The Norfolk project has higher rotational misalignment compared to Roscoe, with 12% outside acceptable tolerances compared to less than 3% for Roscoe. Seven percent of Norfolk joints fall outside the rejection criteria of FHWA and ACPA, compared to less than 2% for Roscoe.
