## Crashworthy Perforated Square Steel Tube (PSST) Mailbox Support – Phase I

# **CRASHWORTHY PERFORATED SQUARE STEEL TUBE (PSST) MAILBOX SUPPORT – PHASE I**

MwRSF Research Report No. TRP-03-473-23

July 7, 2023

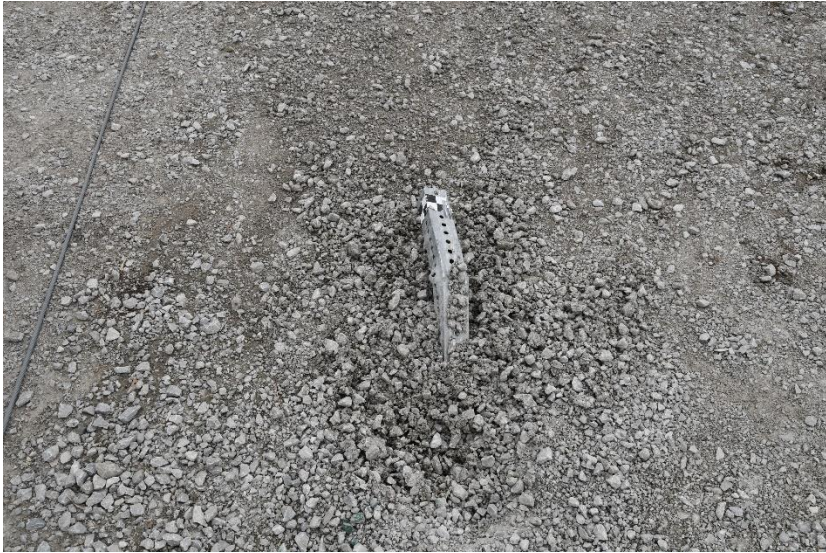
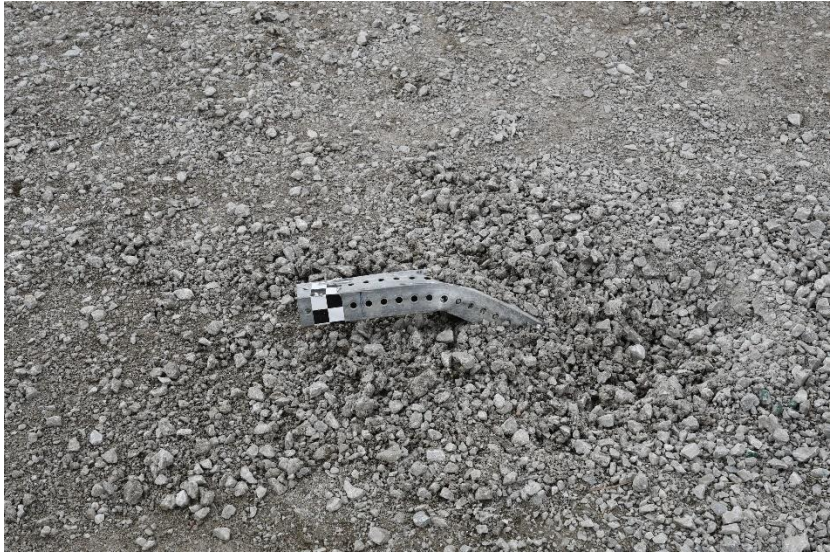
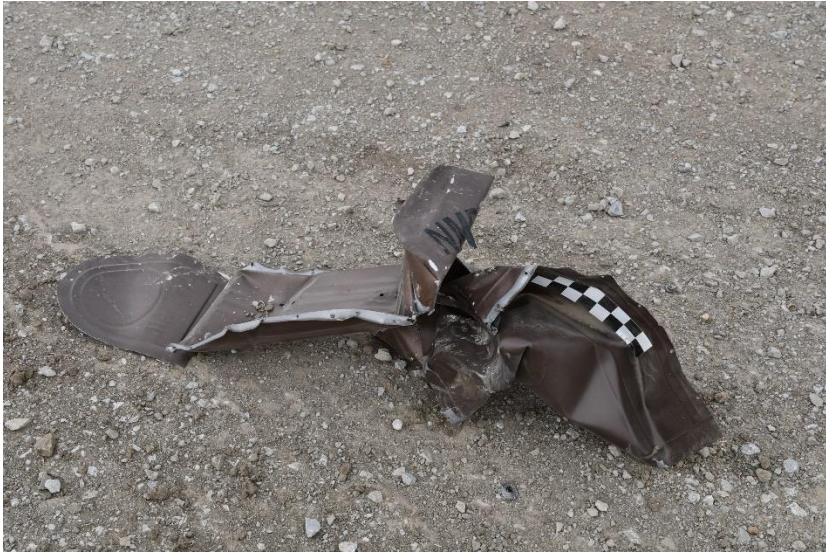
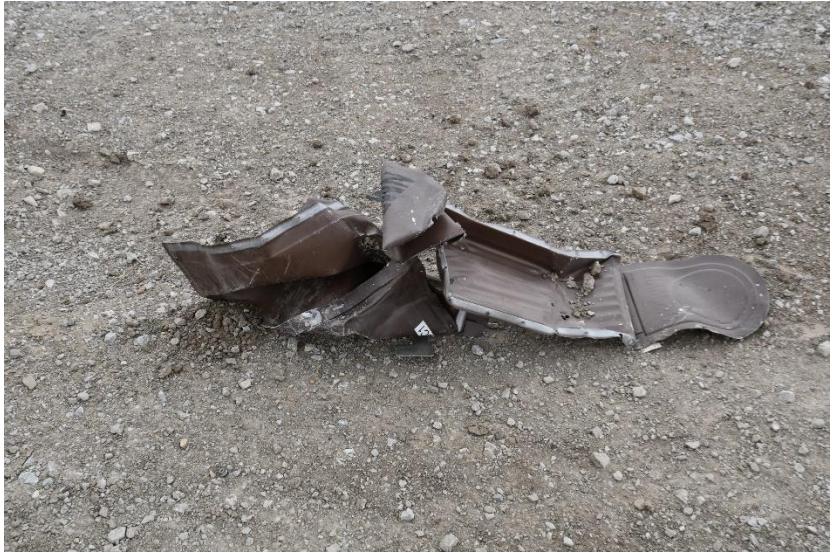
Figure 52. System Damage, Test No. NMB-1A

mailbox down toward the hood. The mailboxes impacted the upper third of the hood at 0.022 sec after initial impact. The PSST did not separate from the embedded stub in this impact, but partial fracture of the PSST post was noted near the stub socket. Without post release from the stub, the post was pulled down beneath the vehicle. This motion generated sufficient load to fracture the spade bolts connecting the TAPCO mounting assembly to the top of the PSST post. Fracture of the spade bolts released the mailboxes and TAPCO mounting bracket from the PSST at 0.040 sec after impact. After the mailboxes released, the mailbox and mounting bracket were propelled up and to the side of the 1100C vehicle with little to no relative velocity toward the windshield. The vehicle continued downstream and overrode the PSST support post and stub. No contact with the windshield or deformation or penetration of the occupant compartment were observed due to contact with the mailbox.

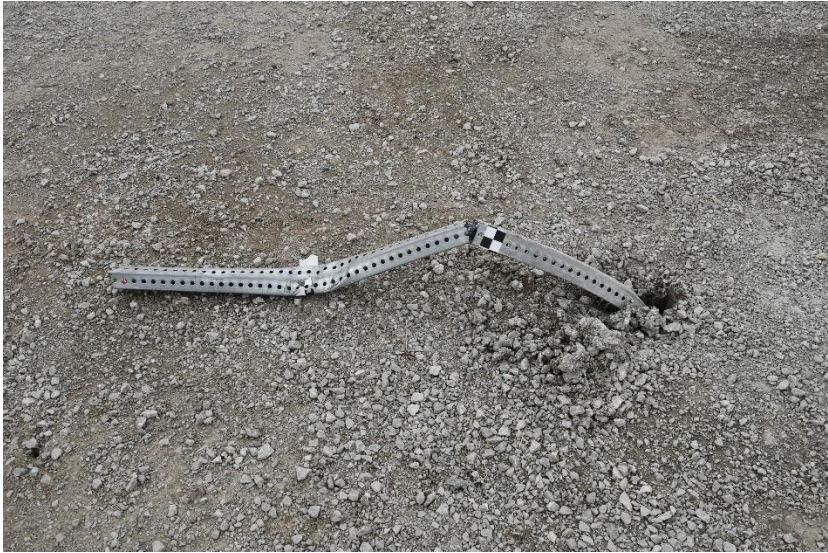
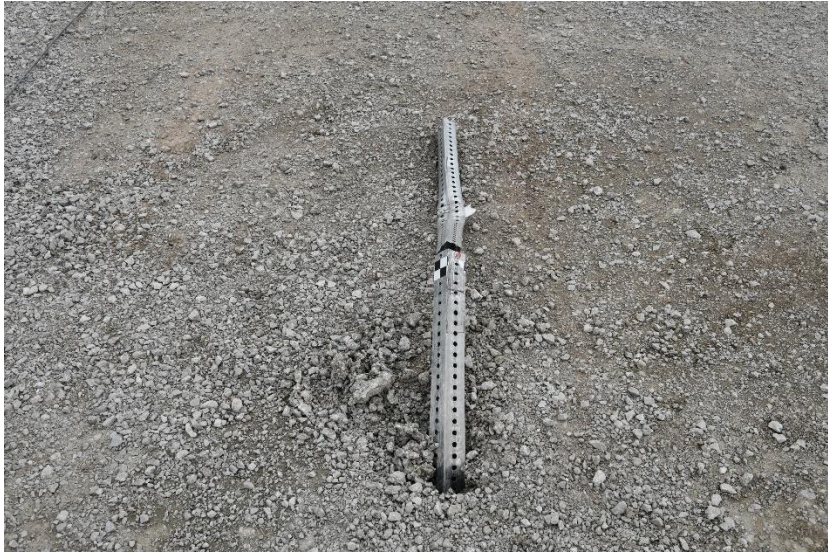
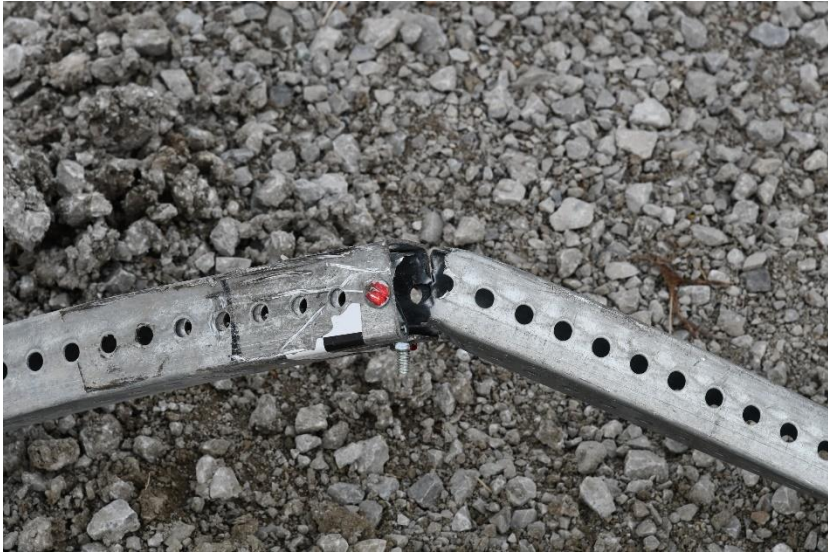
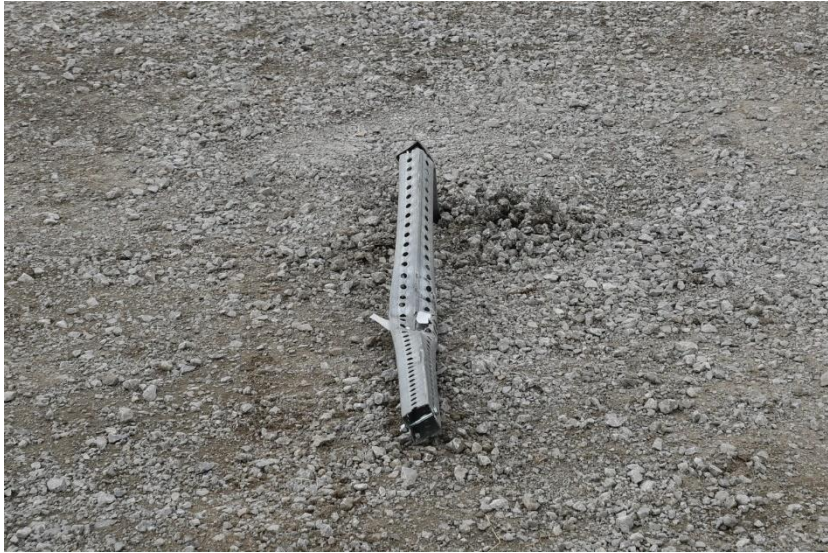
Figure 54. System Damage, Test No. NMB-1B

Damage to System B, the dual mailbox support, was extensive, as shown in Figures 54 and 55. The embedded stub of the mailbox support was displaced several inches through the soil and was bent near the groundline. The mailbox support post remained connected to the embedded stub and the corner bolt connecting the stub and support post remained intact. The mailbox support post was kinked and bent at a location midway along its length and was partially fractured where it was inserted into the stub. The dual mailboxes in System B were completely detached from the support post due to fracture of both spade bolts connecting the support post to the TAPCO mounting bracket. Both mailboxes remained attached to the TAPCO mounting bracket. The flat plate portion of the bracket and the adjustable brackets remained attached to each other and the mailboxes, but the mounting bracket hardware was deformed during impact. The mailbox nearest to the vehicle at impact was severely deformed. The rear mailbox was deformed as well, but the extent of the deformation was significantly less. All mailbox attachment bolts were intact and remained attached.

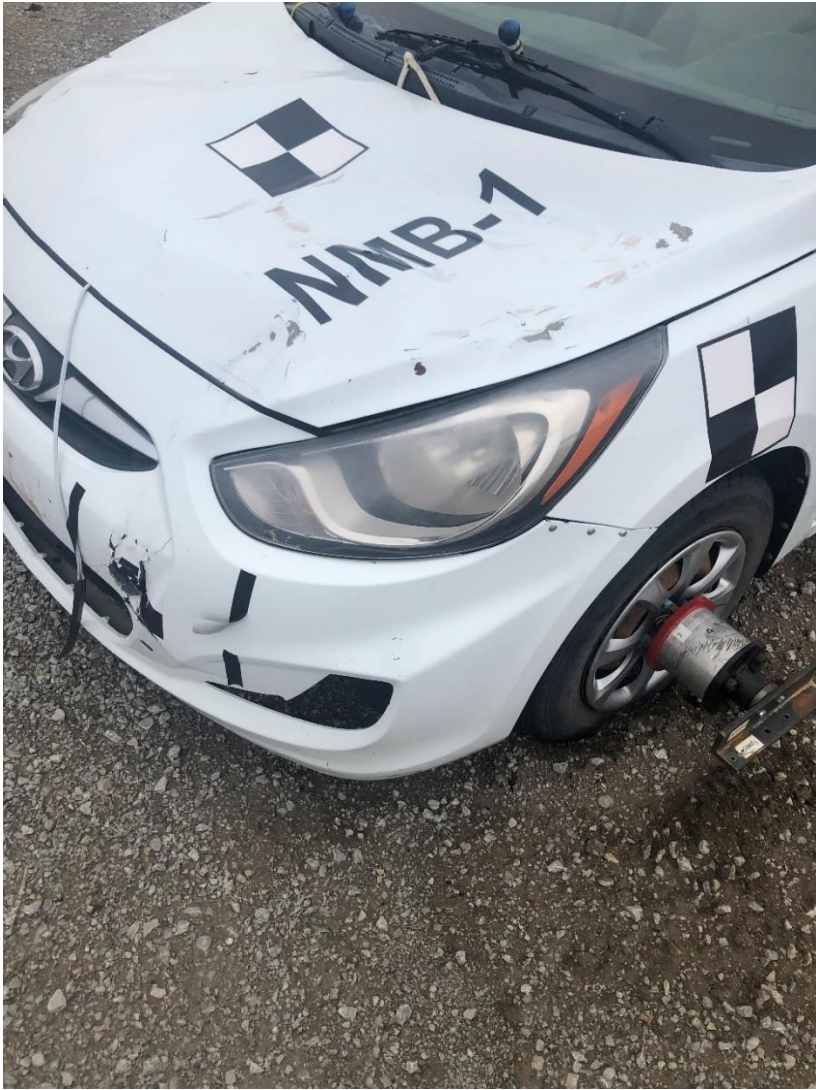
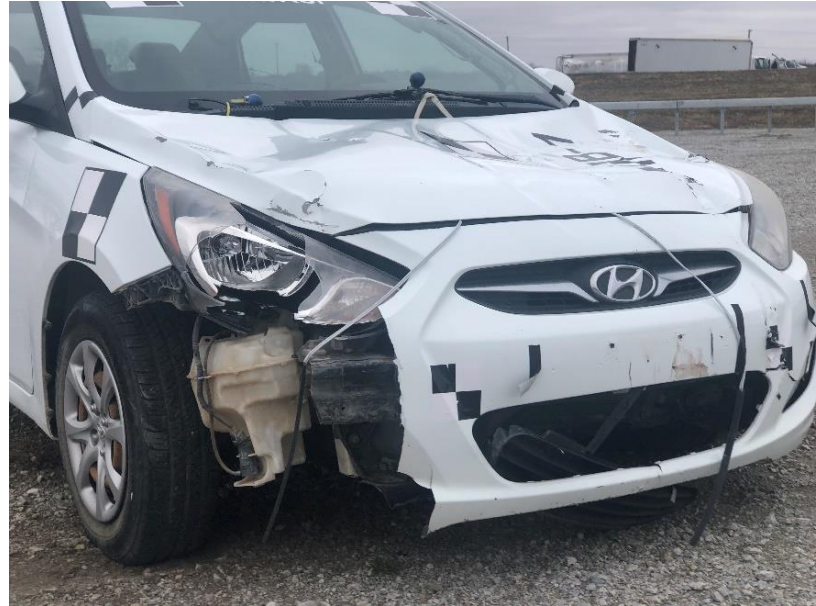
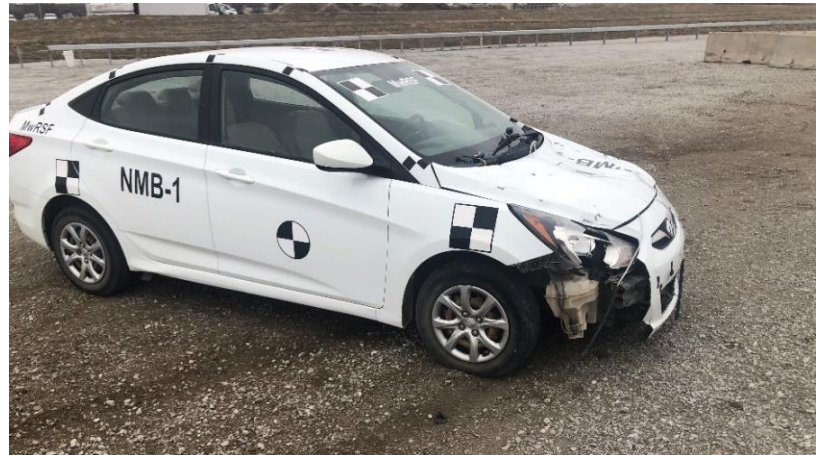
Figure 56. Vehicle Damage Test No. NMB-1

The surrogate, reusable, 1100C test vehicle sustained moderate damage, as shown in Figure 56. Damage consisted of minor deformation and contact marks at the left  $\frac{1}{4}$  point of the front bumper where impact occurred. The right  $\frac{1}{4}$  point of the front bumper sustained more damage as the right quarter of the bumper cover was disengaged, along with minor deformation of the bumper structure, and fracture of the right headlight cover. Indentation was visible on both sides of the vehicle hood due to contact with the mailboxes. No damage was observed to the windshield or roof of the vehicle. Occupant compartment deformations were not formally measured for this non-compliant test with a surrogate vehicle. While undercarriage contact with the System B mailbox support occurred, no visible occupant compartment deformations were observed.
