Hydrogeologic Relationships to Structural Failure Chadron State College, Nebraska

Larry D. Agenbroad
Northern Arizona University

HYDROGEOLOGIC RELATIONSHIPS TO STRUCTURAL FAILURE

CHADRON STATE COLLEGE, NEBRASKA

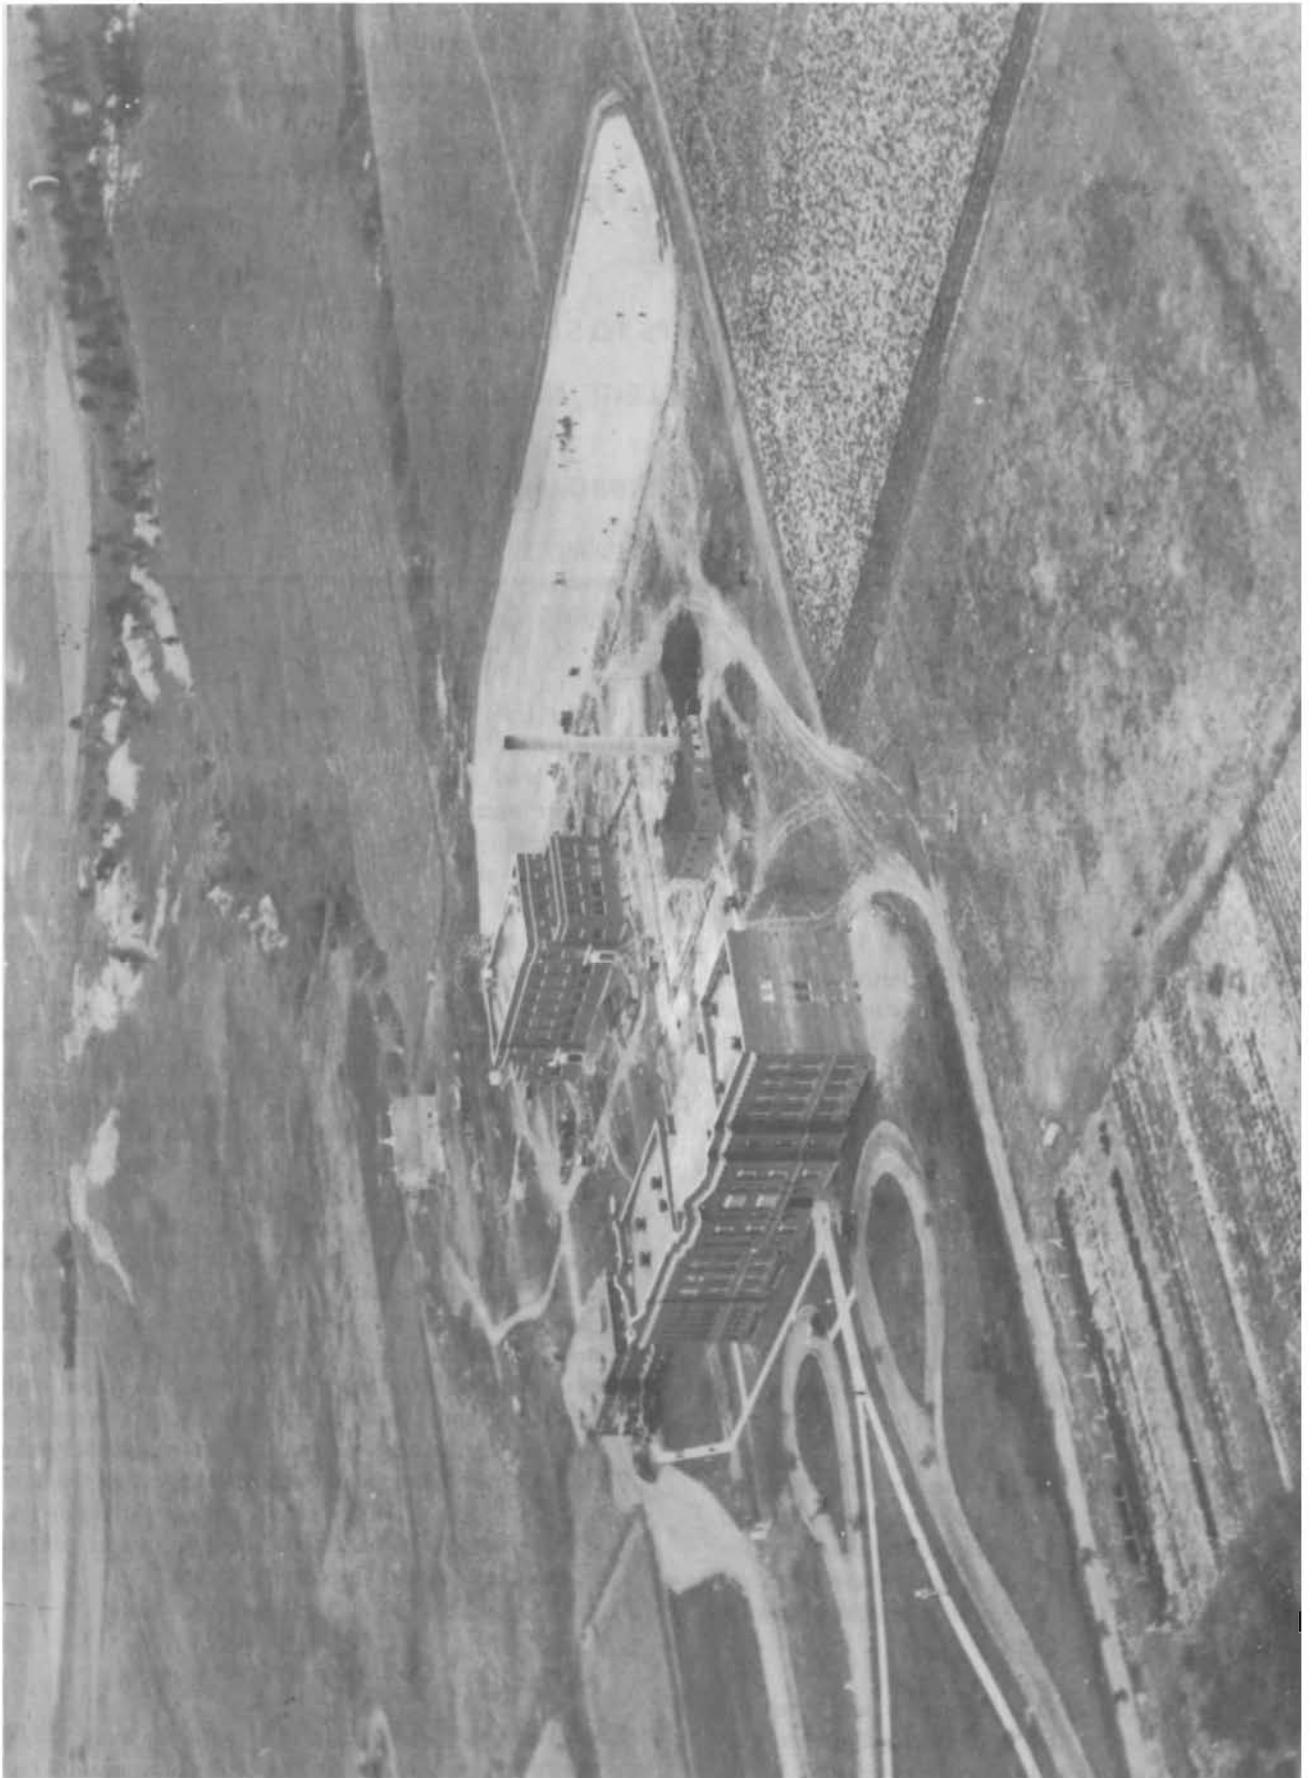
An air photo (Fig. 1) taken in 1920 by Dr. G. E. Condra, State Geologist, shows the confluence of two washes at or near the location of the Armstrong Physical Education Building. A vertical air photo (Fig. 2), taken about 1965, shows that these washes had been filled by simple (noncompacted) procedures and that the football stadium and practice field, the college library, and the north half of the Campus Center were under construction. The Physical Education Building and the National Guard Armory had been completed before 1965.

Projection of the wash alignments into the fill areas indicates the location of the gym is on the west wash alignment at or close to the juncture with the east wash. Similar analysis suggests the Armory is on the east wash alignment. The southwest part of the Campus Center extends onto the fill of the wash alignment, down gradient from the juncture of the east and west wash.

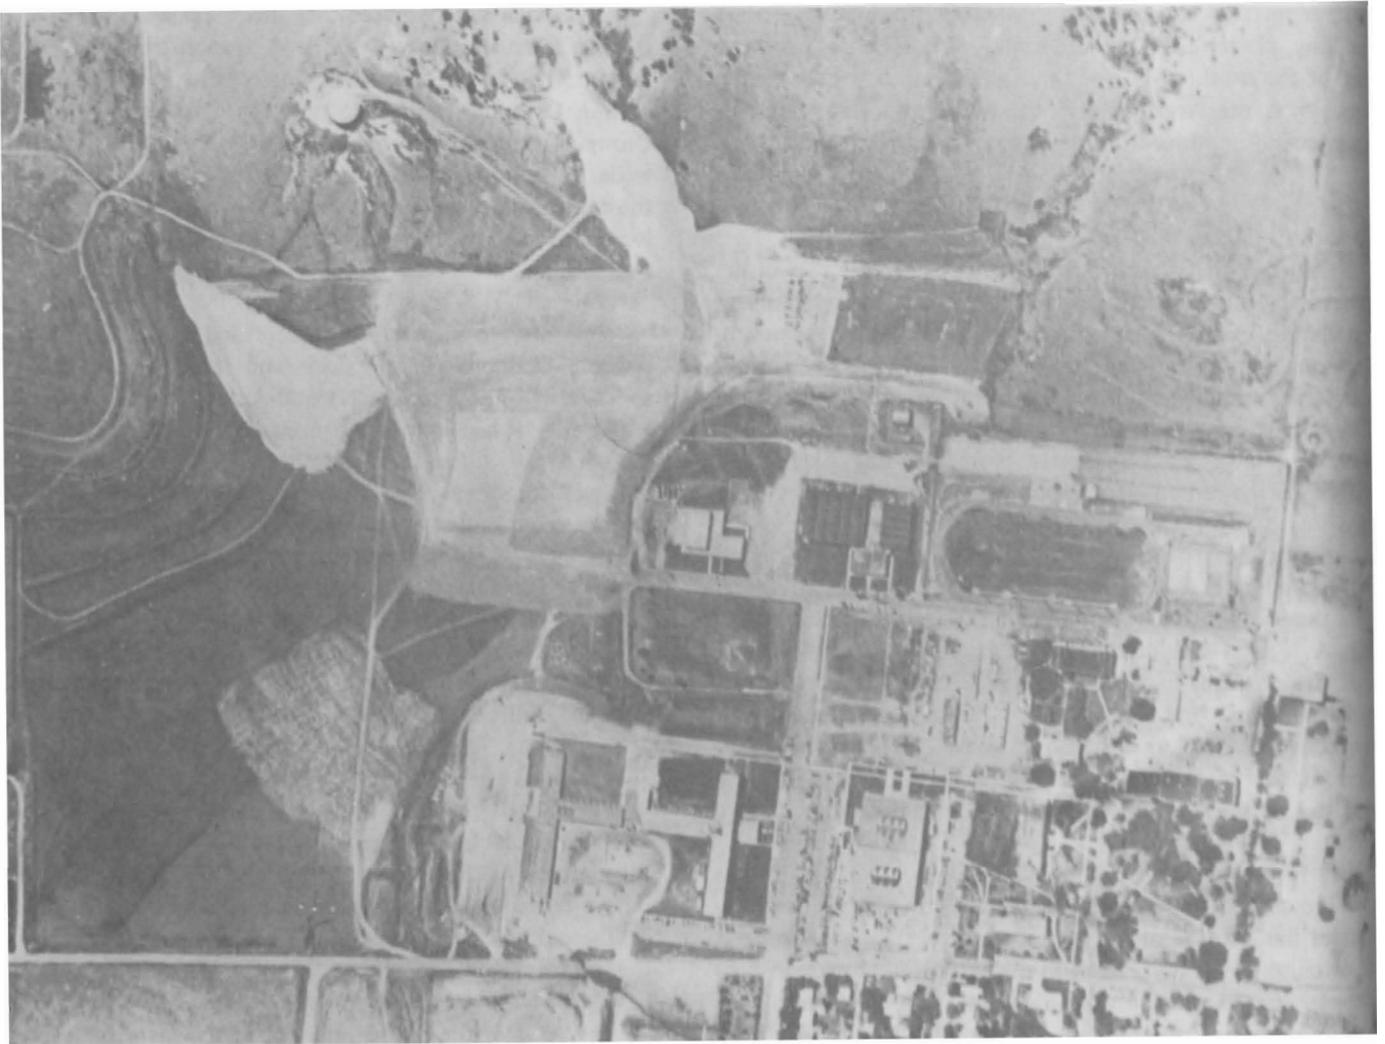
Figure 2. Vertical air photo (ca. 1965) of the Chadron State College Campus. Washes have been obliterated. The Armstrong Physical Education Building, the south half of the Kline Campus Center, and the National Guard Armory had been completed. The library and north half of the Kline Campus Center were under construction. (Photo courtesy of Linda Rector.)

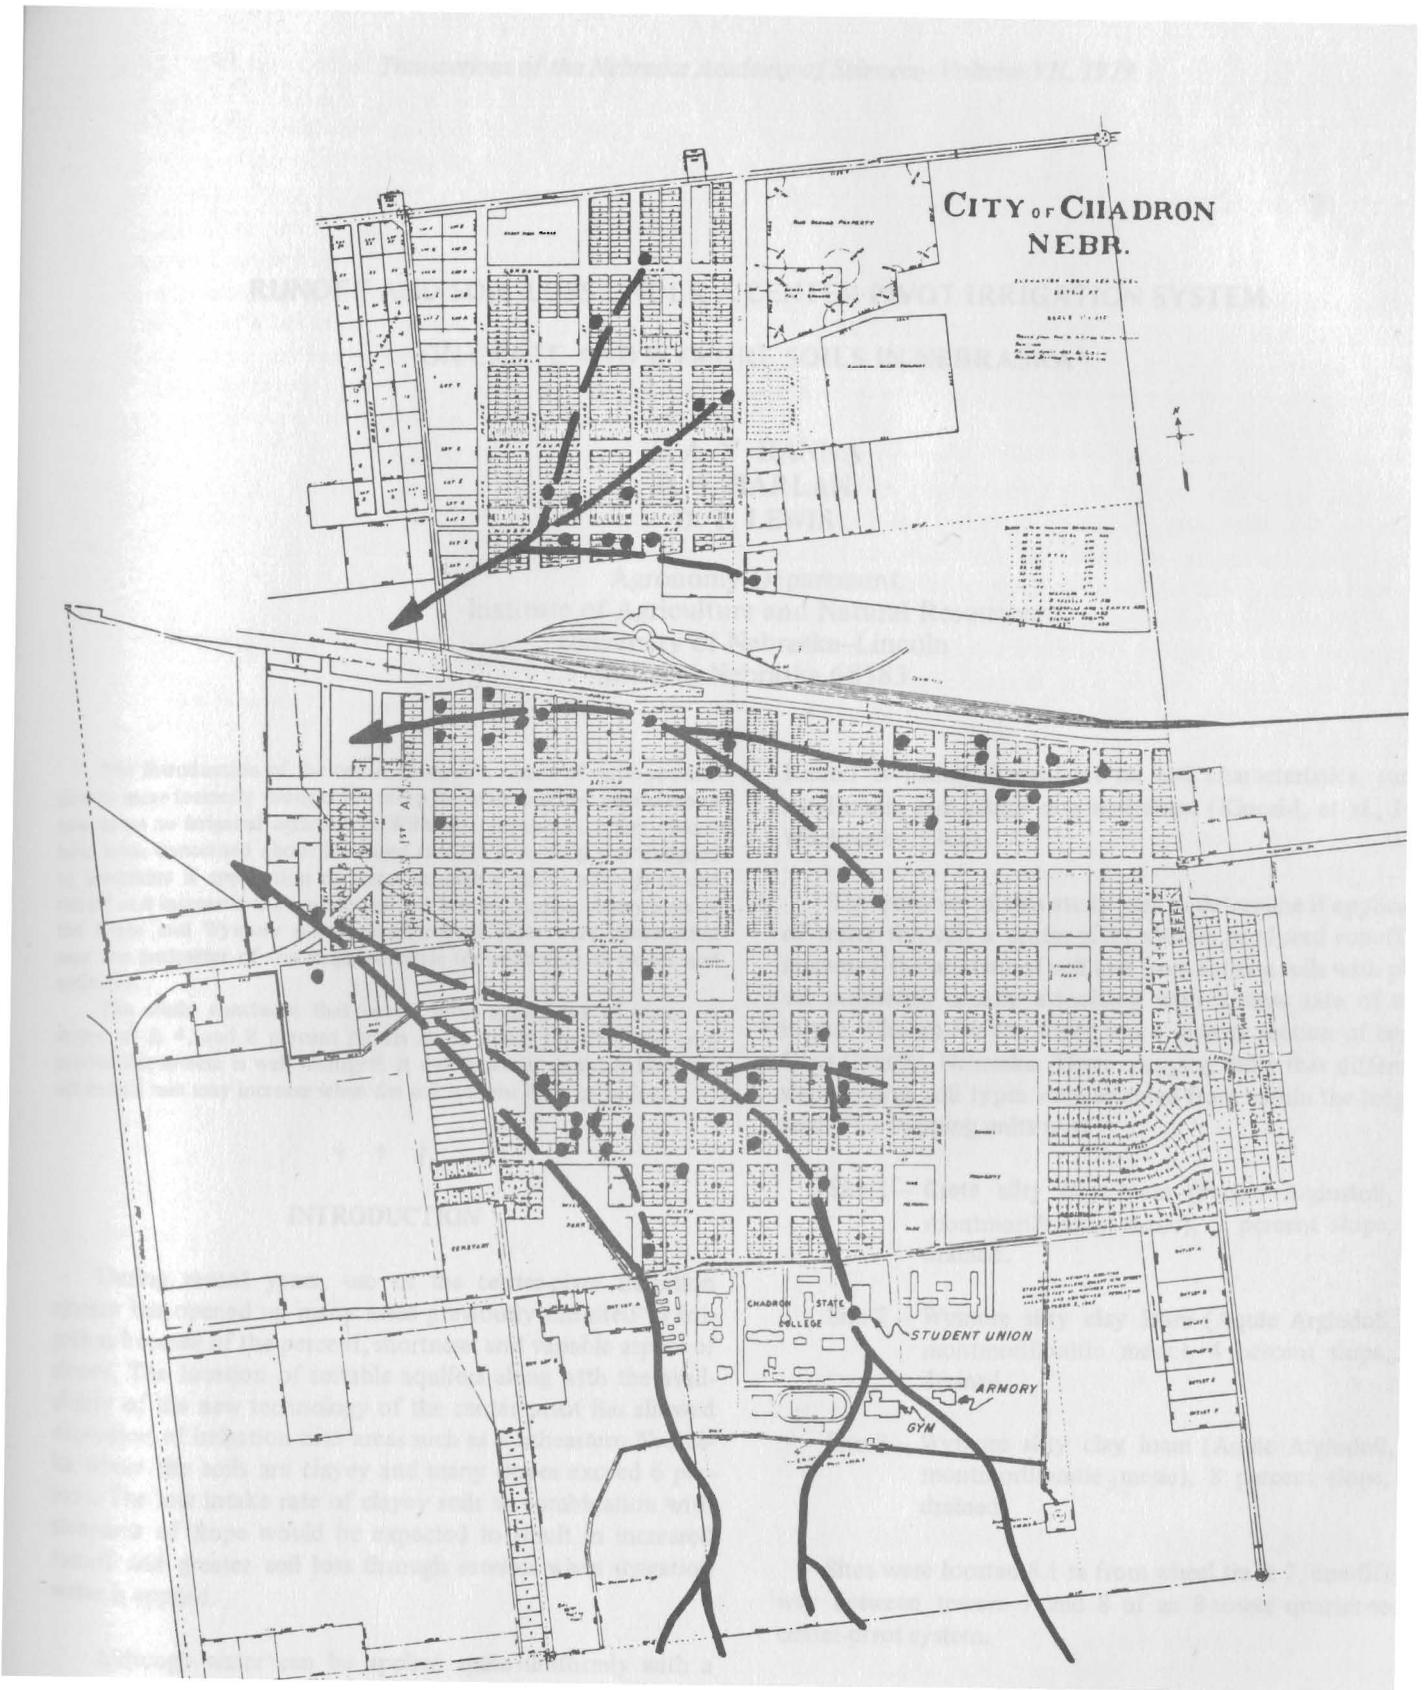
A plot of the domestic wells in the city is shown in Figure 3. Most of the well locations are coincident with the approximate alignments of the pre-construction (urban) drainage features. The data from Condra's photo allow connection of the unmodified portions of the washes, south of the campus, with the well concentrations and topographic lows, defining the original drainage pattern, and is coincident with the damaged structures.

It should also be noted that successful wells are in topographic lows along the postulated pre-construction drainage pattern. The low porosity and permeability of the sandy silts of the Chadron Formation and the Tertiary White River Group of sediment are not generally conducive to successful wells. The alluvium along the drainage pattern established by the pre-construction washes would be of much better hydrologic character, allowing flow of ground water and successful well drilling.

Figure 3. A map of the city of Chadron showing the location of known shallow wells. Projected topographic alignments of former drainage patterns are coincident with the well locations. Dashed lines indicate a lesser degree of certainty of position. (Photo courtesy of Linda Rector.)
