# OBSERVATION OF WOODPECKER DAMAGE TO ELECTRICAL DISTRIBUTION LINE POLES IN MISSOURI

LYLE A. STEMMERMAN, United States Department of Agriculture, APHIS, Animal Damage Control, Kansas City, Missouri 64106.

Proc. Vertebr. Pest Conf. (A.C. Crabb and R.E. Marsh, Eds.),  
Printed at Univ. of Calif., Davis. 13:260-265, 1988

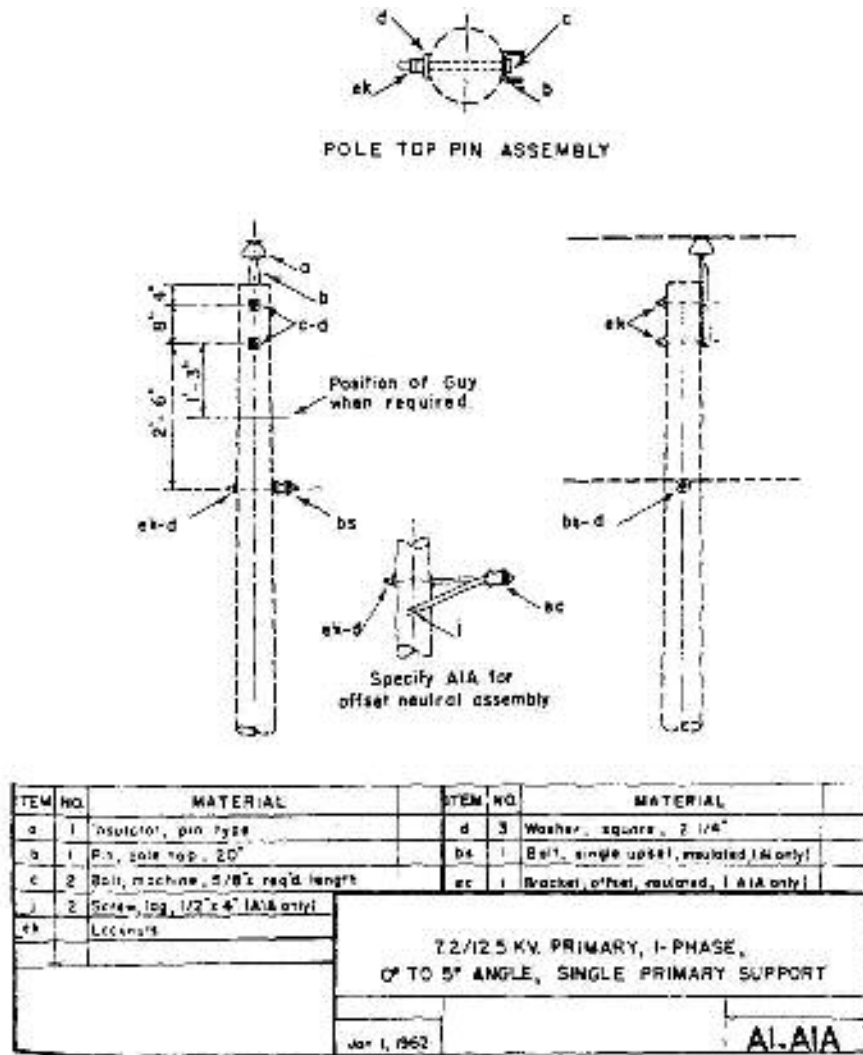
Distribution companies (i.e., Rural Electric Cooperatives) vary in size. The two cooperatives involved in this study each operate a system containing approximately 2,000 miles of line. A 2,000-mile system will contain approximately 36,000 poles. The standard distribution pole is 35' in length. Installed 6' in the ground, the top of the pole is 29' high. Figure 1 shows the standard hardware associated with distribution poles.

Fig. 1. Standard hardware-distribution pole.
