Field Demonstration Report Enhancing Direct Assessment by Inspection through Coatings and Buried Regions of Non-Piggable Pipelines

**Field Demonstration Report
Enhancing Direct Assessment by Inspection through
Coatings and Buried Regions of Non-Piggable Pipelines**

23 August 2007

Contract DTPH56-06-T-0009

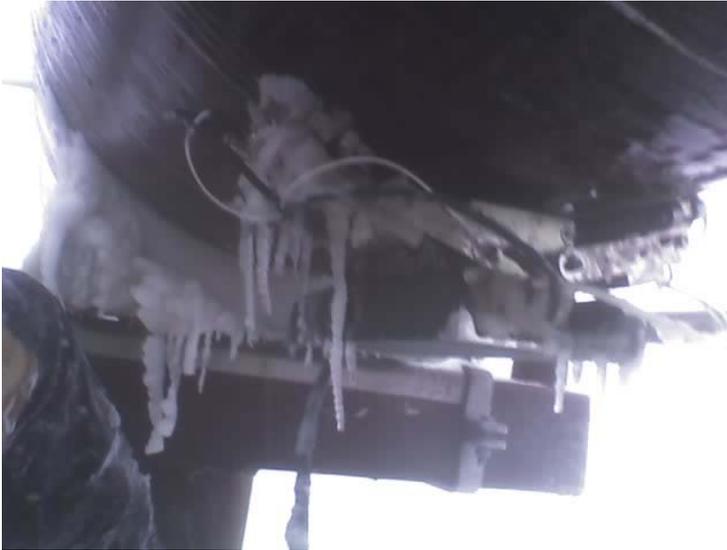
1. During the beginning of this R&D Project, in August of 2006, there was a major petroleum line in Prudhoe Bay Alaska shut down due to internal pitting corrosion. The 34" oil transit line was responsible for approximately three percent (3%) of the petroleum supply to the lower 48 states. This shutdown immediately became highly visible to the environmental groups, jurisdictional authorities and even the national media. Approximately 10 miles of insulated pipe had to be inspected for internal corrosion as soon as possible. Any applicable NDE technique was mobilized to attach this monumental task. The USDOT and DOE became involved to evaluate the effectiveness of these techniques because conventional Ultrasonic Testing, UT, and Automated UT, AUT, was simply too slow to be practical. To make matters worse most of this line was

insulated which required a significant effort to remove the coating and prepare the surface sufficiently for conventional UT. The Non-Contact EMAT CIRC tool was prepared to inspect this pipe through the tape wrapped coating and after extensive qualifications by the DOT and DOE the method was determined to be the “Preferred Screening Tool for Coated Pipelines”. The Sonic Sensors EMAT CIRC tools were the only EMAT tools and they completed the entire exam before Thanksgiving of 2006 where the extreme cold of the North Slope posed great hardships for the equipment and operators. The inspection performance for this pipeline required a 100% probability of detection, POD, for a 50% deep pit. The EMAT CIRC tool proved a 100% POD for a 25% deep pit in uncoated pipe and a 30% deep pit in the tape wrapped coated pipe.

Figure 2: EMAT CIRC Scanner with icicles scanning the bottom of the 34” oil transit line in Prudhoe Bay Alaska.

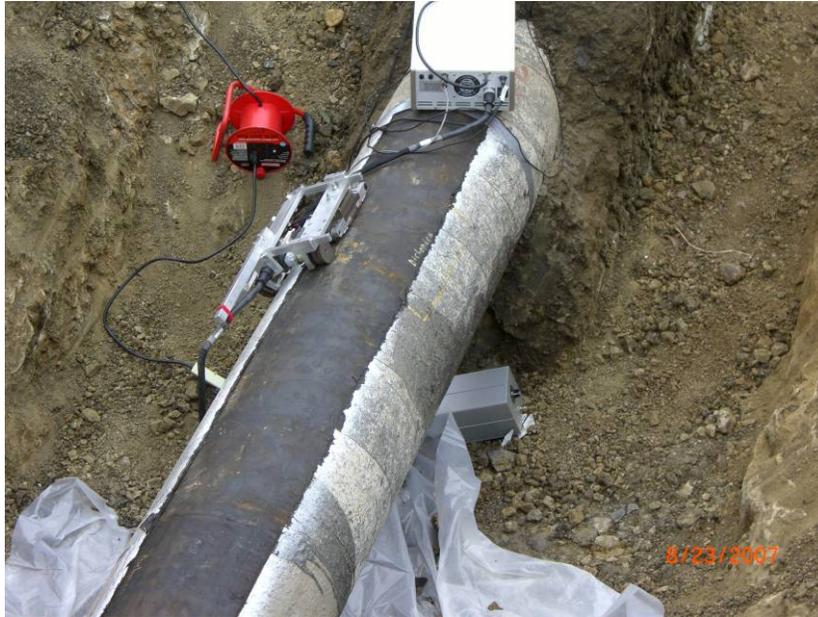
Figure 3: Field demonstration at an ECDA dig on a 20" asphalt coated pipe. The scanner is shown half on the 1/4" coating and half on the bare pipe. The inspection instrument is on the pipe at the top of the photo.

A 20 inch pipeline was completely excavated exposing approximately 10 feet of the pipe. The asphalt coating was approximately 1/4 inch thick and was too thick for the thin coating tool. A 12 inch wide strip of the coating was removed from the top surface of the pipe as shown in Figure 3. One scan was performed on the exposed bare metal surface of the pipe and the other scan was half on the coating and half on the bare pipe. The results of both scans were identical and effectively proved the pipe free of internal corrosion as well as external corrosion without removing the remaining 80% of the asphalt coating. The integrity of the coating was also evaluated and a previous coating repair 14 inches to one side and including the girth weld was bonded significantly better than the original coating. This was apparent on the scan.

The inspection was verified by removing the remainder of the coating exposing no visible external corrosion. The EMAT CIRC scan was repeated on the bare pipe for verification and no corrosion was detected but an insignificant “Stable” long seam variation was detected and visually confirmed.
