## Steel Hull Corrosion of USS Arizona with Applications to Submerged Resources

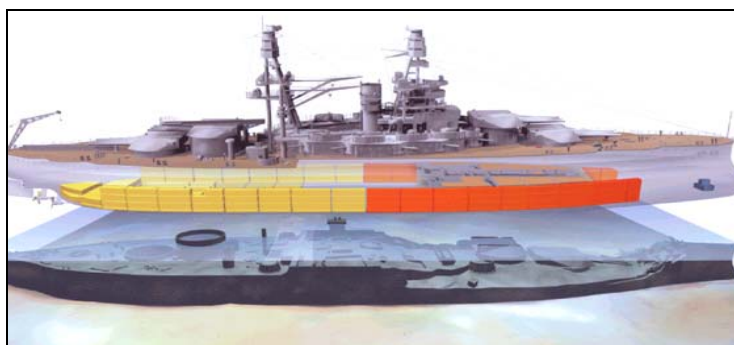
Fig.1. USS Arizona - Destroyed bunkers in red; intact in yellow (courtesy of National Geographic and NPS).

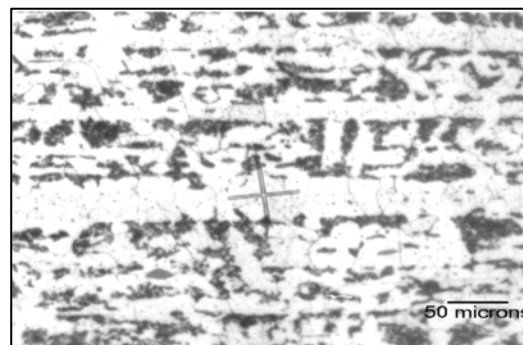
Fig. 2. Alignment of ferrite and pearlite in bands, 0.1 C, boat deck plate, (1913).

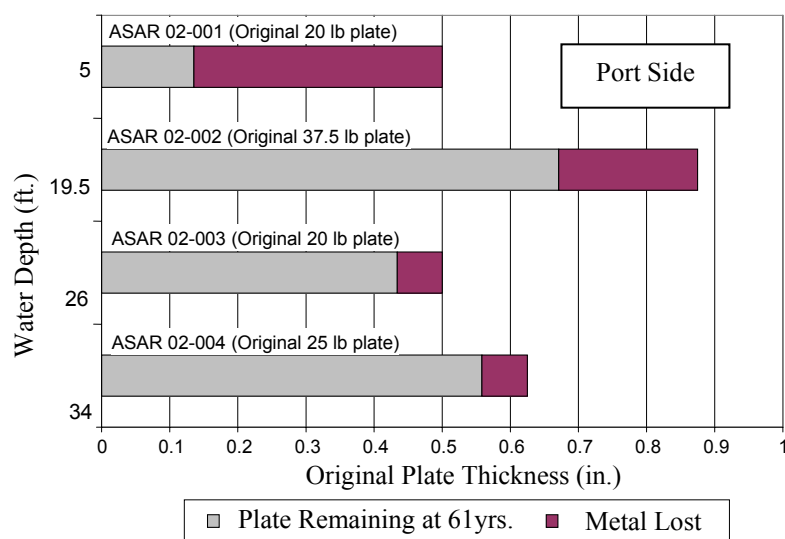
Eight 10 cm (4 in) diameter hull samples (coupons) were removed, four each from port and starboard sides near midship, at vertical positions from 5 ft (1.5m) to just below the mudline at 34 ft (10.4m). Corrosion rate was determined by subtracting final thickness from original thickness and dividing the difference by the submerged time interval, 61 years. Fig. 3 is a port side bar graph of hull plate thickness as a function of water depth [2]. At 5 ft (1.5m), the metal loss is over 50% of original thickness due to fresh seawater exposure on both sides. At 19.5 ft (6m), the loss is less than 25%, at 26 ft (8m) and lower, the loss is less than 15%. Corrosion rate varies from 2.7 mpy (0.07mmpy) near the surface to 1.2 mpy (0.031mmpy) at the mudline. USS Arizona's complete structural deterioration and eventual release of oil inside the hull is, by all indications, not imminent.

Fig 3. Plate loss as a function of water depth.
