# **PERFORMANCE LIMITS FOR 6-IN. (152-MM) HIGH CURBS PLACED IN ADVANCE OF THE MGS USING MASH VEHICLES PART II: FULL-SCALE CRASH TESTING**

MwRSF Research Report No. TRP-03-221-09

October 30, 2009

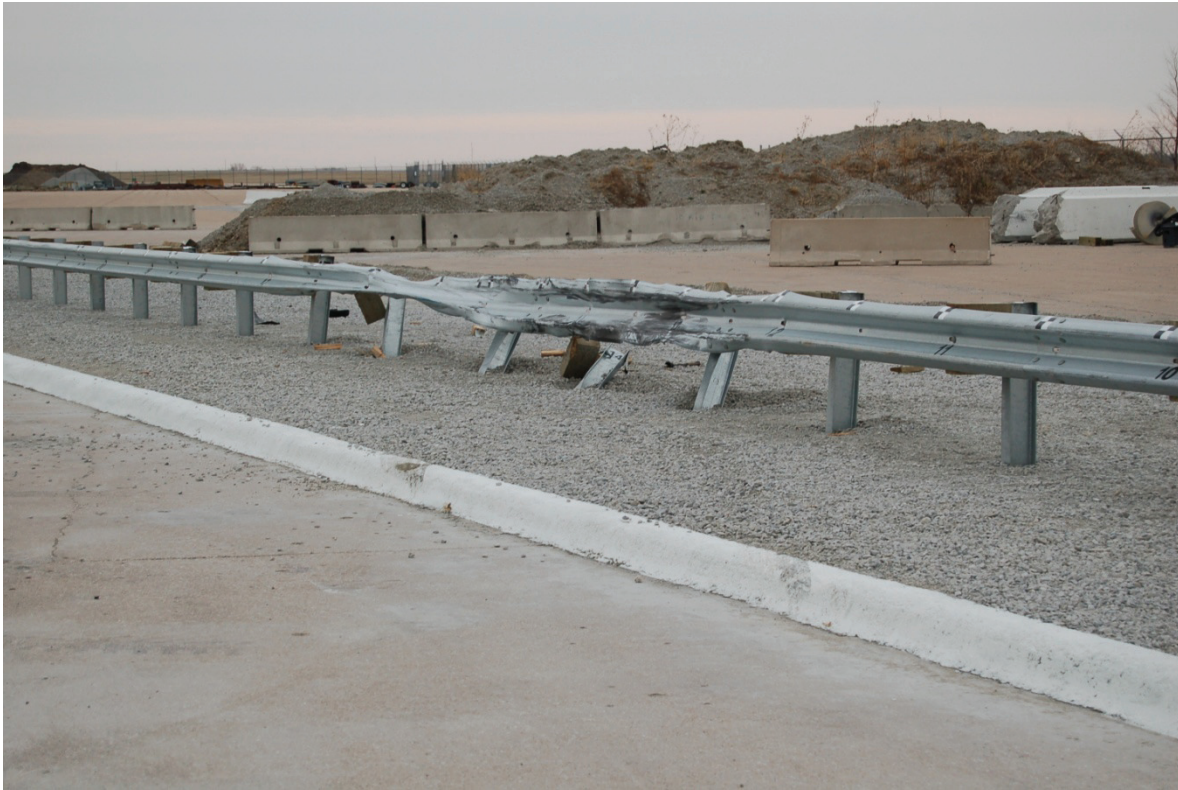
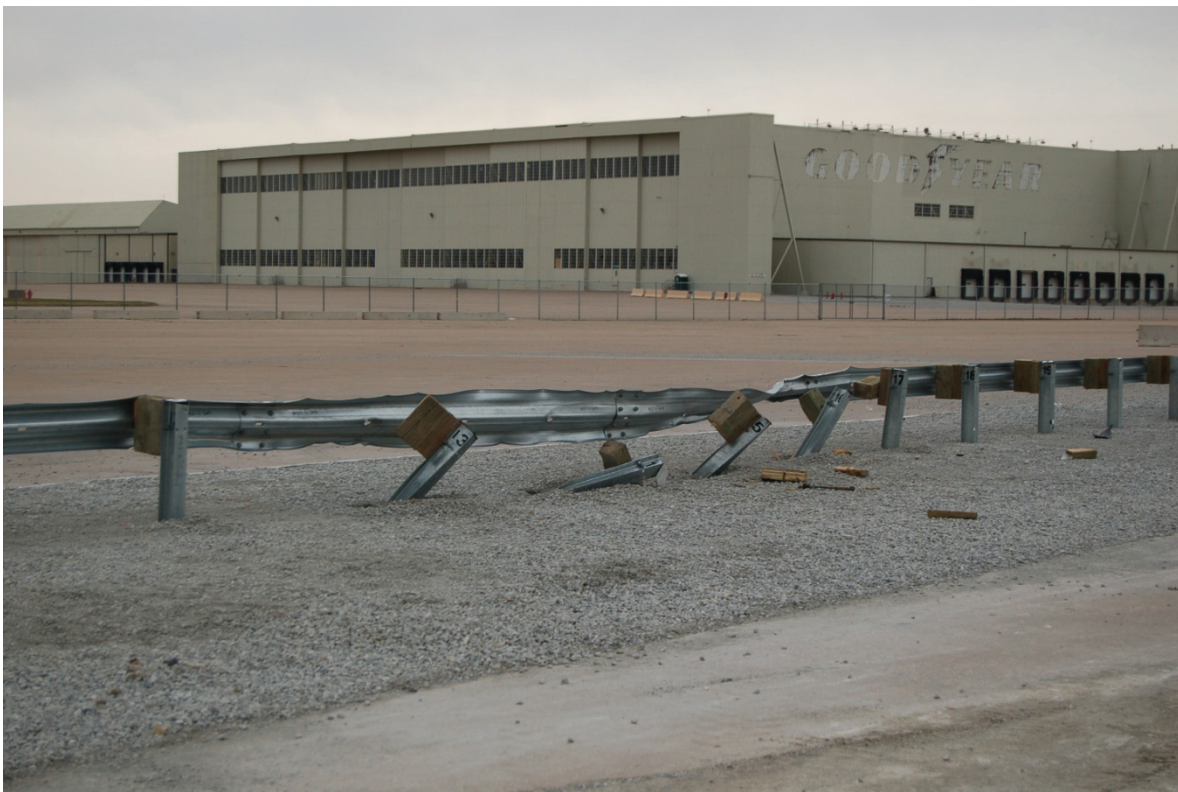
Figure 27. System Damage, Test No. MGSC-5

Damage to the barrier was moderate, as shown in Figures 27 through 38. Barrier damage consisted of deformed guardrail posts, disengaged wooden blockouts, contact marks on several sections of guardrail and the curb, and deformed W-beam rail. Five areas of contact between the vehicle and guardrail occurred, with the most substantial damage occurring at the original impact point. Three regions of light scuff marks occurred downstream of the original impact as the vehicle rolled. The final contact area occurred when the vehicle landed upside-down on the guardrail. The length of the original vehicle contact along the system was approximately 30 ft-3 in. (9.22 m), which spanned from 12 in. (305 mm) downstream of post no. 12 through the centerline of post no. 17.

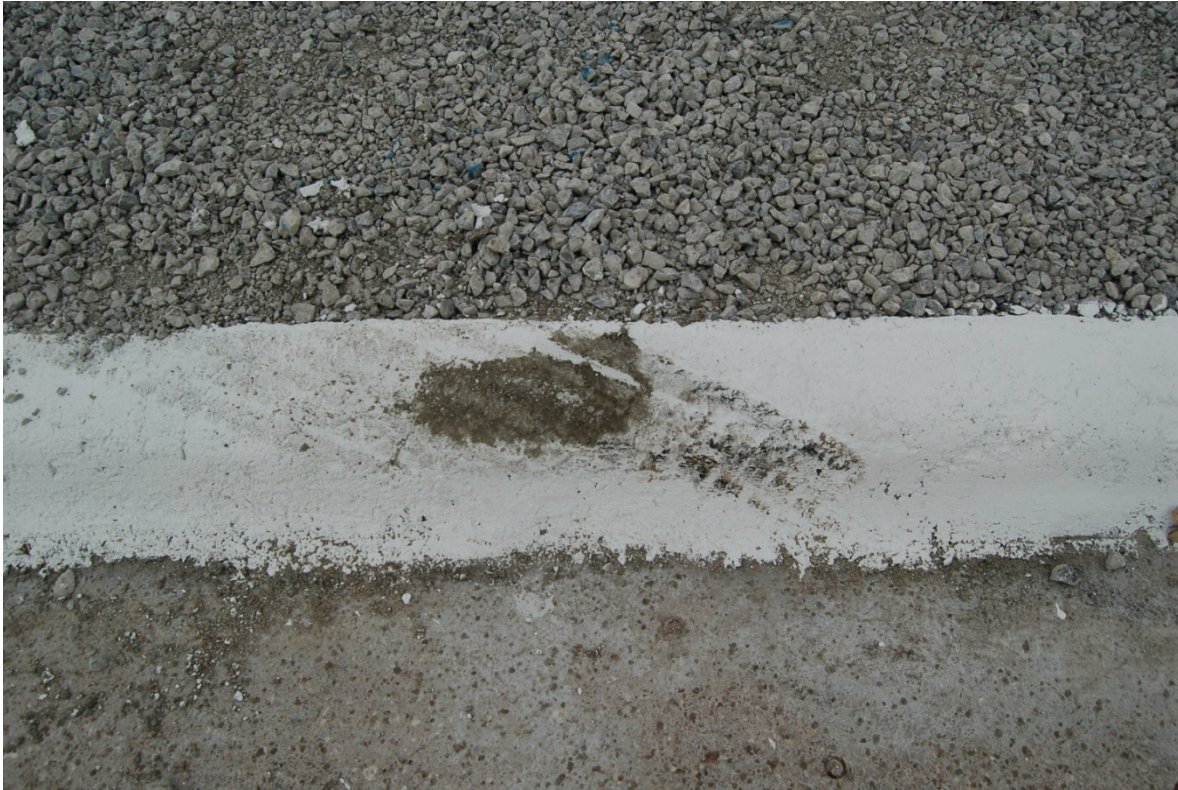
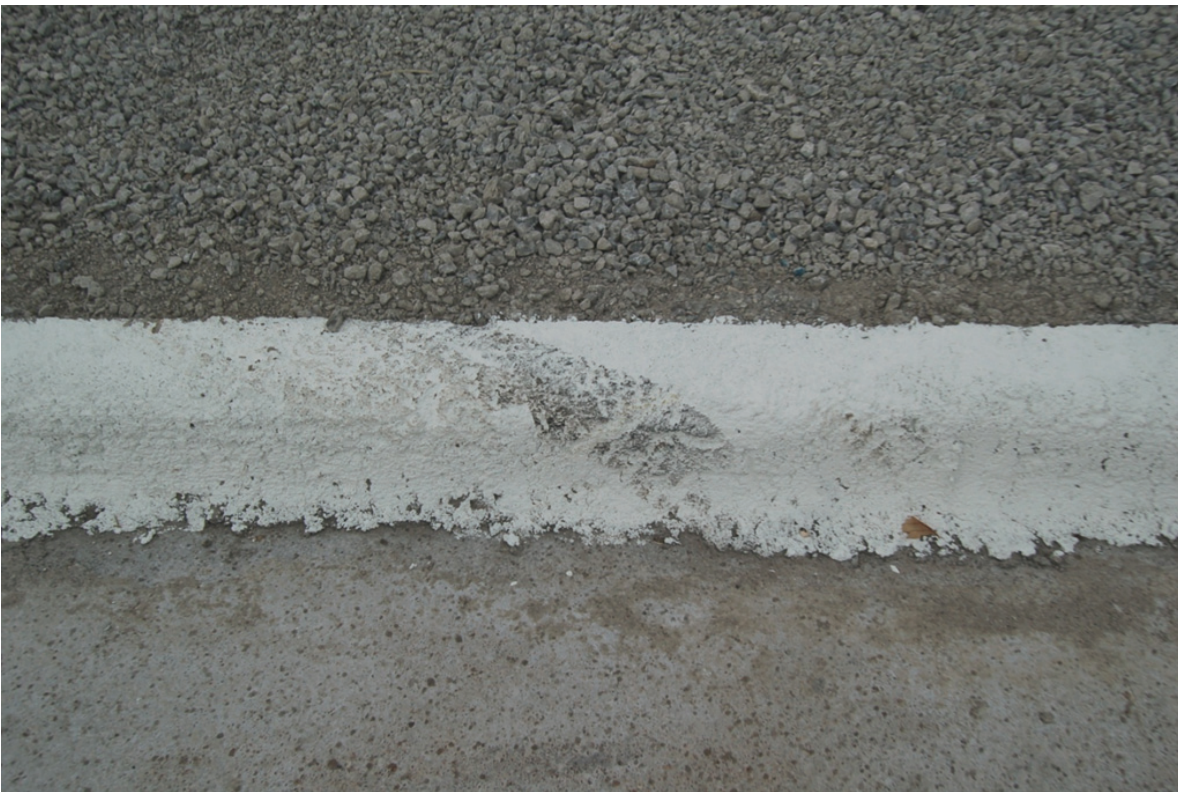
Figure 28. Curb Damage, Test No. MGSC-5

Deformation and flattening of the W-beam guardrail occurred between post nos. 12 and 17, the primary vehicle contact region. Contact marks were visible on the guardrail beginning 12 in. (305 mm) downstream from post nos. 12 and ending at post no. 17. Additional contact marks were found on the top of the rail and included a 37-in. (940-mm) long mark beginning 25  $\frac{3}{4}$  in. (654 mm) downstream of post no. 20, a 77-in. (1,956-mm) long mark beginning 6  $\frac{1}{2}$  in. (165 mm) downstream of post no. 21, an 18-in. (457-mm) long mark beginning 3 in. (76 mm) upstream of post no. 23, and a 96-in. (2,438-mm) long mark beginning 20 in. (508 mm) downstream of post no. 25.

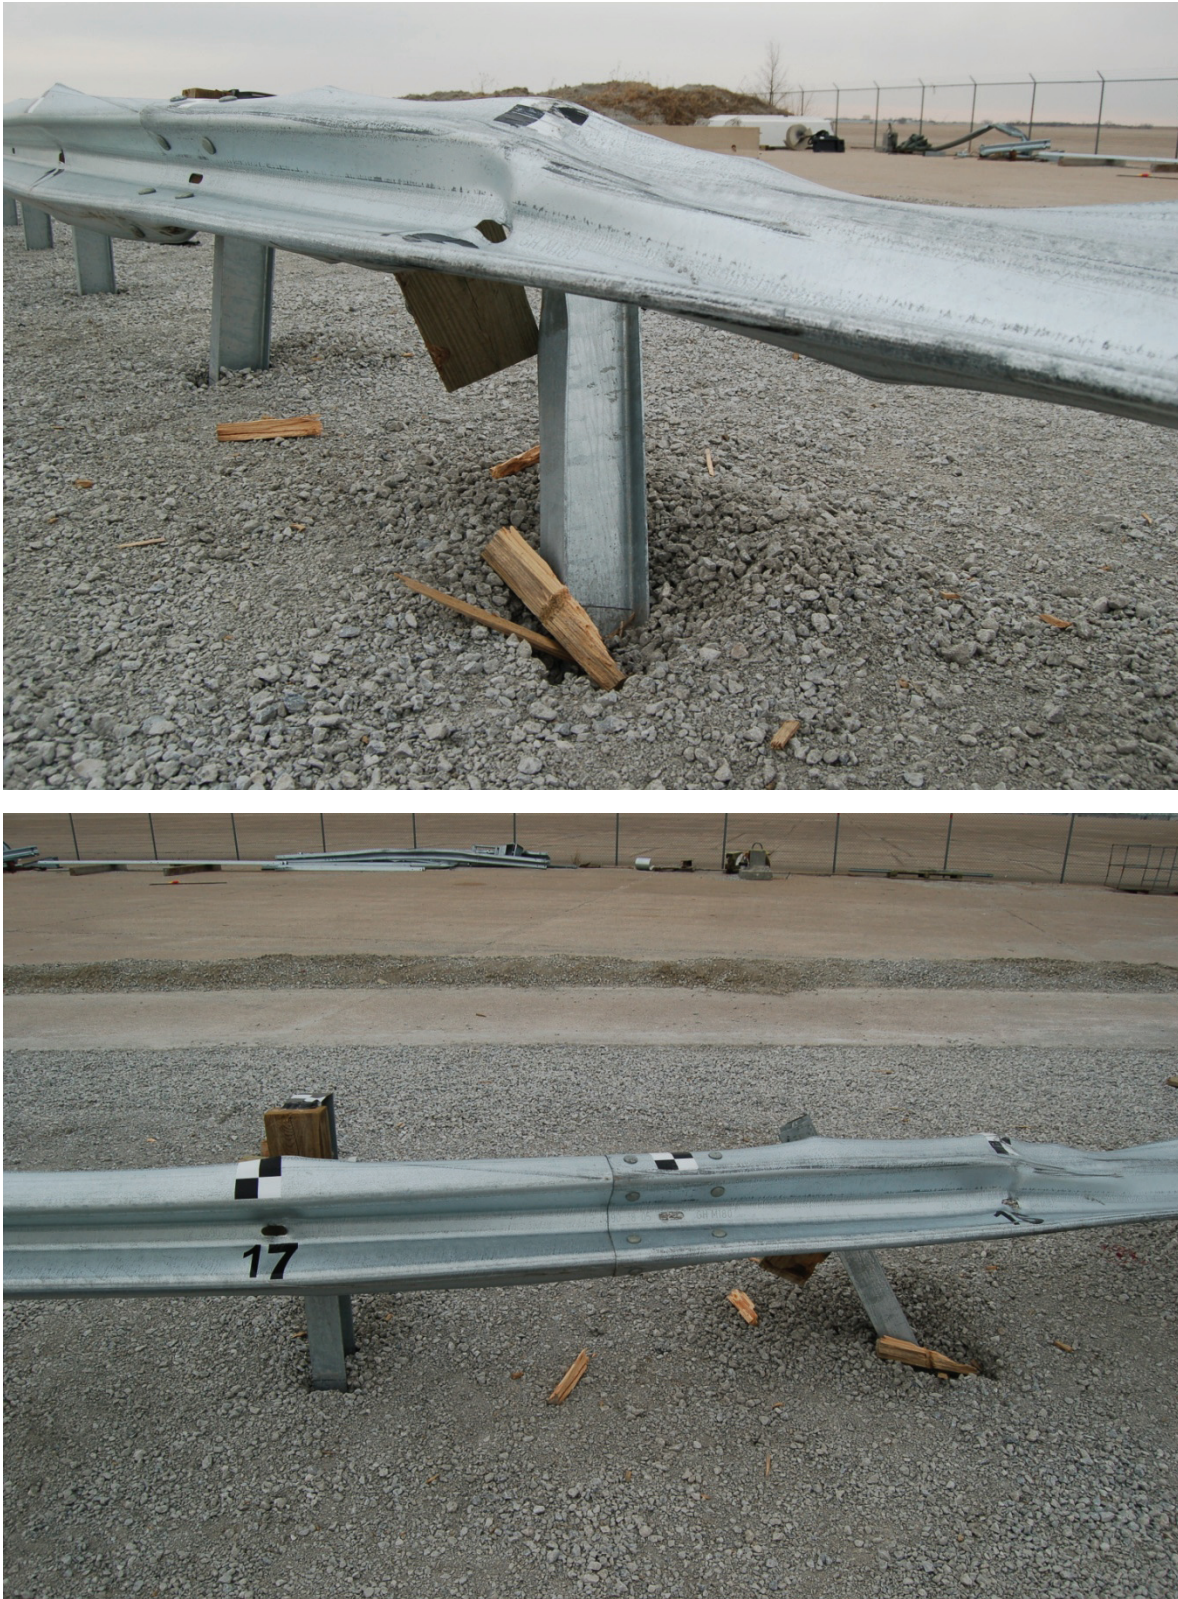
Figure 31. Rail Damage, Post Nos. 16 and 17, Test No. MGSC-5

0.508	The rail disengaged from post no. 17.
0.534	The vehicle reached its critical roll angle and rolled over the barrier.
0.556	The right-rear tire contacted the wood blockout at post no. 16, causing the blockout to fracture.

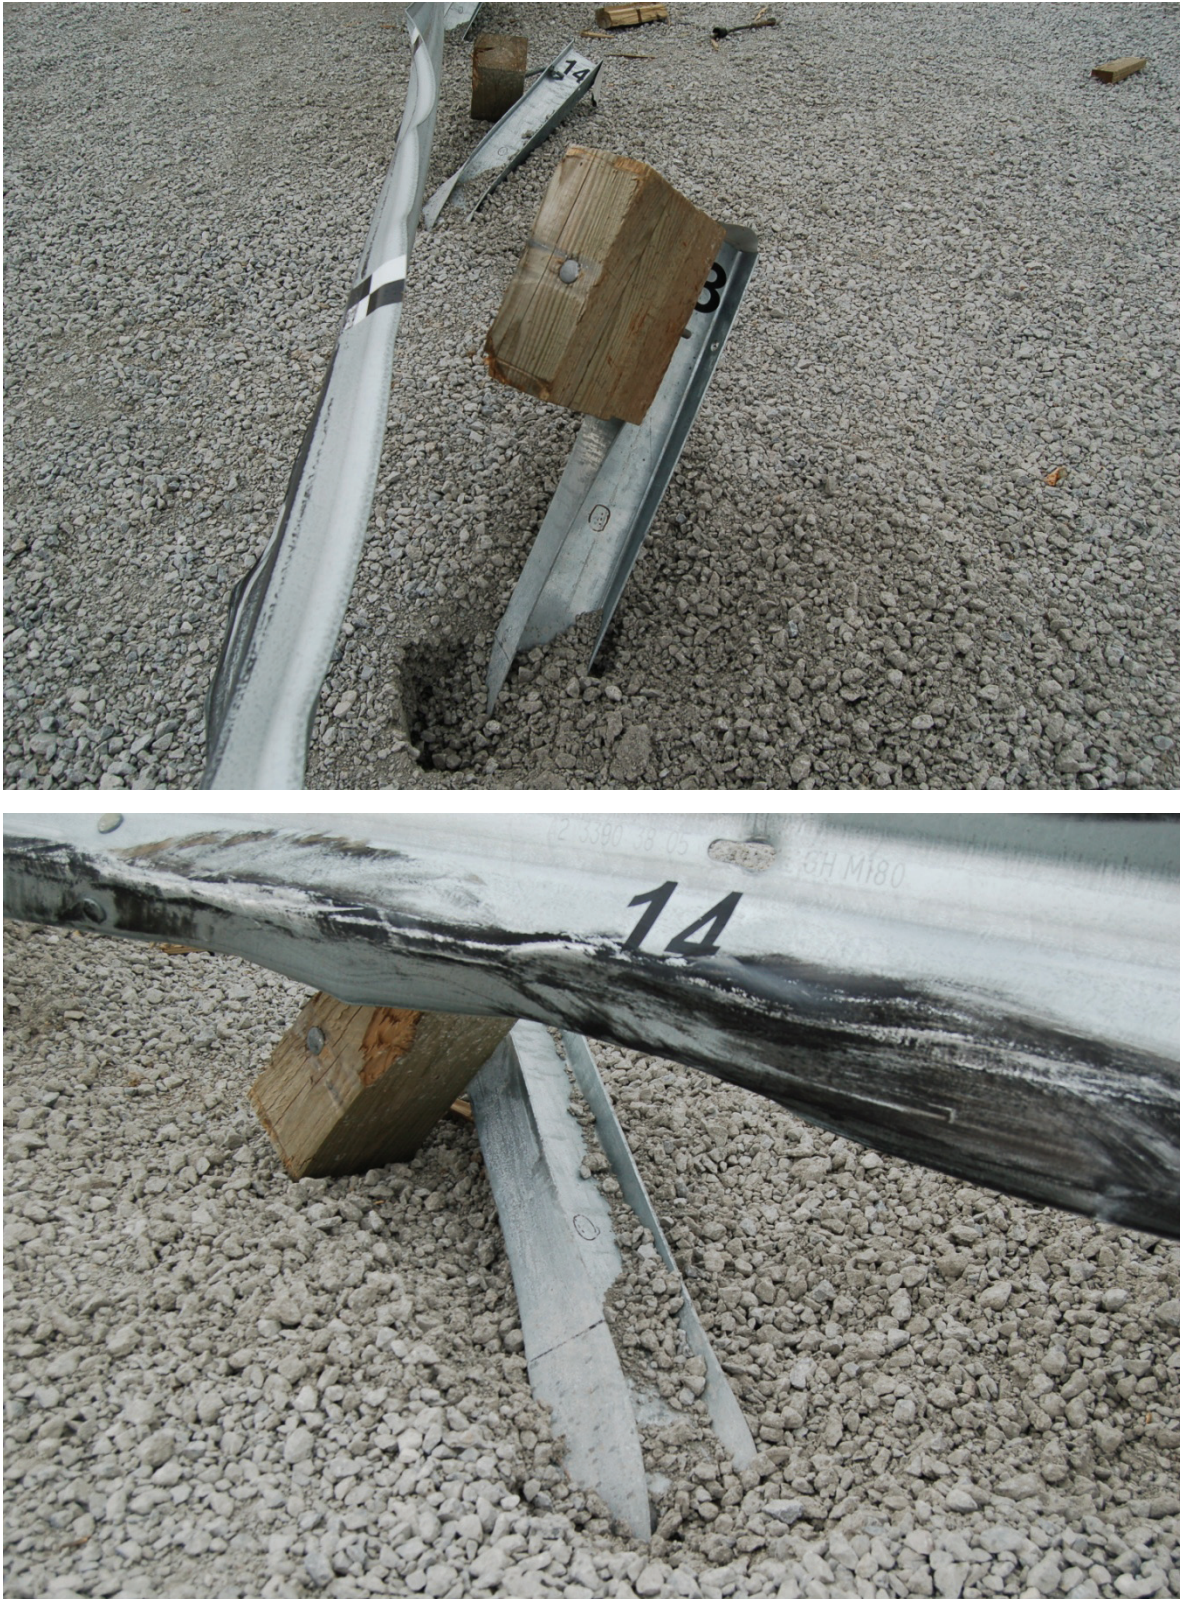
Figure 34. Post Nos. 13 and 14 Damage, Test No. MGSC-5

The blackout at post no. 13 sustained minor damage near its bottom edge due to contact with the rail. The 4-in. (102-mm) deep blackout at post no. 14 fractured and detached, while the

8-in. (203-mm) deep blockout remained attached after sustaining damage from rail contact. The blockouts at post no. 15 twisted away from the post, bending the bolt, and the 4-in. (102-mm) deep blockout sustained a small fracture at its back face. The 4-in. (102-mm) deep blockout at post no. 16 also fractured and detached, while the 8-in. (203-mm) deep blockout remained attached by the deformed guardrail bolt. The 8-in. (203-mm) deep blockout at post no. 17 twisted, but remained attached to the post. All other blockouts remained attached to the posts and undamaged.

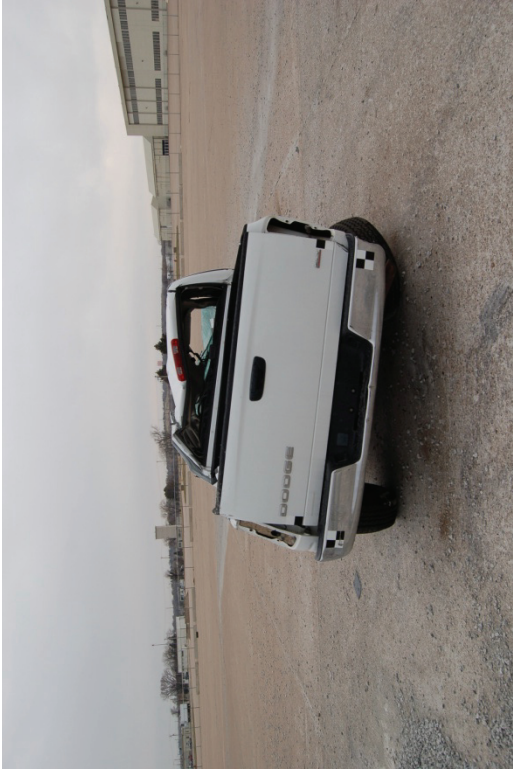
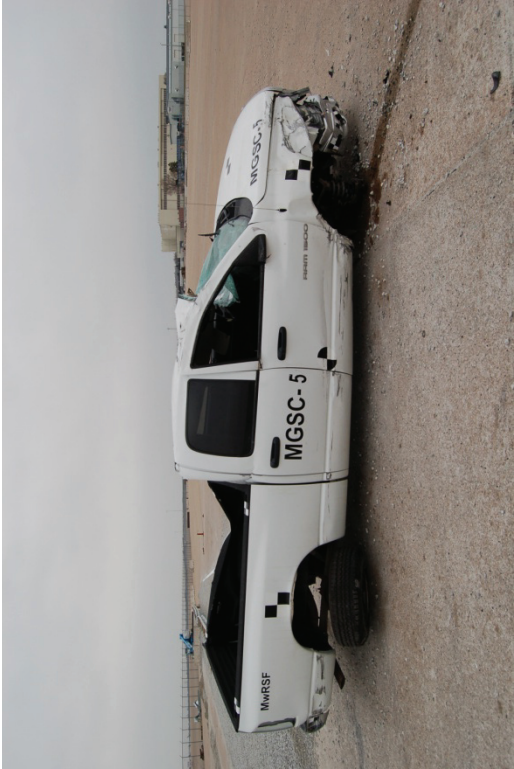
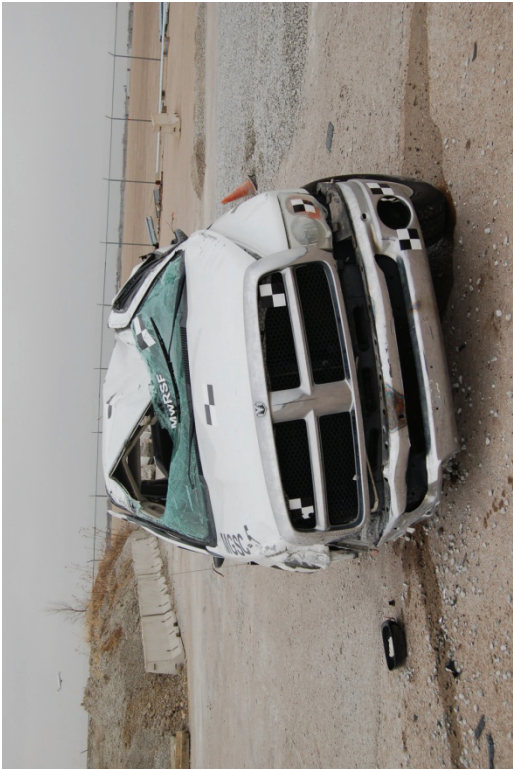
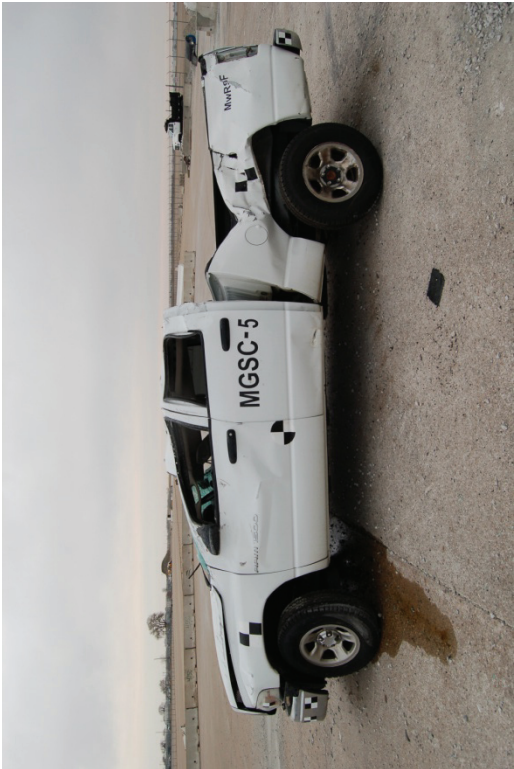
Figure 39. Vehicle Damage, Test No. MGSC-5

The damage to the vehicle was extensive, as shown in Figures 39 through 43. Occupant compartment deformations were judged to be significant to cause serious injury to vehicle occupants. Deformations to the vehicle floorboard were relatively minor, with maximum longitudinal, lateral, and vertical deflections of  $\frac{1}{4}$  in. (6 mm) located throughout the right-side floorboard,  $\frac{1}{2}$  in. (13 mm) located along the right side of the right-side floorboard, and 2 in. (51 mm) located near the center of the vehicle's floorboard, respectively. Complete occupant compartment and vehicle deformations and the corresponding locations are provided in Appendix D.

Exterior damage was located on all portions of the vehicle. Both right-side wheel assemblies were detached from the vehicle. The right-front wheel spindle and assembly detached from the suspension control arms. The rear axle fractured at the right-rear wheel. The right-front quarter panel and bumper were deformed inward toward the engine compartment. Scrapes and gouges were found along the right-side doors and right-rear quarter panel. The right-side headlight and both rear tail lights fractured. The left side of the truck box was significantly deformed and bent away from the cab. Minor deformations occurred along the left-side doors, left-front quarter panel, and rear bumper. Both the left- and right-side mirrors disengaged from the truck. The hood and grill were slightly deformed and displaced. The roof was crushed inward, especially on the left side. The windshield was severely shattered and partially displaced. The right-front door, rear, and both left-side door window glass was fractured and removed from the vehicle. The right-rear door window glass remained undamaged.
