Phase II Development of a Non-Proprietary, Four-Cable, High Tension Median Barrier

TESTING CERT # 2937.01

Midwest States Regional Pooled Fund Research Program

Research Project Number TPF-5(091) Suppl #1

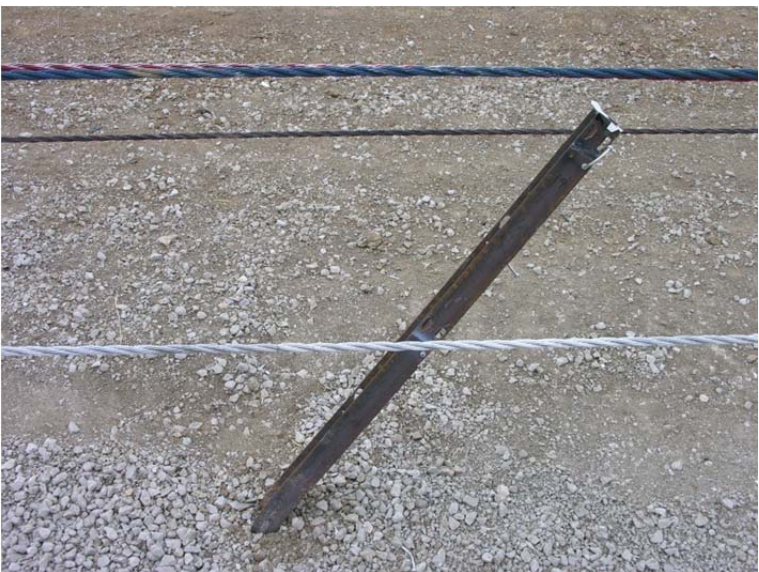
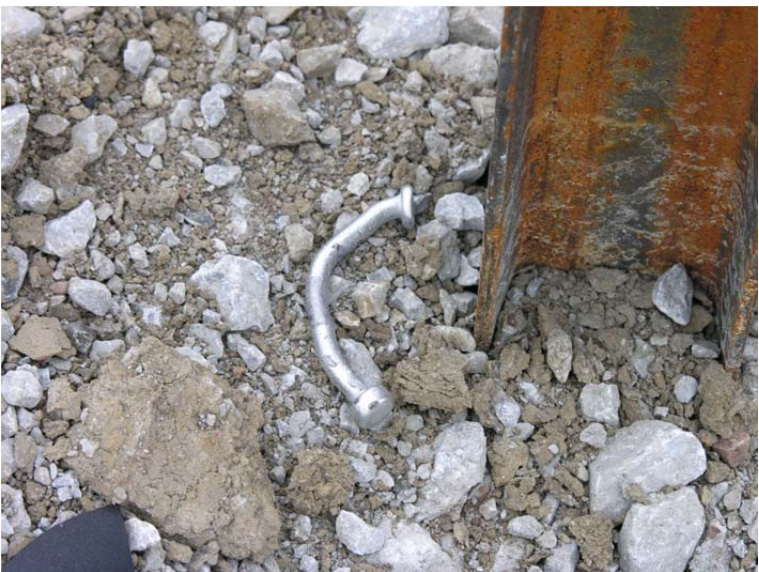
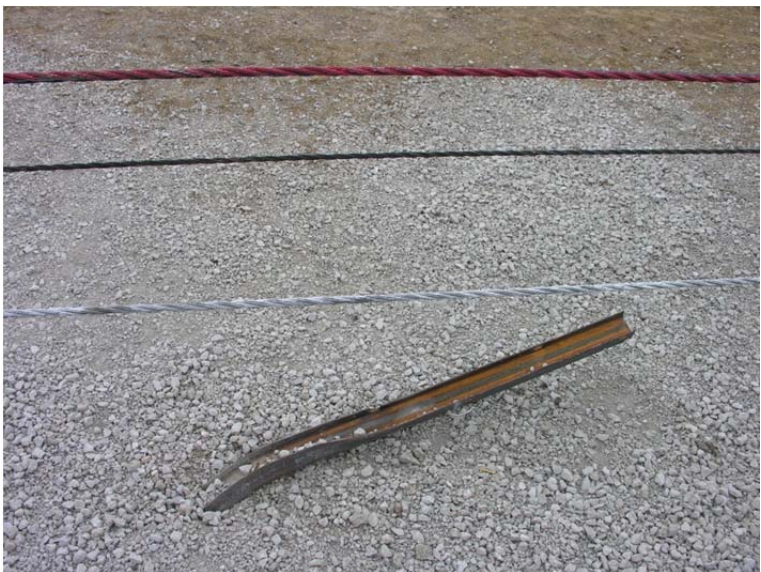
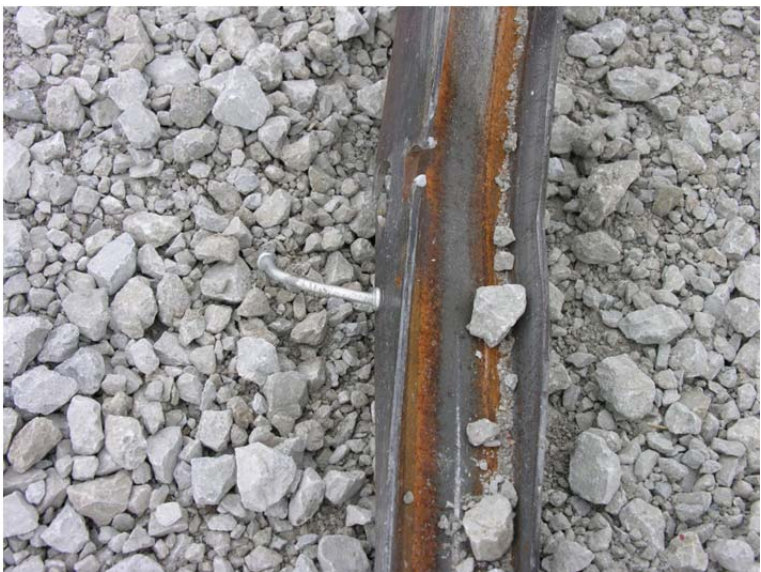
Figure 43. Post and Keyway Bolt Damage, Test No. 4CMB-4

upstream side of the flanges. Post no. 18 was bent backward slightly, and contact marks and gouging were found near the top of the post on the front side. Post no. 19 was bent downstream, and both flanges were dented at the location of cable no. 4. Post no. 20 was bent downstream and twisted to face downstream. The cable no. 4 keyway slot at post no. 20 was torn, and contact marks were found on the upstream side of the back flange near the top of the post. Post no. 21 was bent downstream with the right-rear wheel of the vehicle was resting on the post. Contact marks were found on the upstream side of both flanges extending the entire height of the post, and cable nos. 3 and 4 keyway slots were deformed. Post no. 22 was bent forward, and a $\frac{3}{4}$ in. (19 mm) soil gape was found on the back side of the post. Post no. 24 was deflected backward, and a $\frac{7}{8}$ in. (22 mm) soil gap was found on the front side of the post.

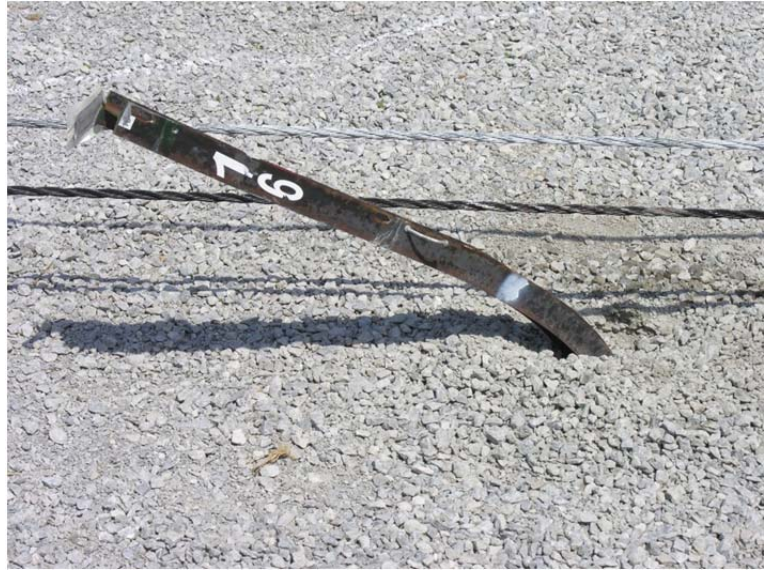
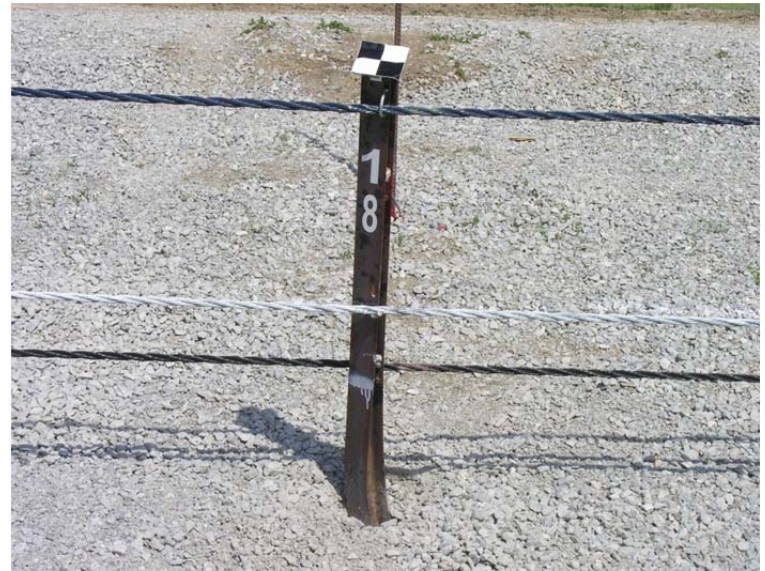
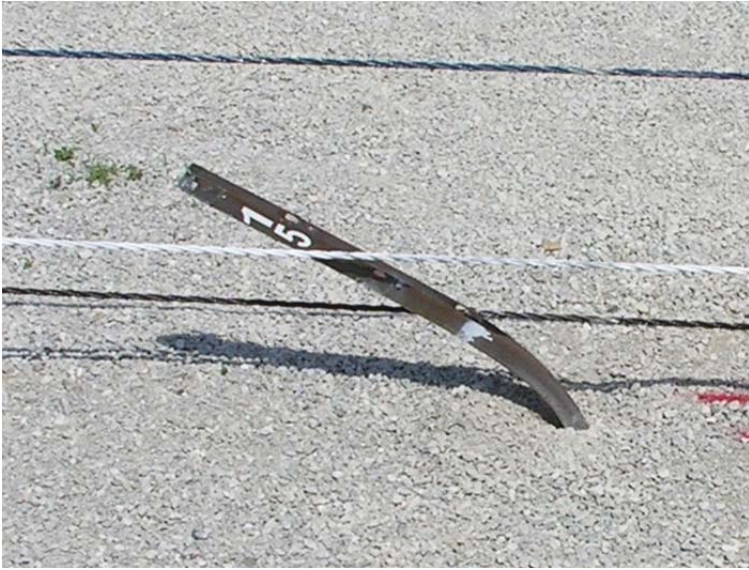
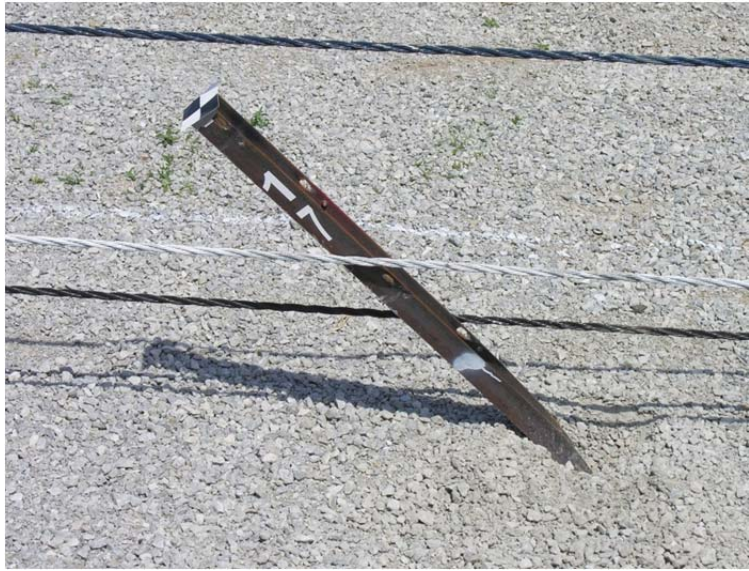
Figure 81. Post Damage, Test No. 4CMB-5

Damage to the barrier was moderate, as shown in Figures 80 through 82. Tension was released in the cables prior to taking all post-test documentation photos. Barrier damage consisted of deflected posts and disengaged cables and keyway bolts.

The maximum lateral permanent post deflections were not calculated for this test. The maximum lateral dynamic post deflection was 57.5 in. (1,461 mm) at post no. 17 and the maximum lateral dynamic cable deflection was approximately 101.5 in. (2,578 mm) in cable 2 just prior to failure, as determined from high-speed digital video analysis. The working width of the system was not calculated for this test.

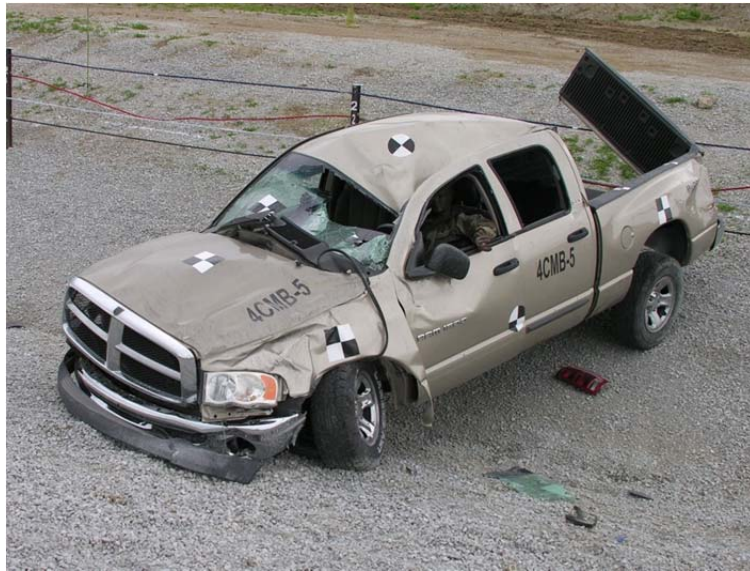
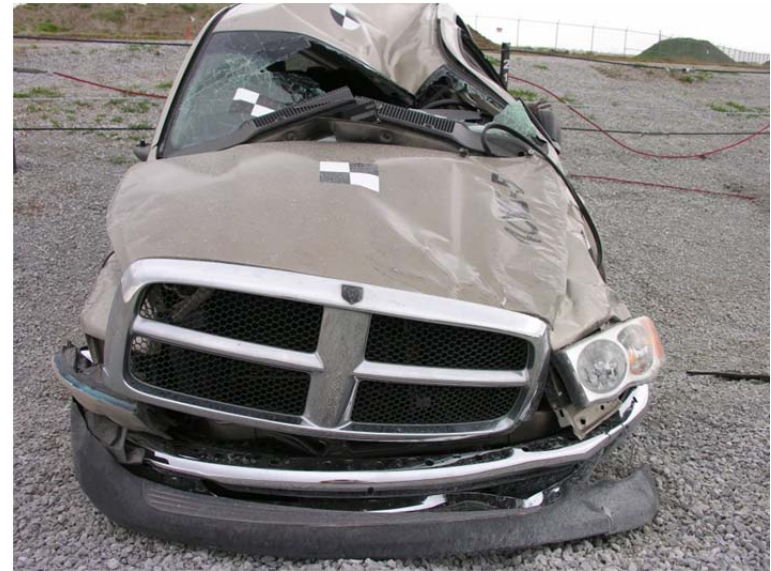
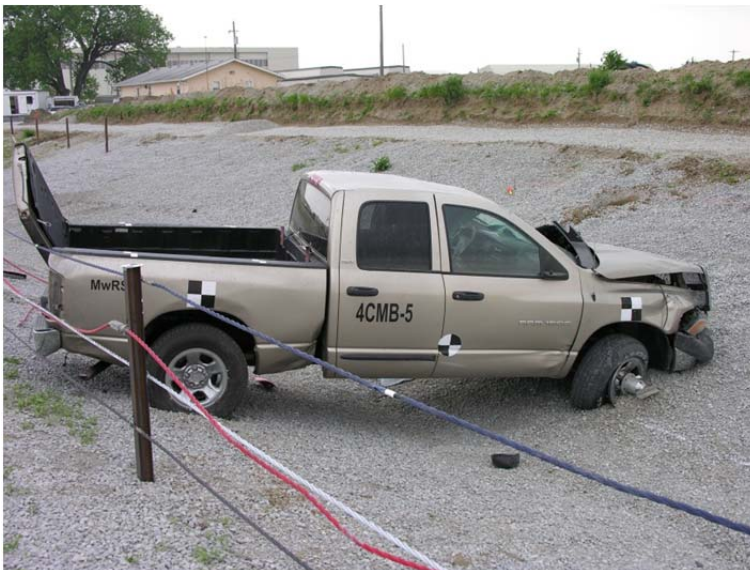
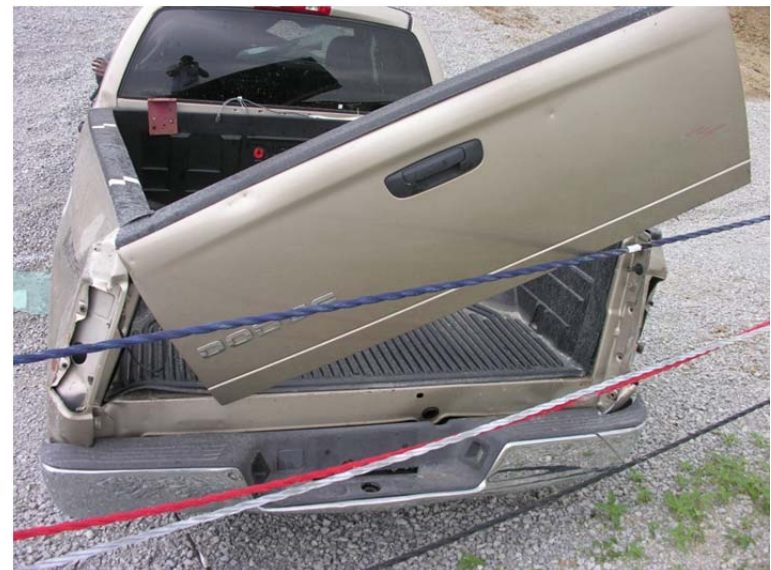
Figure 83. Vehicle Damage, Test No. 4CMB-5

The damage to the vehicle was severe, as shown in Figures 83 through 86. The maximum occupant compartment deformations are listed in Table 12 along with the deformation limits established in MASH for various areas of the occupant compartment. The roof deformation of $15\frac{1}{2}$ in. (394 mm) exceeded the MASH limit of 4 in. (102 mm). Complete occupant compartment and vehicle deformations and the corresponding locations are provided in Appendix D.

Damage occurred to all sides of the vehicle due to the rollover. The plastic bumper cover was disengaged and torn on the right side, and the bumper was dented near the center and the left side. The front frame member was bent and torn. The hood was crushed and ajar. The left side of the grill was fractured. The dash was fractured and deformed upward. The left side of the roof was severely crushed. The windshield was shattered and torn on the left side. The left headlight was disengaged and fractured. The left-front upper control arm, tie rod, and brakes were disengaged. The left-front lower control arm was fractured. The left fender was crushed inward at the front and deformed outward by the left-front door. The front and top of the left-front door and mirror were crushed inward. Both left windows were shattered and disengaged. The left-rear door was crushed at the top. The left-rear quarter panel was crushed inward behind the wheel. Both taillights disengaged. The tailgate disengaged on the right side. The right-rear quarter panel was scratched and dented behind the wheel well. The front of the right side of the box was crushed inward. The right-rear shock mount and shock fractured and disengaged. The right-front door was slightly ajar. Denting occurred at the lower-front of the right-front door. The right
