Safety Performance Evaluation of the Non-Blocked Midwest Guardrail System

*Midwest States Regional Pooled Fund Research Program
Fiscal Years 2011 (Year 21)
Research Project Number TPF-5(193) Supplemental #33
NDOR Sponsoring Agency Code RFPF-11-MGS-3*

SAFETY PERFORMANCE EVALUATION OF THE NON-BLOCKED MIDWEST GUARDRAIL SYSTEM (MGS)

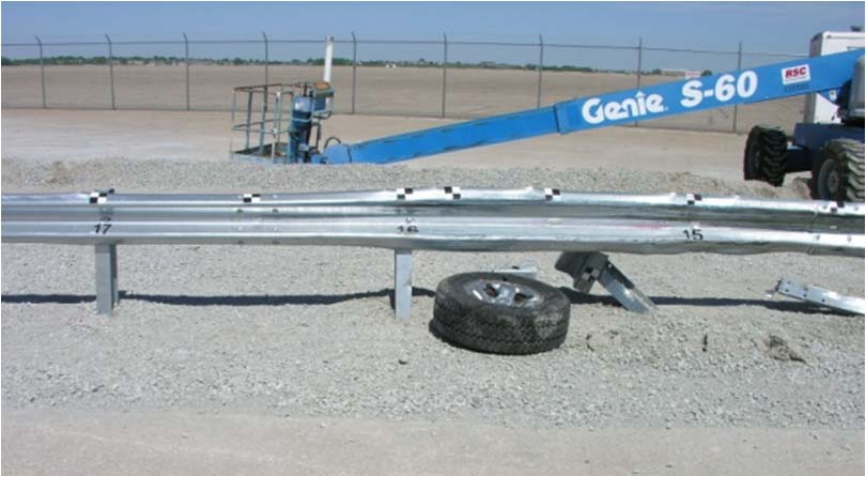
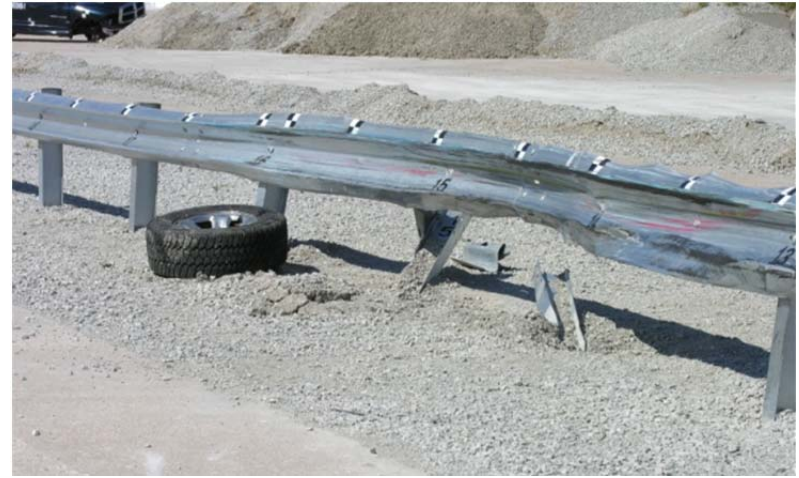
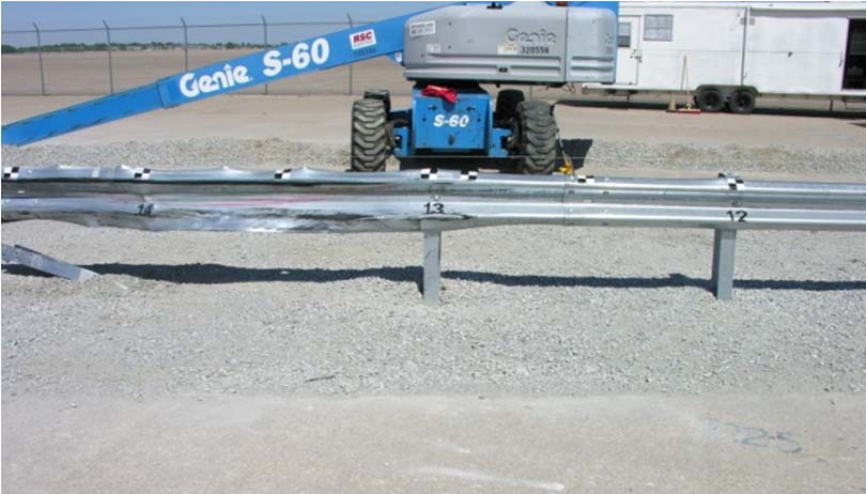
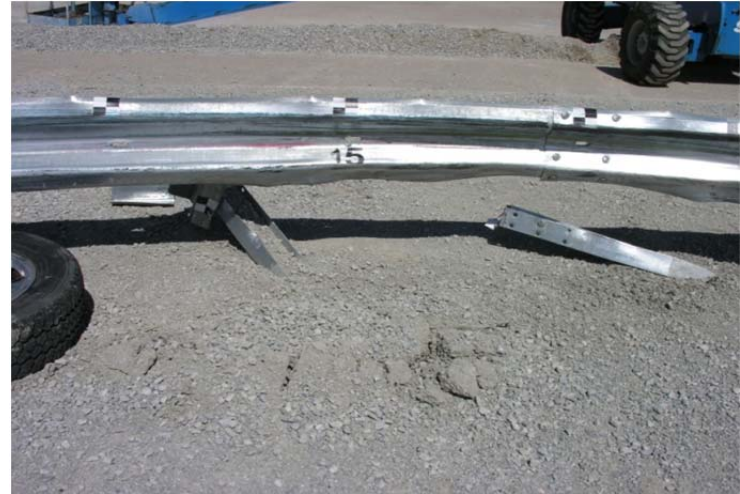
Figure 40. Guardrail Damage between Post Nos. 13 and 17, Test No. MGSNB-1

The W-beam backup plate at post no. 14 disengaged and the top corrugation was deformed. The bottom corrugation of the W-beam backup plate at post no. 15 was buckled. A 1 $\frac{1}{4}$ -in. (32-mm) gap between the top of the backup plate and the rail section was formed at post no. 16. A $\frac{1}{2}$ -in (13-mm) gap between the backup plate and the top of the rail section was found at post no. 17.

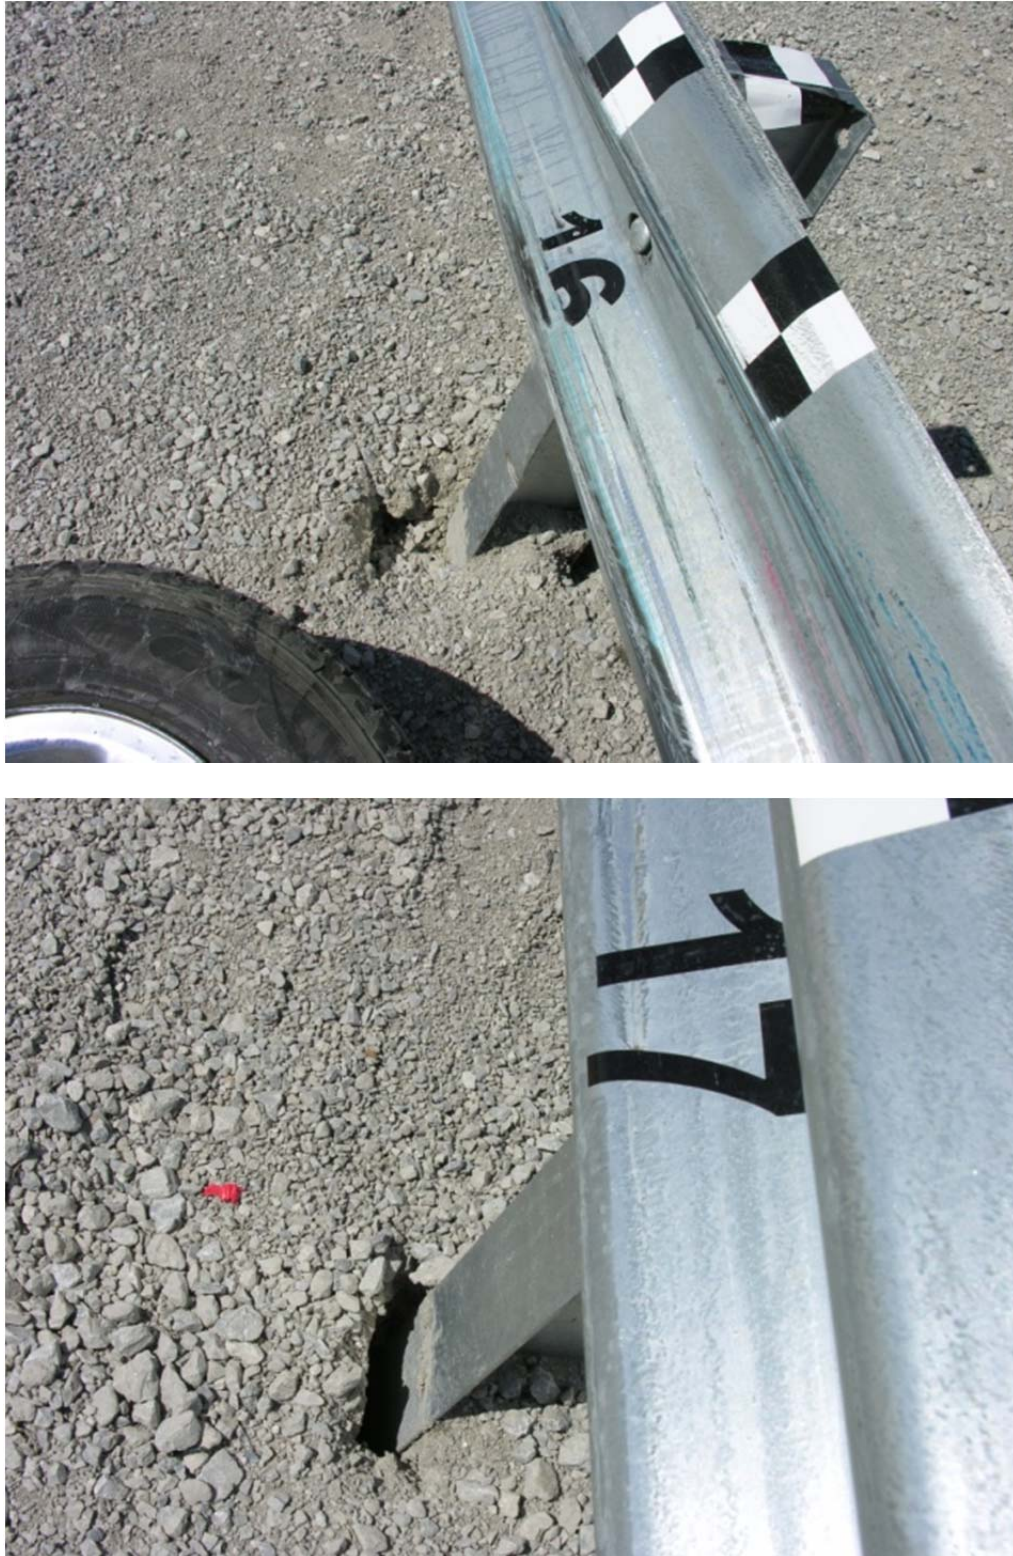
Figure 42. Post Damage between Post Nos. 13 and 15, Test No. MGSNB-1

Post nos. 12 through 17 rotated backward. Post no. 14 also bent downstream, and post no. 15 rotated downstream. Tire marks and scratches were observed on the front face of post nos. 13 and 14 just below the rail. The front flange of post no. 14 buckled 15 in. (381 mm) from the top, and the post twisted such that the front flange faced upstream. The upstream edge of the front flange of post no. 15 encountered tire marks and buckle points at 15 in. (381 mm) and 24 in. (610 mm) from the top of the post. The front flange of post no. 16 twisted upstream. A gouge was found on the upstream edge of the front flange of post no. 16 at 22 $\frac{3}{4}$ in. (578 mm) from the top of the post.

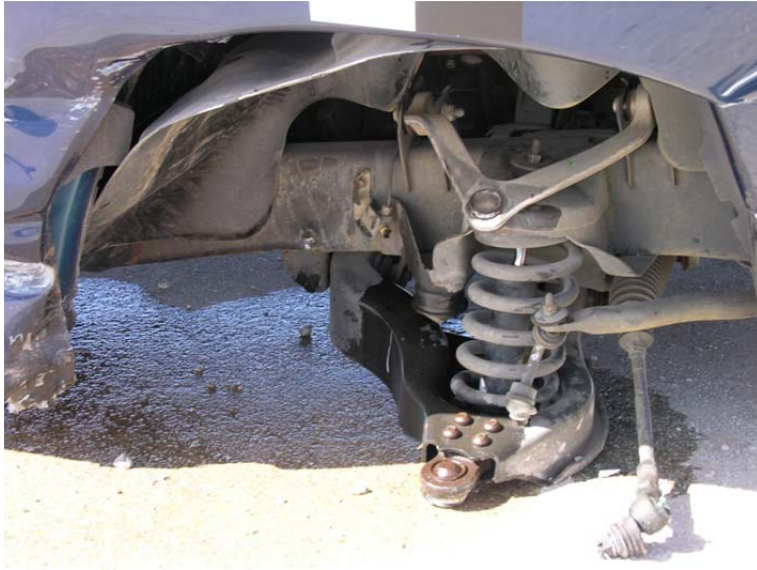
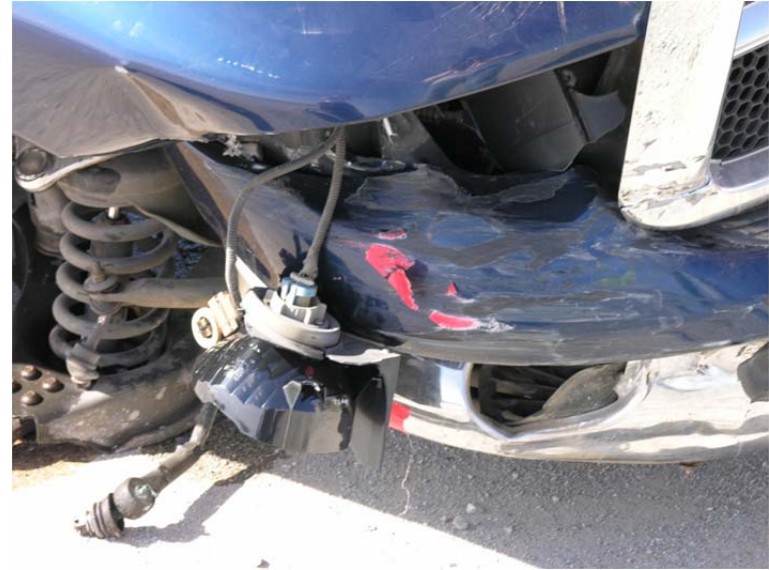
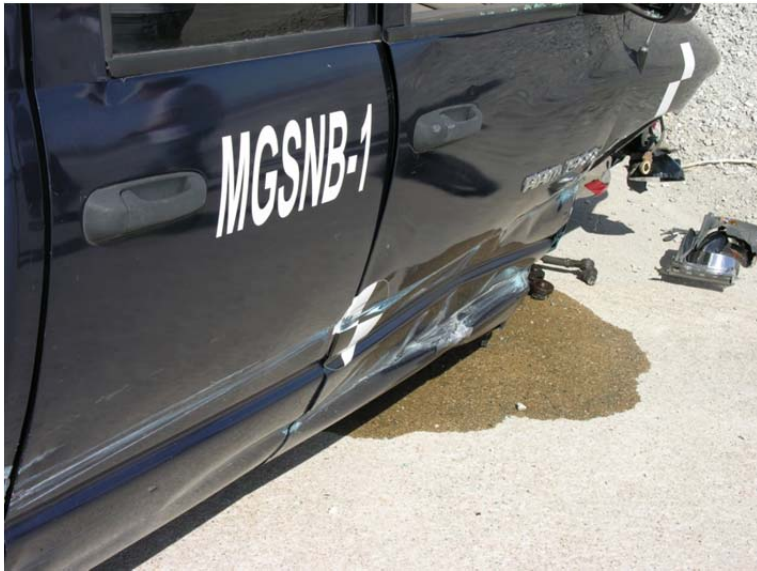
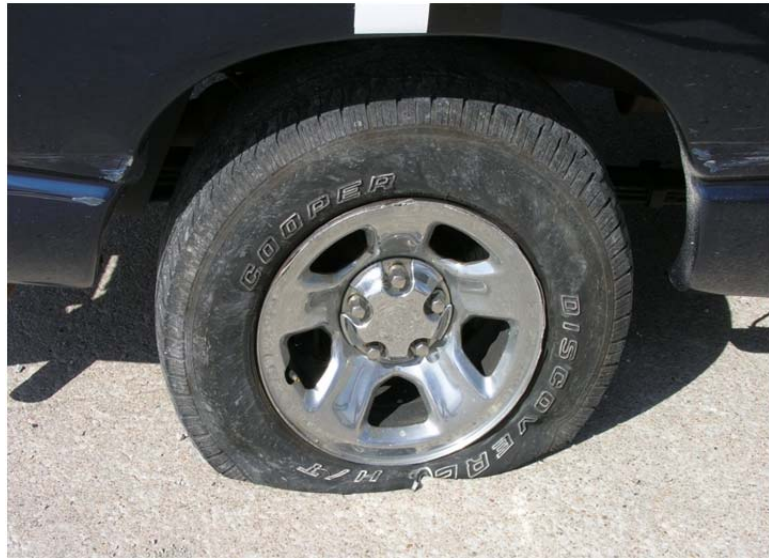
Figure 44. Vehicle Damage, Test No. MGSNB-1

Damage to the vehicle was moderate, as shown in Figures 44 and 45. The maximum occupant compartment deformations are listed in Table 5 along with the deformation limits established in MASH for various areas of the occupant compartment. None of the MASH

The majority of the damage was concentrated on the right-front corner and right side of the vehicle. The right-front tire was detached from the vehicle at the ball joint. The right-front tire was torn, and the steel rim was scratched and deformed. The right-front lower control arm fractured at the tie rod. The right-front tie rod and sway bar linkage were bent. The right-front wheel well was deformed inward and downward, and the right-front fender was bent inward. The right-side headlight was disengaged from the vehicle and fractured. The right-side of the front bumper was deformed inward toward the engine compartment. The left side of the front bumper was scraped, and a $1\frac{3}{4}$ -in. (44-mm) gap was found between the front bumper and the left-side headlight. The lower portion of the center of the grill was fractured. The left side of the hood was ajar 1 in. (25 mm). The left-front wheel well was torn. The right side of the rear bumper was deformed and deflected downward $3\frac{1}{2}$ in. (89 mm). The right side of the box rotated outward at the top and crushed inward at the bottom. The right-rear tire was torn and deflated. Deformations and contact marks extended along the entire right side of the vehicle. Both right-side doors were

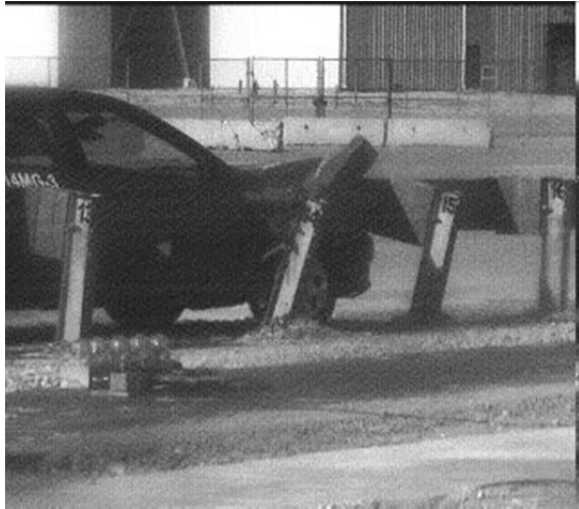
2214MG-3 – Blocked

A significant wheel snag occurred at post 14 during test no. MGSNB-2, which did not occur during test no. 2214MG-3, as shown in Figure 67. Initial impact for both tests was just upstream of post no. 13, and each vehicle easily cleared post no. 13 without tire-post overlap. The wheel snag at post no. 14 during test no. MGSNB-1 was the cause for the relatively abrupt change in longitudinal velocity (see Figure 64), as well as the relatively high OIV compared to the blocked test, test no. 2214MG-3 (31.3 ft/s versus 14.8 ft/s). It also helped pull post no. 14 out-of-the-ground as well as helped disengage the tire/wheel during the test.
