Analysis Of Trees Damaged From Flooding And Ice In Columbus, Nebraska

ANALYSIS OF TREES DAMAGED FROM FLOODING AND ICE IN COLUMBUS, NEBRASKA

AN UNDERGRADUATE THESIS

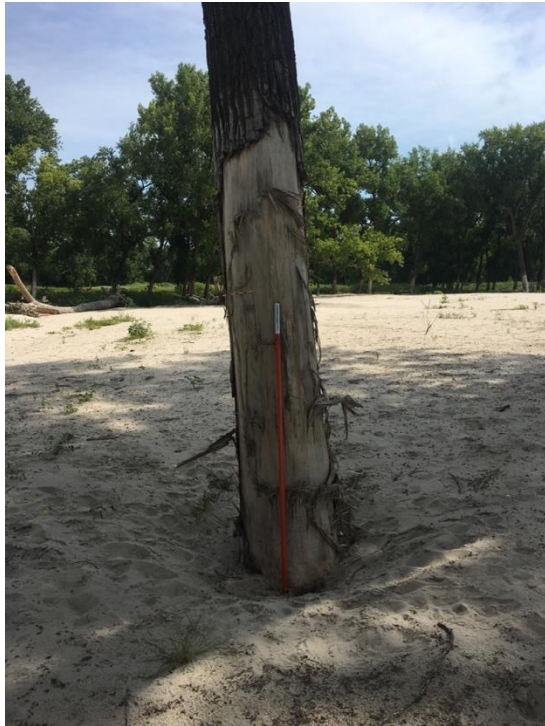
The flow of the water was moving northeast, and therefore the damage on the trees was seen on the south and west sides of the trunks. Figure 1 shows the kind of damage that was created due to ice rubbing against the bark and sand being displaced from the river.

Figure 1. Ice damage on the southwest side of a cottonwood.

deficiency; these trees should be watched in the years to come to determine if treatment is necessary. All of the trees that have scarring from the ice in the flood should be monitored for signs of declining health. This can be determined by examining the new growth on the twigs to see if it has grown less than previous years. Foliage is also a good way to determine the health of a tree. If the leaves are abnormally small or discolored, this could be a symptom of declining health.

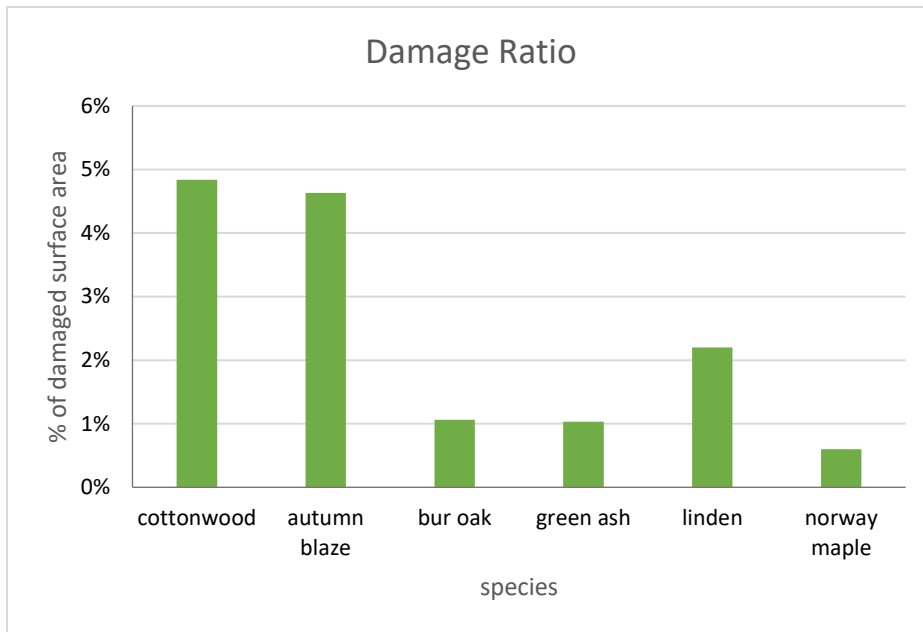
To calculate the percentage of the tree that had damage, the surface area of the tree was estimated using the height and circumference at breast height. Although circumference changes with height of the tree, this consistent calculation allowed an estimation of trunk damage. The average damage ratio is broken down by species in Chart 1.

Chart 1. Damage ratio by species

The amount of damage seen on each species is consistent with Justin Evertson's list of trees susceptible to ice damage in Nebraska. The cottonwoods endured the most amount of ice damage. This could be due to their high susceptibility to storm damage or the fact that these trees were closest to the river bed. Autumn blaze maples, which are a hybrid between red and silver maples, experienced quite a lot of damage, whereas the Norway maples resisted most of the damage. This observation lines up with Evertson's list, as well. The green ash trees resisted damage unusually well, but this could be due to the location and distance from the river bed and protection from surrounding trees.
