A Minimum-Impact Method for Measuring Corrosion Rate of Steel-Hulled Shipwrecks in Seawater

Current research on USS *Arizona* is focused on a minimum-impact technique for calculating corrosion rate of the battleship's steel hull by analysing physical and chemical properties of marine encrustation covering the exposed hull. An equation is derived that allows concretion thickness, density, and total iron content to be used to calculate corrosion rate of steel hull plate.

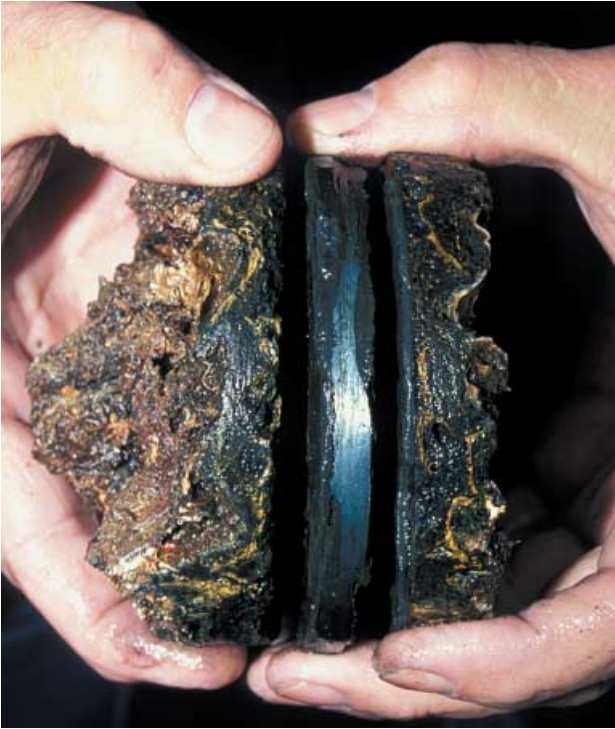
Figure 3. Hull coupon no. USAR-02-001, showing interior and exterior concretion. This sample is from the main deck, outer hull, in water less than 2 m deep with continuous seawater circulation on both sides, which explains thick concretion on both sides and extensive steel corrosion. (Brett Seymour/NPS)

thickness at Rail Sciences, Inc. in Omaha, Nebraska (Johnson *et al.*, 2003: 74–80). Although there is some unevenness across the surface of each coupon, corrosion was essentially uniform. Researchers measured steel thickness in nine locations on each coupon and averaged the measurements to obtain a thickness for each sample. The original ship plans provided as-built steel thickness in terms of theoretical weight, in pounds per square foot, at each location (Johnson *et al.*, 2003: 82). Standard tables were used to convert theoretical weight to nominal thickness in inches—unfortunately, no thickness tolerances are available.

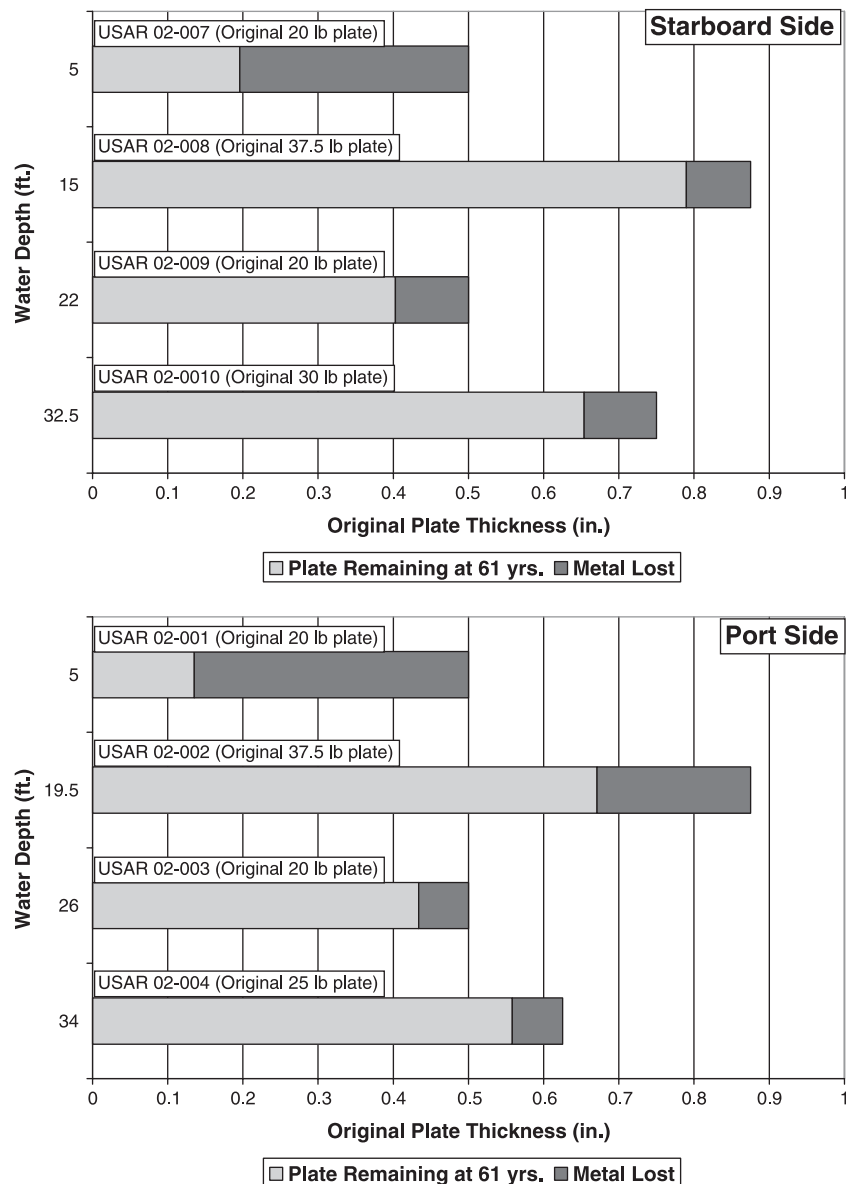
Figure 4. Metal loss as a function of original hull plate thickness and water depth, data from 2002 hull coupons.

Results from equation [1] for each coupon are given in Fig. 4 as a function of water-depth, and the results from equation [3] are given in Table 1. Because coupons were collected in 2002, $t = 61$ yr for these calculations. Note that for the two shallowest samples in Table 1 (USAR-02-001 and USAR-02-007, both in 1.52 m (5 ft) water-depth), corrosion rate (i_{corr}) was halved from the absolute value obtained from the direct-measurement technique. Values were halved because, at those two locations, both the inside and outside of the hull are open to free-circulating seawater causing corrosion and concretion formation on both the interior and exterior sides of the hull, effectively doubling the corrosion rate. On all other samples there was little observable interior corrosion or concretion formation, and internal dissolved oxygen levels measured after coupon removal were at or near zero, indicating the majority of corrosion was taking place on the exterior only. Therefore, to be consistent with concretion analysis in which only exterior

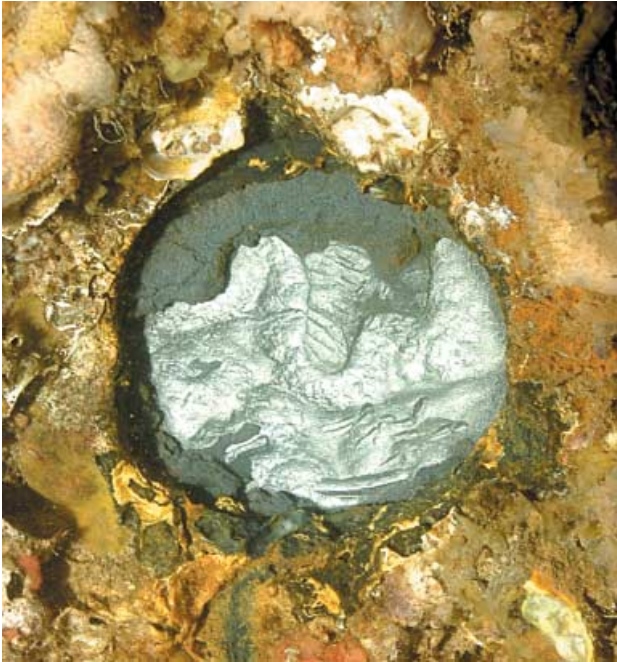
Figure 5. Surface of *Arizona*'s hull after removal of a 76-mm (3-inch) diameter concrete disk and surface preparation. Note the unevenness of the surface, even after significant surface preparation. (Brett Seymour/NPS)

possible) before consistent, repeatable readings can be obtained. In some cases, even after extensive surface preparation, there are locations where UT measurements are unreliable because of unevenness of the surface due to corrosion (Fig. 5), which makes it impossible to couple the face of the UT probe evenly against the hull. Therefore, we are currently focusing our attention on determining corrosion rate by analysing chemical and physical properties of hull concretion.

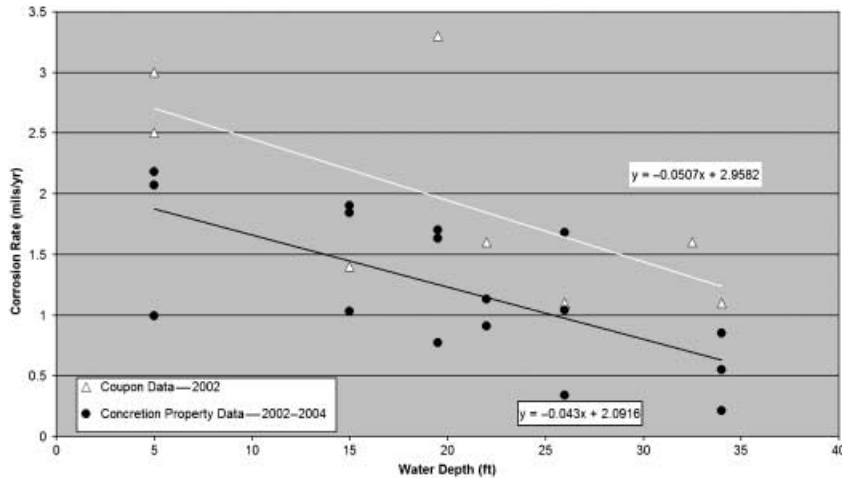
Figure 6. Corrosion rate versus water depth as a function of direct measurement of coupons (white line) and concretion property analysis (black line).

Physical and chemical properties for 16 concretion samples and corresponding corrosion rates calculated from equations [4] and [5] are tabulated in Table 2. Corrosion rates in mils/yr calculated from concretion constituent analysis (Column 8 in Table 2) and corrosion rates in mils/yr based on the direct-measurement technique (equation [3]) are compared in Fig. 6 and plotted against water-depth in feet. The actual corrosion rate obtained from the direct-measurement technique is higher than that predicted by concretion constituent analysis using equation [4], as indicated by the separation between the two trend lines. The reasons for the difference are: (1) higher initial (pre-concretion) corrosion rates almost certainly produced soluble iron that was not incorporated into concretion; (2) formation of an oxide layer between the steel surface and the concretion, which strongly adheres to the hull and is not captured during concretion removal and therefore is not included in the analysis; and (3) possible interior corrosion. Analysis of the ratios of the two

trend lines in Fig. 6 reveals that corrosion rates obtained from the coupons using the direct-measurement technique is higher than corrosion rates predicted by the concretion constituent analysis by a factor of 1.6. With this ratio factored in, a general equation for estimating corrosion rate directly from physical and chemical concretion properties is given in equation [6], where the constants in equations [4] and [5] are multiplied by 1.6 for English and SI units respectively:
