# A Minimum-Impact Method for Measuring Corrosion Rate of Steel-Hulled Shipwrecks in Seawater

Current research on USS *Arizona* is focused on a minimum-impact technique for calculating corrosion rate of the battleship's steel hull by analysing physical and chemical properties of marine encrustation covering the exposed hull. An equation is derived that allows concretion thickness, density, and total iron content to be used to calculate corrosion rate of steel hull plate.

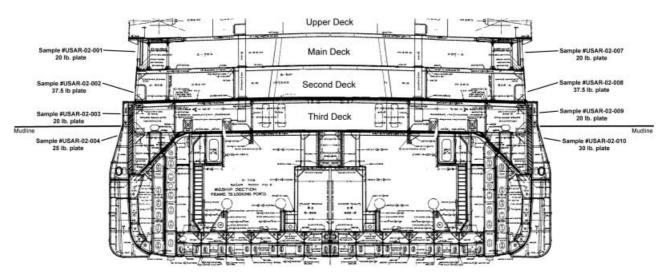
Figure 2. Cross-section of USS Arizona's midship at Frame 75 showing hull coupon locations.

As an initial control for this research, 10-cm diameter hull samples ('coupons'), (4-in) including intact exterior and interior concretion, were removed using a hydraulic-powered hole saw with a task-specific bit designed to retain the coupon plus interior and exterior concretion. Eight coupons were removed from external, vertical hull locations on both port and starboard sides (Figs 2 and 3). On each side of the ship, one sample was taken from the upper-deck level near the water line: from the second-deck level above the torpedo blister; from the third-deck level in the torpedo blister; and from the first platform level in the torpedo blister below the mud-line. Immediately after removal, each location was plugged using a standard plumber's pipe plug and sealed with marine epoxy to prevent formation of localised corrosion cells and minimize exchange of interior and exterior water.

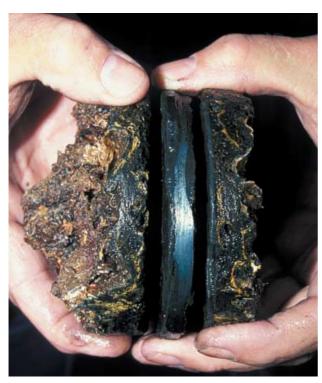
Figure 3. Hull coupon no. USAR-02-001, showing interior and exterior concretion. This sample is from the main deck, outer hull, in water less than 2 m deep with continuous seawater circulation on both sides, which explains thick concretion on both sides and extensive steel corrosion. (Brett Seymour/NPS)

thickness at Rail Sciences, Inc. in Omaha, Nebraska (Johnson et al., 2003: 74–80). Although there is some unevenness across the surface of each coupon, corrosion was essentially uniform. Researchers measured steel thickness in nine locations on each coupon and averaged the measurements to obtain a thickness for each sample. The original ship plans provided as-built steel thickness in terms of theoretical weight, in pounds per square foot, at each location (Johnson et al., 2003: 82). Standard tables were used to convert theoretical weight to nominal thickness in inches—unfortunately, no thickness tolerances are available.

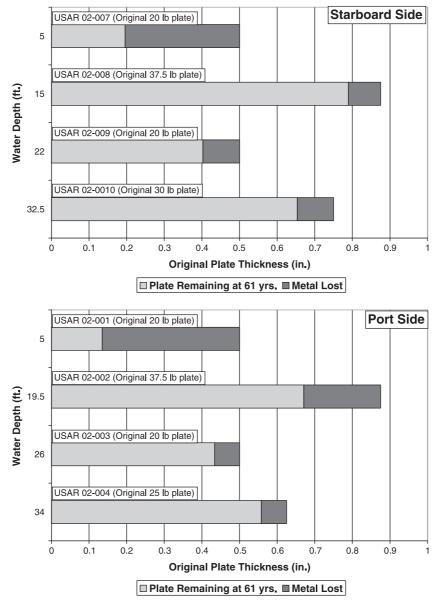
Figure 4. Metal loss as a function of original hull plate thickness and water depth, data from 2002 hull coupons.

Results from equation [1] for each coupon are given in Fig. 4 as a function of water-depth, and the results from equation [3] are given in Table 1. Because coupons were collected in 2002, t = 61yr for these calculations. Note that for the two shallowest samples in Table 1 (USAR-02-001 and USAR-02-007, both in 1.52 m (5 ft) waterdepth), corrosion rate (icorr) was halved from the absolute value obtained from the directmeasurement technique. Values were halved because, at those two locations, both the inside and outside of the hull are open to free-circulating seawater causing corrosion and concretion formation on both the interior and exterior sides of the hull, effectively doubling the corrosion rate. On all other samples there was little observable interior corrosion or concretion formation, and internal dissolved oxygen levels measured after coupon removal were at or near zero, indicating the majority of corrosion was taking place on the exterior only. Therefore, to be consistent with concretion analysis in which only exterior concretion is available for analysis (and therefore corrosion is estimated using only exterior concretion, see below), we halved the directly measured corrosion rate for the shallow coupons that had corroded extensively on both sides.

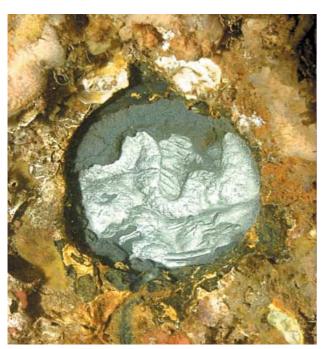
Figure 5. Surface of Arizona's hull after removal of a 76-mm (3-inch) diameter concretion disk and surface preparation. Note the unevenness of the surface, even after significant surface preparation. (Brett Seymour/NPS)

possible) before consistent, repeatable readings can be obtained. In some cases, even after extensive surface preparation, there are locations where UT measurements are unreliable because of unevenness of the surface due to corrosion (Fig. 5), which makes it impossible to couple the face of the UT probe evenly against the hull. Therefore, we are currently focusing our attention on determining corrosion rate by analysing chemical and physical properties of hull concretion.

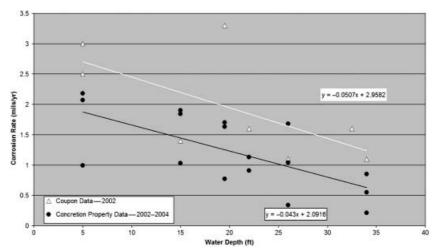
Figure 6. Corrosion rate versus water depth as a function of direct measurement of coupons (white line) and concretion property analysis (black line).

Physical and chemical properties for 16 concretion samples and corresponding corrosion rates calculated from equations [4] and [5] are tabulated in Table 2. Corrosion rates in mils/yr calculated from concretion constituent analysis (Column 8 in Table 2) and corrosion rates in mils/yr based on the direct-measurement technique (equation [3]) are compared in Fig. 6 and plotted against water-depth in feet. The actual corrosion rate obtained from the directmeasurement technique is higher than that predicted by concretion constituent analysis using equation [4], as indicated by the separation between the two trend lines. The reasons for the difference are: (1) higher initial (pre-concretion) corrosion rates almost certainly produced soluble iron that was not incorporated into concretion; (2) formation of an oxide layer between the steel surface and the concretion, which strongly adheres to the hull and is not captured during concretion removal and therefore is not included in the analysis; and (3) possible interior corrosion. Analysis of the ratios of the two

trend lines in Fig. 6 reveals that corrosion rates obtained from the coupons using the direct-measurement technique is higher than corrosion rates predicted by the concretion constituent analysis by a factor of 1.6. With this ratio factored in, a general equation for estimating corrosion rate directly from physical and chemical concretion properties is given in equation [6], where the constants in equations [4] and [5] are multiplied by 1.6 for English and SI units respectively:
