An Artesian Well System in Beaver Crossing, Nebraska- It's Development and Demise

Disclaimer: The following thesis was produced in the Environmental Studies Program as a student senior capstone project.

An Artesian Well System in Beaver Crossing, NE - Its Development and Demise

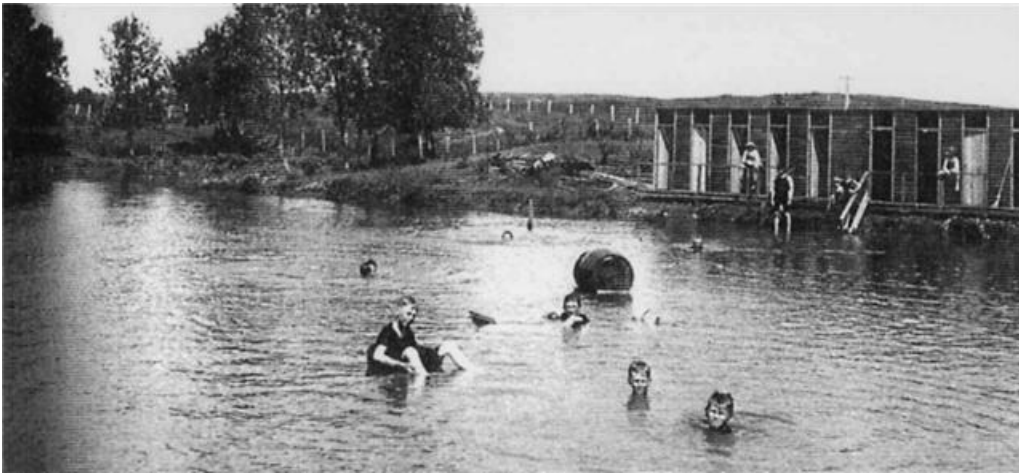
Figure 5. An early photo of the pool approximately 1908 (BCCC 1975)

town leased it to a local resident and with the addition of bath houses, it soon became a favorite local attraction. By 1909, the town had been hosting annual summer picnics for years, so the addition of an open air pavilion with a seating capacity of 2,000 people added to the attraction (Fig. 5, BCCC 1975).

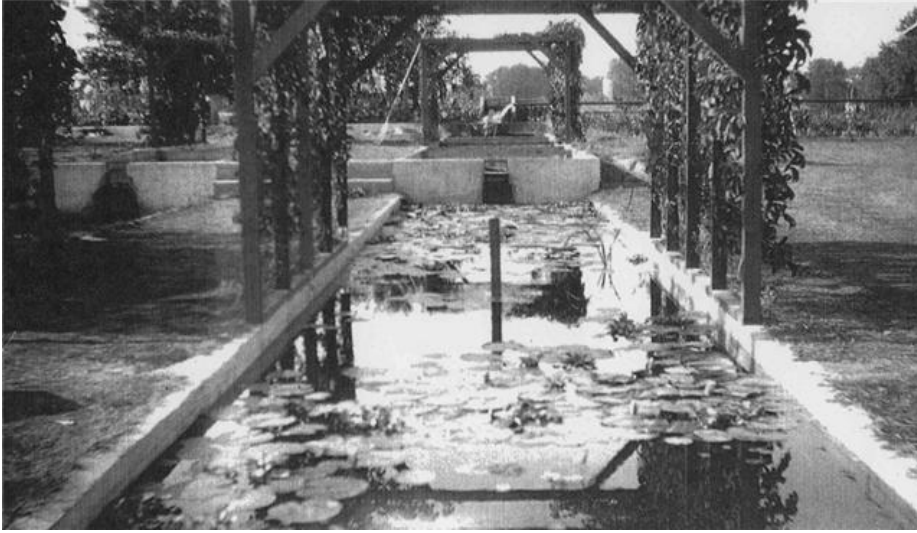
Figure 8. Concrete pond, artesian well at rear, Smiley's Water Garden (Anne Müller, Private Collection)

In August, 1927, Mr. Erle Smiley purchased some land southeast of town and platted it for a fish farm. He chose the artesian well area because he knew that rainbow trout would successfully breed in the constant year round temperature of 54 degrees. After several attempts with dirt bottom ponds, which proved too porous to hold water, he constructed nine concrete ponds 50 x 8 feet and three feet deep (Fig. 8, Anne Miiler). After some trial and error, a few years later he added a hatching house. He proved successful in hatching, raising, and selling thousands of the trout to hotels and the Pullman dining service(BCCC 1975) (Fig 9, Anne Miiler).

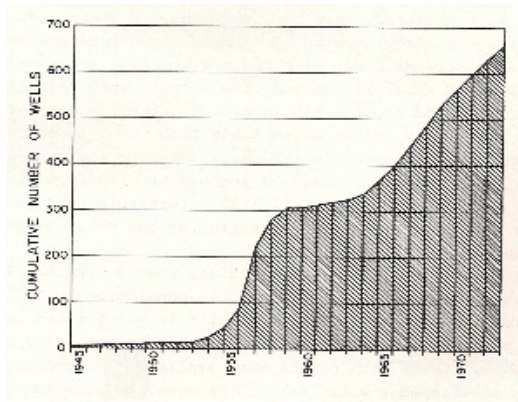
Figure 11. Number of Irrigation Wells installed per year in Seward County (Keech 1978)

In Seward County a few irrigation wells were installed by the end of 1948, and only fifteen more were in use by 1952. The years between 1955 and 1957 were very dry, during two of those years rainfall in Seward County was at least ten inches below normal (Keech 1978) and farmers were becoming desperate to improve their crop yields. By the end of 1957, 300 irrigation wells were in use in the county and by 1970 the number of irrigation wells would be over 500 (Fig. 11, Keech 1978).
