# External characteristics of houses prone to woodpecker damage

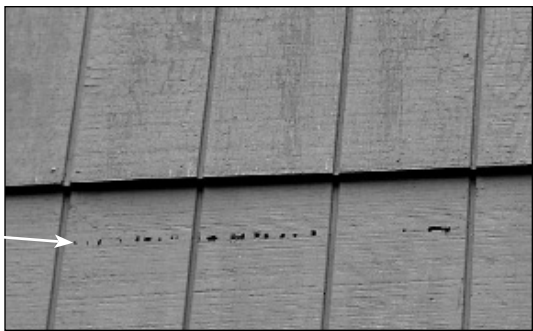
**a**

**Figure 4.** Examples of woodpecker damage to houses near Ithaca, New York, April 2001 to March 2002: (a) horizontal rows of foraging holes following core gaps in grooved plywood siding, (b) foraging damage on stained cedar shakes, (c) damage caused by foraging for carpenter bee larvae on fascia boards of a house, and (d) roosting or nesting holes in board-and-batten siding.

Effects of siding type on the form of damage. Siding types differed in their susceptibility to the 3 kinds of woodpecker damage (Table 3). In 28% of the houses with damage, woodpeckers had carried out some type of foraging behavior. Grooved plywood was the siding type most susceptible to foraging damage, which often took the form of small holes in horizontal lines (Figure 4a). Our observations indicated that woodpeckers were feeding on insects living in the siding. When the vertical grooves were cut into the upper layers of the plywood to create the board-and-batten look, core gaps in the middle layers were exposed. These narrow tunnels provide an attractive, egg-laying and over-wintering site for insects. We removed the insects and insect casings from the core gaps of 14 houses with grooved plywood siding and sent them to the Cornell University Entomology Lab for identification. We found larval casings of grass bagworms (*Psyche casta*) in 13 (93%) of

these samples, and larval casings of leafcutter bees (*Magachile* spp.) in 8 (57%). We also found sunflower seeds, most likely cached by black-capped chickadees (*Parus atricapillus*), as well as katydids (*Tettigoniidae*) and other unidentifiable matter in core gaps. Woodpeckers were clearly able to detect the insects hidden in core gaps, and they bored a series of holes into the wood to reach them.
