## Extent of Gully Erosion in an Agricultural Field in Northeastern Nebraska at Section 35 Township 29 North Range 1 West in Cedar County

AN UNDERGRADUATE THESIS

Major: Environmental Studies

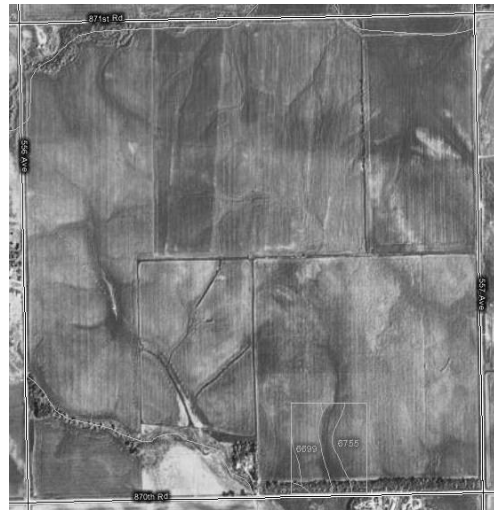
**Figures 2:** Aerial photograph of section 35 Township 29 north Range 1 west from 2006 taken from the NRCS Web Soil Survey.

The study area is within northeast Nebraska. Section 35 Township 29 North Range 1 West is located on the border with Piece County. The gully in question for this study is within the southwest quarter of the southeast quarter of the section (Figures 1, 2, and 3). The south east quarter of the field has been under cultivation since before 1937. The crop rotation for the last 30 years has been corn- soybeans

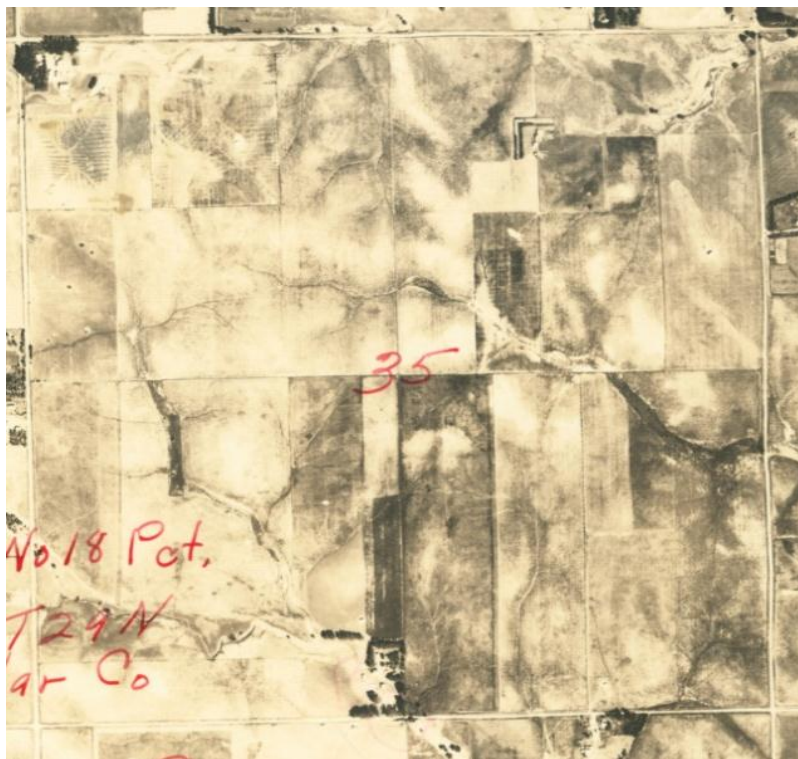
**Figure 5:** 1937 aerial photograph of the southeast quarter of section 35 Township 29 north Range 1 west. Photo retrieved from Nebraska Maps.

Aerial photo analysis was completed by digitizing the 1937, 1955, and 2006 photos. Nebraska Maps has provided aerial photographs of the field for two years: 1937 and 1955 (Figures 5 and 6) and a photo from the Web Soil Survey was screen captured for the 2006 photo (Figure 7). The photos were digitized and a measure of the visible erosion was made.

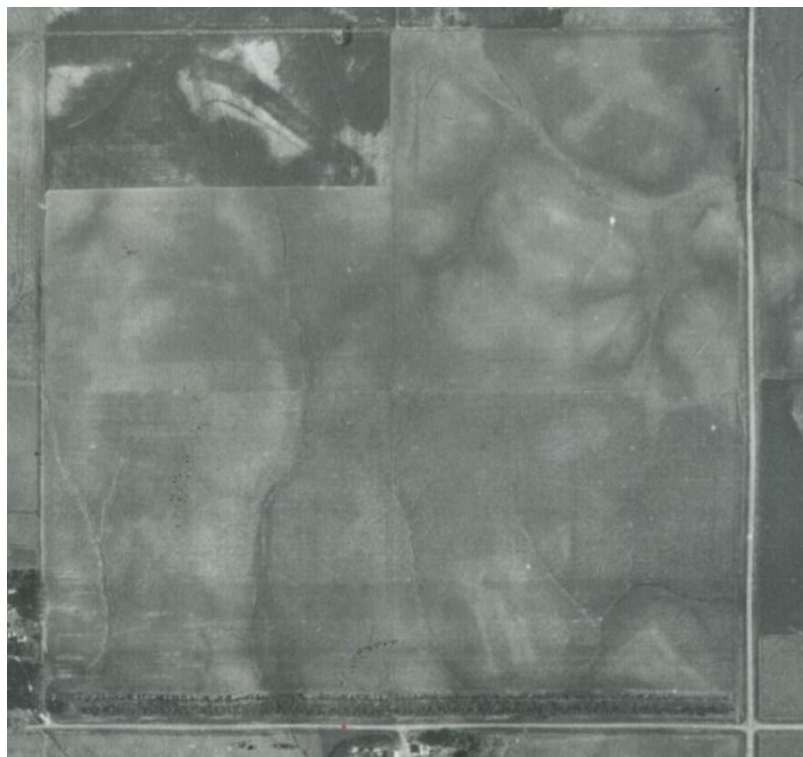
**Figure 6:** 1955 aerial photograph of the southeast quarter of section 35 Township 29 north Range 1 west.

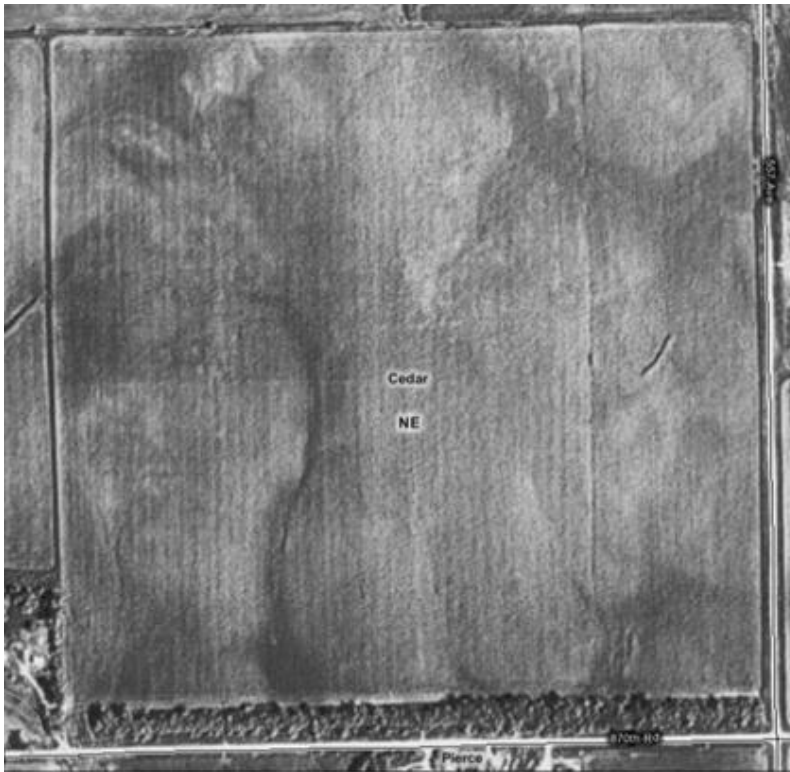
**Figure7:** 2006 aerial photograph of the southeast quarter of section 35 Township 29 north Range 1 west. Photo retrieved from NRCS Web Soil Survey.

The parcel of land was purchased in 1990 and has been in cropland before and after it was purchased. The trees were planted in the 1940s to protect homesteads from northern winds during winter (Figure 7). The cropping system has been dry land corn-soybean rotation since purchase by current land owner (Table 3).

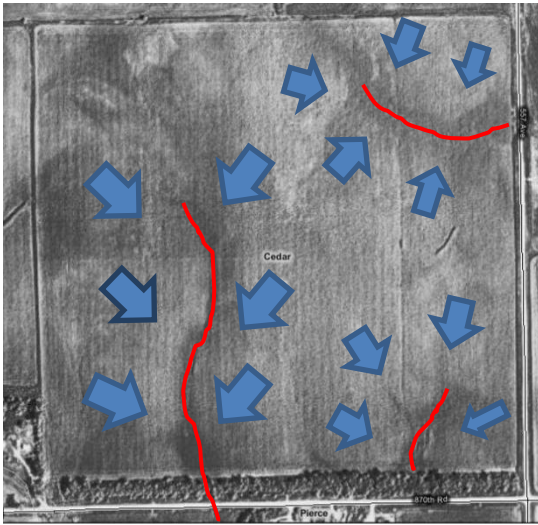
**Figure 10:** Diagram of water movement within the southeast quarter of section 35 Township 29 north Range 1 West. Red lines show the relative placement of the dry waterways. Background image was taken from NRCS Web Soil Survey.

The Section 35 Township 29 North Range 1 West's southeast quarter has three distinct directions of water flow by land surface (Figure 10). The field contains no wet streams. However, dry waterways are present and play a huge part in the water flow during heavy rain events and cause concentrations of rain water flow.

The southeast quarter can be divided down the middle from north and south dividing the land into East and West halves. The west side has a flow into a single valley going in a southerly direction. The east side of the field can also be divided into two halves, north and south. The north contains a valley that flows to the east. The south half of the east half flows to the south. In this south half, water flowing to the south can only come out one of two valleys. This concentrates the water flow creating favorable conditions for gully development. Both valleys that flow to the south proceed south until joined one third of a mile into Pierce County and meet a wet stream that comes from the northwest (Figure 11).

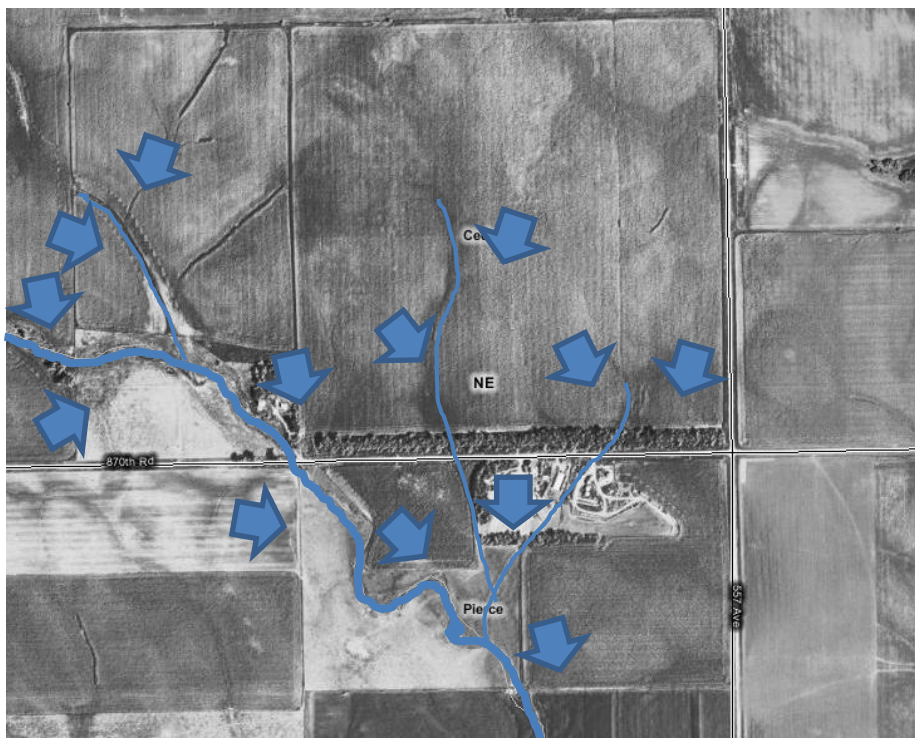
**Figure 11:** Expanded view of water movement encompassing sections 35 Township 29 north Range 1 west and section 2 Township 28 north Range 1 west. Blue line shows the relative placement of waterways. Background image was taken from NRCS Web Soil Survey.

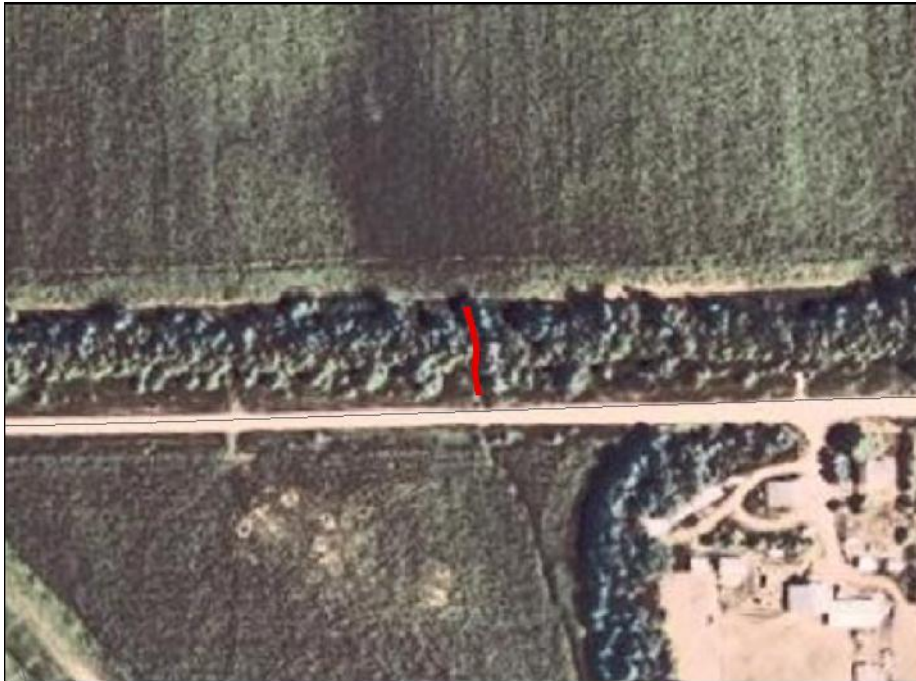
**Figure 17:** 2006 aerial photograph with measured area of gully in red within section 35 Township 29 north Range 1 west.
