**Report to DOT/PHMSA Steering Committee on
Collaborative Demonstration of Guided Wave Ultrasonics
NYSEARCH**

Controlled Tests & Data Analyses

By
Daphne D'Zurko
Executive Director, NYSEARCH
Version for Public Release
April 2007

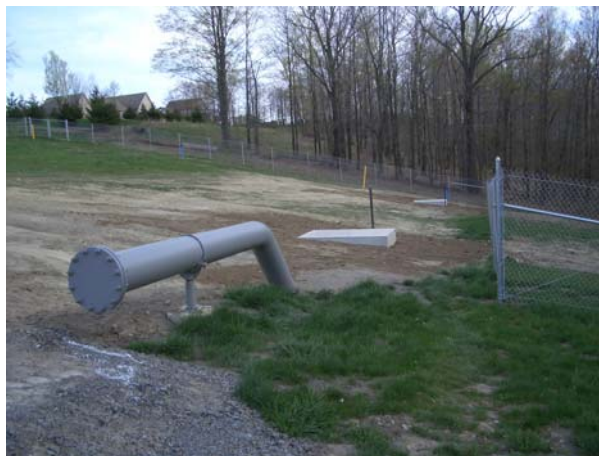
Figure 1. Access points for 12" Cased Pipe

It is worthy of note that two of the three 100' cased pipe sections are above-ground sections. The third is a 12" carrier pipe in a 16" casing in an underground network. In the 12" carrier pipe case, the vendors were notified that the guided wave transducer belt could be applied above-ground near the access point but between two 45-degree bends OR at the same level as the overall cased pipe section because of underground excavation vaults that had been constructed on both the North and South ends of the 12" cased pipe for the purpose of integrity inspection tests. Figure 1 illustrated both access points; in the foreground is the above-ground access point to the 12" pipe and in the background is one of the two underground vaults for direct straight-pipe access.
