# Post-disaster Assessment of Northeastern Coastal Region for the 2011 Sendai Earthquake and Tsunami

**Abstract**—The 2011 Sendai Earthquake has hit the north-east of Japan triggering a destructive tsunami that has caused extensive damage. A fast and effective post-disaster assessment is highly imperative for the recovery of this region. This study modeled the tsunami-affected areas of coastal Fukushima Prefecture using Landsat-7 ETM+ data and terrain analysis. The result shows that most of the coastal areas were significantly affected by the tsunami. The low-lying plains along the coast are particularly vulnerable to the tsunami.

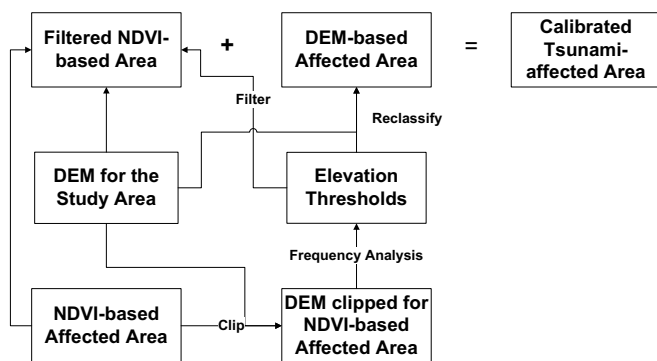
Figure 4. The procedure to calibrate tsunami-affected areas using DEM.

DEMs and GIS have been widely used to aid remotely sensed flood mapping. For example, Wang et al. [5] used DEM data to identify flooded areas under forest canopies, which cannot be captured using remote sensing. In this study, we used the following method to calibrate the NDVI-based inundated areas (Fig. 4). Two elevation thresholds were selected using the following methods to eliminate the pixels that were incorrectly classified as inundated areas and complement the areas that were not captured by NDVI. Firstly, the ASTER GDEM was clipped for the NDVI modeled areas. Since the elevation of the tsunami-affected extents is dominantly below 10 m (Fig. 5), all pixels with an elevation above 9 m were treated as non-tsunami-affected area and filtered using GIS. Considering some low-lying inundated areas were not well captured, we reclassified the areas of northern Fukushima below 4 m as inundated, and the southern areas below 2 m as flood-affected. The difference in selected elevation thresholds for northern and southern Fukushima was due to the distance from the earthquake epicenter. Low-lying coastal areas close to earthquake epicenter may be more vulnerable to tsunami inundation. Finally, we combined filtered NDVI-based areas and low-lying land as the tsunami-affected extent.

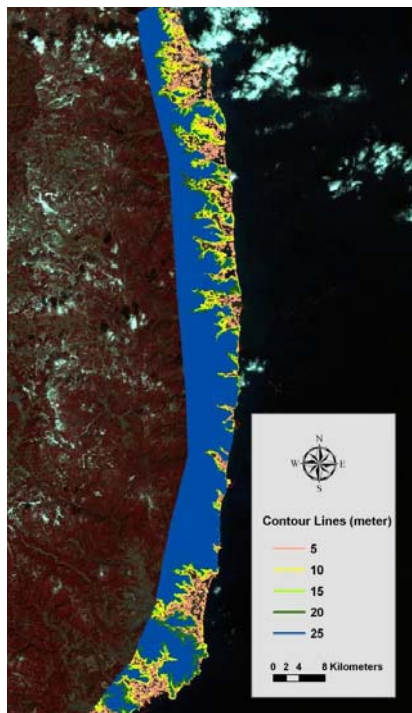
Figure 7. Topography of the Fukushima coastal areas.

Fig. 7 exhibits the elevation contours along the Fukushima coast. Based on a comparison of Fig. 6 and Fig. 7, the tsunami-affected area was closely related to the topography. The low and flat plains along the Japanese coast southwest of the earthquake epicenter are particularly vulnerable to tsunamis. This is similar to the observation in the west coast of Myanmar after 2004 Indian Ocean Tsunami, where low-elevation areas were highly susceptible to tsunami flooding. Also, the distance from earthquake epicenter may be another factor affecting the tsunami inundation. As shown in Fig. 6 and Fig. 7, the southern low-lying areas did not show similar inundation to the northern part of the study area.
