Nebraska Extension Faculty & Staff
Publications

Closing Abandoned Livestock Lagoons Effectively to Utilize Nutrients and Avoid Environmental Problems

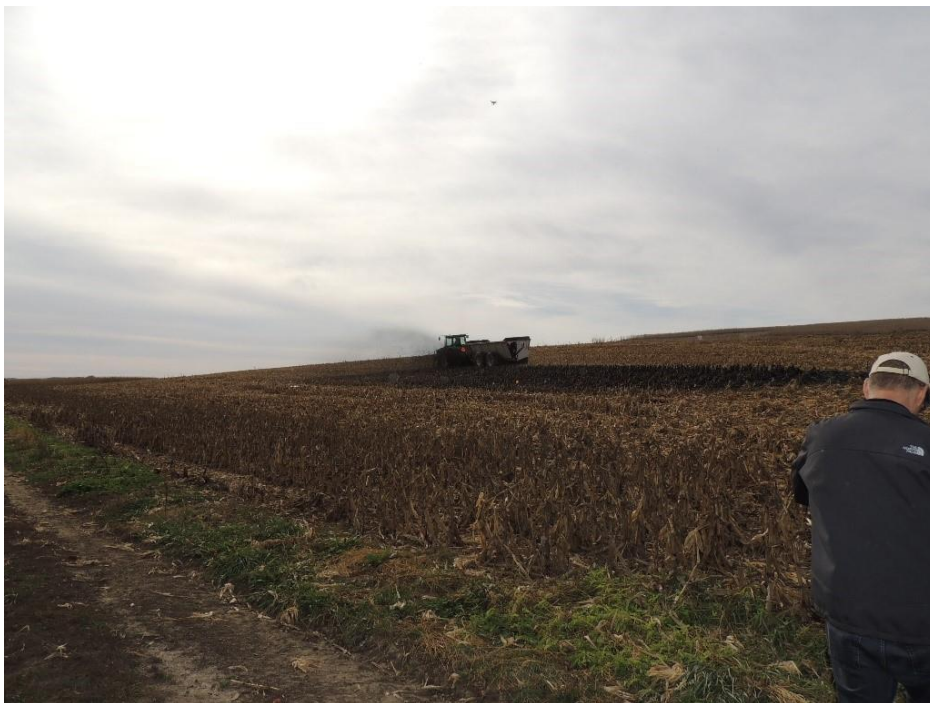
Figure 3. Land application of the sludge and calibration of the manure spreader.

3) Given the high phosphorus content in the sludge and that the nearby fields at the Haskell Ag Lab were not in need of phosphorus, an appropriate application rate for the sludge was determined as 8-10 tons/acre;

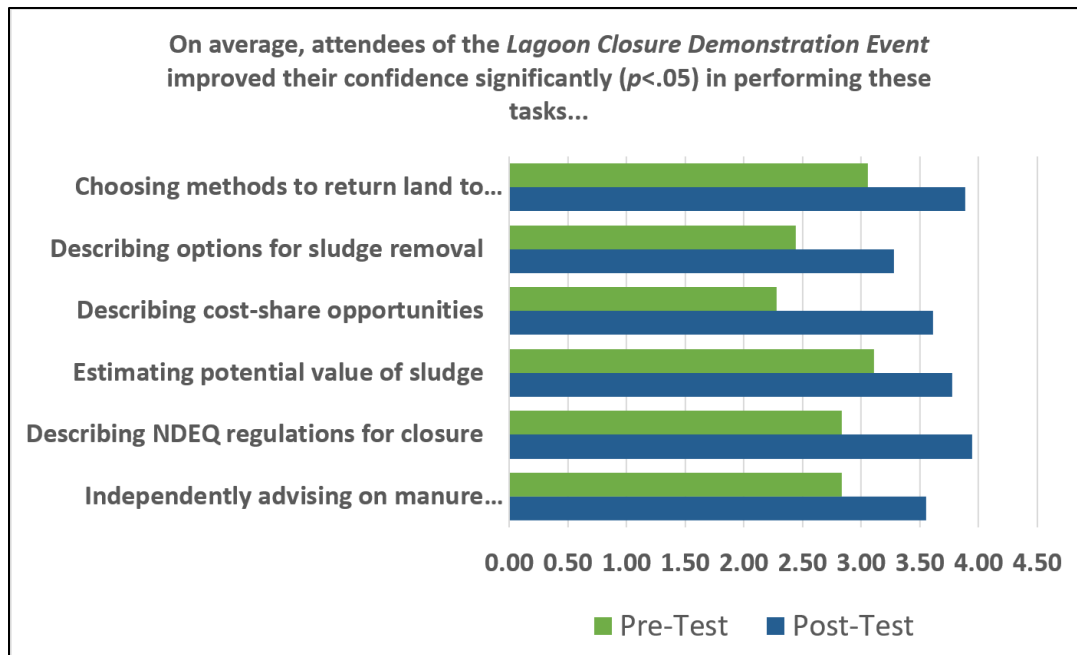
Pre-post surveys completed by 33 attendees of the demonstration event revealed that attendees improved their confidence in performing six key tasks identified by the team as being impactful. Results are summarized in Figure 4.

Figure 4. Impacts of the lagoon closure demonstration event.
