Monitoring the Effects of Knickpoint Erosion on Bridge Pier and Abutment Structural Damage Due to Scour

Report # MATC-UI-UNL: 471/424

Final Report

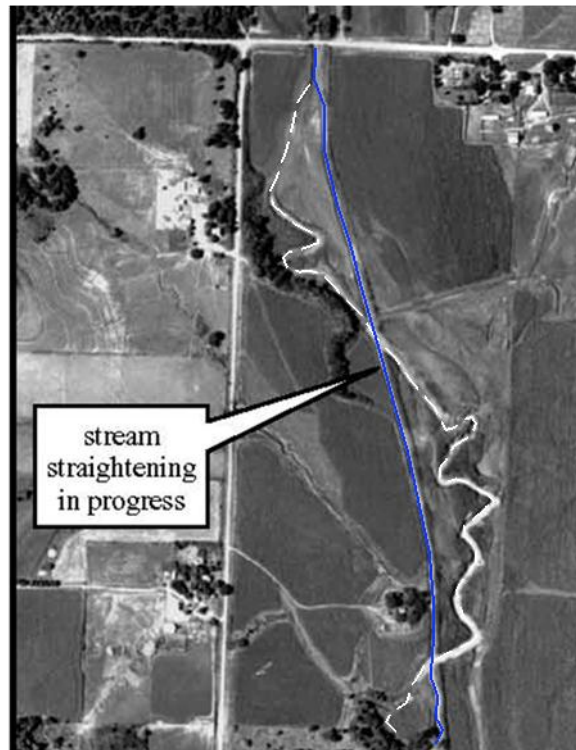
Figure 1.1 (a) Channel straightening of Mud Creek, IA in the 1950s. The white line is the original channel. The blue line is the creek after straightening.

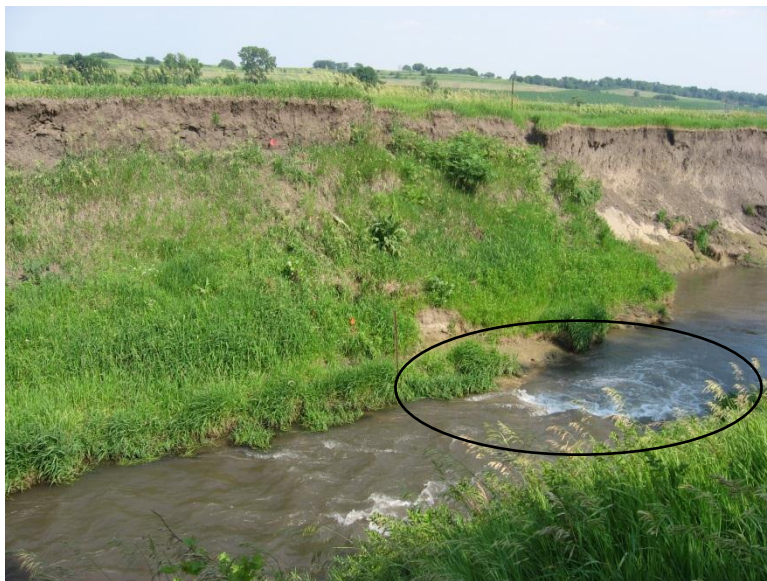
Figure 1.2 Knickpoint formation. The circled area is a knickpoint in Mud Creek, IA.

Streambed degradation occurs in the loess soils of western Iowa and eastern Nebraska by the formation and headward migration of knickpoints (fig. 1.2). Ongoing research suggests that knickpoints can account for more than 60% of the erosion in the streams where they form (Alonso et al. 2002). In addition, preliminary observations suggest that knickpoints greatly influence the flow thalweg (i.e., line of deepest flow) in small rivers, which is a primary factor contributing to bank erosion and scour.

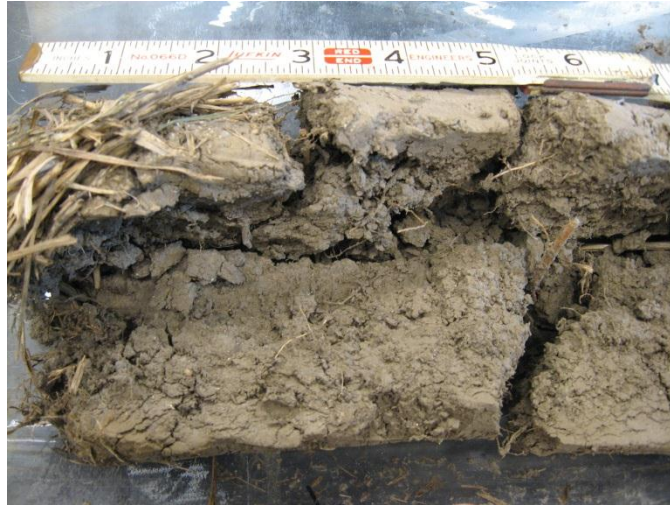
Figure 3.3 Stratigraphic interpretation. A close-up of the surface section for the stream bank core used in the stratigraphy analysis. The ruler in the image is in inches.

One of the 10 m stream bank cores was classified using a standard stratigraphic interpretation of the Natural Resources Conservation Service (NRCS). The examined soil characteristics during this stratigraphic interpretation included matrix color, soil texture, soil structure, and organic matter (fig. 3.3).

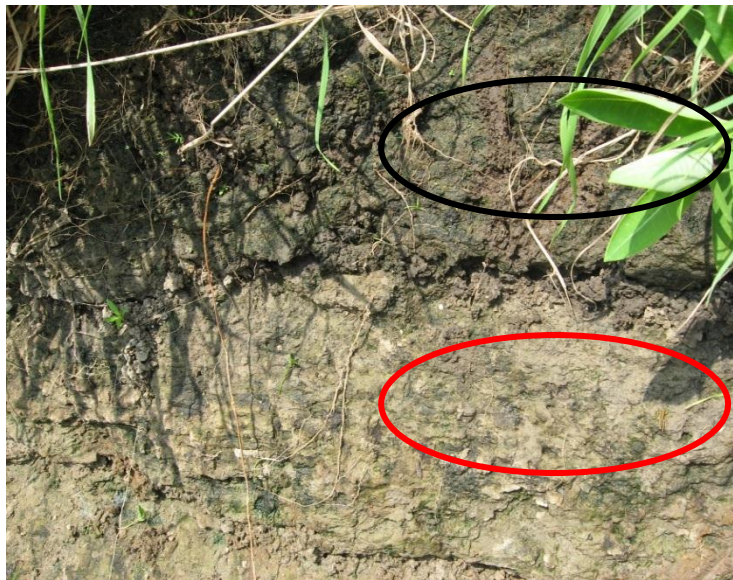
Figure 4.1 Stratigraphic discontinuity. There appears to be a stratigraphic discontinuity close to the knickpoint with a darker sediment (in the black circle) overlaying a lighter-colored sediment (in the red circle).

A visual analysis of the stratigraphy of the bank soil profile at the knickpoint site in Mud Creek identified a discontinuity that can be seen in figure 4.1. The image distinctly shows two different layers, as well as what appears to be a “fault” between the two layers. This stratigraphic discontinuity is at the same level (i.e., elevation) as the top of the knickpoint face.

Thus, the particle size distribution and soil texture data support the division between the two stratigraphic layers at the study site. The Roberts Creek Member was found in the bank soils, while the Gunder Member was found in the bed sediments. The higher clay content of the Roberts Creek Member caused (at least partially) the darker soil color relative to the Gunder Member of the bed sediment (fig. 4.1). The Gunder Member also trended from loam to sandy

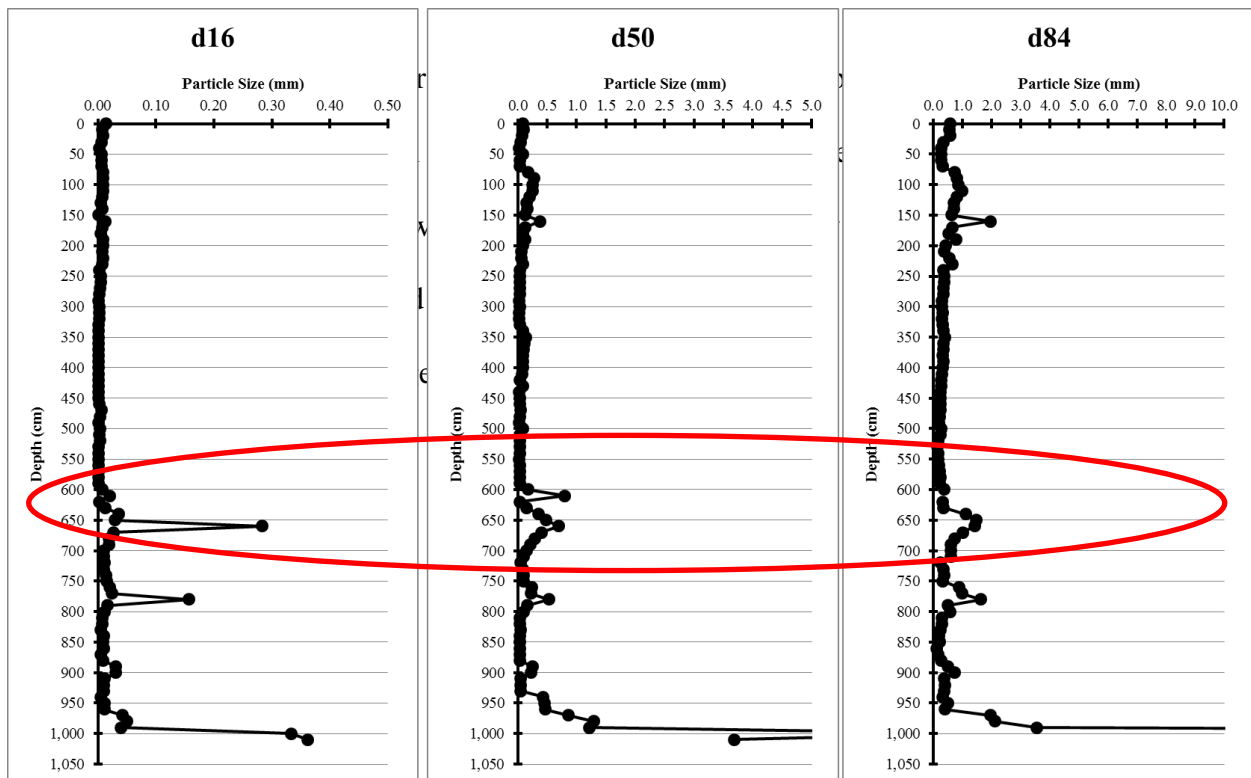
Figure 4.2 Particle size distribution. These graphs show key particle size diameters of the sampled depth intervals in a stream bank core from the study site. The d16, d50, and d84 for each interval are plotted relative to depth. The red circle highlighting the 600–650 cm depth interval corresponds to a coarsening of the overall particle size distribution, as there are increases in the d50 and d84. This elevation corresponds to the top elevation of the knickpoint face.

In this core, the stratigraphic discontinuity was found at a depth between 600 and 650 cm below the surface. The red circle in figure 4.2 highlights the location of this discontinuity. The bank soils above the discontinuity and the bed sediments below the discontinuity had slightly different particle size distributions (fig. 4.2). Visually, a shift was observed where the particle sizes of the key diameters increased at the discontinuity, signifying a coarsening of the sediment.

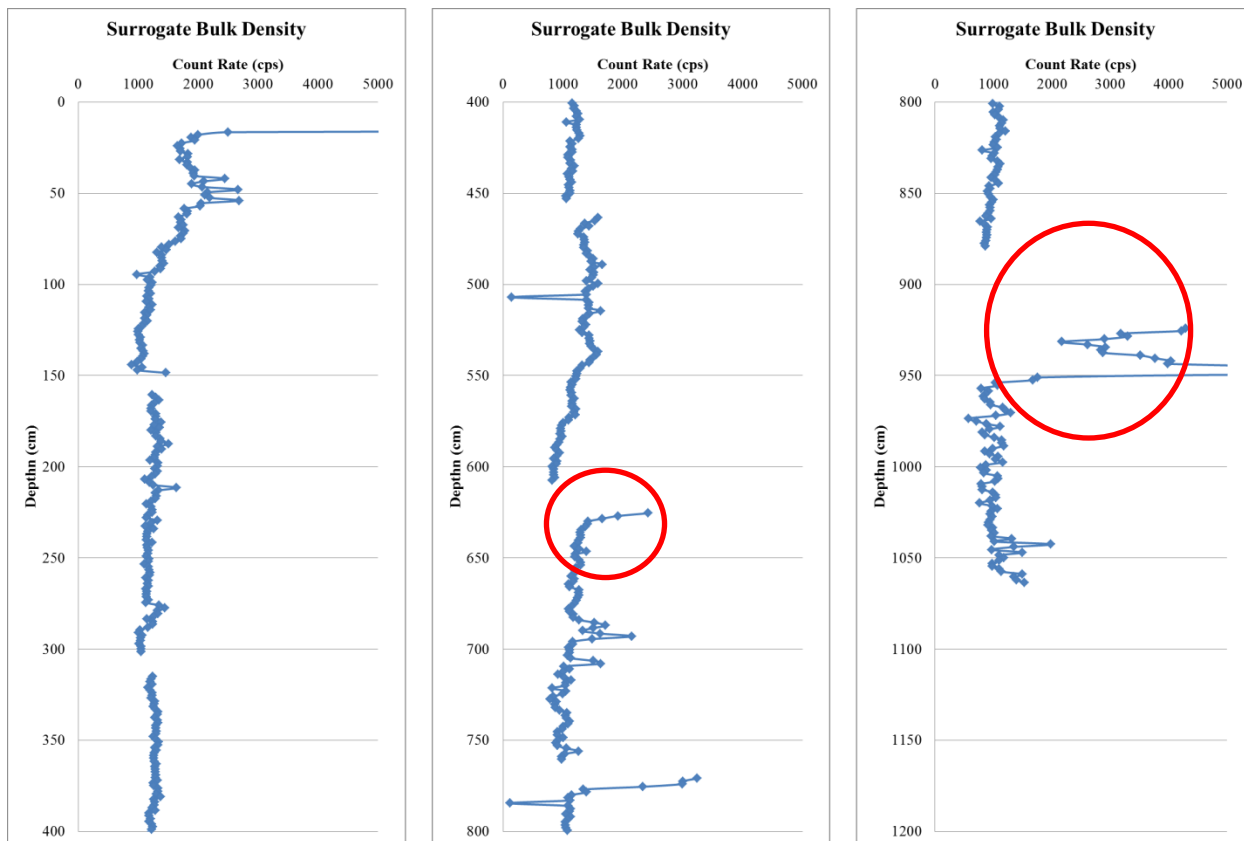
Figure 4.6 Surrogate bulk density. The density of a stream bank core was measured using the attenuation of a gamma radiation source. These graphs show the depth profile of attenuation count rates for a stream bank core. A high count rate translates to high transmission of the gamma source through the core, so that depth interval will have a lower bulk density. The red circles highlight shifts in the depth profile.

The second, intact, 10 m core from the stream bank was used in the next set of analyses. A radioactive ^{241}Am sealed source and NaI detector were used to determine the porosity/density of this second core. Figure 4.6 shows the depth profile of the attenuation count rates determined as a result of this analysis.
