Pipeline Inspection Technologies Demonstration Report Final

Pipeline & Hazardous Materials Safety Administration

Pipeline Inspection Technologies Demonstration Report

Pipeline Safety Research & Development Program

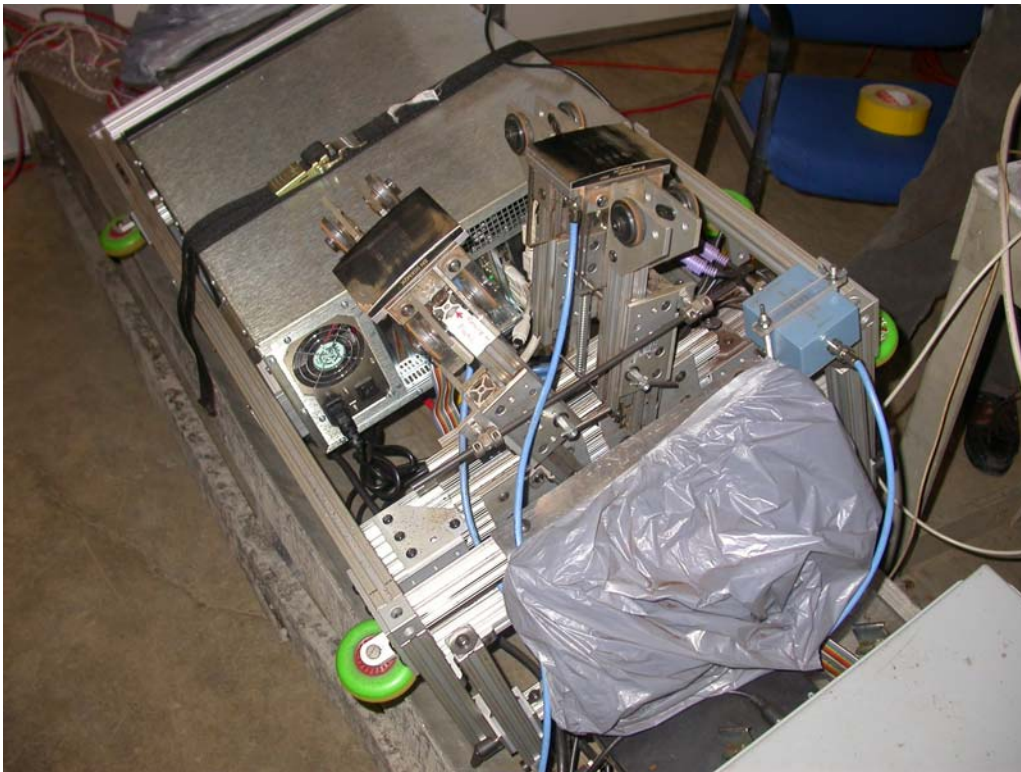
Figure 1. ORNL Shear Horizontal EMAT

ORNL Shear Horizontal Electromagnetic Acoustic Transducer (EMAT) – Oak Ridge National Laboratory (ORNL) has developed an EMAT system that uses shear horizontal waves to detect flaws on natural gas pipelines. A wavelet-based analysis of ultrasonic sensor signals is used for detecting physical flaws (e.g., SCC, circumferential and axial flaws, and corrosion) in the walls of gas pipelines. Using an in-line non-contact EMAT transmitter-receiver pair, flaws can be detected on the walls of the pipe that the current magnetic flux leakage (MFL) technology has problems detecting. One EMAT is used as a transmitter, exciting an ultrasonic impulse into the pipe wall while the second EMAT located a few inches away from the first is used as a receiving transducer. ORNL's technology is depicted in Figure 1.

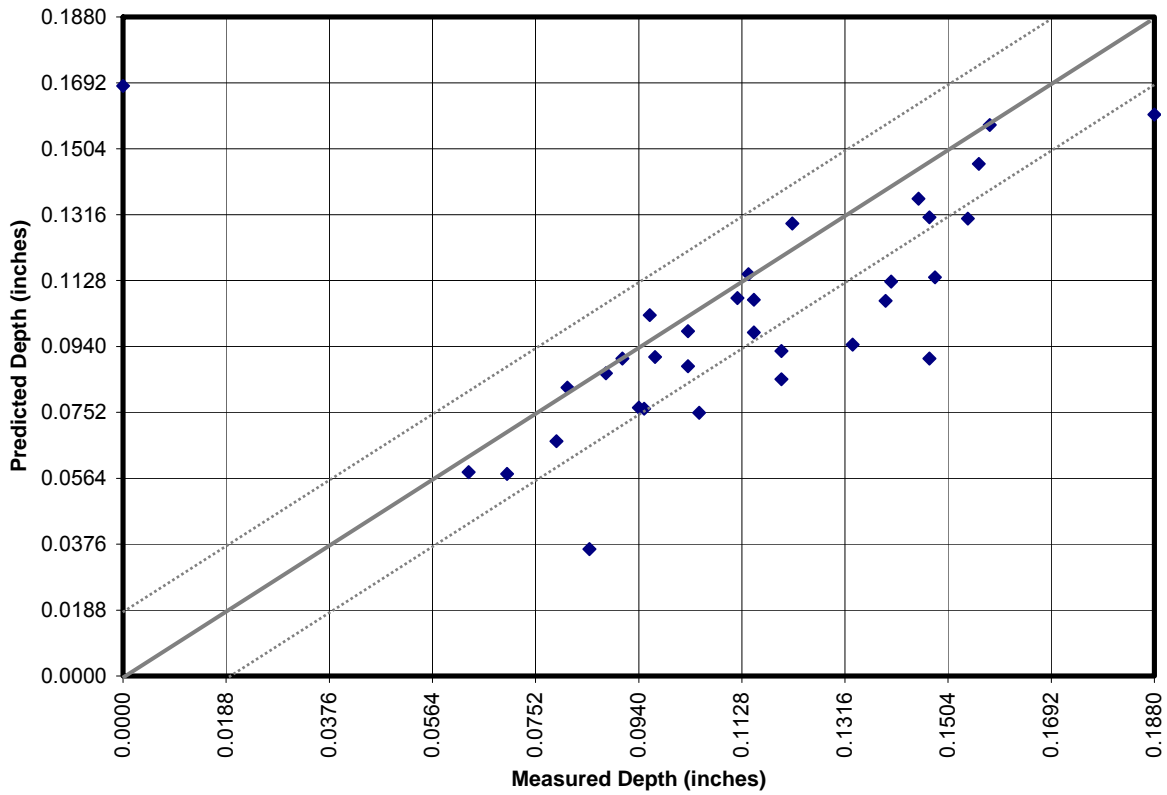
Figure 10. Measured Depth vs. Predicted Depth for the SwRI RFEC

The SwRI *RFEC* technology detection rate was 100%, detecting all defect sites on Pipe Sample 1, Pipe Sample 2, and Pipe Sample 3. On average, SwRI located anomalies slightly past the actual start of the defect location with a standard deviation of 1.71 inches. The SwRI *RFEC* technology detected one false positive signal on Test Line 1 of Pipe Sample 2. The false positive signal was identified as a repeatable signal without typical flaw signal characteristics with a depth of nearly 90% of the wall thickness and approximately 1 5/8 -inch in length. SwRI’s sizing accuracy is depicted in Figures 10 through 12 in which the predicted and measured anomaly depths, lengths, and widths are presented.

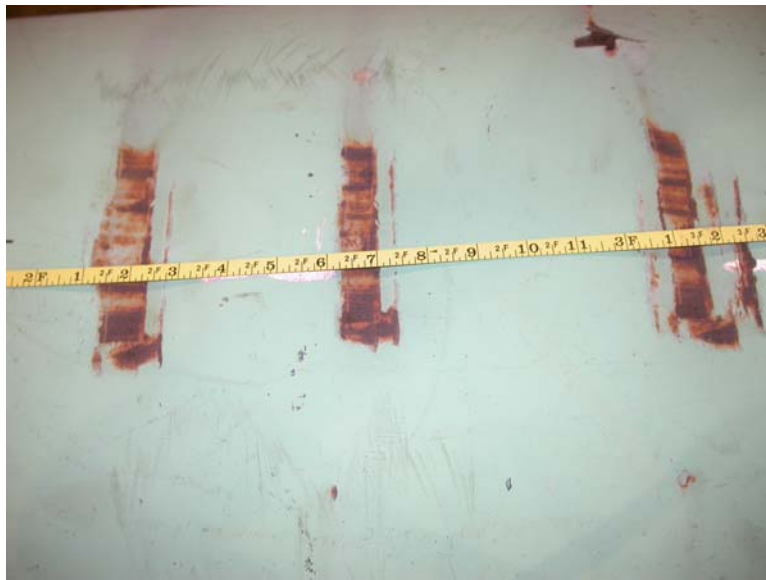
Figure 19. Example Mechanical Damage Defect from Pipe Sample 1

Only one technology, the PNNL *Ultrasonic Strain Measurement* technology, was tested for assessment of mechanical damage. Two 24-inch diameter pipes were inspected by PNNL for mechanical damage. The first pipe (Pipe Sample 1) consisted of two pipes welded together with mechanical damage defects along three rows separated by 120° and measured approximately 28-feet in length. The test line on Pipe Sample 1 consisted of mechanical damage created using a 50-ton track hoe. An example mechanical damage defect from Pipe Sample 1 is shown in Figure 19. The second pipe (Pipe Sample 2) measured approximately 40 feet in length with plain (or smooth) dent defects along one test line. An example mechanical damage defect from Pipe Sample 2 is shown in Figure 20.

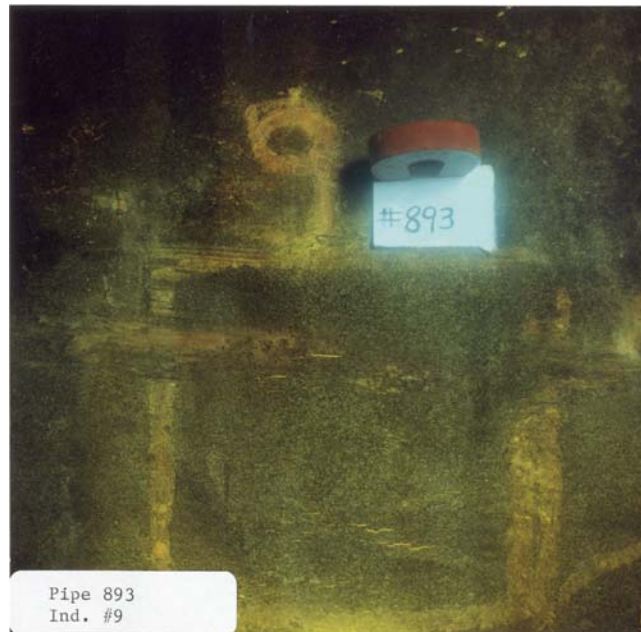
Figure 21. Example SCC Defect

Only one defect site (SCC2) provided no discernable signal; however magnetic particle analysis showed that these cracks are small and difficult to detect. Additionally, the location of the crack colony listed as SCC3 is off by a couple of inches. This is possibly due to defect (18), not considered as part of the test and located approximately 3-inches away in the circumferential direction, which may have been detected over the smaller SCC colony in SCC3. The most significant cracks (SCC8, SCC9, and SCC10) in the test sample were detected by the ORNL *Shear Horizontal EMAT* technology. An example SCC defect is shown in Figure 21. The benchmark data and test results for ORNL's *Shear Horizontal EMAT* technology are shown in Table 10.

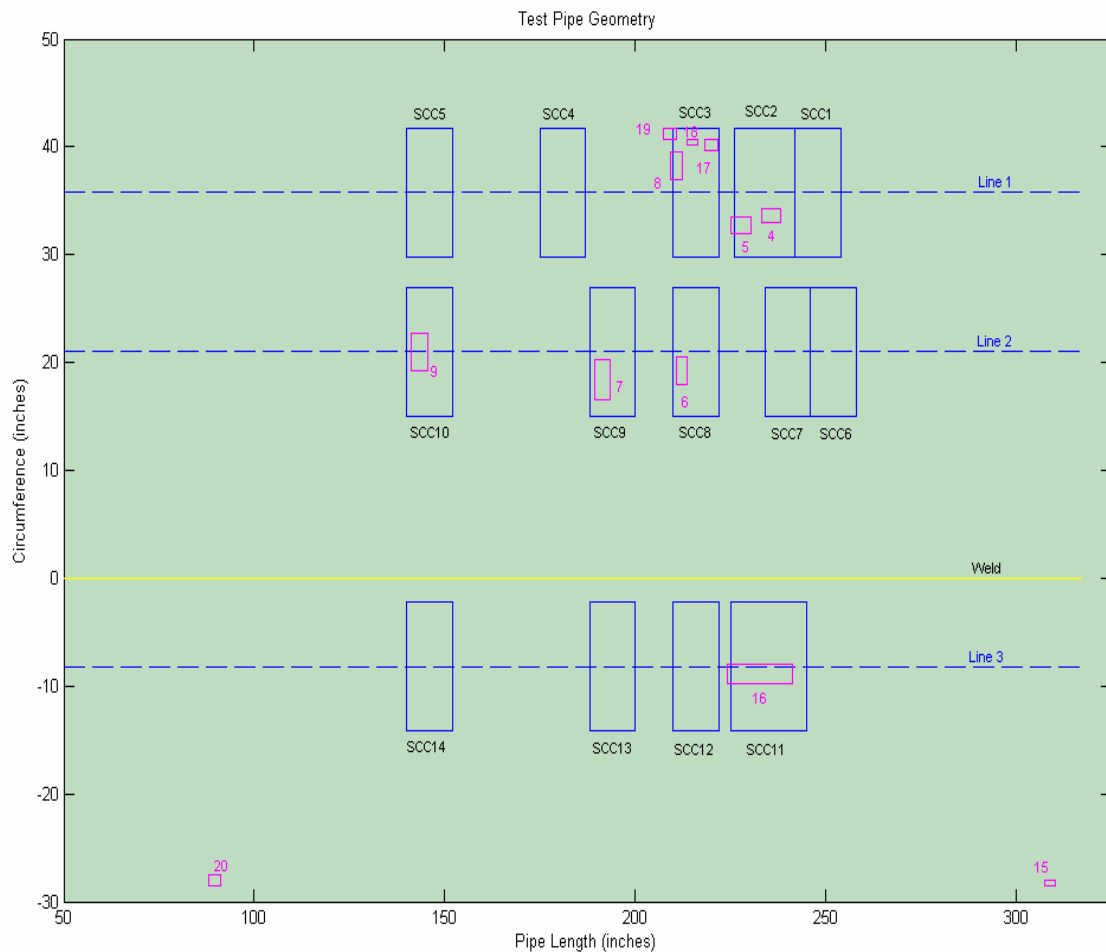
Figure 4. Test setup.

In testing, we were instructed to test along three different lines of the test pipe to determine the presence of defects over particular spans along each line. Figure 1 shows the pipe layout for the test. Each test box (blue boxes labeled SCC1 – SCC14) along with every defect previously identified on the pipe (pink boxes labeled 4-9, 15-20) are pictured. The dashed lines represent the three scan lines. As mentioned in the results, the SCC defect we were to locate in SCC3 is defect 8 (far left side of box). However, we positioned this defect to the right by several inches. Since the EMATs scans an arc of ~12 inches around the circumference of the pipe, the SCC boxes within the figure have been drawn with 12 inch height to show the area covered by the sensor. From the figure, we see that defects 17, 18, and 19 are all on the upper edge of SCC3.

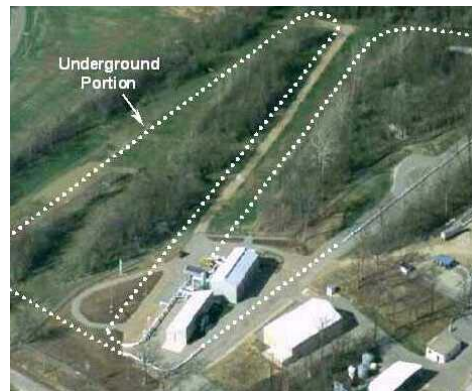
Figure 1-1. PSF Flow Loop

The flow loop is the largest and most significant part of the Pipeline Simulation Facility. The loop is a simulated operating pipeline in which research, development, and demonstrations can be conducted under realistic conditions. For inspection related developments, tests can be made using test bed vehicles or in-line inspection tools. The loop is approximately 4,700 feet long and 24 inches in diameter, and it allows both pressure and flow velocity to be controlled. It contains a number of typical pipeline features, such as bends, road crossings, underwater sections, and anchors. It can be used to complete the development of pipeline technologies and test the technologies without risking the integrity or throughput of an operating pipeline.

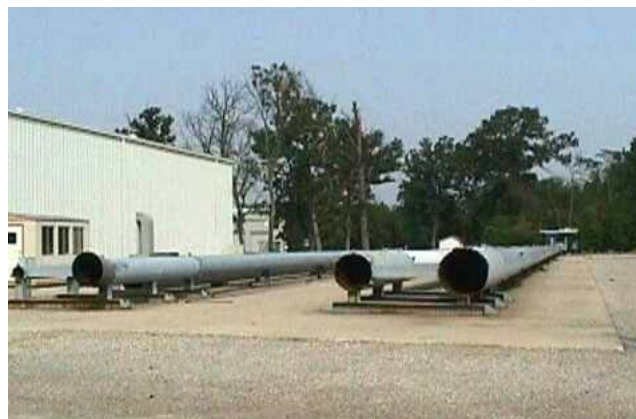
Figure 1-2. PSF Pull Rig

The pull rig is used for tests of complete inspection systems under unpressurized conditions. It consists of four 300-foot long pipe runs with diameters of 12, 24, 30, and 36 inches. In-line inspection tools and test bed vehicles can be pulled through the pipe sections using the rig's winch. Depending on the tool, pull forces up to 56,000 pounds and speeds up to 25 mph can be achieved.

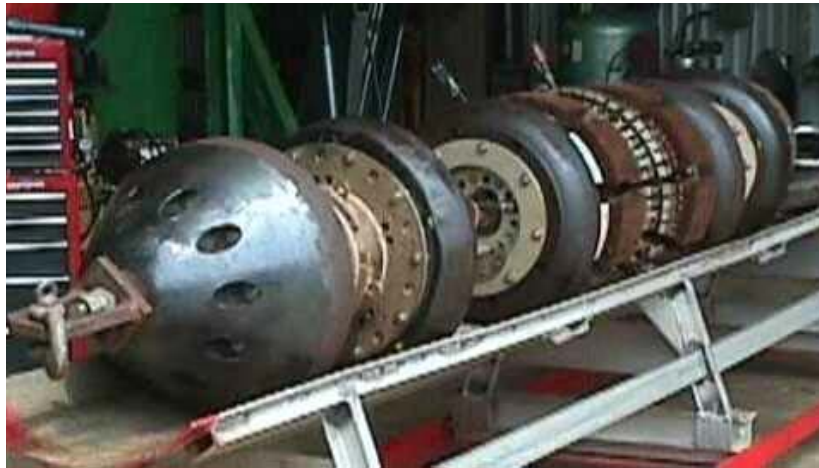
Figure 1-3. Sensor Development Sled

The sensor development sled is a moveable platform on which sensors and partial magnetizing or inspection assemblies can be installed and pulled along pipe segments at accurate velocities up to 10 mph. The sensor development sled can be used to measure the effects of velocity and sensor position on defect-to-signal relationships, and it can support virtually any nondestructive evaluation sensor technology.

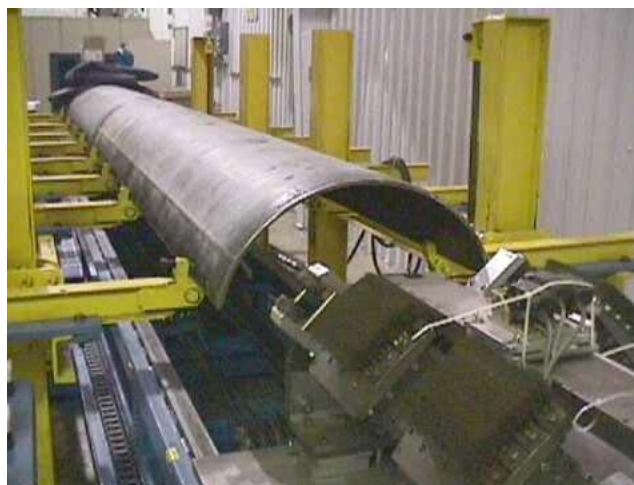
Figure 1-4. Test Bed Vehicle

The test bed vehicles are generic in-line inspection platforms upon which inspection hardware can be mounted and tested. Two test bed vehicles are available: the magnetic flux leakage (MFL) vehicle, which is specialized for MFL technology, and the advanced sensor vehicle, which is specialized for high data-rate inspection technologies.

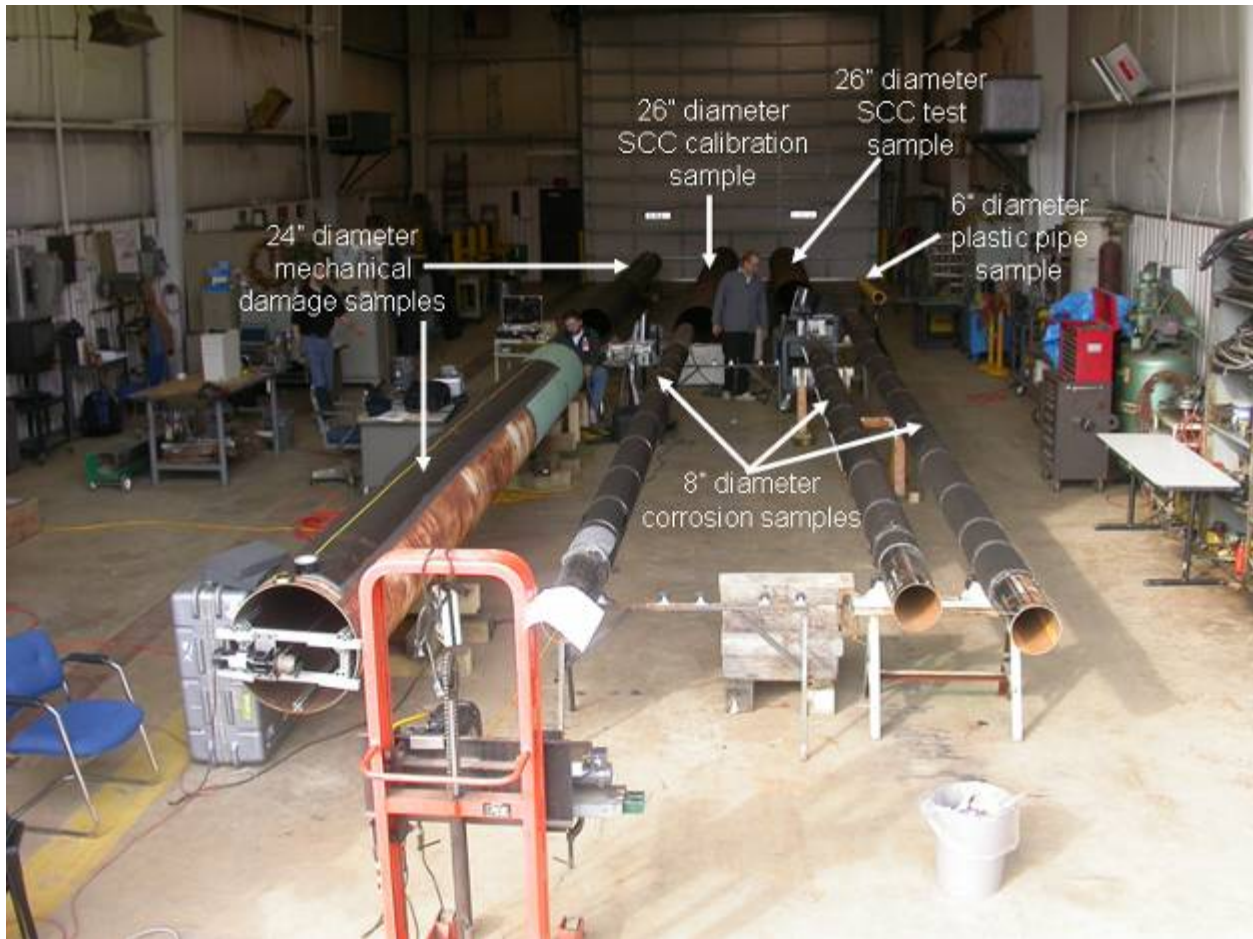
Figure 1-6. Benchmarking Demonstration Setup

This benchmarking study was designed to assess the current inspection capability of the sensor technologies prior to full hardware implementation (for pull rig testing or testing on a robotic platform). Therefore, the pipe samples were placed within the pipeline testing lab, which is a 40 foot by 100 foot building with overhead doors. The three 8-inch diameter pipes, one 6-inch diameter plastic pipe, two 24-inch diameter pipes, and two 26-inch diameter pipes were placed parallel to each other with a separation distance between each pipe of approximately 4 feet. All developers brought their own method for pulling their sensor carriage through the pipe samples including a return cable or rope to pull the unit back to the insertion point. The layout of the pipe samples is shown in Figure 1-5 with a photograph of the actual benchmarking set-up shown in Figure 1-6.

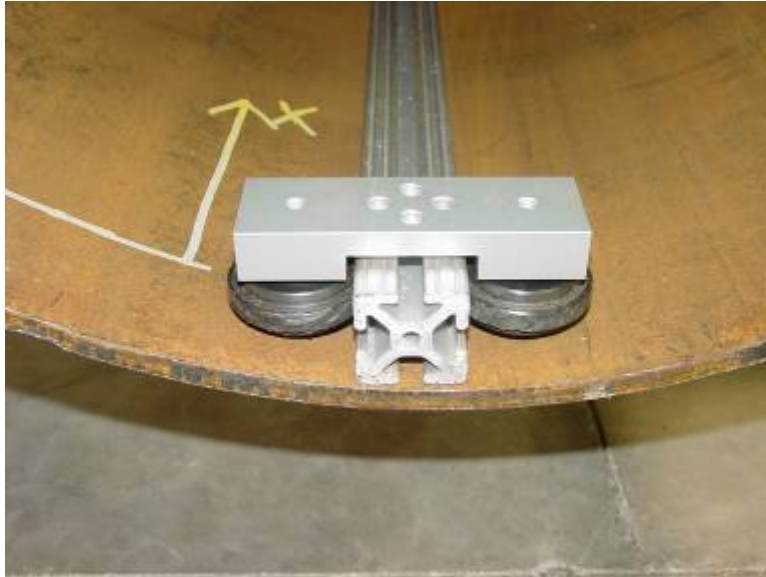
Figure 1-7. Aluminum Rail Guide Assembly

Tool rotation is a significant problem in dented pipe since each dent can easily spin the tool. For the 24-inch pipe, a rail was available 180° from the dents to be evaluated to position the control carriage and prevent rotation. The rail was 1.5" by 1.5" aluminum tubular modular material with a wheel assembly that could be attached to the sensor carriage unit (see Figure 1-7). The clock position of other dent rows within the pipe sample were provided to the sensor developer prior to the benchmarking so that wheels on sensor carriages would not run over defects that were not part of the benchmarking demonstration.

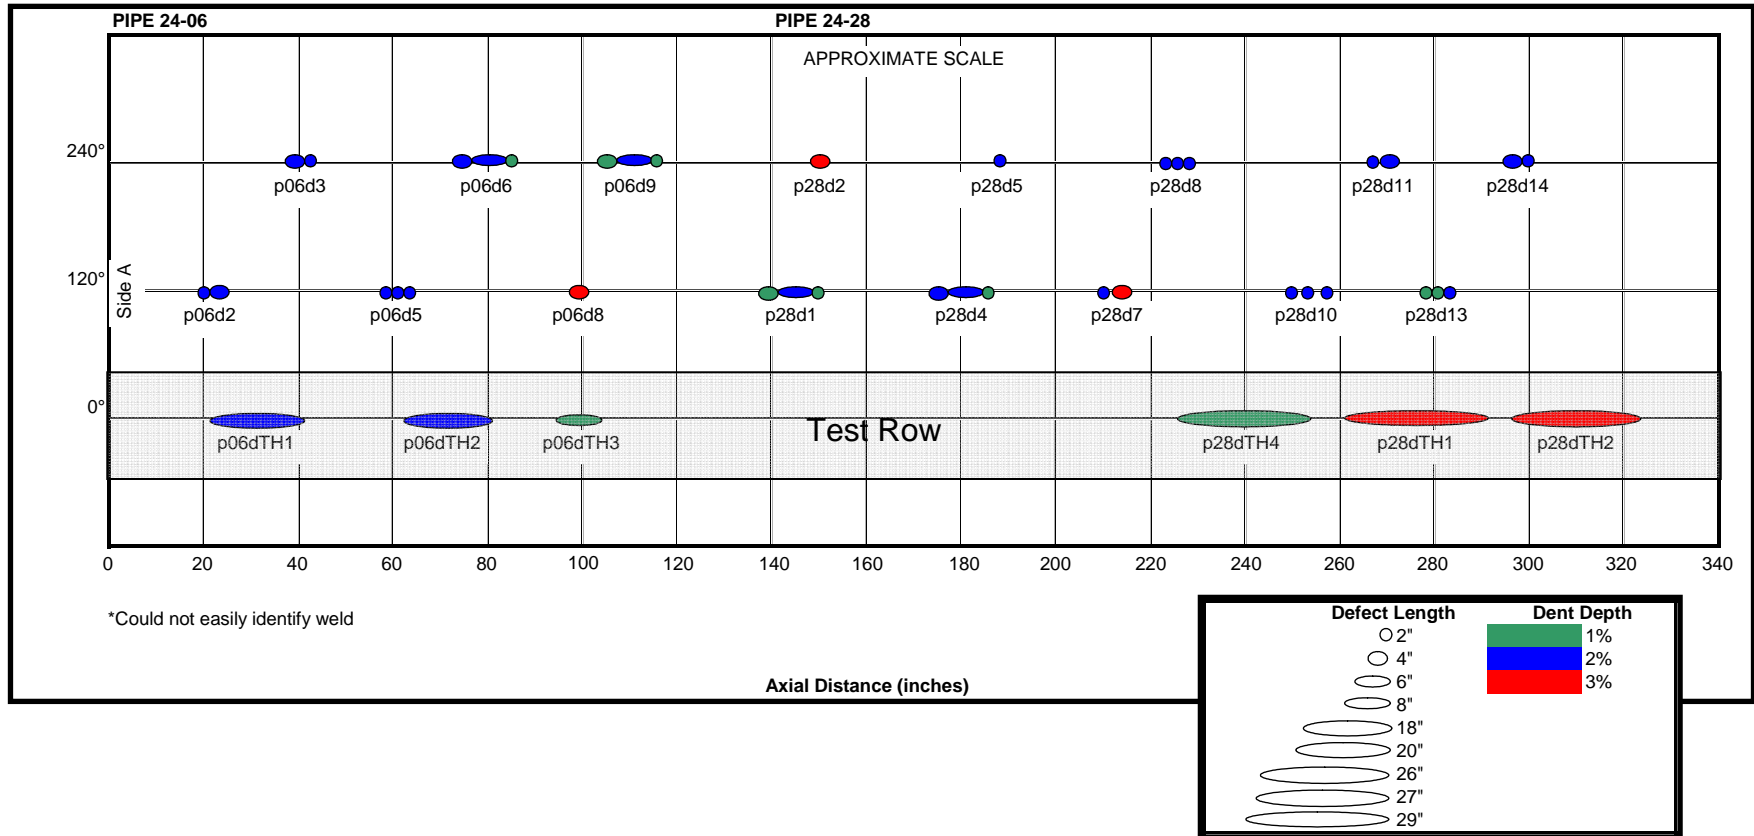
Figure 3-1. 24 inch Mechanical Damage Pipe Sample 1 Defect Map

For defects made using the track hoe, a trench was excavated so that the pipe samples would fit securely within. The depth of the trench was slightly less than the pipe diameter so that the crown of the pipe was an inch or so above grade. The track hoe was able to straddle the trench so that the bucket could impact the crown of the pipe, parallel to the pipe direction, to produce the mechanical damage defects. The track hoe was also moved to the side of the trench so that defects could be produced that were transverse to the pipe direction. The location of mechanical damage defects are shown in Figure 3-1.

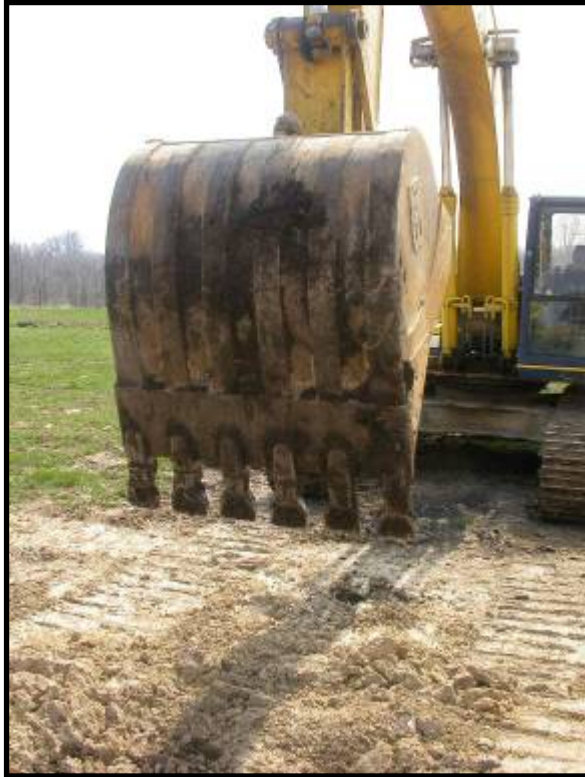
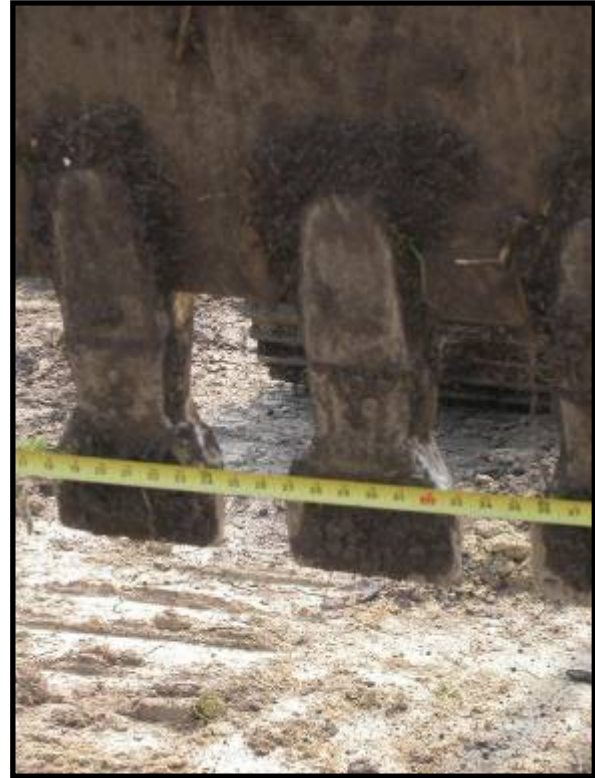
Figure 3-3. Close-Up of Bucket and Teeth from the Kobelco Mark SK200 Track Hoe.

The track hoe bucket consisted of six teeth measuring approximately 6 inches in width and 1 inch in depth. Close-up photos of the track-hoe bucket and teeth are shown in Figure 3-3.

Additionally, the track hoe bucket was positioned in two different configurations during defect installation. The first configuration allowed the teeth of the bucket to directly impact the crown of the pipe. The second configuration allowed two teeth to straddle the crown of the pipe when impact was made. Various track hoe defect parameters for each pipe sample are provided in Table 3-3. For the track hoe defects, dent depth range refers to the maximum depth measured after defect installation and possible re-rounding.

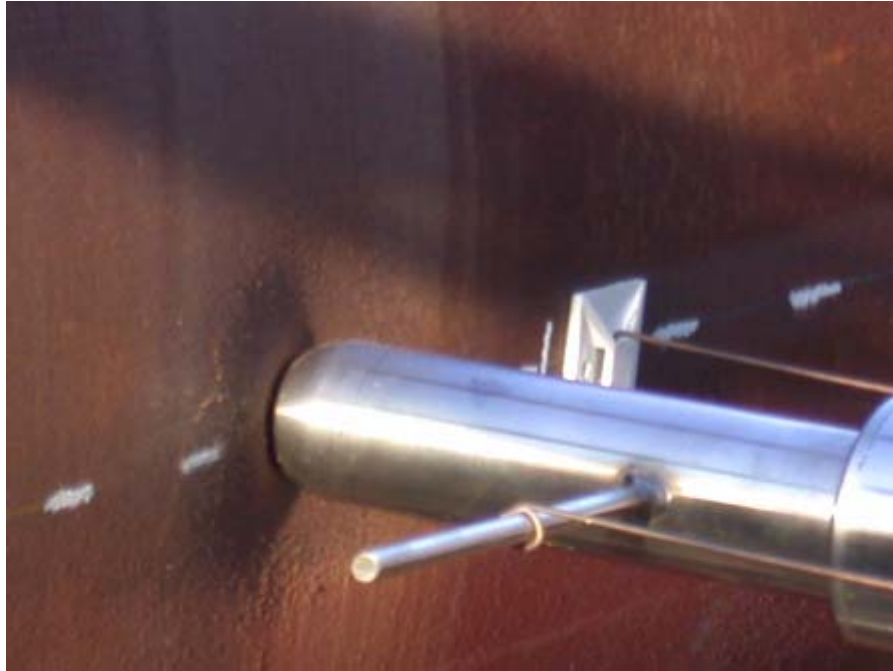
Figure 3-26. The spherical indenter, made from a non-ferromagnetic material, photographed while holding a 2 percent dent.
Note the connections for the two linear cable extension transducers.

Three indenters were used to dent the pipe. Each indenter was made from a non-ferromagnetic 300 series stainless steel. Each shaft was 6 inches long to keep the ferromagnetic hydraulic actuator sufficiently away from the pipe to minimize interference with the flux leakage inspection equipment. Figure 3-26 shows a spherical indenter made from 1.5-inch diameter rod, photographed during the denting process. Figure 3-27 shows the two longer indenters. The radius of the rounded indenter matches the spherical indenter radius of 0.75 inches. The sharp indenter is rounded to a radius of 0.125 inches to provide a more concentrated load, but avoid piercing. The length of the long rounded indenter and the long sharp indenter is 4.5 inches. The shape changes were chosen to facilitate comparison of results. For the spherical and long rounded indenter, the radius is the same but the contact shape is changed from a sphere to a cylinder. For the two longer indenters, the length was the same, but the contact shape is changed from gradual to abrupt.
