## AN ANALYSIS OF THE IMPACTS OF TEMPERATURE SEGREGATION ON HOT MIX ASPHALT

A THESIS

In Partial Fulfillment of Requirements  
For the Degree of Master of Science

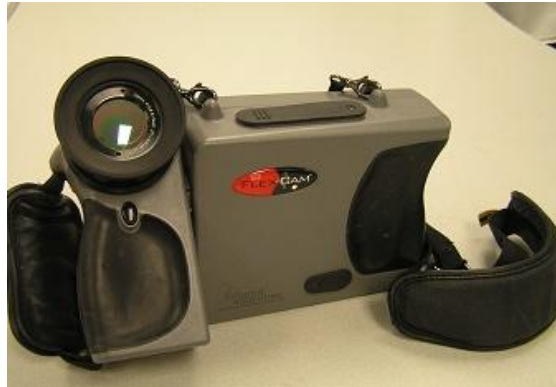
**Figure 3.1 Infrared camera**

For verification of the use of thermal image data in HMA applications, temperature readings were initially taken on the surface of the HMA as well as internally using a temperature probe. The internal and external temperature readings were compared to those obtained by the infrared camera. This was also done to ensure the specific infrared camera used in this study provided accurate temperature measurements. The accuracy of infrared cameras in general has already been proven in HMA applications from the University of Washington study, noting that both temperature probes and infrared cameras are adequate tools for proving temperature differentials (Willoughby & Kim, 2001). Figure 3.1 shows a Flex Cam XR2, the infrared camera used in this research. Figure 3.2 shows infrared images taken from Nebraska paving sites.

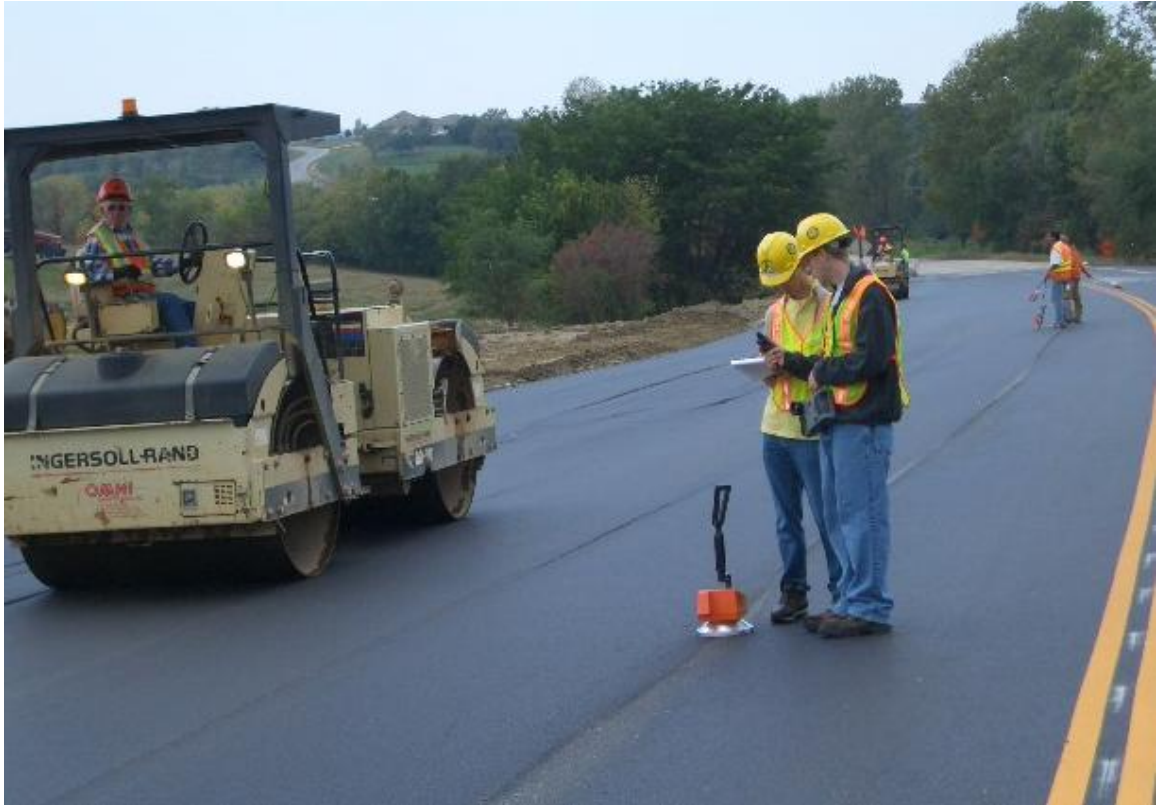
**Figure 3.3 Taking PQI density readings onsite**

was used in place of lab tested core samples to generate the offset needed by the PQI. Using a nuclear gauge to calibrate the PQI has been validated by the Wisconsin DOT (Schmitt, 2006). Both methods were used as part of this study.

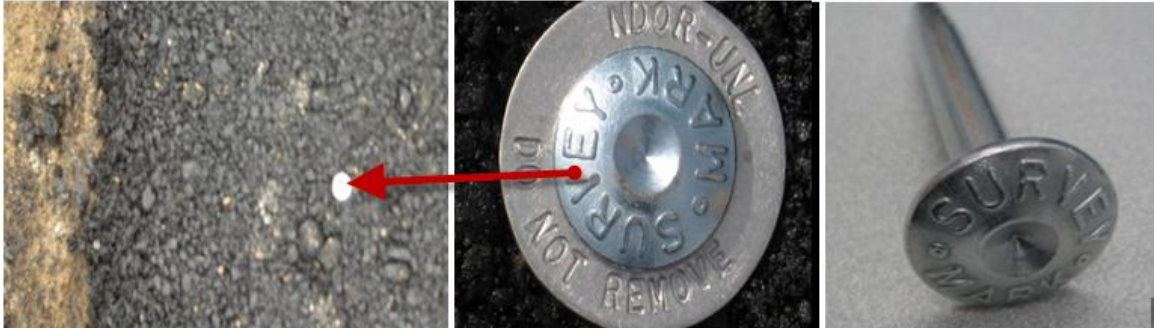
**Figure 3.6 Physical location markers**

physical markers were driven into the shoulder pavement while still malleable and a distance directly across from the marker to the location was recorded.

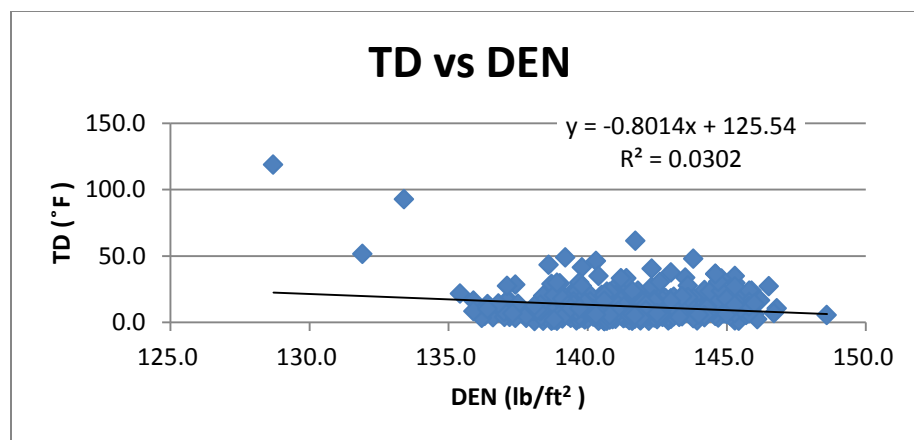
**Figure 4.2 Relationship for All Collected Data Between temperature differential (TD) and density (DEN)**

Including all 304 density readings and charting them against their corresponding temperature differentials provides a slight negative relationship. On the other hand, a more detailed look at the relationship between temperature differential (TD) after compaction and pavement density (DEN) to be insignificant (Figure 4.2).

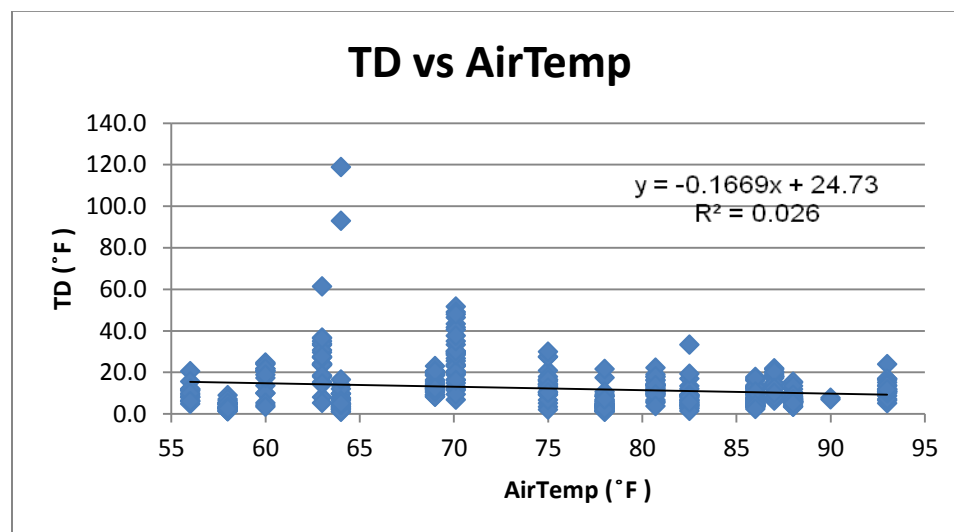
Figure 4.4 Relationship between ambient jobsite air temperature and temperature differential

The 18 site visits carried out during this project occurred at varied times throughout the paving season across Nebraska. Sites were visited in early spring, the middle of summer, and far into the fall paving season. By visiting at varied times of the year, the effect outside air temperature has on the instances of temperature differentials (TD) was able to be studied. It is a common practice for mix types to compensate for cold weather. Essentially, boosting the mix temperature during manufacturing gives the lay down crew adequate time to use the material before it reaches its cessation point. It is still important however to investigate if these changes are sufficient at reducing temperature segregation. As can be seen in Figure 4.4 there was no statistically significant relationship ( $R^2 = 0.026$ ) between the outside air temperature (AirTemp) and the occurrence of temperature differentials (TD) during the two typical paving seasons in which this study took place.

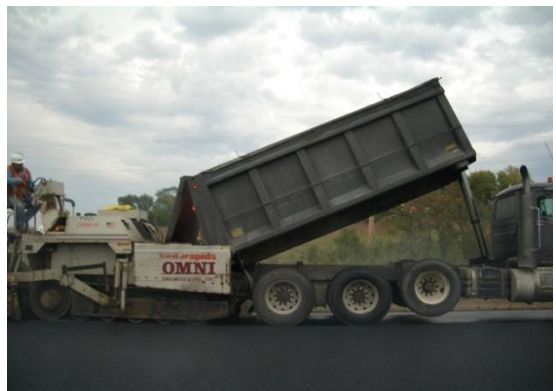
Figure 4.6 Direct dump between truck and paver

There are two types of material feeding processes from a delivery truck to a paver used in Nebraska. Either HMA trucks directly dump delivered HMA into the hopper of a paver (Figure 4.6), or belly dump trucks and live belly dump trucks deposit the material ahead of a pickup machine which scoops up the HMA and transfers it into the hopper of a paving machine (Figure 4.7).

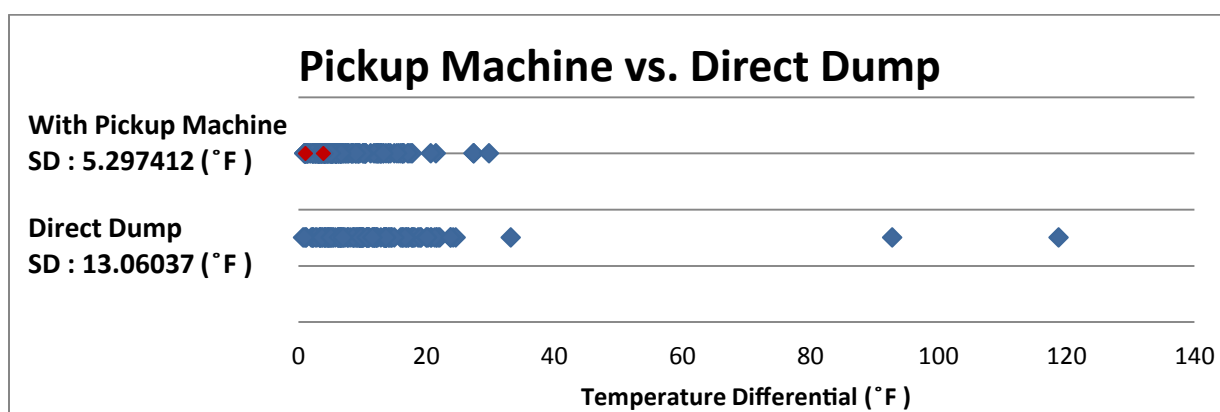
Figure 4.8 Temperature Differential based on feeding types

Figure 4.8 shows the temperature differential variation for each material feeding process. When a pick-up machine is used between a belly dump truck and a paver, the completed material shows a more consistent temperature profile (standard deviation = 5.3°F) than when a truck directly dumps HMA material into a road paver's hopper (standard deviation = 13.1°F). The significantly smaller standard deviation demonstrates how a pickup machine is a very cost-effective solution to reduce temperature differential of delivered HMA without using expensive MTVs.

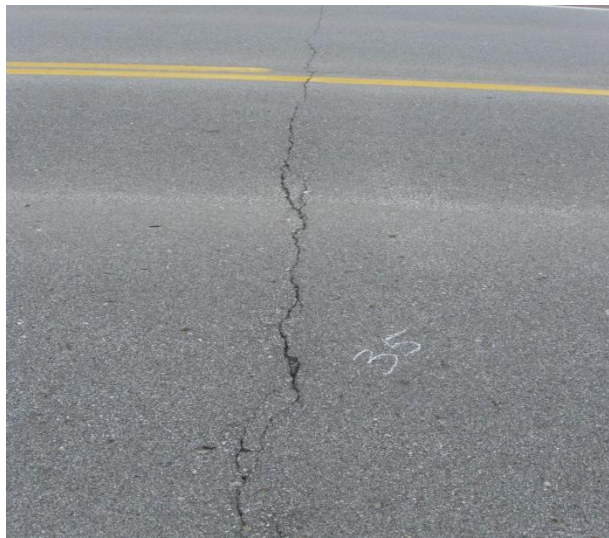
Figure 5.2 Observed Transverse Crack

The picture below is indicative of a transverse crack (Figure 5.2). Transverse cracks are formed perpendicular to the direction the asphalt paver travels, and are often the result of asphalt shrinkage. Because areas of different temperature expand and contract at different rates, transverse cracks are of particular interest in this investigation. Cracks of this type also often occur as reflective cracks which will be discussed later.

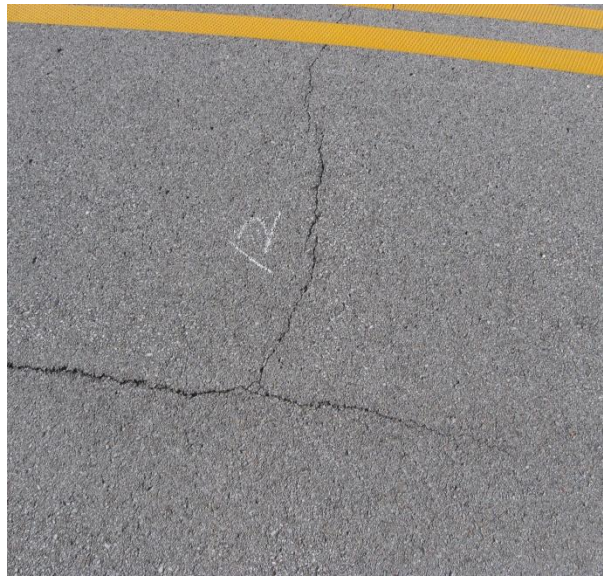
**Figure 5.3 Observed multi-crack joint**

can be assumed to be a combination of the reasons for transverse cracks and longitudinal cracks. Longitudinal cracks are often formed due to shrinkage, reflective cracking, and longitudinal segregation caused by poor paver operation. The reason transverse cracks are formed have been stated previously (Walker, 2009).

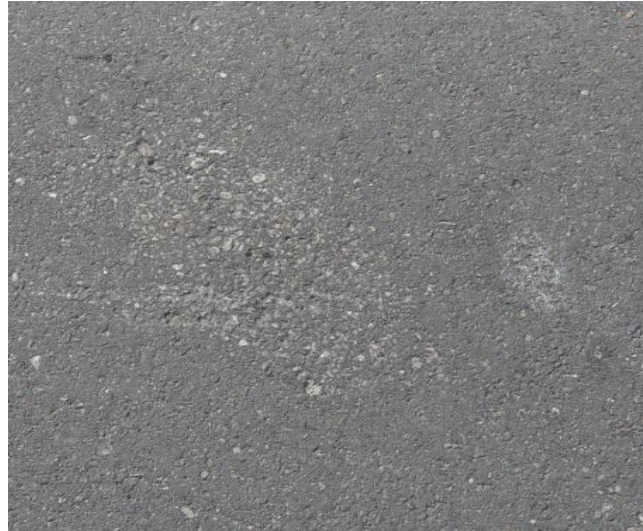
**Figure 5.4 Observed Material Segregation**

segregation can be thought of as including a disproportionate amount of coarse aggregate to fine aggregate as well as low asphalt content (Williams et al., 1996). Aggregate segregation in HMA can be caused by improper mixing. Aggregate segregation leads to flaws like: accelerated rutting, fatigue failure, and potholes (Williams et al., 1996; Walker, 2009).

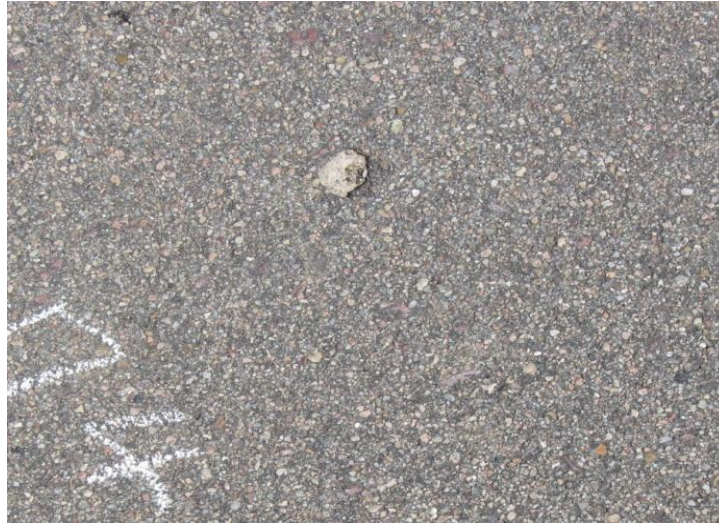
**Figure 5.5 Observed Surface Void**

popping out of the surface of the pavement during the freeze-thaw cycle. Because these voids have not degenerated the pavement quality to date, later data analysis deals with their inclusion at certain times only.

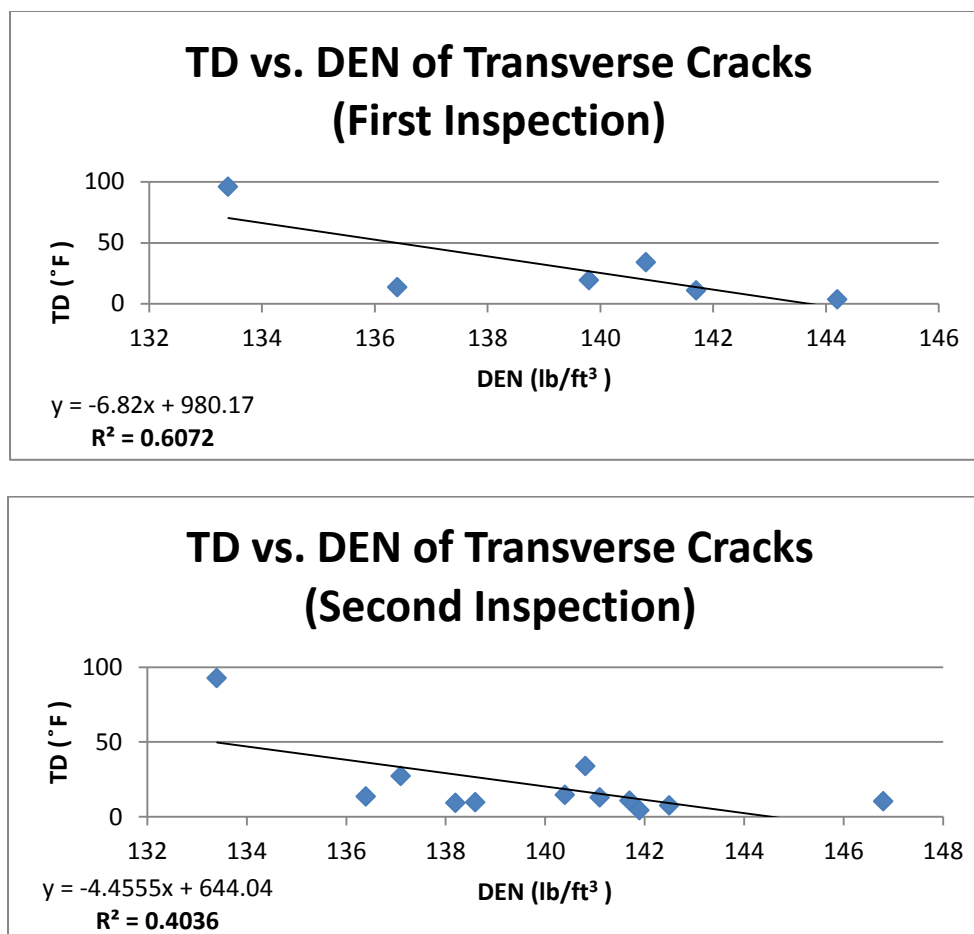
**Figure 5.10 Relationship between temperature differentials (TD) and density (DEN) excluding reflective cracks**

The 15 locations were not further included in data analysis as these locations were almost certainly influenced primarily by the previous pavement underlayments. After excluding the suspected reflective cracks, the remaining six transverse cracks that had developed before the first inspection were found to possess an increased relationship (60.7%  $R^2$ ) between temperature differentials and density (Figure 5.10). Of the transverse cracks observed during the second year's inspection, the remaining twelve cracks were found to have a 40.4%  $R^2$  relationship between temperature differential and density.

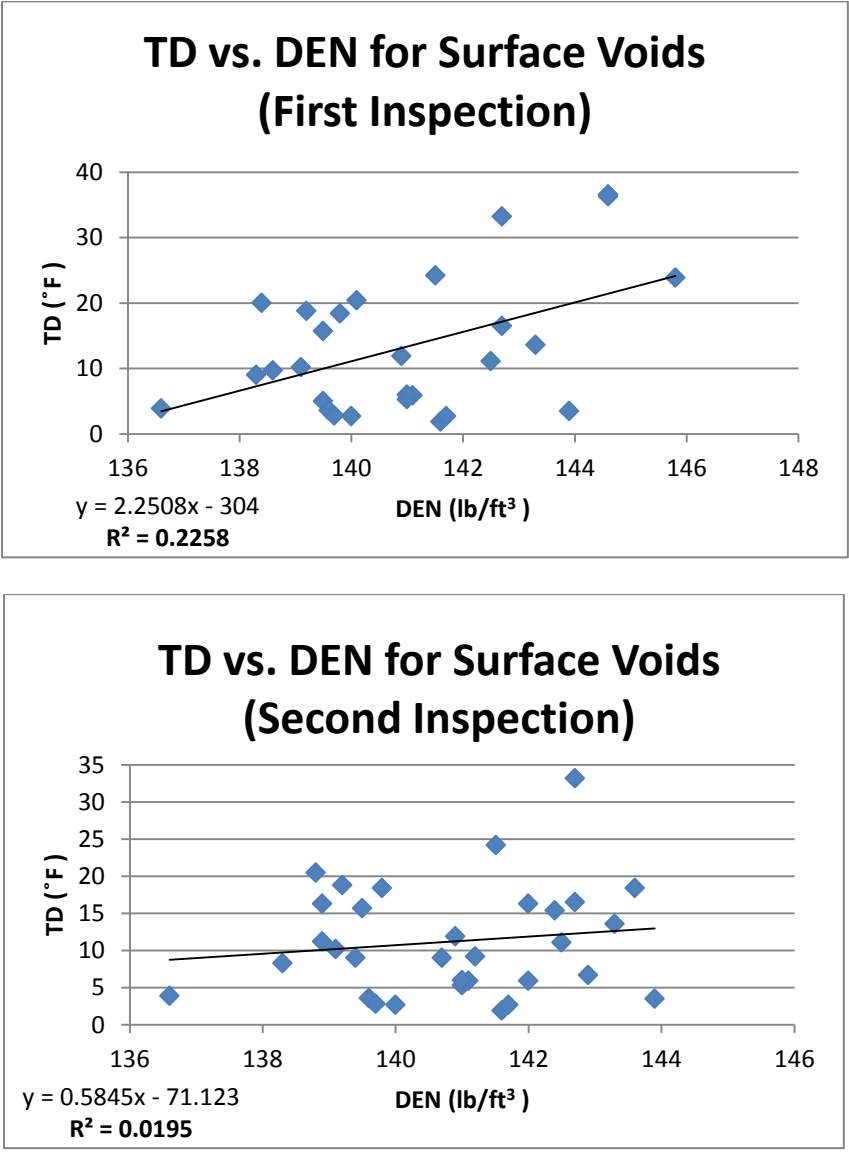
Figure 5.11 Relationship between temperature differentials (TD) and density (DEN) among surface voids

differentials and pavement density. This positive relationship follows counter to the assumed negative relationship where high temperature differentials would translate to low densities. This is more easily explained by referencing Figure 5.11 below.

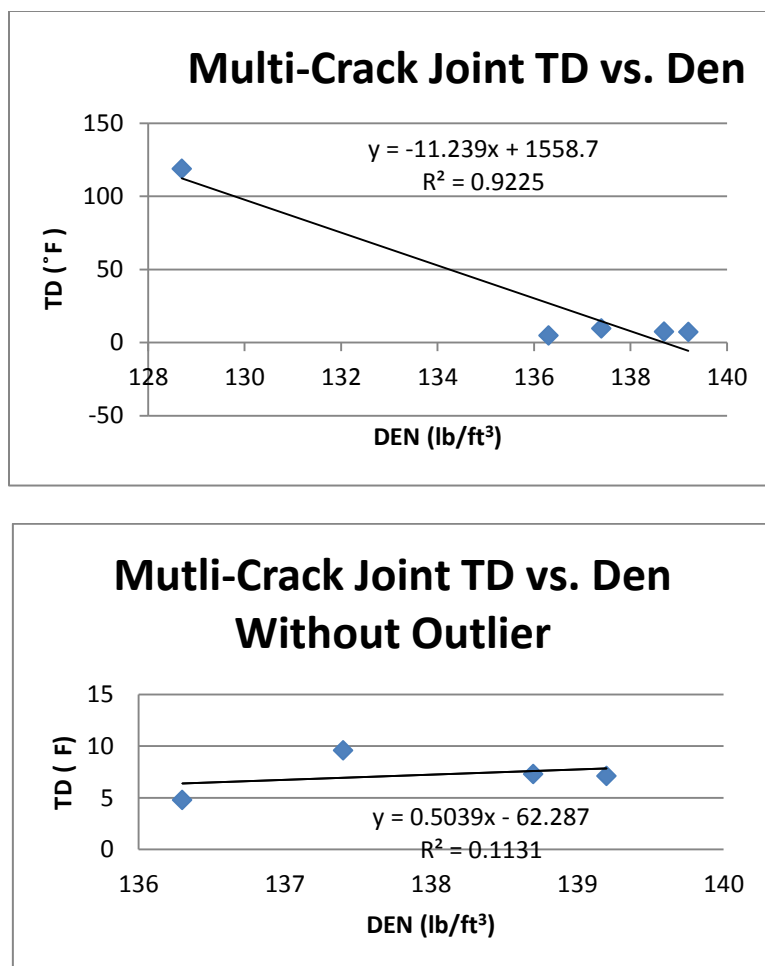
Figure 5.12 Correlation between temperature differential and density among multi-crack joints

Of the five instances of multi-crack joint type of premature flaws located during visual inspections, a 92% negative relationship was calculated between temperature differential and density. It should be noted that four of the five multi-crack joints were found during the first wave in inspections on jobsites at least one year old. It is also important to point out that if the extreme outlier with a temperature differential of 118 degrees is removed from the data set the relationship drops drastically to under 12%  $R^2$  (Figure 5.12). However, if considering only the three multi-crack joints found in the first year, the correlation between temperature differential and density remains in the 90<sup>th</sup> percentile.

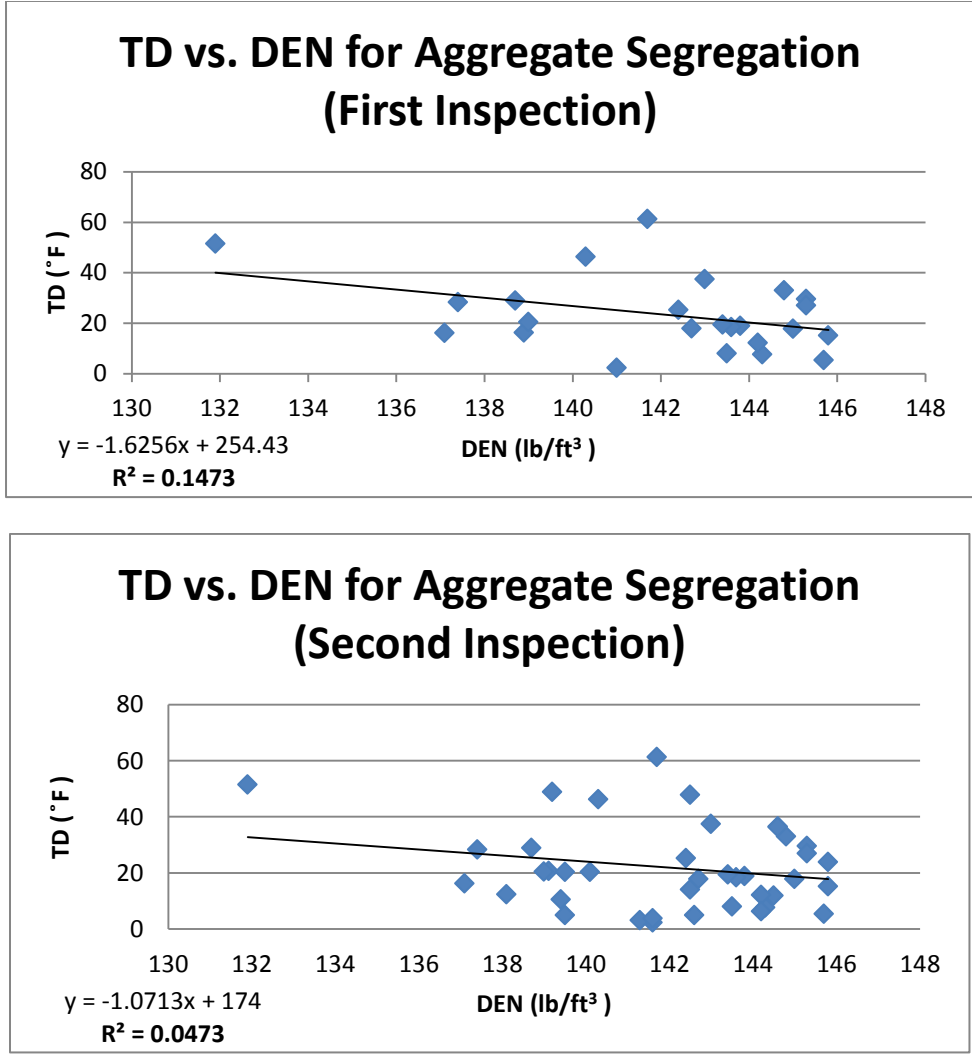
Figure 5.13 Relationship between temperature differentials (TD) among aggregate segregation

thaw cycles, thereby turning into premature distresses in the form of surface voids or potholes. Of the 24 locations with visible material segregation, a 15% negative relationship was found between temperature differential (TD) and density (DEN) (Figure 5.13). The correlation between TD and DEN decreases further to under 5% in the second year, with 40 locations being noted.

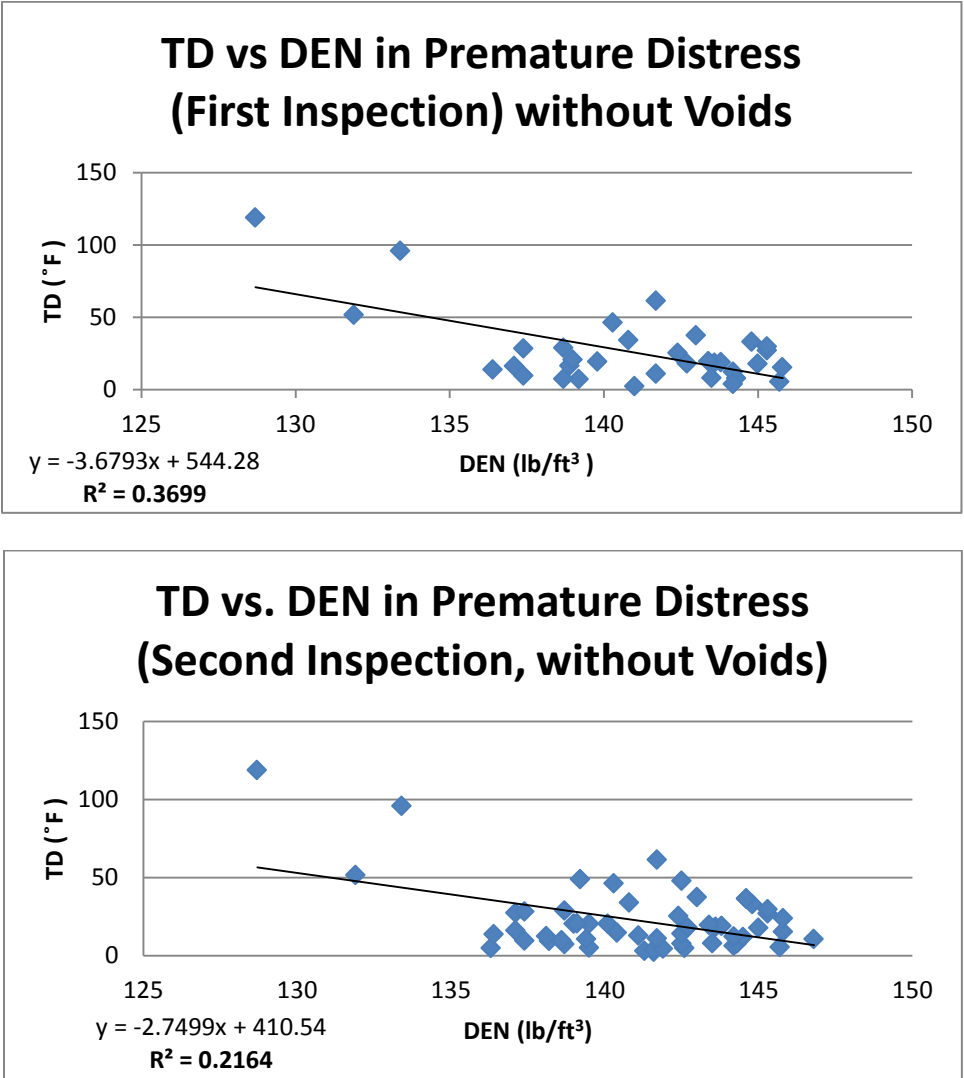
**Figure 5.15 Relationship between temperature differentials and premature distresses, excluding surface voids**

density. Results are improved and shown graphically in Figure 5.15, with the first year's analysis improving 19% from 17% up to 37%, and the second year's analysis improving 7% from 15% up to 22%.
