# Infrared Thermography-Driven Flaw Detection and Evaluation of Hot Mix Asphalt Pavements

**Report #: SPR-PI (08) P309**

**Final Report**

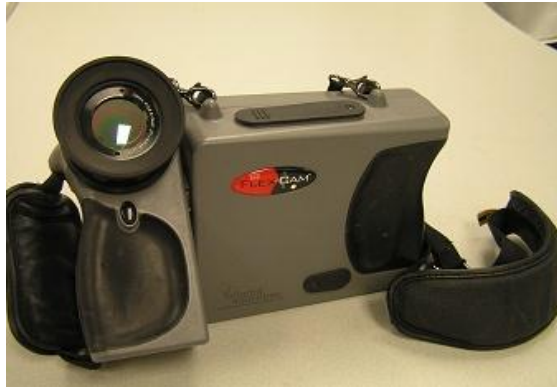
**Figure 3.1** Infrared Camera

For verification of the use of thermal image data in HMA applications, temperature readings were initially taken on the surface of the HMA as well as internally using a temperature probe. The internal and external temperature readings were compared to those obtained by the infrared camera. This was also done to ensure the specific infrared camera used in this study provided an accurate representation of temperature differentials. The accuracy of infrared cameras in general has already been proven in HMA applications by the University of Washington study, which notes that both temperature probes and infrared cameras are adequate tools for proving temperature differentials (Willoughby 2001). Figure 3.1 shows a Flex Cam XR2, the infrared camera used in this research. Figure 3.2 shows infrared images taken from Nebraska paving sites.

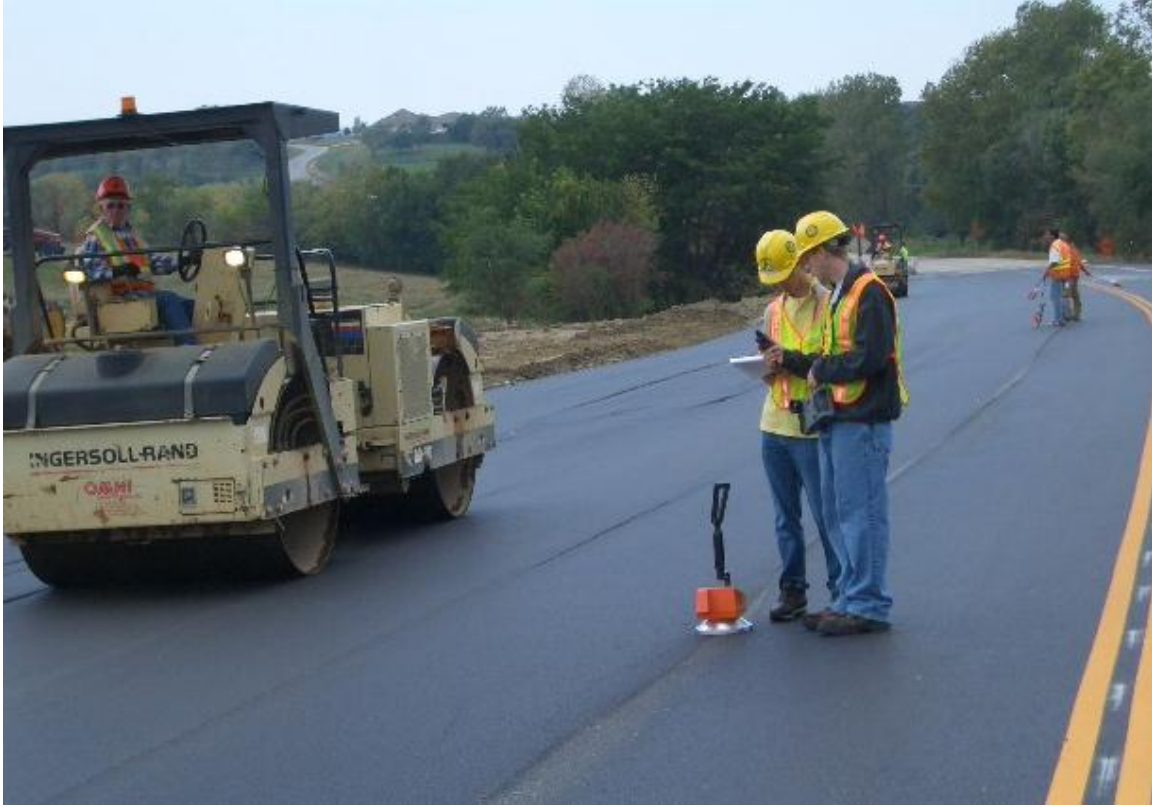
**Figure 3.3** Taking PQI Density Readings Onsite

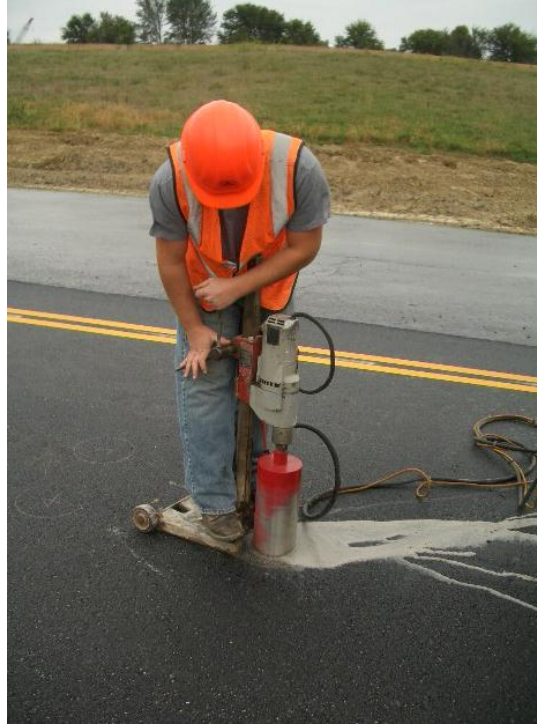
**Figure 3.4** Taking Cores for PQI Calibration

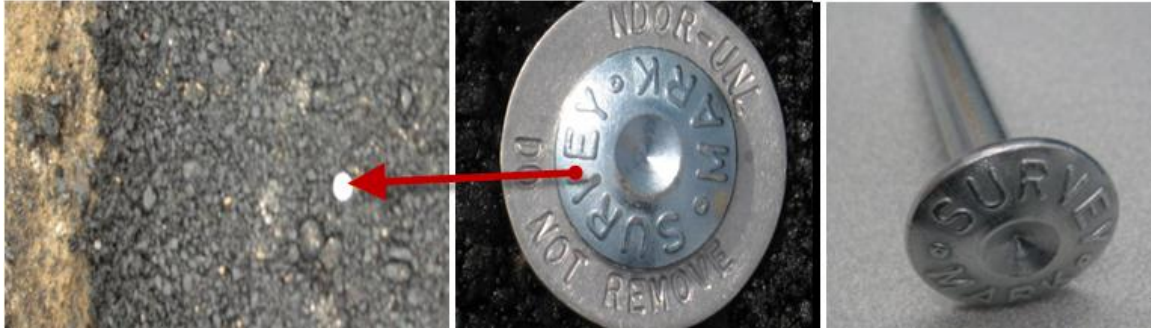
**Figure 3.6** Physical Location Markers

physical markers were driven into the shoulder pavement while still malleable and the distance directly across from the marker to the location was recorded.

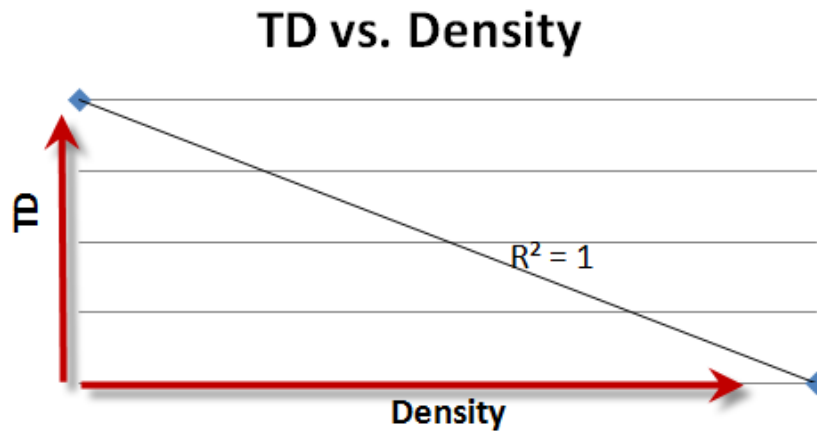
**Figure 4.1** Theoretical Relationship between Temperature Differential (TD) and Pavement Density

Throughout this project, 304 unique locations have been evaluated with the primary intention of investigating the effect that temperature differentials (TD) have within the HMA paving process. As found within earlier studies, the areas possessing increased temperature differentials after final compaction are expected to yield lower densities (Figure 4.1).

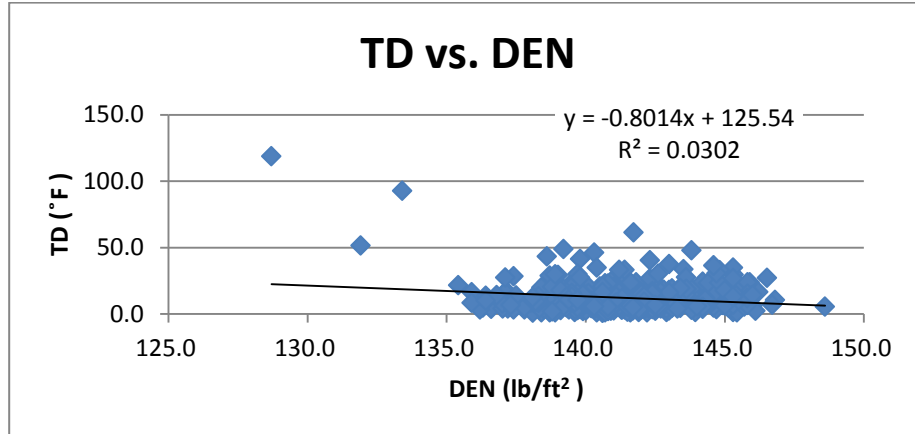
**Figure 4.2** Relationship for All Collected Data between Temperature Differential (TD) and Density (DEN)

Although a negative relationship was found, the general analysis between temperature differentials (TD) after compaction and pavement density (DEN) showed the relationship between the two variables not to be significant (Figure 4.2). This analysis included all 304 density readings obtained throughout the project and charted them against their corresponding temperature differential.

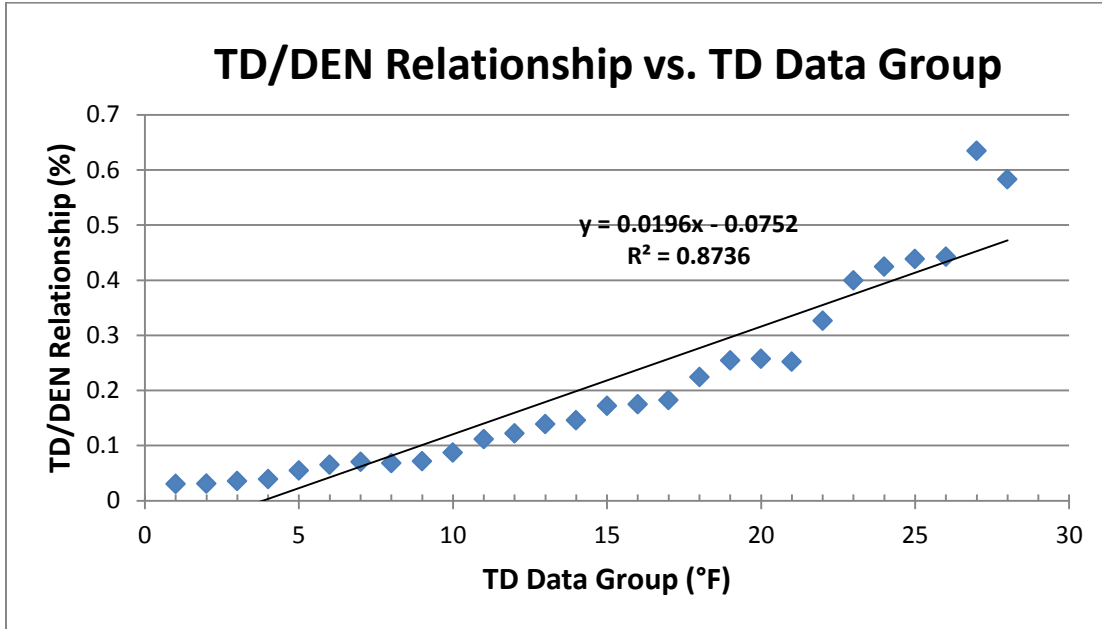
**Figure 4.3** A Graphical Representation of the Relationship between Individual Temperature Groups and TD and DEN

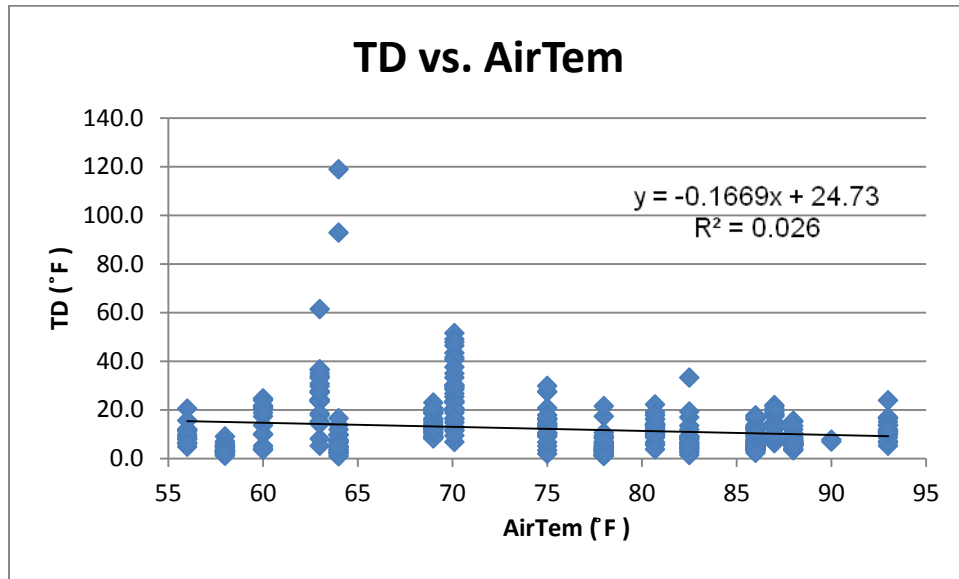
**Figure 4.4** Relationship between Ambient Jobsite Air Temperature and Temperature Differential

temperature segregation. As can be seen in Figure 4.4, there was no statistically significant relationship ( $r^2 = 0.026$ ) between the outside air temperature (AirTem) and the occurrence of temperature differentials (TD) during the typical paving seasons in Nebraska: between 50°F and 95°F.

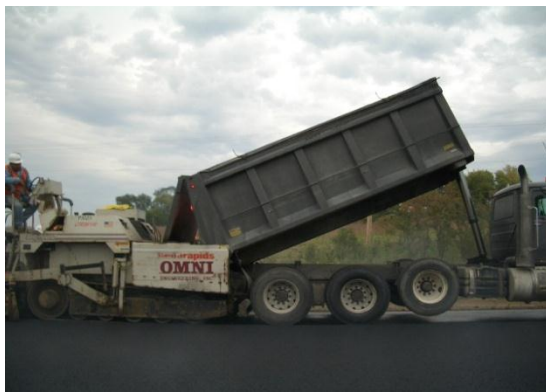
**Figure 4.6** Direct Dump between Truck and Paver

There are two types of material feeding processes from a delivery truck to a paver in Nebraska. Either HMA trucks directly dump delivered HMA into the hopper of a paver (Figure 4.6), or belly dump trucks and live belly dump trucks deposit the material ahead of a pick-up machine that scoops up the HMA and transfers it into the hopper of a paving machine (Figure 4.7). Unlike a material transfer vehicle (MTV), such as Roadtec, Inc.'s, Shuttle Buggy MTV, the pick-up machine does not have a special remixing auger or chute.

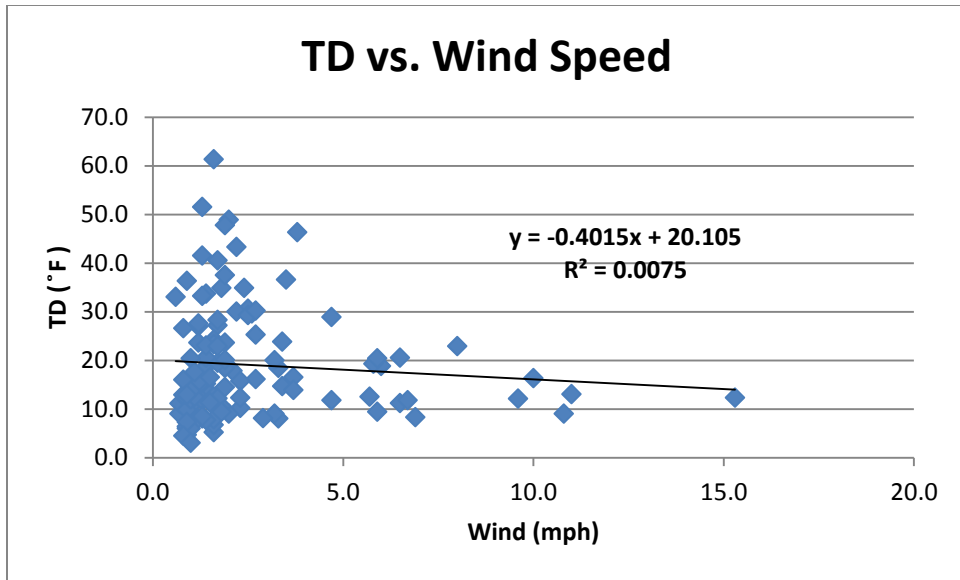
**Figure 4.9** Relationship between Wind Speed and Temperature Differentials (TD)

Wind speed was collected at each location for Sites 11-15 with a hypothesis that its effects could lead to HMA temperature segregation (Figure 4.9). The data suggests that wind speed has a negligible effect on temperature segregation, showing less than a 1% relationship. This is because the wind is likely affecting the pavement overall, rather than focalized areas.

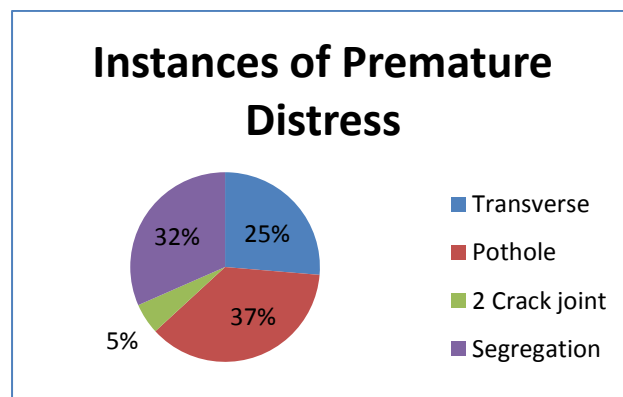
**Figure 5.1** Instances of Premature Distress

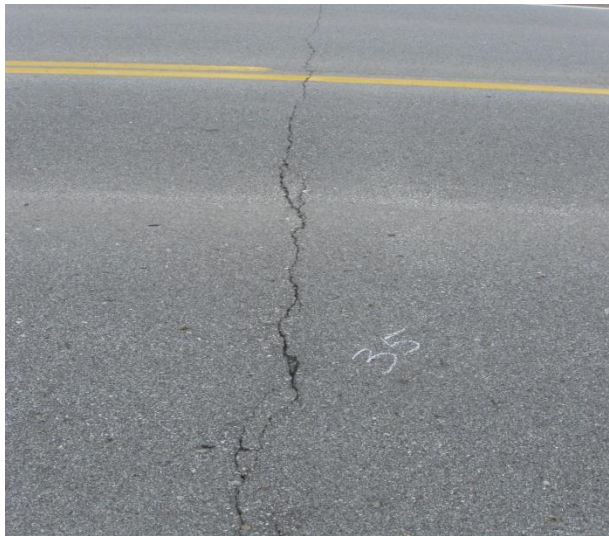
**Figure 5.2** Observed Transverse Crack

The following picture is indicative of a transverse crack (Figure 5.2). Transverse cracks are formed perpendicular to the direction the asphalt paver, and are often the result of asphalt shrinkage. Because areas of different temperature expand and contract at different rates, transverse cracks are of particular interest in this investigation. Cracks of this type also often occur as reflective cracks, which will be discussed later.

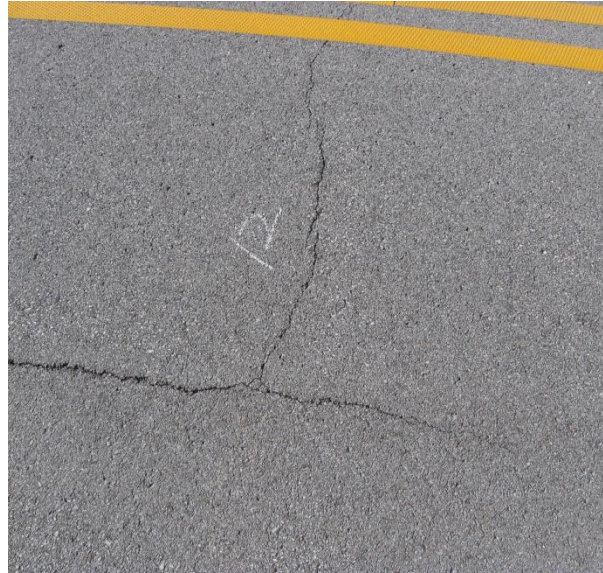
**Figure 5.3** Observed Multi-Crack Joint

assumed to be a combination of the reasons for transverse cracks and longitudinal cracks. Longitudinal cracks are often formed due to shrinkage or reflective cracking, and longitudinal segregation caused by poor paver operation. The reasons transverse cracks are formed have been stated previously (Walker 2009).

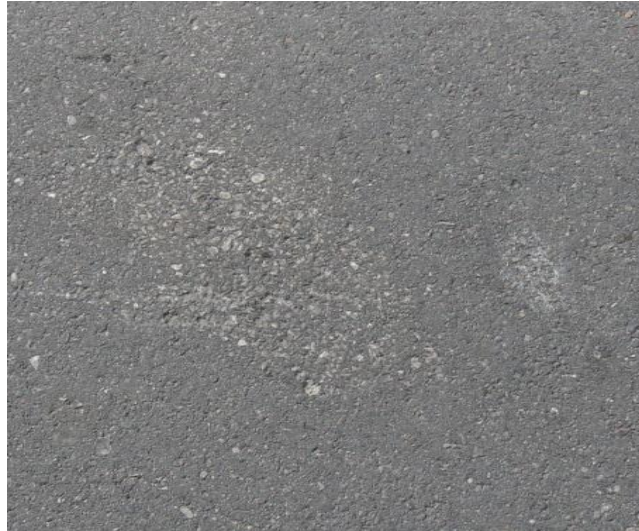
**Figure 5.4** Observed Material Segregation

compared to fine aggregate as well as low asphalt content (Williams et. al 1996). Aggregate segregation in HMA can be caused by improper mixing. Aggregate segregation leads to flaws like accelerated rutting, fatigue failure, and potholes (Williams et. al 1996; Walker 2009).

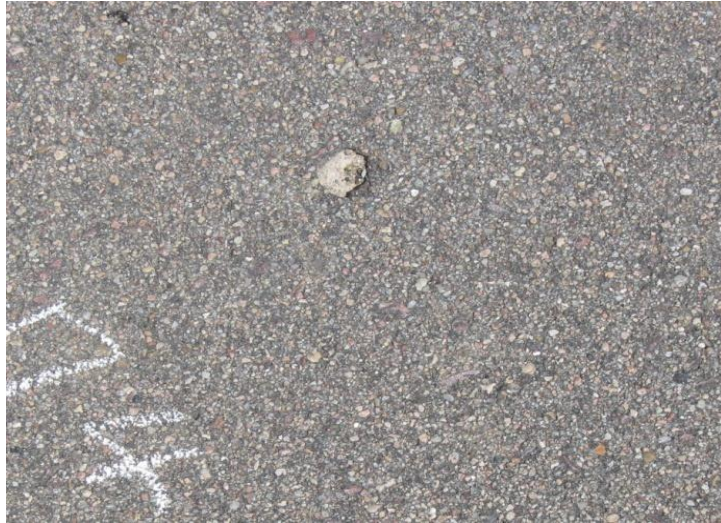
**Figure 5.5** Observed Surface Void

freeze-thaw cycle. Because these potholes have not degenerated pavement qualities to date, later data analysis deals with their inclusion at certain times.

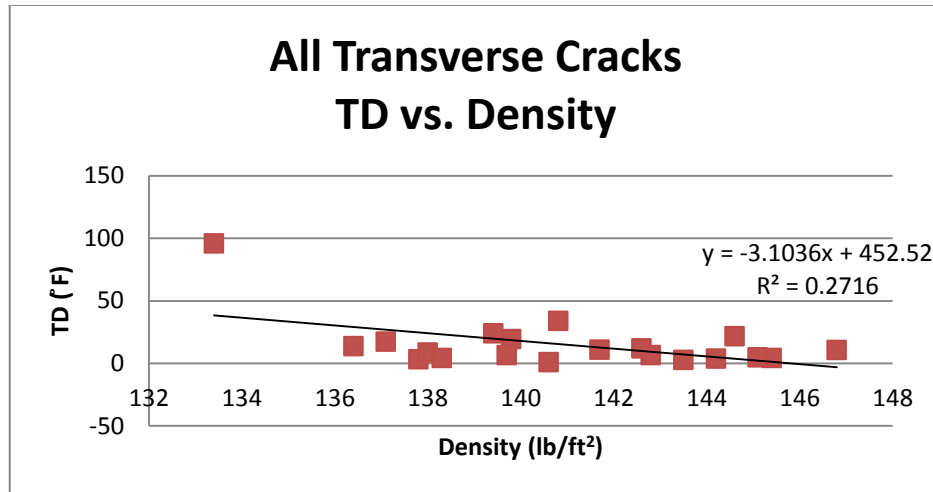
**Figure 5.7** Relationship of TD and Density among Transverse Cracks

temperature differentials and density, all 20 locations were evaluated based on that criteria. After calculating this relationship, a correlation of just greater than 27% was obtained (Figure 5.7). This correlation was lower than expected because the collected data included reflective cracks which were not affected by temperature differential.

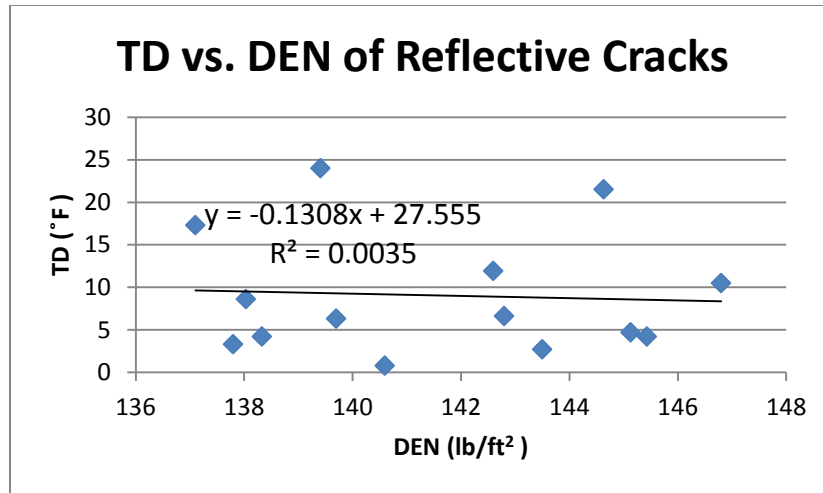
**Figure 5.9** Temperature Differentials and Density Relationship among Reflective Cracks

From the 20 observed instances of transverse cracking, 14 were found to exhibit signs of reflective cracking. When analyzing the 14 locations alone, a relationship of less than 1% was found between temperature segregation and density. This analysis further solidifies the researcher’s assumption that these locations were caused by cracks permeating up through old layers of material (Figure 5.9).

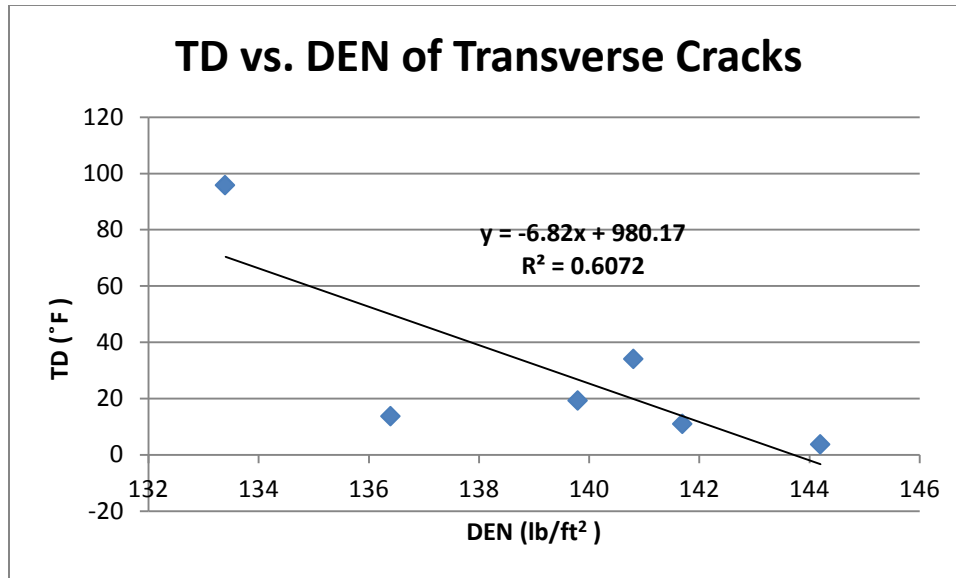
**Figure 5.10** Relationship between Temperature Differentials (TD) and Density (DEN),  
Excluding Reflective Cracks

The 14 locations were not further included in data analysis as these locations were almost certainly influenced primarily by the previous pavement underlayments. After excluding the suspected reflective cracks, the remaining six transverse cracks that had developed were found to possess an increased relationship (60.7%) between temperature differentials and density (Figure 5.10).

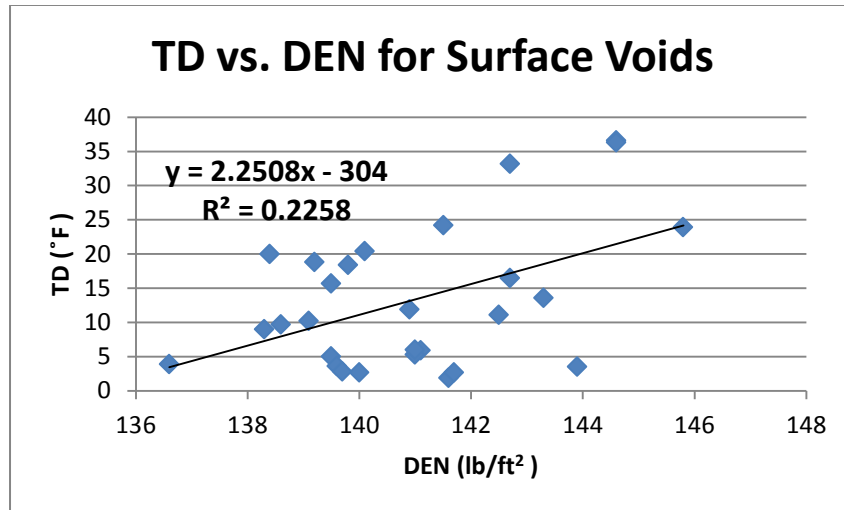
**Figure 5.11** Relationship between Temperature Differentials (TD) and Density (DEN) among Surface Voids

Small surface voids, or “potholes” for the purpose of this report, have proven to be a counterintuitive flaw. It is assumed that surface voids in the material will begin to develop at specific locations because of inadequate densities. One primary cause of inadequate density, and the focus of this research, is temperature segregation, namely cold spots. It is assumed that these cold spots would “set up” faster than the surrounding warmer temperatures, thereby increasing its ability to resist compaction. However, when analyzing locations classified as a surface void (or pothole), a positive relationship was found between temperature differentials and pavement density. This positive relationship follows counter to the assumed negative relationship where high temperature differentials would translate to low densities. This is more easily explained by Figure 5.11.

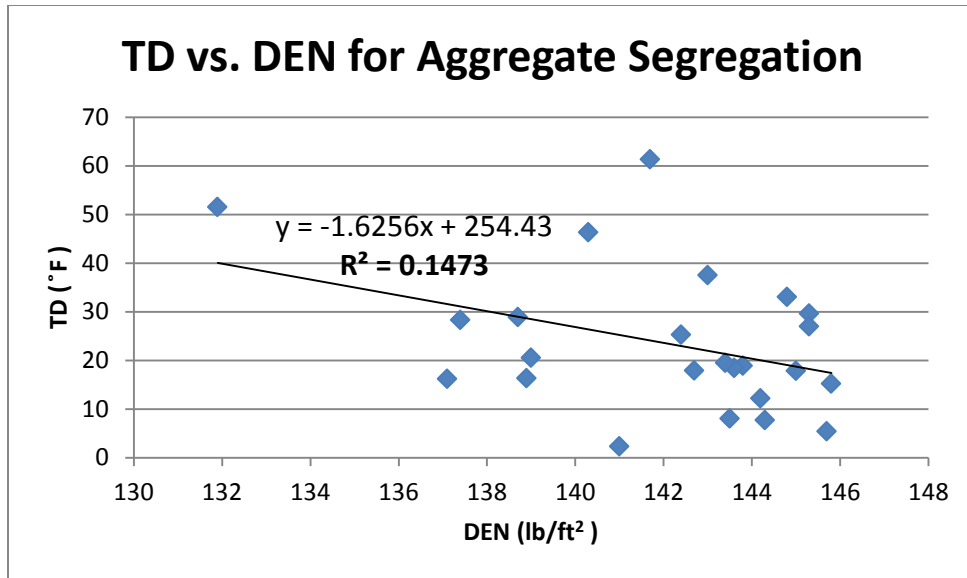
**Figure 5.12** Relationship between Temperature Differentials (TD) among Aggregate Segregation

Of the 24 locations with visible material segregation, a 15% negative relationship was found between temperature differential (TD) and density (DEN).

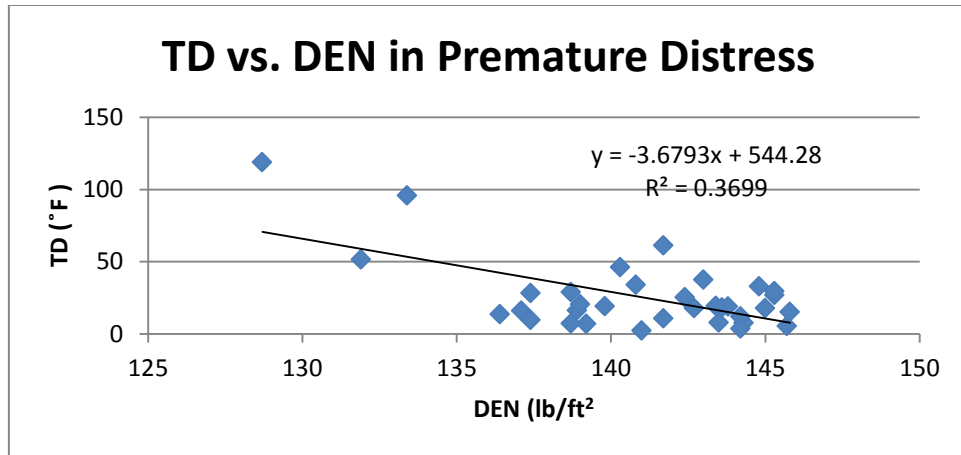
**Figure 5.14** Relationship between Temperature Differentials and Premature Distresses, Excluding Small Surface Voids

Recall, however, that when analyzed individually the pothole type of flaw exhibited a positive relationship between TD and density. Because all other flaw types show signs of being affected by temperature differentials in regard to their corresponding densities, while the locations with small voids do not, they were removed from the data set. The remaining 34 premature distresses or flaw locations were analyzed with regard to TD and density and were found to have a relationship of 37% (Figure 5.14): an improvement of 19% over the inclusion of small voids.

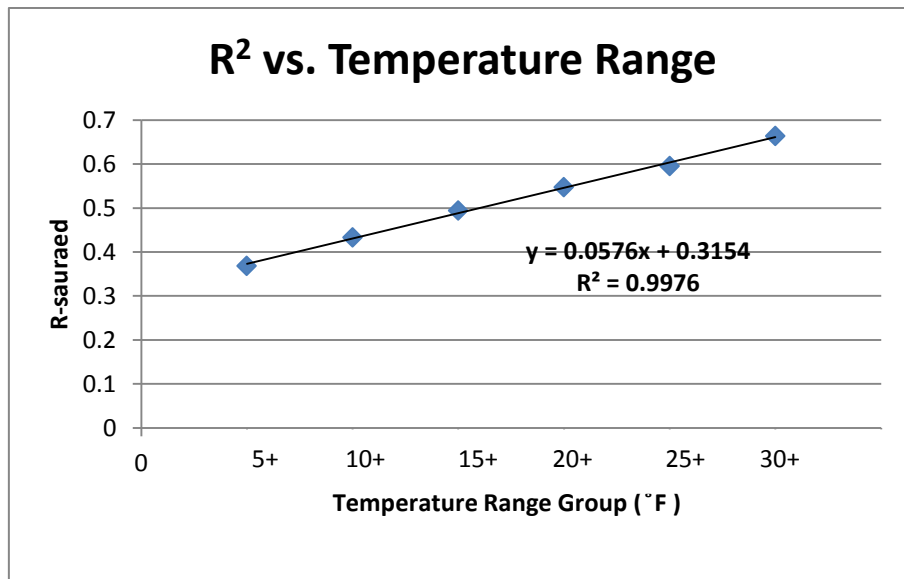
**Figure 5.15** Relationship between the Correlation of TD and DEN for a Given Temperature Range and the Temperature Range Group

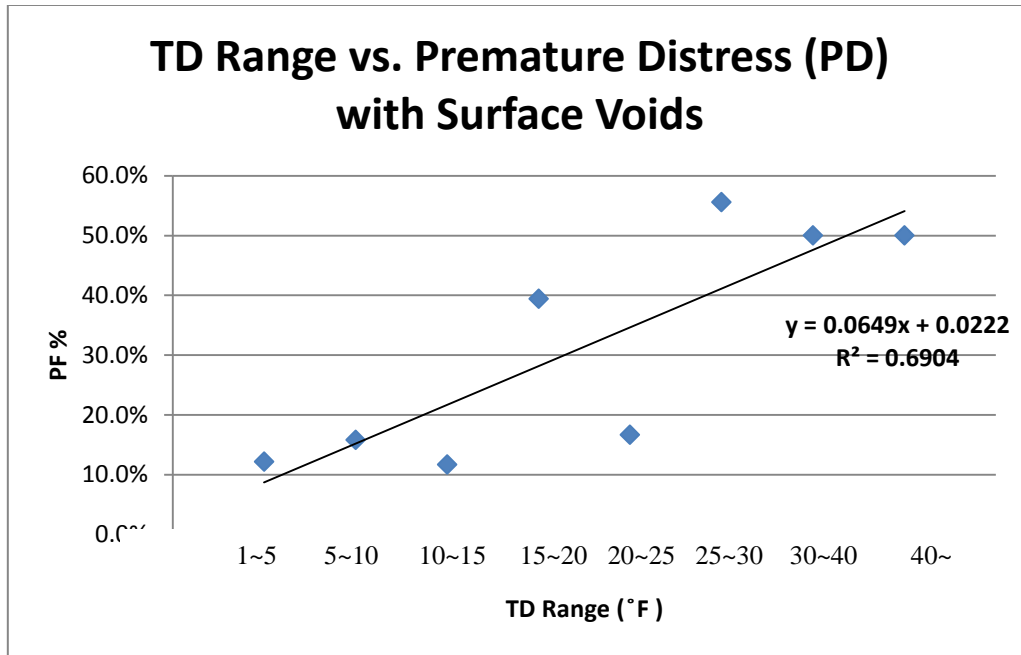
**Figure 5.16** Correlation between the Percentages of Premature Distresses, Including Surface Voids, Found within a Specified Temperature Range

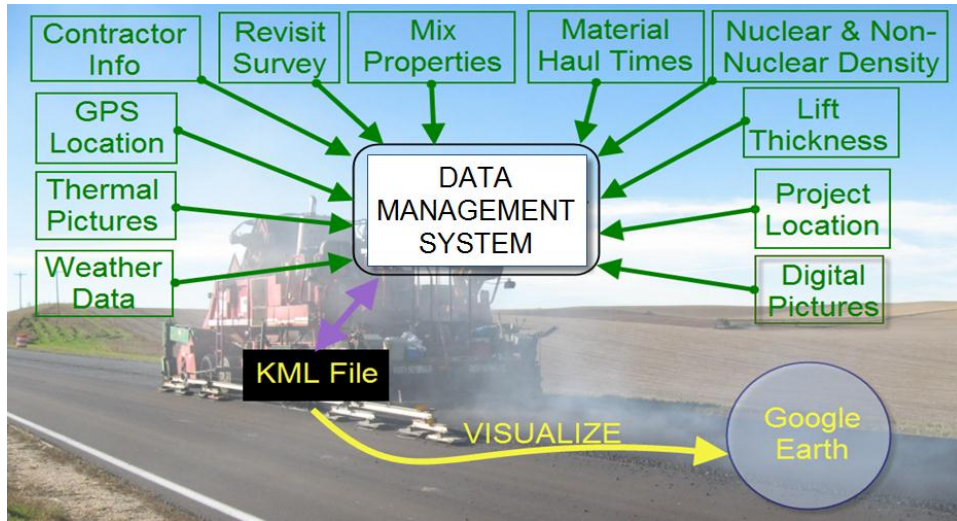
**Figure 6.1** Developed Data Management System

In order to perform this investigation, a number of devices were utilized. Those devices included (1) a portable anemometer to record current weather conditions, (2) portable GPS unit to digitally mark areas of interest for later revisit, (3) a thermal imaging camera to locate areas of HMA temperature segregation, (4) a penetrating thermometer to validate the thermal camera, (5) a digital camera to record site conditions and procedures, and (6) nuclear and non-nuclear pavement density devices to measure the compacted density of the material. In addition to data collected via portable devices, site-specific information was collected, including (1) pavement or mix type, (2) lift thickness, (3) haul time, (4) equipment used, and (5) location.

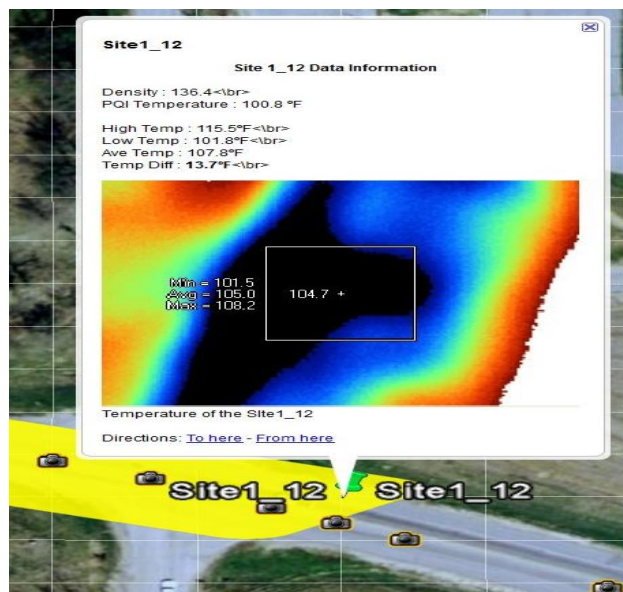
Figure 6.3 Location-Specific Data via Google Earth

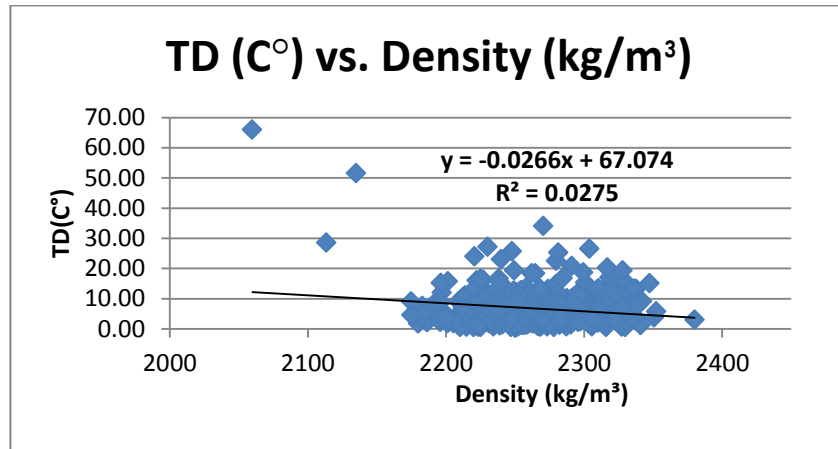
**Figure 4.2** Relationship for All Collected Data between Temperature Differential (TD) and Density (DEN)

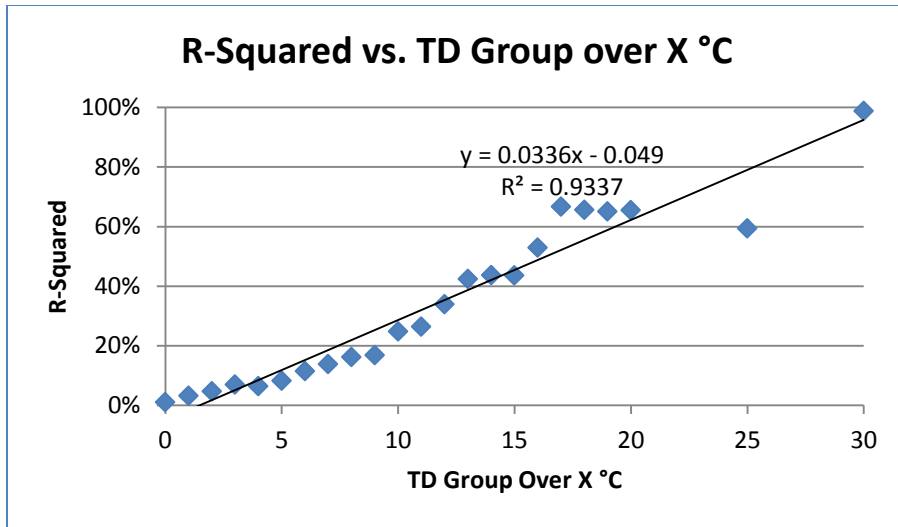
**Figure 4.3** A Graphical Representation of the Relationship between Individual Temperature Groups and TD and DEN

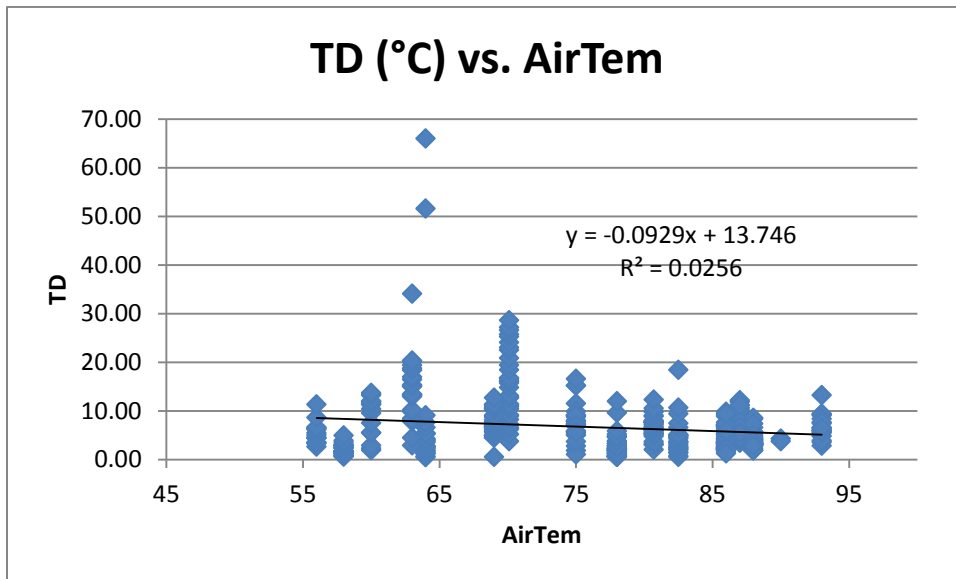
**Figure 4.4** Relationship between Ambient Jobsite Air Temperature and Temperature Differential

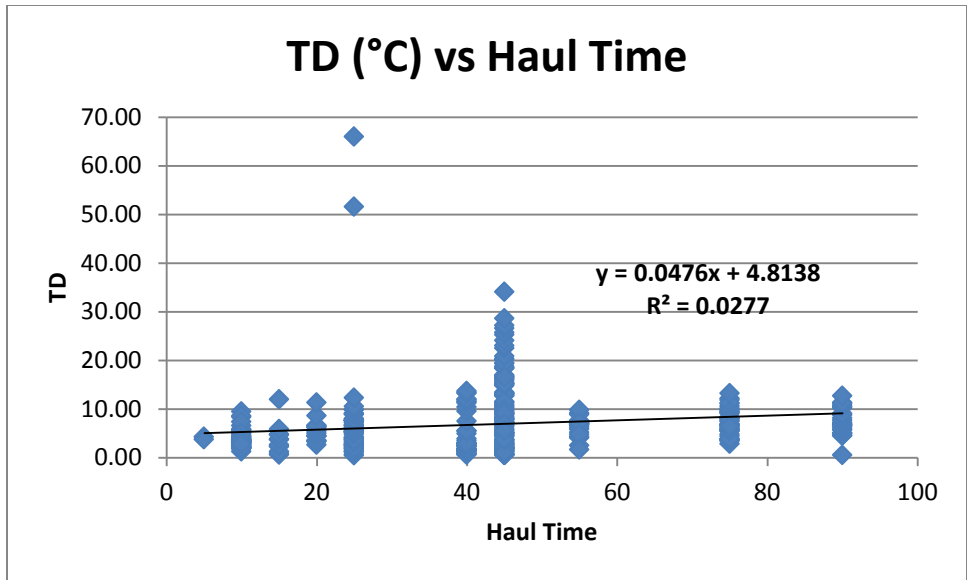
**Figure 4.5** Relationship between Haul Time and Temperature Differentials

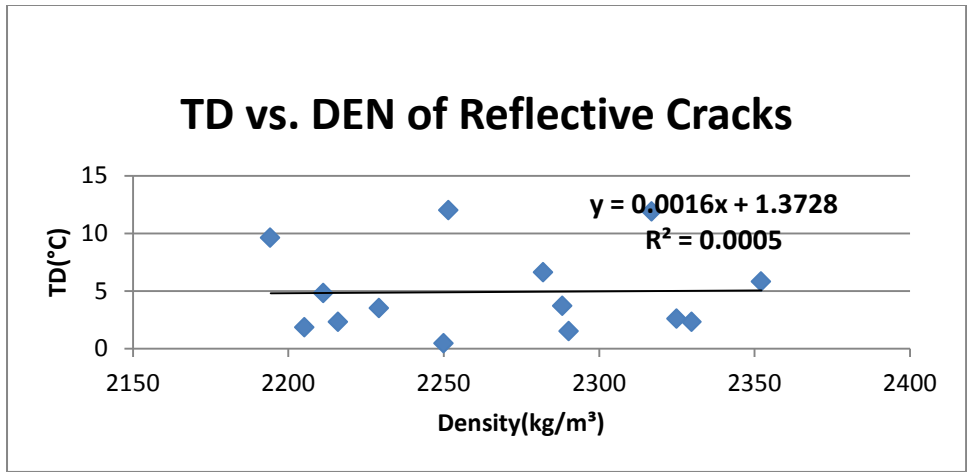
**Figure 5.9** Temperature Differentials and Density Relationship among Reflective Cracks

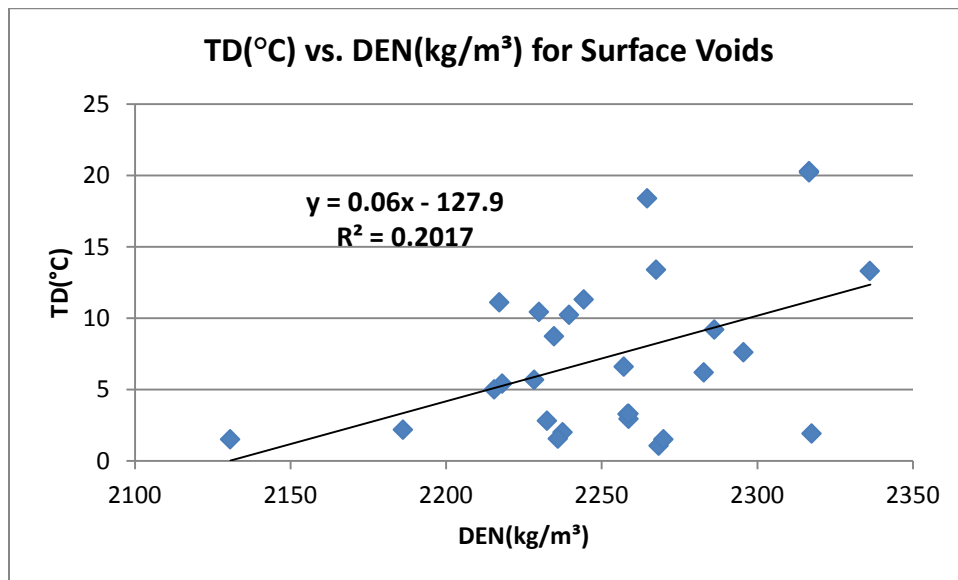
**Figure 5.11** Relationship between Temperature Differentials (TD) and Density (DEN) among Surface Voids

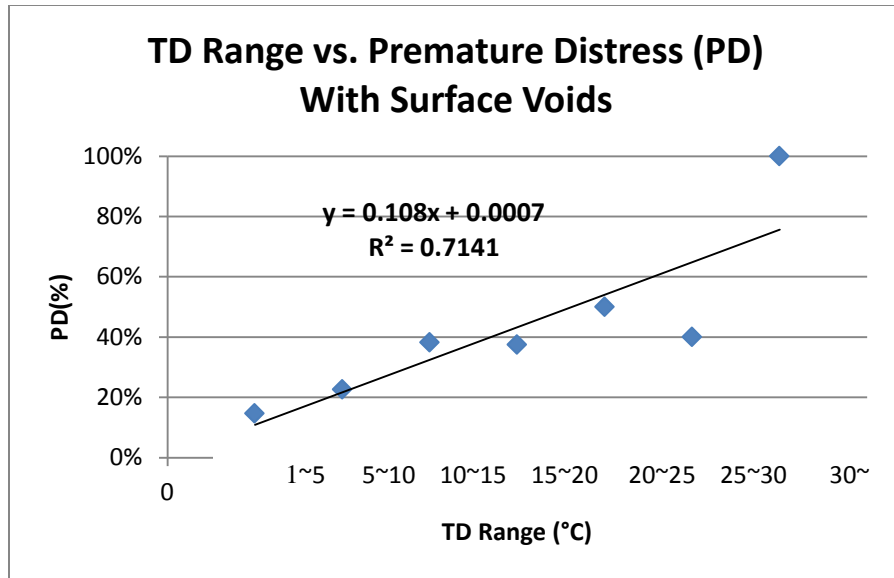
**Figure 5.16** Correlation between the Percentages of Premature Distresses, Including Surface Voids, Found within a Specified Temperature Range
