Precast/Prestressed Concrete Truss-Girder for Roof Applications

PRECAST PRESTRESSED CONCRETE TRUSS-GIRDER
FOR ROOF APPLICATIONS

A THESIS

Presented to the Faculty of
The Graduate College at the University of Nebraska
In Partial Fulfillment of Requirements
For the Degree of Master of Science

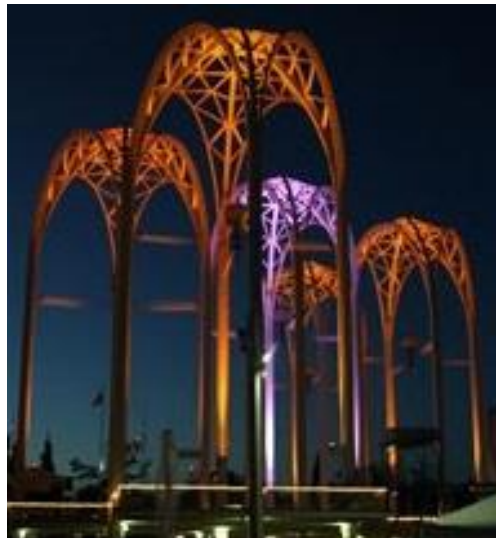
Figure 2.1 Concrete trusses Pavilion Science Center in Seattle, WA

The use of concrete trusses was first introduced in 1978 by W. Carroll, F. Beaufait, and R. Bryan in an ACI Journal article titled “Prestressed Concrete Trusses”. Precast concrete trusses were first used in 1962 for the U.S. Science Pavilion (now Pavilion Science Center) in Seattle, WA; however these trusses were non-structural trusses (PCI 2004). In 1976, Rock Island Parking Structure was built using Vierendeel trusses (PCI 2004). Vierendeel trusses are trusses made out of rigid joints and no diagonals. The trusses used were almost 12 ft deep and had a clear span of 32 ft and 16 in. x 22 in. cross-section dimensions for the top, bottom, and vertical members (Shah and May 1977). The vertical members that are resisting tension forces were post-tensioned. The Pavilion Science Center arches and the Rock Island Parking façade are shown in Figure 2.1 and Figure 2.2, respectively.

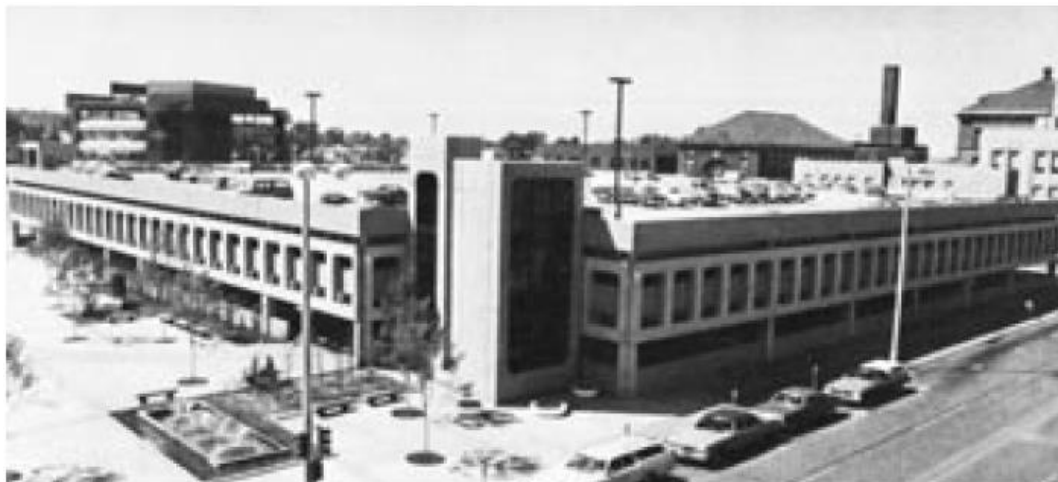
Figure 2.2 Vierendeel trusses used on the façade for the Rock Island Parking Structure. The ACI journal paper was published in 1978 by William Carroll about Prestressed Concrete Trusses (Carroll and al. 1978). The paper discussed two prototypes for the trusses. A prototype that had a clear span of 20 ft 4 in. and a depth of 2 ft, for a span to depth ratio of 10. The other prototype had 60 ft 10 in. and 8 ft 6 in. for span and depth, respectively, yielding a span to depth ratio of 7. The smaller trusses that were suggested in the paper consisted of diagonal members only without any vertical ones; however the bigger ones had only two verticals near the center of the trusses. Figure 2.3 and Figure 2.4 show the two prototypes of the trusses researched.

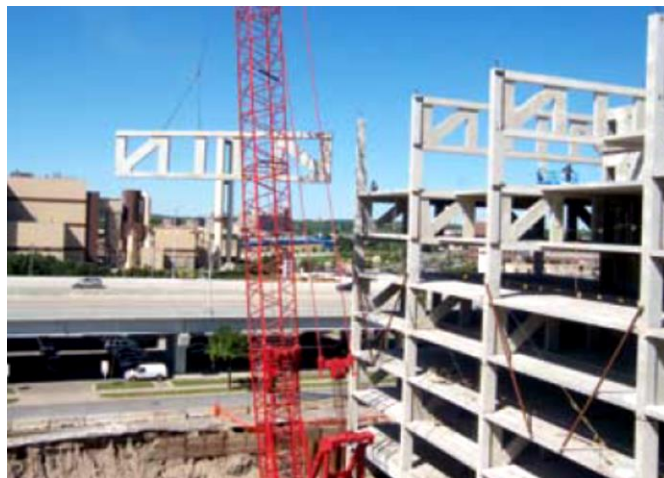
Figure 2.5 Erection of ER-POST trusses (Trygestad and DeSutter 2007)

In 2007 a new idea for concrete trusses evolved. A multi-level condominium building was built in Minneapolis, MN using what is called “ER-Post”. The ER-Post is system invented by M. DeSutter of Erickson Roed & Associates. The purpose of the system was to provide a column-free space for the condominiums, Figure 2.5, (Trygestad and DeSutter 2007). DeSutter was able to merge Vierendeel trusses with pretensioning to

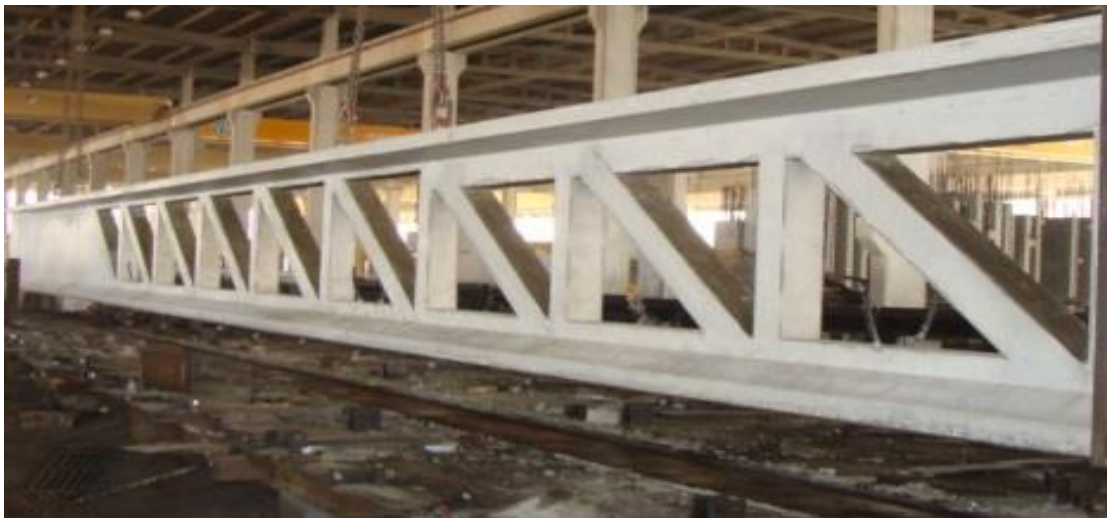
Even with the progress concrete designers has achieved, none were able to provide a system that can compete and eventually replace the steel trusses that are used for long spans as in warehouses, airplane hangars, and such. In 2010, a precast concrete truss-girder was used to support the roof of a coal storage facility in Sharjah, United Arab Emirates (UAE). Designed by e.Construct USA, LLC, the 1.5-meter (5-foot) deep truss had a span of 50 m (165 ft) without intermediate supports. Figure 2.7 shows the truss as fabricated while in the precast plant.

Figure 2.7 The truss designed by e.Construct USA, LLC (the view is center to end) A full truss consists of two halves, each 25 m (82.5 ft) long. The two pieces are post-tensioned together forming one full 160 ft span. The trusses are arranged to be 10 m (30 ft) apart. Figure 2.8 shows a 3D view of the project and trusses arrangement. Each two halves of the truss rested on a temporary support (as shown in Figure 2.9) at the center of the span till post-tensioning was applied. Figure 2.10 is the elevation and cross-sectional dimensions of the top chord, bottom chord, verticals, diagonals, and end blocks as designed by e.Construct USA, LLC. All pictures are courtesy of e.Construct USA, LLC.

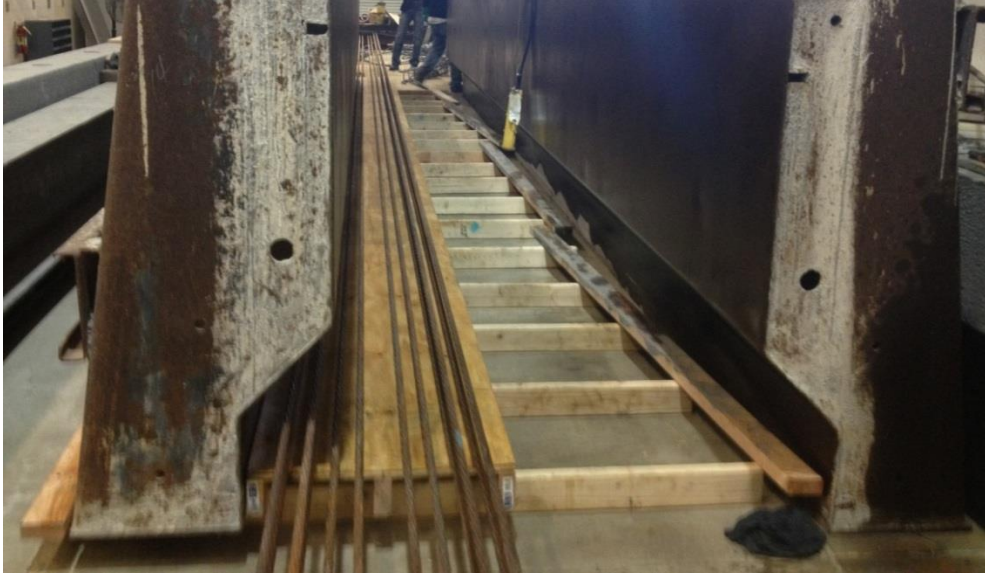
Figure 4.15 Fixing one side of the form in place

The strands were laid out on the bed on top of the plywood, as shown in Figure 4.14. They were tensioned just enough to get them straight. The plywood was then centered with the strands and one side of the steel form was put and fixed against the plywood block-out. 2X4 timber was used to hold the steel forms in place at the bottom. Figure 4.15 show the side of the form in place with the timber behind it to support it in place. The strands were then tensioned to 100 ksi, half of the jacking stress, in order to start putting the rebar together, were some would be resting on the strands. Bottom flange stirrups were then tied on to the strands (Figure 4.16) and bearing plates were also put in place before the end bulkheads were attached.

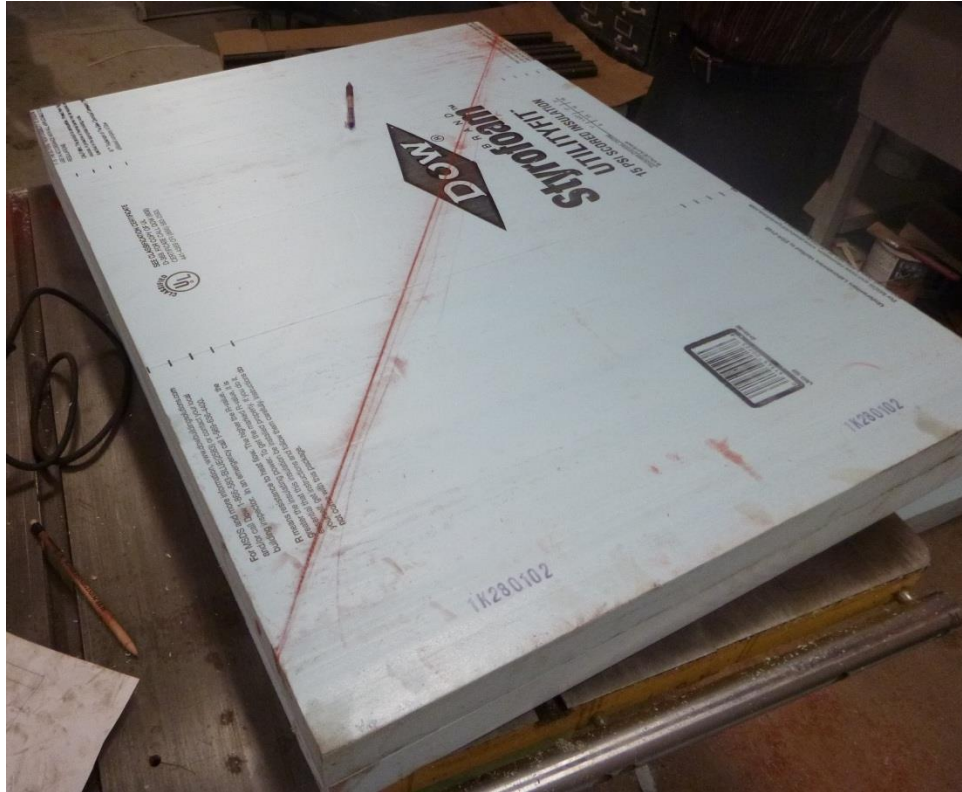
Figure 4.18 The Styrofoam rectangular pieces with the line representing the diagonal cut

The 8-in. thickness of the block-outs was divided into two 4 in. thick pieces. All the pieces shown in the pictures are only 4 in. thick. 4'x8' boards of foam were cut into the required shape and size. Rectangular pieces were first cut then diagonally cut again as shown in Figure 4.18.

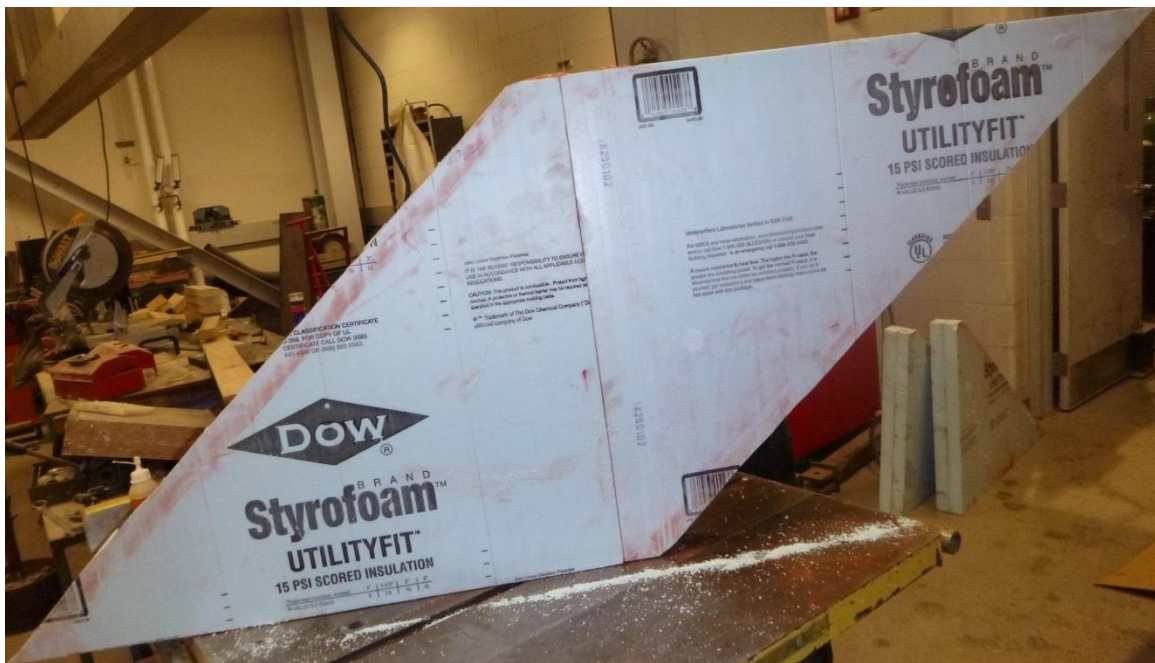
Figure 4.19 Two pieces of foam put together after being cut diagonally

0.75 in. x 0.75 in. grooves were removed from the edges of the Styrofoam pieces shown in Figure 4.19. To ease the foam removal from the concrete web, plastic sheets were wrapped around the edges of the foam. Figure 4.20 clearly shows the grooves and the plastic sheets in the foam pieces. Assistive lines were drawn on the steel forms prior to gluing the foam so as to facilitate the measuring process for locating the foam block-outs. All the foam pieces glued on the steel form are represented in Figure 4.21. The other half of the block-outs were planned to be glued on the other side of the form. To avoid errors in the location of the foam pieces due to slight differences in measurements between the two form sides, the other half of the form was decided to be glued on the already existing foam pieces after attaching the rebar.

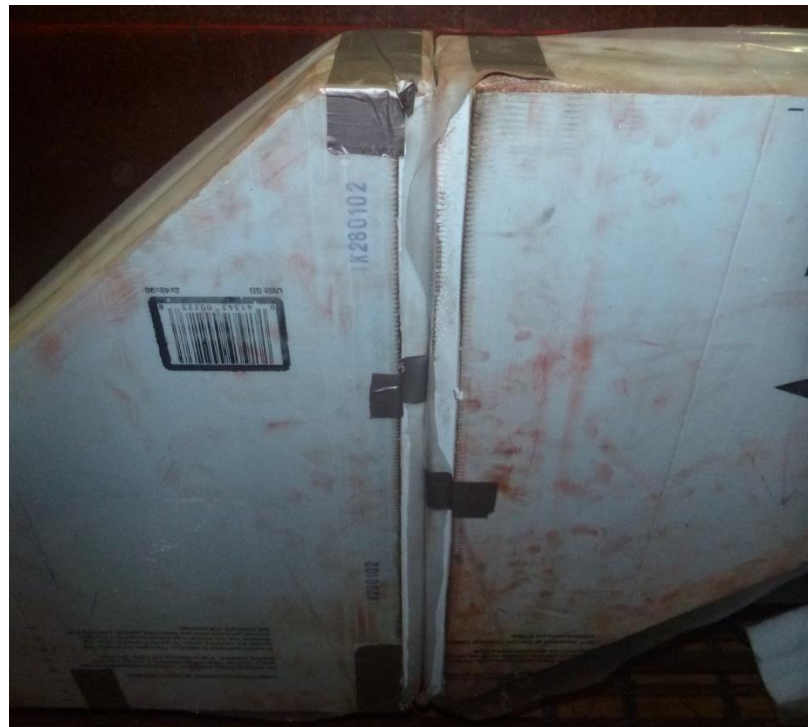
Figure 4.20 The groove and the plastics sheet on the block-outs

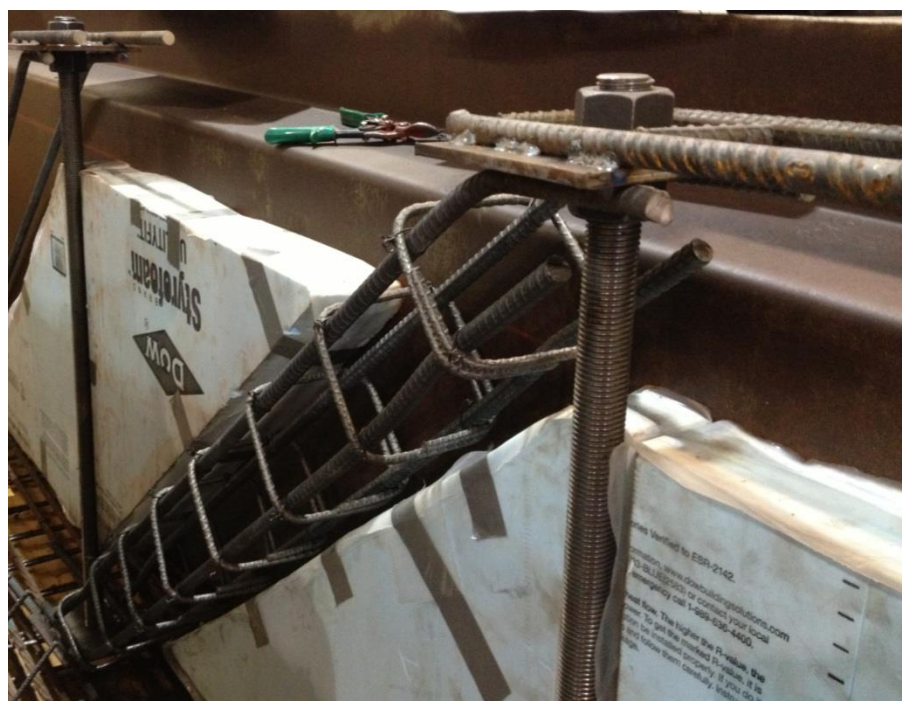
Figure 4.22 The diagonal reinforcement assembly

The changes that were done made the fabrication process very easy. The assembly can be seen in Figure 4.22.. These reinforcing bars were the most challenging part of the fabrication due to the interference between the bars from the verticals and those supporting the diagonals. Four 4 in. x 4 in W2 meshes were put at each end of the truss as

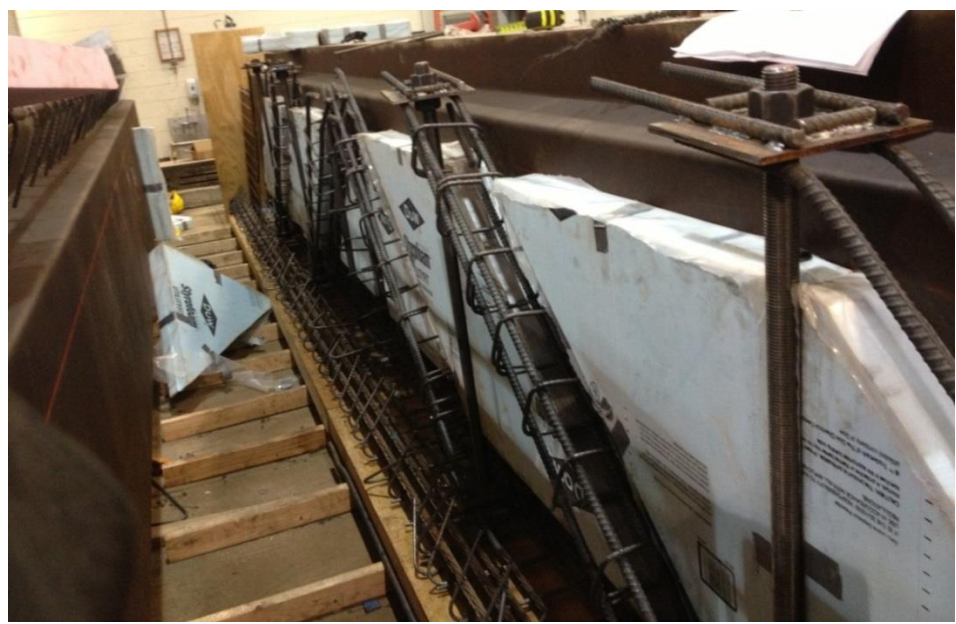
Figure 4.23 All the reinforcements after being fixed in the form

shear reinforcements. Figure 4.23 through Figure 4.24 are different views of the final stage in the reinforcement fabrication for the diagonal and vertical members.

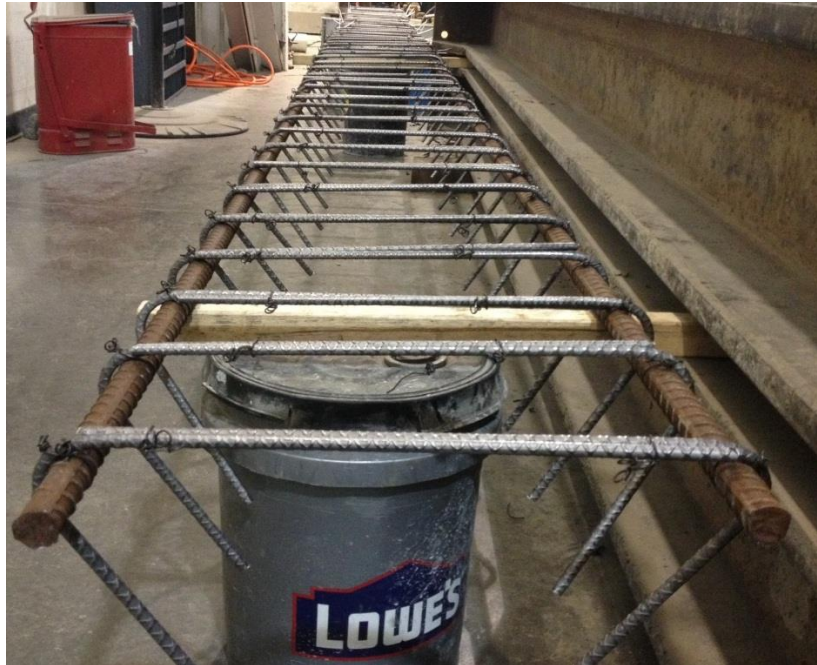
Figure 4.25 The top flange reinforcements after assembly

The top flange was designed for 4 #4 bars for the full 30-foot span specimen. Due to the time constraints, 2 #8 bars were used instead as they were already in the lab. The top flange reinforcements were done and tied together with the stirrups as in Figure 4.25. After the form was closed, the bars with the stirrups sat on 2 in. high chairs on the steel form. The hats for the stirrups were not added as the supplied ones had a smaller angle than the truss was designed for; therefore, the hats were not used for the stirrups as they did not fit in the form. After the form was closed, 2x4 timber ties were bolted to brace the steel forms against opening. The prestressing strands were then pretensioned to 202.5 ksi (0.75 ultimate stress of 270 ksi). Final elongation of the strands was 6 in. Figure 4.26 shows the truss formwork right before casting the truss.

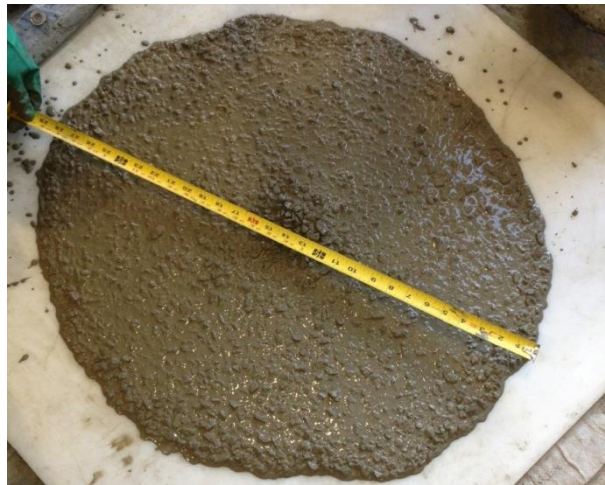
Figure 4.27 Self-consolidating concrete spread test

Self-consolidating concrete was delivered on March 11th, 2013 to the structural lab. The mix was made with 3/8 in. maximum nominal size aggregates. The concrete had a spread test of 28 in. (Figure 4.27). The concrete was patched and ordered for a 28-day strength of 8,000 psi. Cylinders were casted for strength testing at the time of stripping and testing.

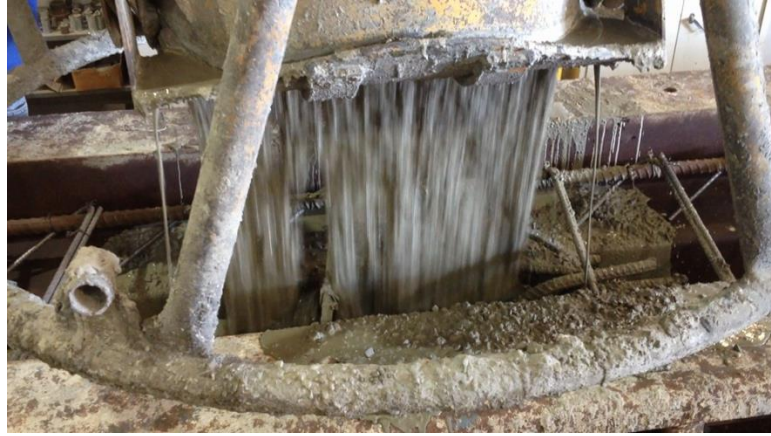
Figure 4.28 Pouring the concrete through the middle vertical member

Pouring the concrete started at the middle vertical as shown in Figure 4.28. Two snake cameras were attached at the bottom of the truss, one at each end. Another camera was recording the pouring process from the outside. The main purpose of the snake cameras was to test the flowability of concrete through the bottom flange at the locations of the vertical and diagonal embedment. The concrete mix passed successfully through the bottom flange. Figure 4.29 shows the concrete flowing from the location of the pour at the middle vertical to the location of the camera at the south bottom end of the specimen.

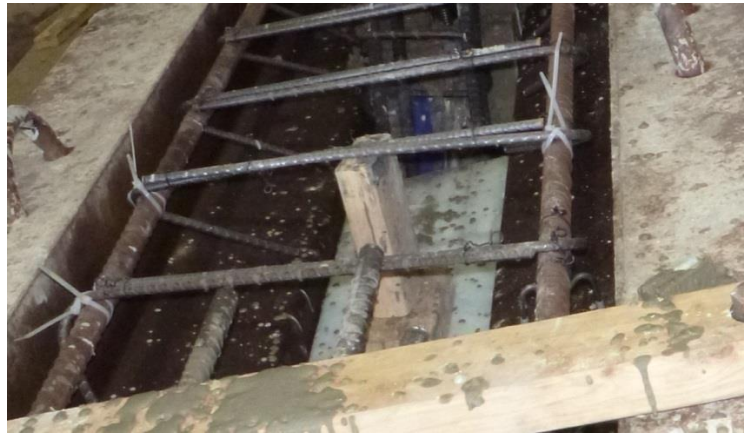
Figure 4.30 Holding down the block-outs

No issues were faced till the bottom flange was completely filled. However, as soon as the concrete started to go up the diagonals and the web, the buoyant forces on the Styrofoam block-outs was extensively high. The glue attaching the block-outs to the form was not strong enough to hold them in place, and not very long after the concrete started to go above the lower bottom of the block-outs, the foam was detached from its place and floated. The buoyant force was very high that prying the foam down was not effective.

2x4 timber pieces were but on top of the foam as spacers between the foam and the steel plates that were welded to the diagonals, and between the foam and the top flange steel reinforcements. Figure 4.30 shows how the block-outs were held by means of the top flange reinforcements. The weight of the steel reinforcement was not enough to hold the foam in place. Timber spacers were slid between the reinforcements and the ties holding the steel form (as shown in Figure 4.31) to prevent them from floating. Foam has proved that it is not the efficient or suitable material for the block-outs and alternatives had to be suggested. Alternatives are discussed in the conclusion section.

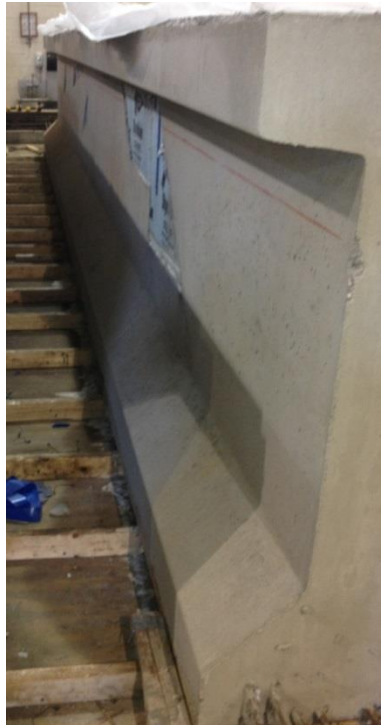
Figure 4.32 The side of the truss after moving the steel form (View is South to North)

The form was stripped and strands were released at a 3-day strength of 7,800 psi. The steel forms were easily removed away from the truss. The foam, however, was embedded in the concrete and did not come out as one piece as planned before construction. The pressure of the concrete on the form led to the form being widened by an average increase of 0.5 in. for a maximum widening of 1 in. at the northern end and no widening at the southern one. That increase in thickness caused the web to be wider than the Styrofoam at some locations, which increased the difficulty of removing the block-outs (See Figure 4.32).

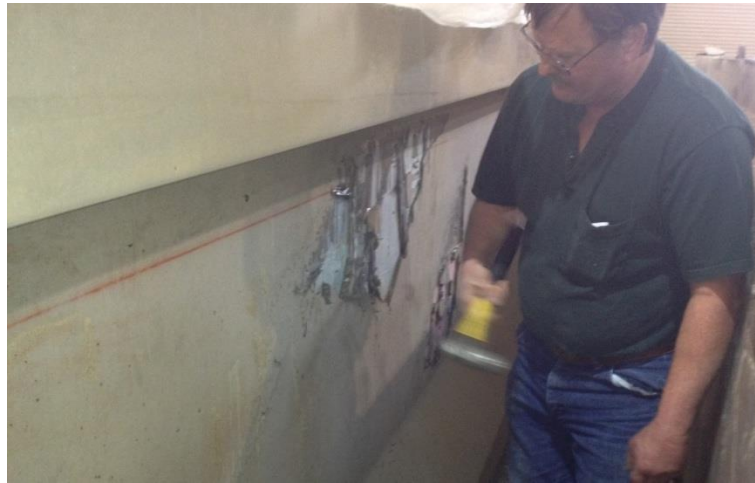
Figure 4.33 Chipping out the concrete layers covering the block-outs

Removing the Styrofoam block-outs was a more challenging task than what was planned. Concrete shrinkage enhanced their positioning inside the concrete. The web widening led to having some pieces covered from both side with concrete layers. The concrete layers needed to be chipped out first as in Figure 4.33.

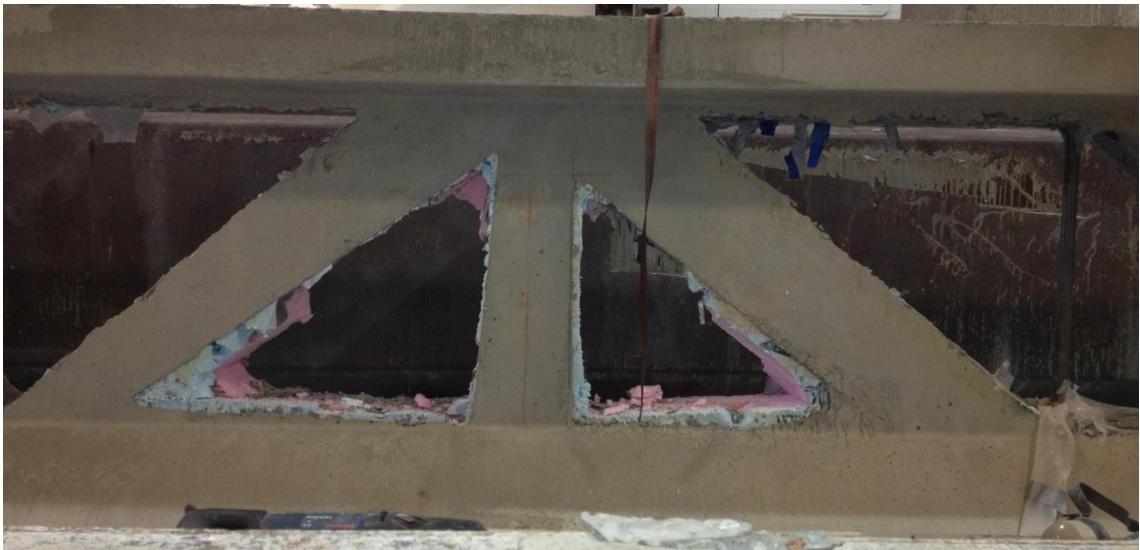
Figure 4.35 The middle of the truss after stripping the forms

Even though the plastic covering on the edges of the block-outs was not as helpful as expected in the removal process, the triangular pieces at the middle were more challenging to remove. A small layer of the edges of block-outs in the middle could not be removed from the concrete. The difference in the finish between the middle block-outs and the rest of the truss can be clearly seen in Figure 4.35. A chipping hammer was used as in Figure 4.36 to remove as much as possible without risking damage the concrete

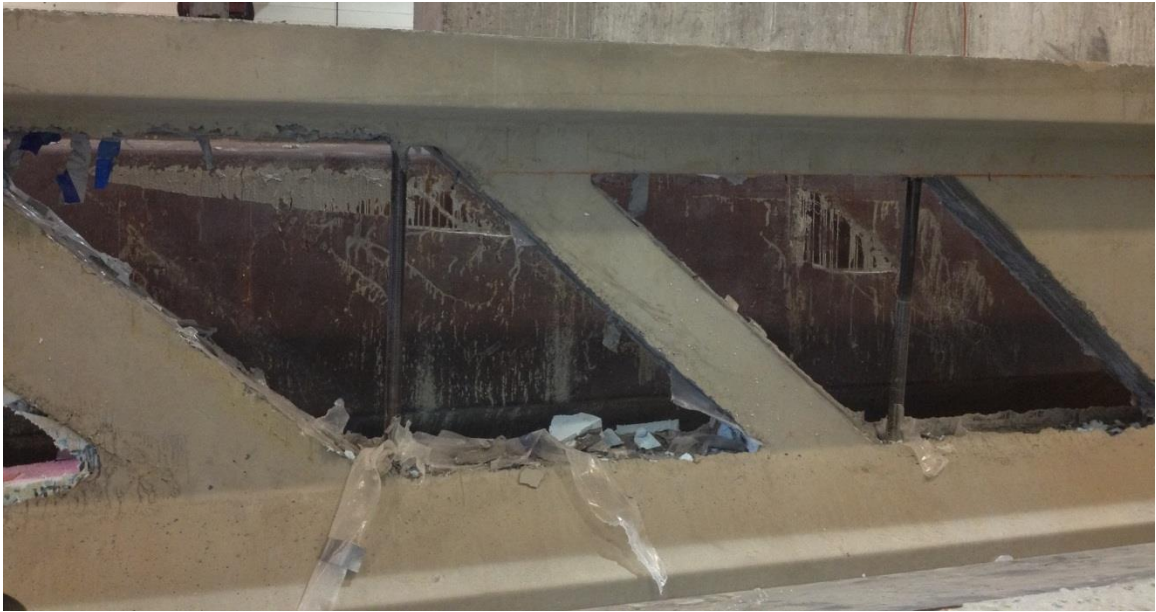
Figure 4.37 Some irregularity that occurred in the truss diagonal and vertical members and locations of block-outs

The flotation and movement of the block-outs during the casting process caused some irregularity in the shape of the truss. Two diagonal members were widened and the other two became thinner, along the length of the truss. The block-out locations were shifted as well with the movement of the Styrofoam. The two vertical members at each end were slightly rotated. A sample of the irregularity that happened during the fabrication process is shown in Figure 4.37.

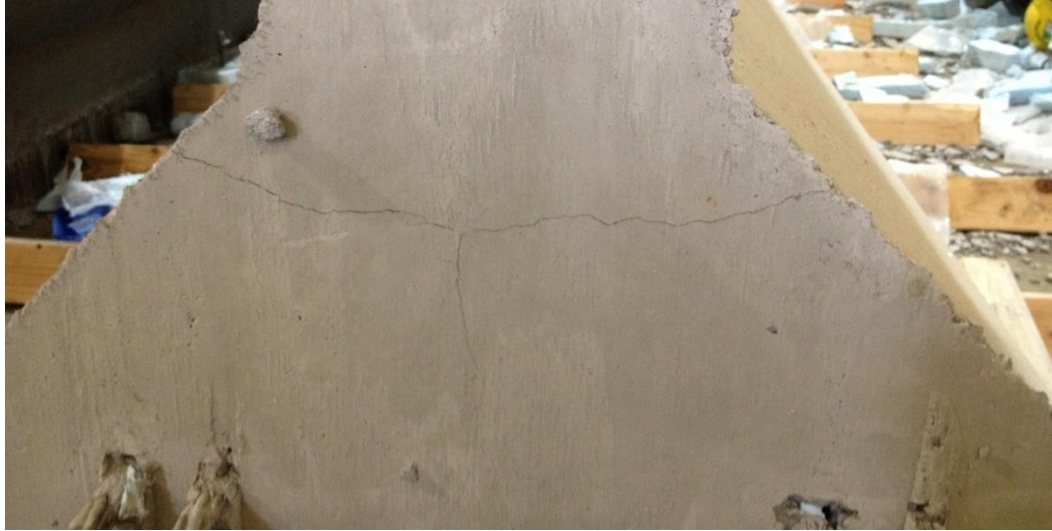
Figure 4.38 End zone cracking at the south end

The strands were released by means of the prestressing jack mentioned in section 4.3.1. End zone cracking occurred at both ends, as the end zone reinforcements needed to be closer to the ends. Cracking at the south side shown in Figure 4.38 was a little more extensive than the north side cracking shown in Figure 4.39. Very slight cracking occurred at the south end side of the web. No camber occurred due to prestressing.

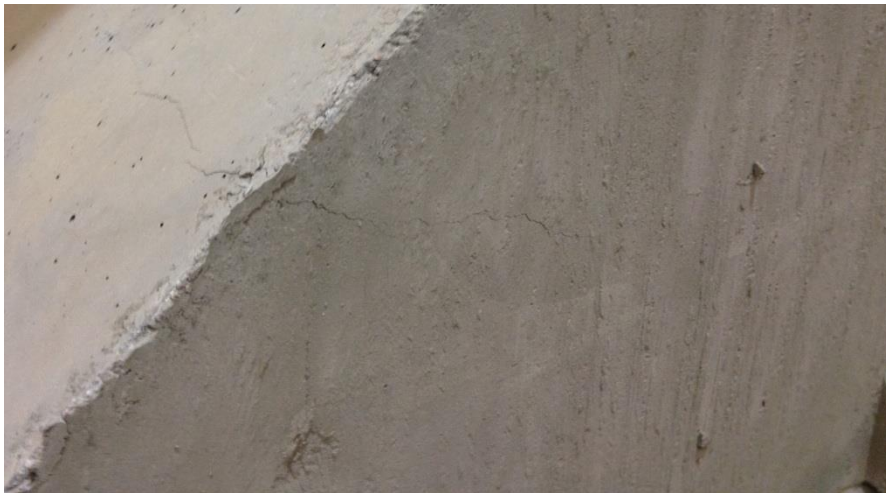
Figure 4.39 End zone cracking at the north end

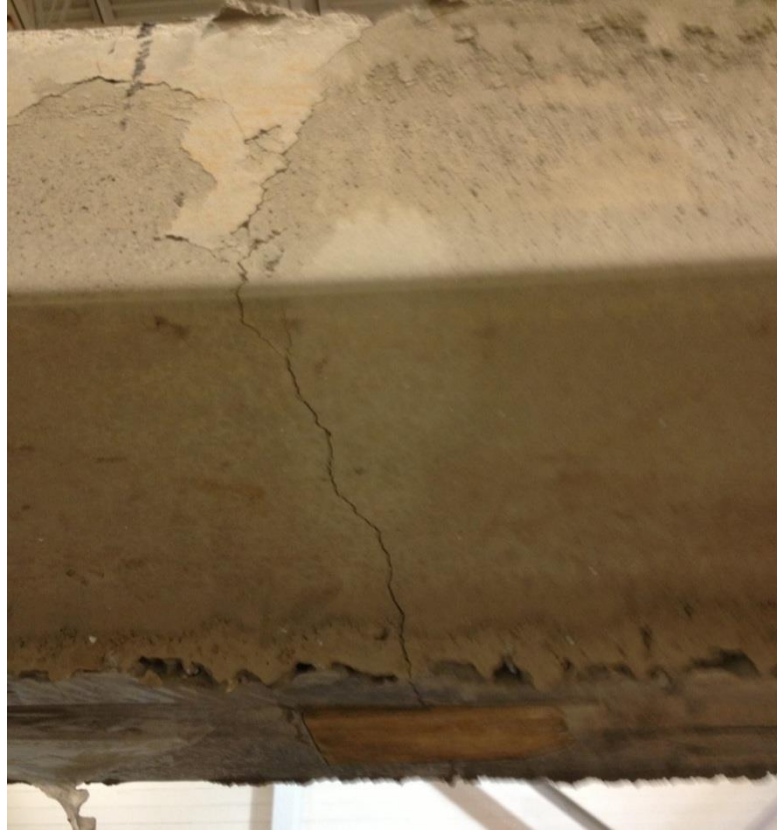
Figure 4.40 Shrinkage cracking where a 2x4 timber piece was left

Some shrinkage cracks occurred in the top flange, some of which could be barely seen, others were very extensive. Most of the big cracks occurred at the locations where the wood holding the Styrofoam block-outs was left. The shrinkage cracking was believed to not be crucial when testing the truss as they occurred only in the top flange, which is a compression member. One of the biggest cracks can be seen in Figure 4.40.

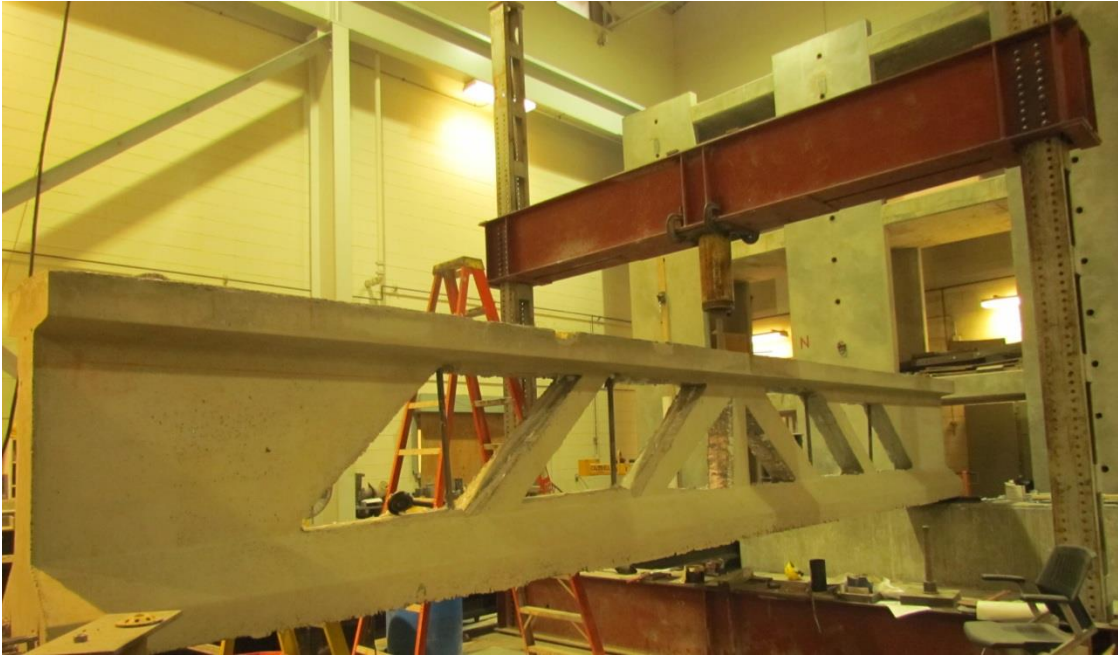
Figure 4.41 The truss testing setup

To properly interpret the test results, the western truss face was painted in white. The paint was very helpful in tracking any cracks that occurred during loading. Strain gages were also attached to the steel rods, the concrete members, and the top and bottom flanges (at the midspan). On one hand, the steel rods were grinded so as to remove the threads and make a smooth surface for the strain gage. On the other hand, the concrete strain gages were all placed on the non-painted side of the truss. In both cases, the strain gages were glued on the steel and concrete using Superglue.

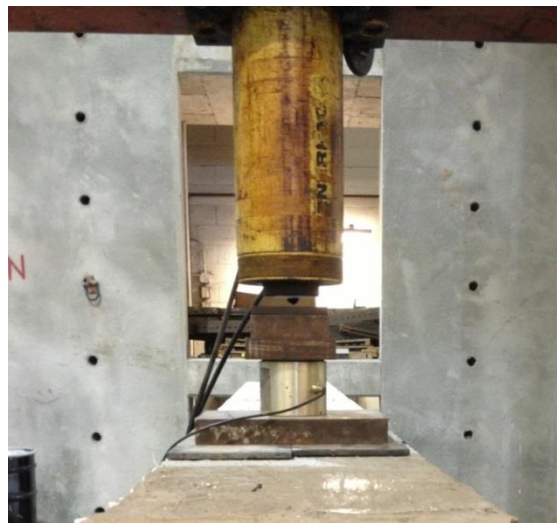
Figure 4.42 The plates' organization and the load cell at the point of loading

A deflection gage was also installed to measure any deflection that occurred during loading. An angle was embedded in the bottom of the truss at the midspan. A fishing line was then connected to the gage. For the loading jack, rubber pads were placed on top of the truss at the midspan to make a smooth surface for a uniform loading. On top of the pad, a 2-in steel plate was placed then a load cell centered on the plate. The loading cell is used to measure the amount of load applied by the jack. Another 3 plates were then placed between the loading jack and the load cell.

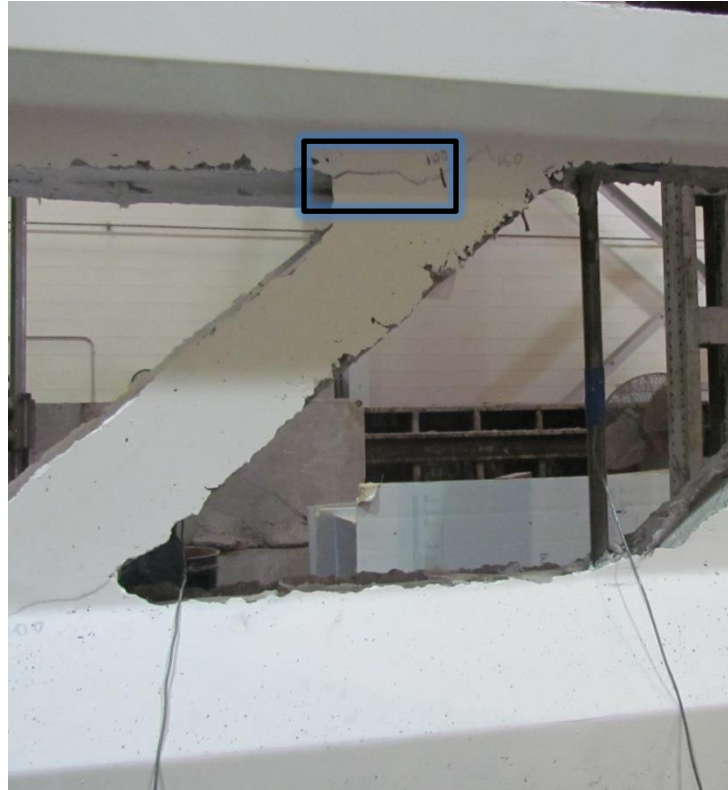
Figure 4.44 The only cracking that occurred at 100 kips of load.

After the first 50 kips, the deflection had reached 0.19 in. There were no cracking at 50 kips loading point. The loading continued till 100 kips at 0.39 in deflection. At 100 kips, cracking started to show at the top of far northern diagonal connection with the top flange at the sharp angle side (Figure 4.44).

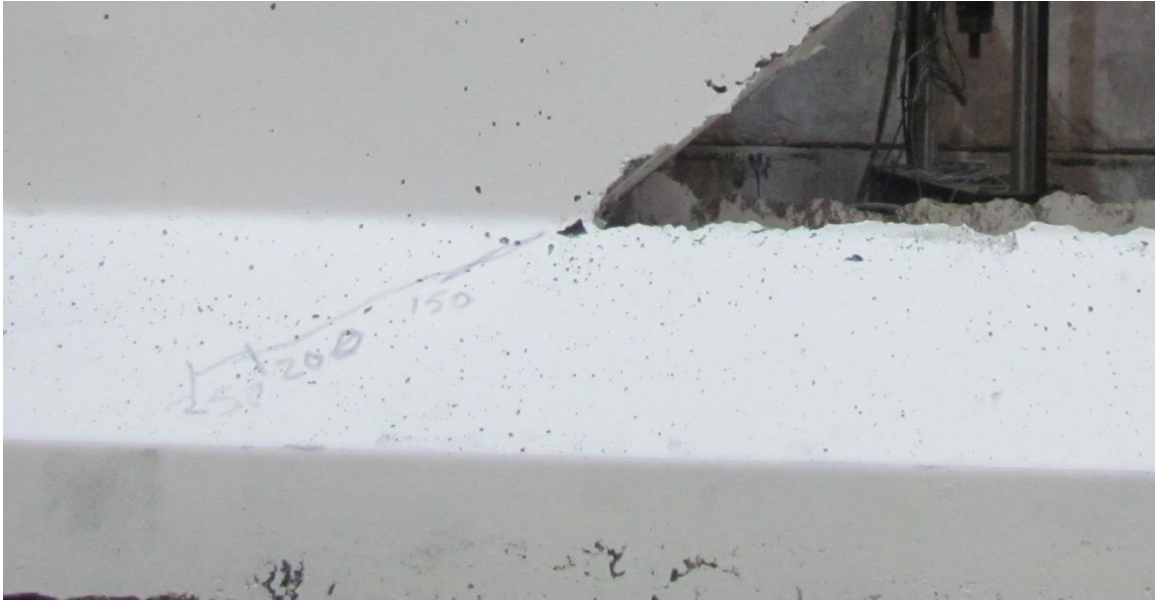
Figure 4.45 Cracking extents vs. loading points for the north diagonal to web connection

At 150 kips, the deflection reached 0.57 in. Cracking at 150 kips started at the connection between the far north diagonal and the web (Figure 4.45). The middle vertical started to crack as well at the top and bottom from both sides (Figure 4.46). At 200 kips the cracking had affected all the sharp angle connections, especially at the web/diagonal interface (Figure 4.47). At 250 kips, most cracking severity did not increase than the 200- kip loading point except at the south diagonal/web joint where cracking increased. Despite the cracking, the deflection at 200 kips and 250 kips was 0.75 in and 0.93 in, respectively.

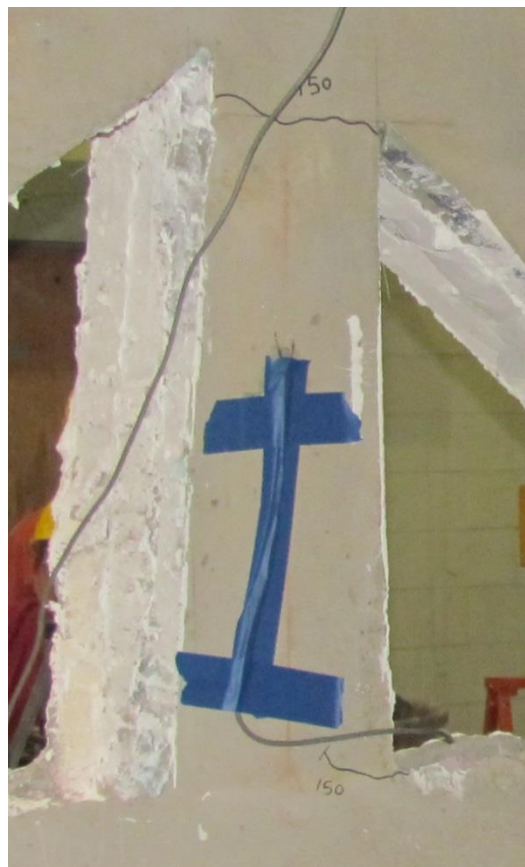
Figure 4.46 The middle vertical cracking at the 150 kip loading point

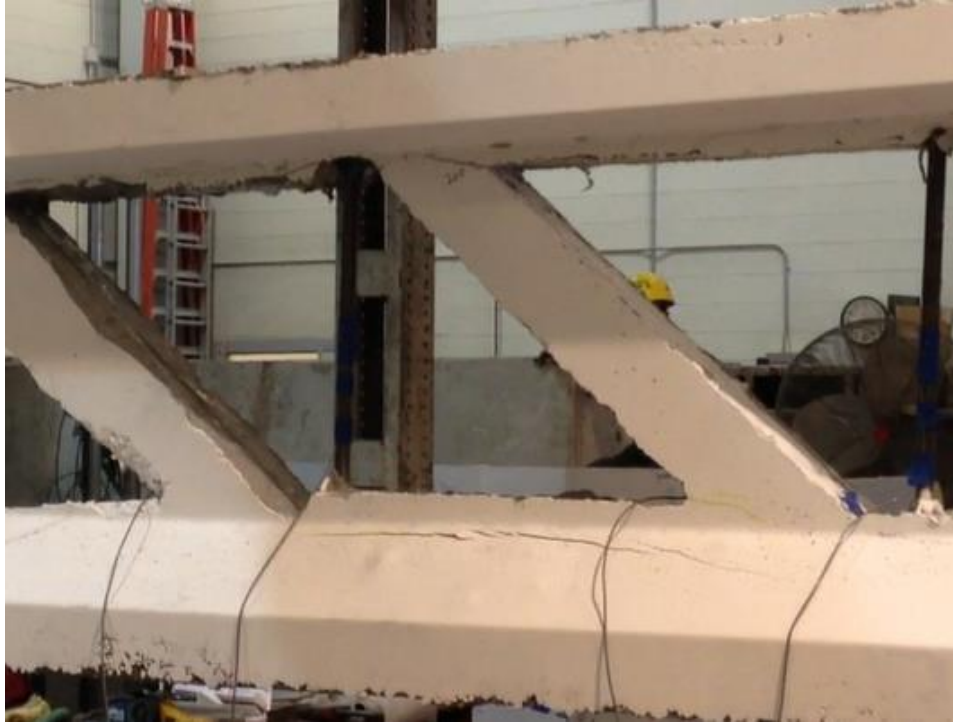
Figure 4.48 Excessive cracking before failure

After the 250-kip cracking investigation point, the load increased uniformly without interruptions with some excessive cracking at locations of the rods embedment in the bottom flange (Figure 4.48) till failure at 385 kips of loading. The failure was rather dramatic; however, it was not sudden as evident cracking was seen before the failure (Figure 4.49). The failure occurred at the far south steel rod where the embedded steel pulled out of the bottom flange and the rod snapped up causing the diagonal to snap with it and the top flange to buckle and fail (Figure 4.50). The failure of embedment occurred as one of the #6 short bars that were welded onto the plate sheared and the other one pulled-out (Figure 4.51).

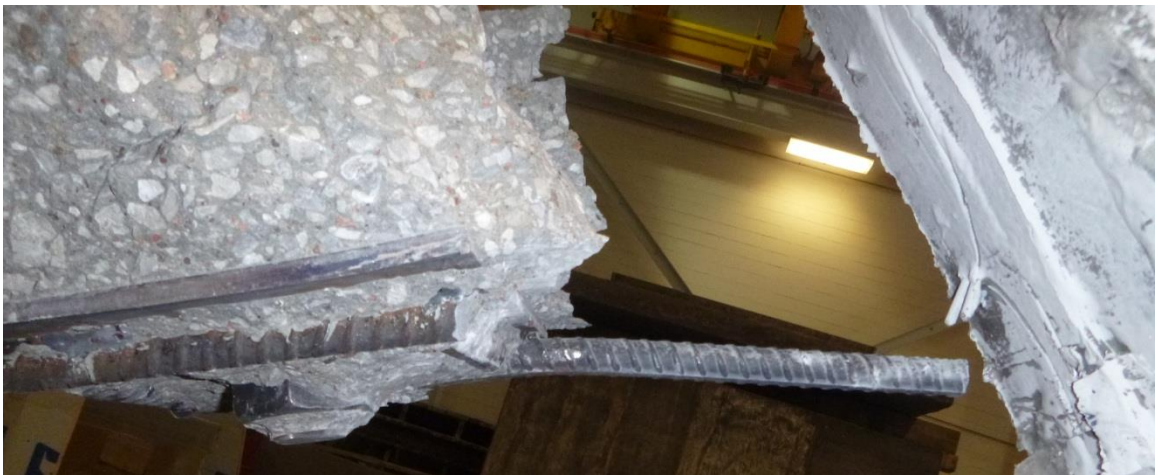
Figure 4.51 The failure of the anchoring bars (one in shear while the other pullout)

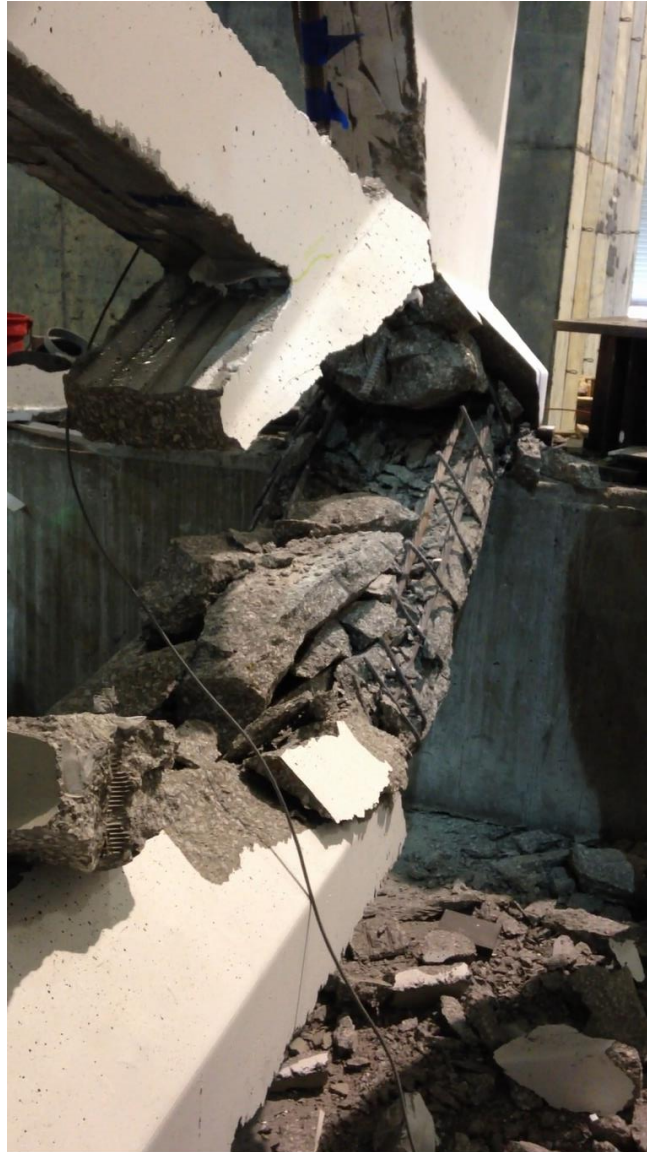
Figure 4.52 Location of failure

The failure is believed to be associated with the fact that the stirrups hats were not placed and the shear reinforcing mesh was not extended all the way to the bottom of the flange to make up for the absence of the hats (Figure 4.52). The hats would have provided more confinement for the concrete, hence, more strength. Despite the fact that the loading did

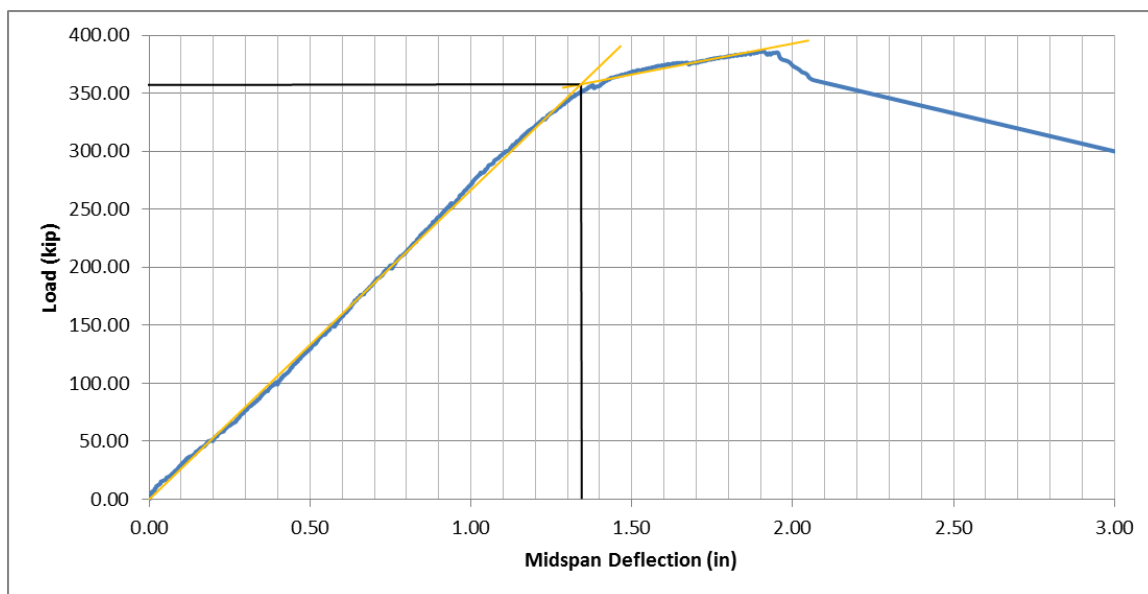
Figure 4.54 Load vs. deflection curve (black lines indicate end of elastic behavior)

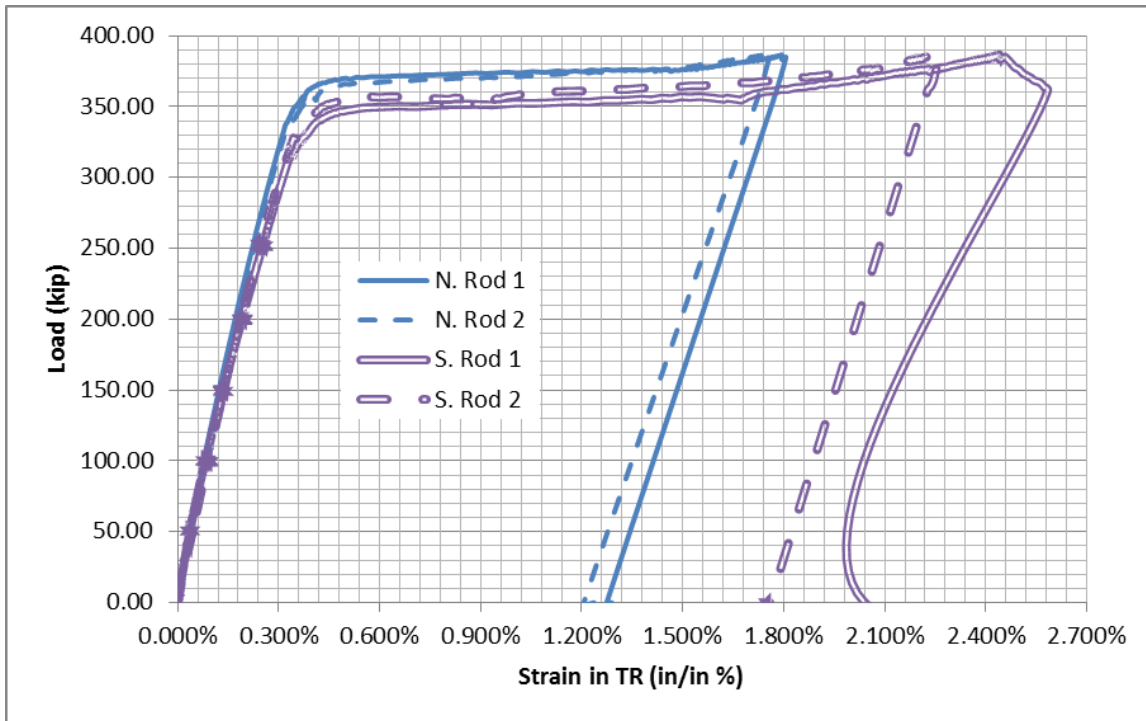
Figure 4.56 Strains in the Threaded Rods (TR) while loading (tension)

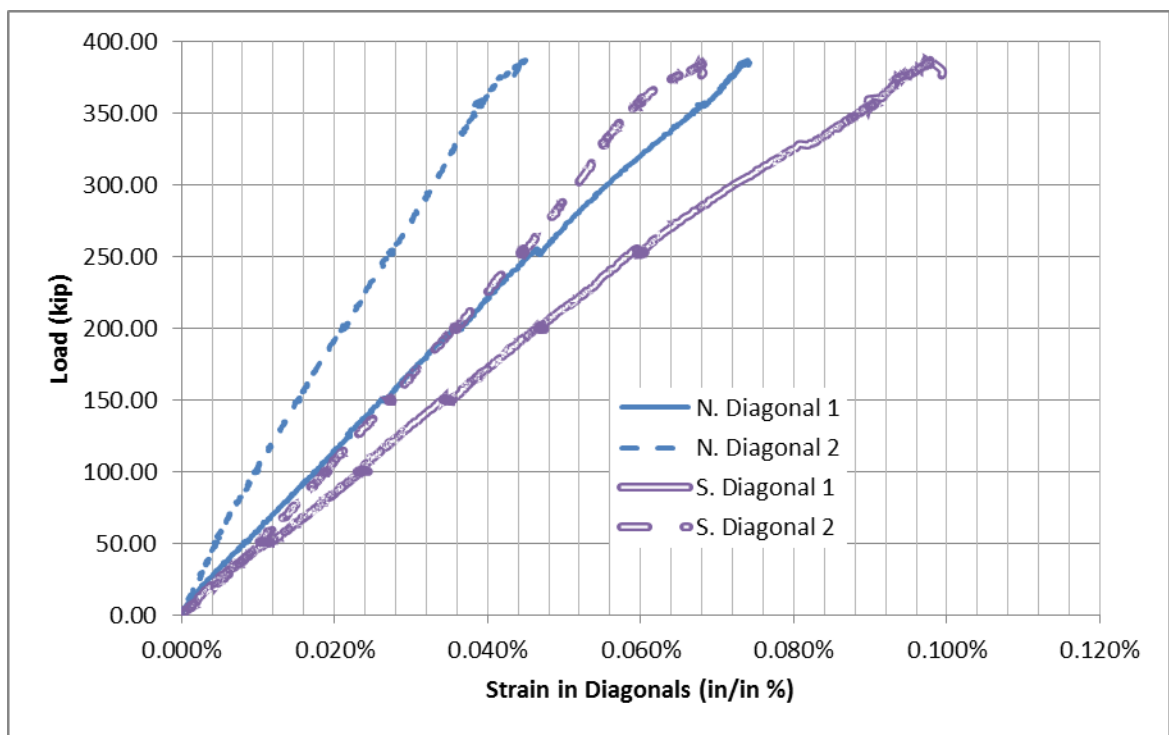
Figure 4.58 Strains in the diagonals while loading (compression)
