Precast/Prestressed Concrete Truss-Girder for Roof Applications

PRECAST PRESTRESSED CONCRETE TRUSS-GIRDER
FOR ROOF APPLICATIONS

A THESIS

Presented to the Faculty of
The Graduate College at the University of Nebraska
In Partial Fulfillment of Requirements
For the Degree of Master of Science

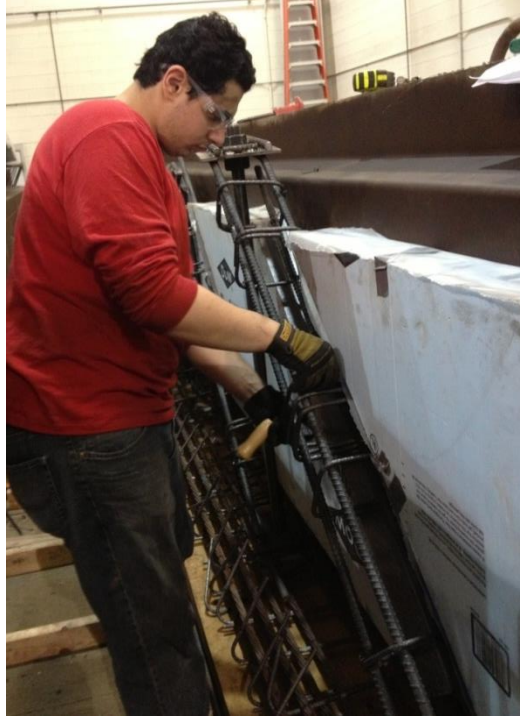
Figure 5.1 Tying the diagonal member reinforcements together after attaching the vertical

The weight of the reinforcing steel is another important issue. Assembling the rebar completely and then attaching it as one piece to the form can be a tedious job. Even if the measurement were done very precisely, the handling of the system can waste time and effort. As an alternative, the diagonals can be tied together while in the form after they have been screwed in with the vertical threaded rods (as shown in Figure 5.1). This practice will allow the diagonals to slide against each other for some tolerances. It is important to coordinate with the designer to achieve the optimum and minimum amount of steel needed for development as this is the best way to achieve maximum efficiency.
