## Precast Concrete Insulated Wall Panel Corbels without Thermal Bridging

**PRECAST CONCRETE INSULATED WALL PANEL CORBELS WITH-  
OUT THERMAL BRIDGING**

A THESIS

Major: Construction

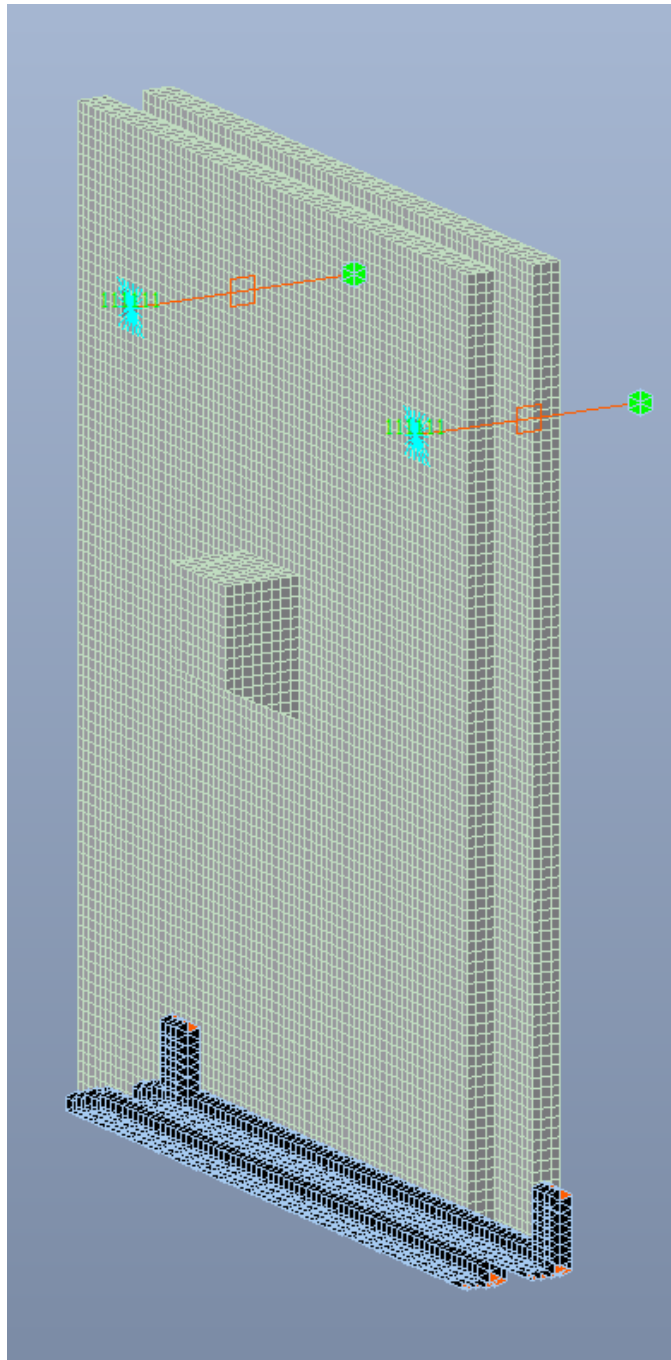
Figure 3-14: FEM Models geometry - 3D View

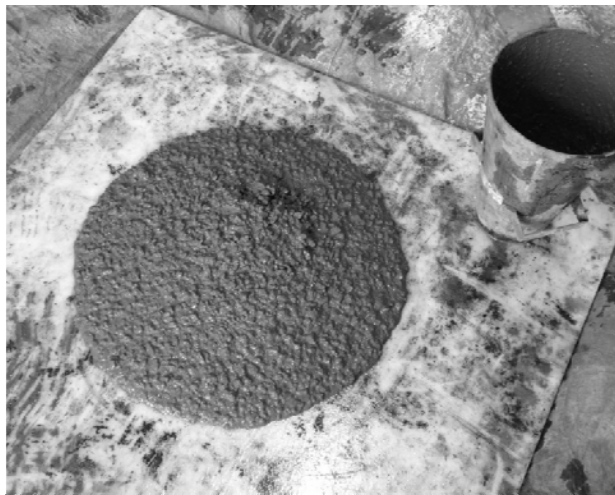
Figure 3-19: SCC Slump-Flow

Self consolidated concrete (SCC) is commonly used in precast construction. SCC offer excellent workability characteristics. The concrete workability is critical property in the concrete used to cast relatively thin elements similar to the insulated wall wythes. Ready-mix supplied SCC was used to cast the specimens of this study to follow the common practice in the industry. Figure 3-19 show the slump flow for the concrete used in specimens A2 and B2.

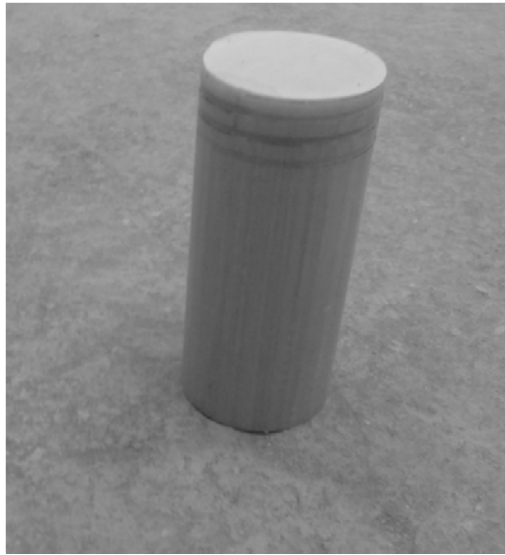
Figure 3-22: GFRP Pin 2" diameter x 4½" long

- GFRP pins used in Set 3 showed great flexibility in fabrication. The pin was placed in hand sawn hole in the insulation board. Refer to Figure 3-22.

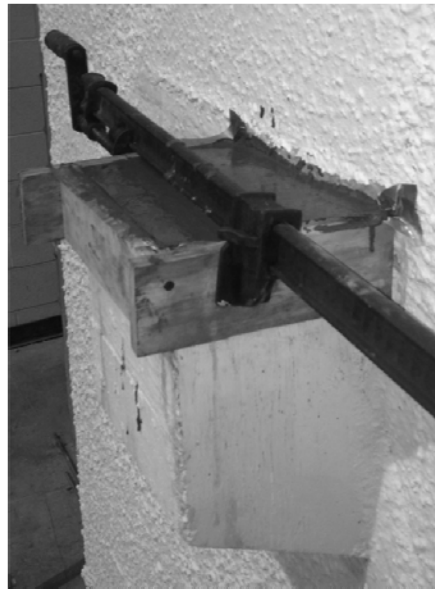
Figure 4-6: Forming of leveling grout pad used for specimens A1, A2 and B1

The placement of the precast-corbel was a challenge. The corbel of GFRP system was not tied to the form during the casting process; this caused the corbel top surface to be unparallel to bottom side (bearing side on ground) of the wall. This issue was solved by providing a grout pad at the corbel top surface.

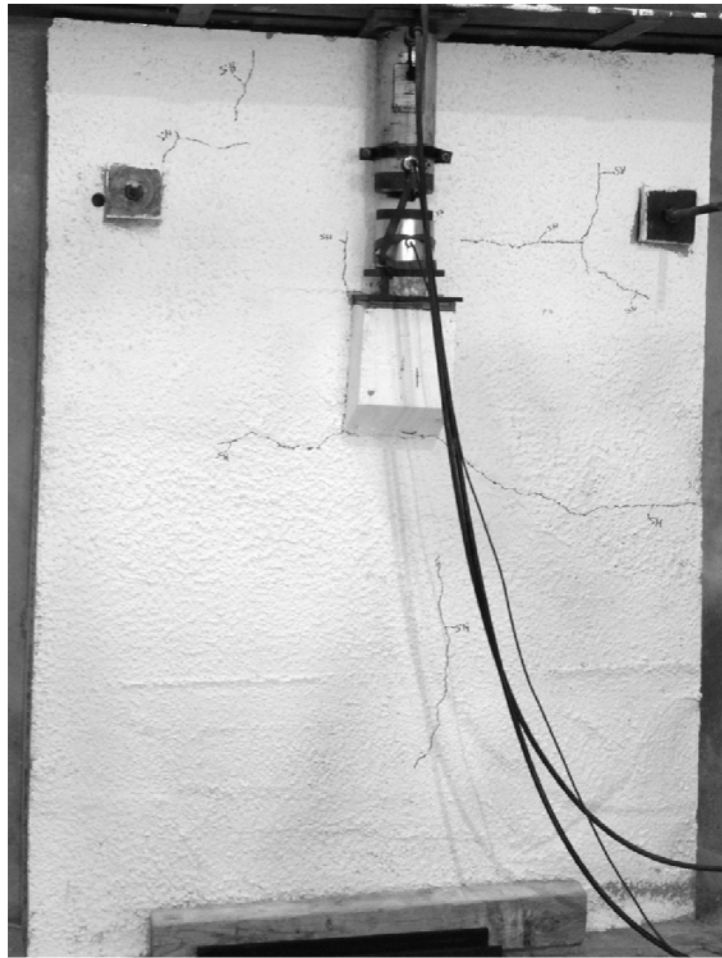
Figure 4-7: Marked plastic shrinkage cracks in specimen A1 prior to loading

Prior to testing, early-age shrinkage cracks were observed in the exposed face of this specimen. Refer to Figure 4-7. These plastic shrinkage cracks originated from the prefabricated corbel location and were directed towards the vertical edges of the wall. These shrinkage cracks were observed only in the top face 2 days after casting. The cracks should be considered as an adverse factor to the capacity of the connection, since these cracks will form a weak plane across the interior wythe.

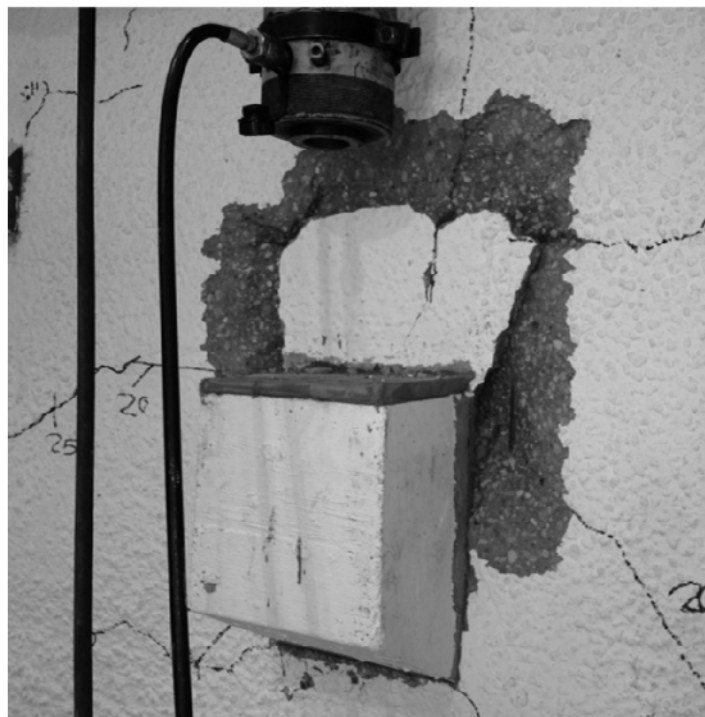
Figure 4-8: Specimen A1 crack pattern at failure

There was neither explosion nor loudly failure just a regular increase in the deflection of corbel. The cracked part was the top part of the wall just above the corbel, around 10 inches vertically from top of corbel by 16 inch horizontally almost symmetrical about the corbel center line. After the loading was completed, the cracked part was taken-off to observe the cause of failure. The observations were that the 2 ties in corbel were intact and the anchorage bar was bent outwards. One bar only was obviously bent and the other bar was not clear. There was no sign of slippage of any rebars. Refer to Figure 4-8, Figure 4-9 and Figure 4-19.

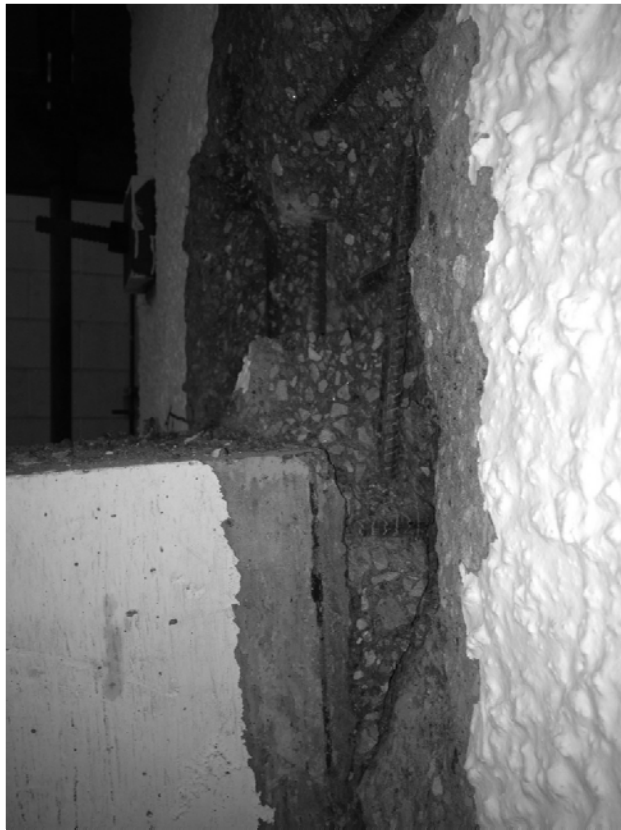
Figure 4-9: Cause of failure for specimen A1, concrete breakout

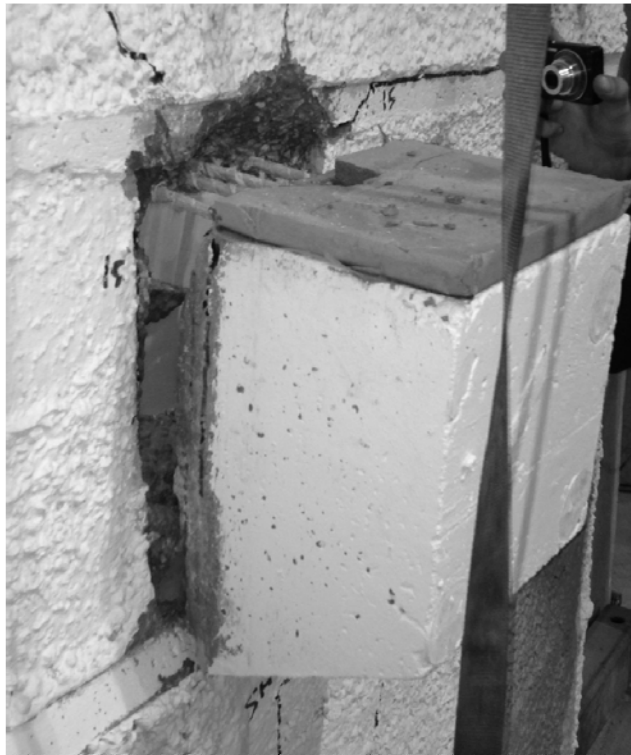
Figure 4-11: Failure of specimen B1

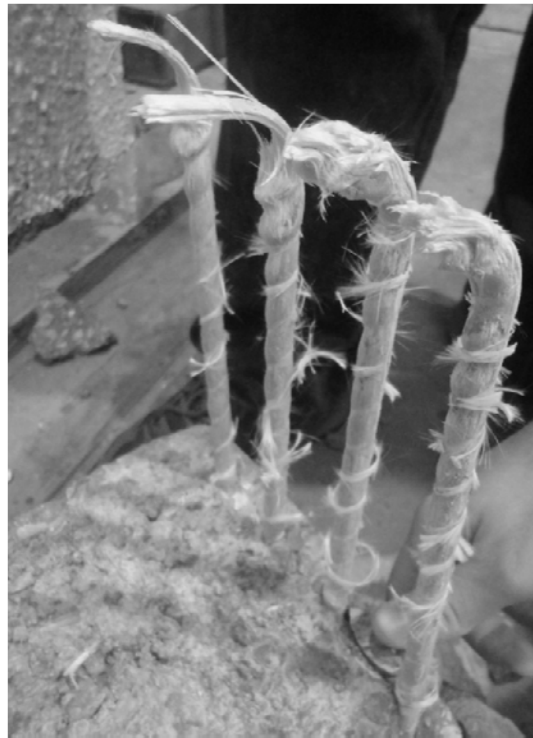
Figure 4-12: Ruptured GFRP Bars in specimen B1

The prefabricated corbel could be easily separated from wall panel after loading was stopped after failure. The failure is caused by the rupture of the GFRP bars in the proximity of the bend location; this can be seen obviously in Figure 4-12. After the corbel was disengaged from the wall, it was noticeable that concrete of exterior wythe did not flow freely behind the corbel. The concrete flew behind the corbel approximately 3in. measured from the corbel faces, except that the bottom face where concrete flew 4 inch. The casting of the exterior wythe started from the bottom edge (bearing side) and then continued towards the top edge. This casting direction gave the bottom part of the corbel advantage to allow concrete flow. In the following specimens, special care was taken for the concrete flow behind the prefabricated corbel. Refer to Figure 4-22.

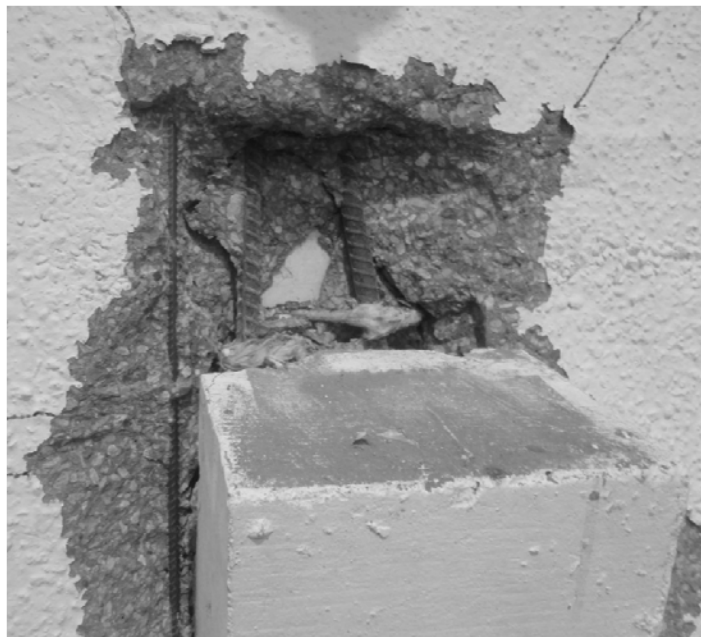
Figure 4-14: Ruptured NU-Ties in specimen A2

The first crack was observed at an applied load of 30kip. The failure load for this specimen was 74.8kip. Similar to set 1 specimens no cracks were observed on the back wythe. The first crack was a 45 deg crack near the top of the corbel; At applied load close to failure load, new cracks started to appear close the bottom of the corbel at 45 deg. The cracks started to get longer till it reached the edge of the wall in a manner similar to specimen A1 and B1. The failure occurred with 2 in. deflection of the corbel at the tip. Refer to Figure 4-13, Figure 4-14 and Figure 4-20. Since the wall panel bottom side was not grouted for this specimen, more noise was heard during the test. The cause of failure was the rupture of NU-Ties.

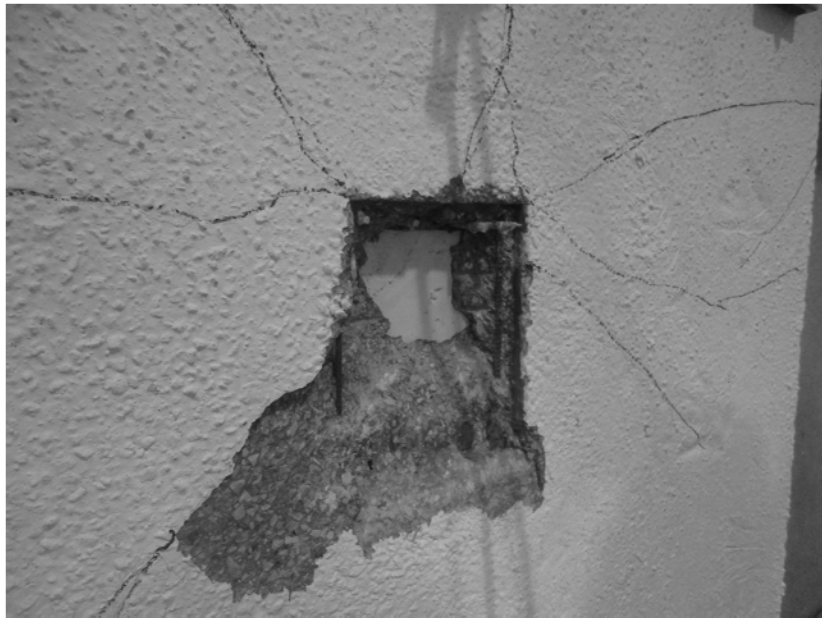
Figure 4-15: Marked Cracks at failure and failure mode of specimen B2

The failure cause was the concrete shear break-out, this can be seen in Figure 4-15, Figure 4-16 and Figure 4-23.

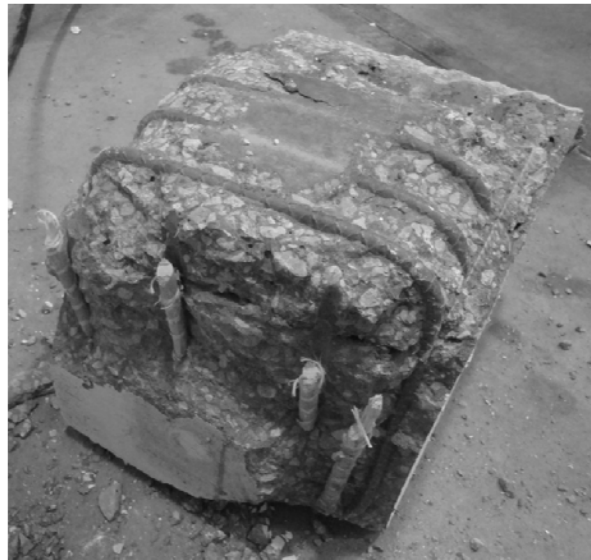
Figure 4-16: Corbel block on ground after cutting the GFRP bars - specimen B2

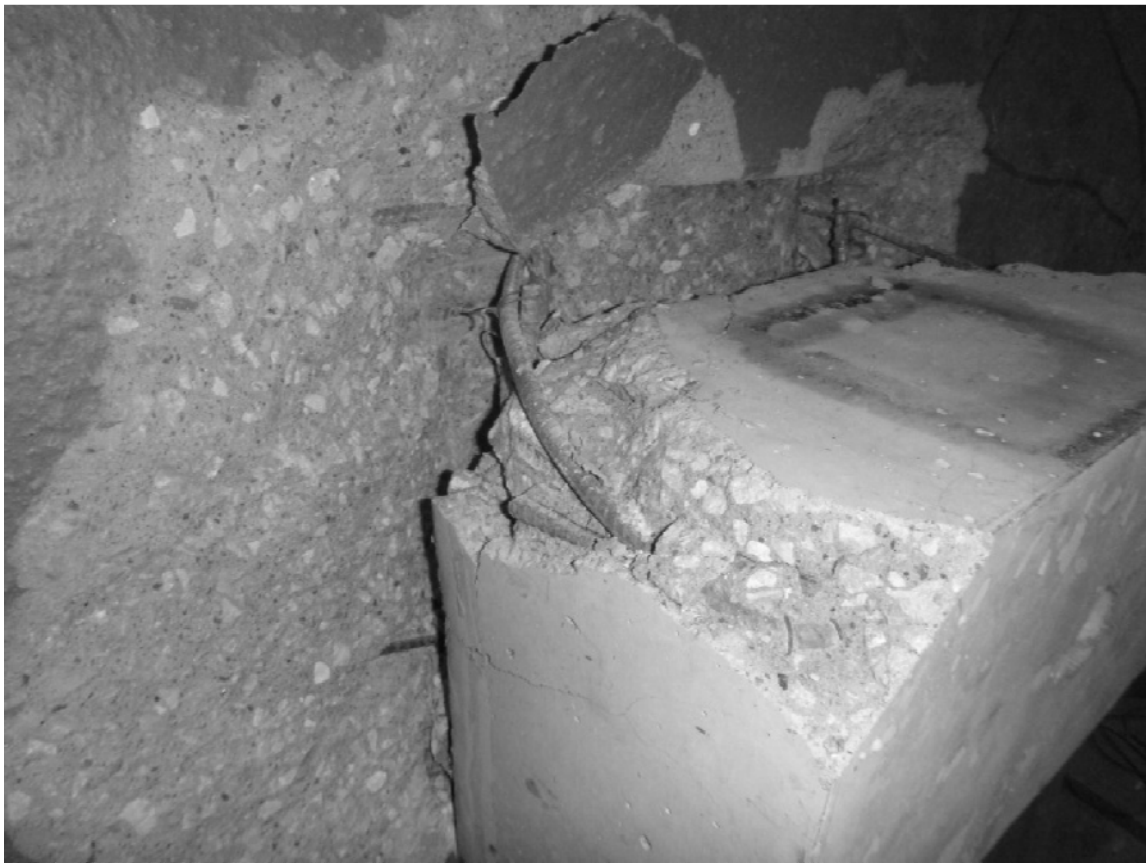
Figure 4-18: Bent stirrups followed by concrete breakout in specimen A5

There was neither explosion nor loudly failure just a regular increase in the deflection of corbel. The cracked part was the top part of the wall just above the corbel, around 2 inch vertically from top of corbel had sloped crack surface (Break-out failure). After the loading was completed, the cracked part was taken-off to observe the cause of failure. The observations were that the 2 ties in corbel were bent just beyond the #5 anchorage bars. There was no sign of slippage of any rebars. Refer to Figure 4-17, Figure 4-18 and Figure 4-27.

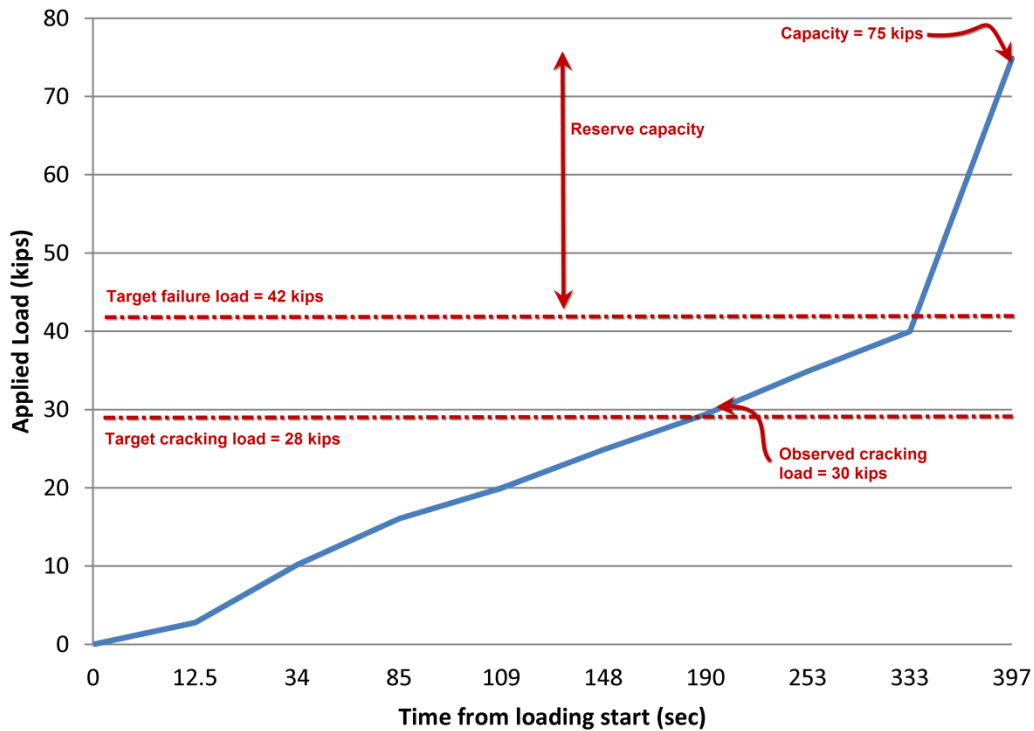
Figure 4-24: Loading and results of specimen A2

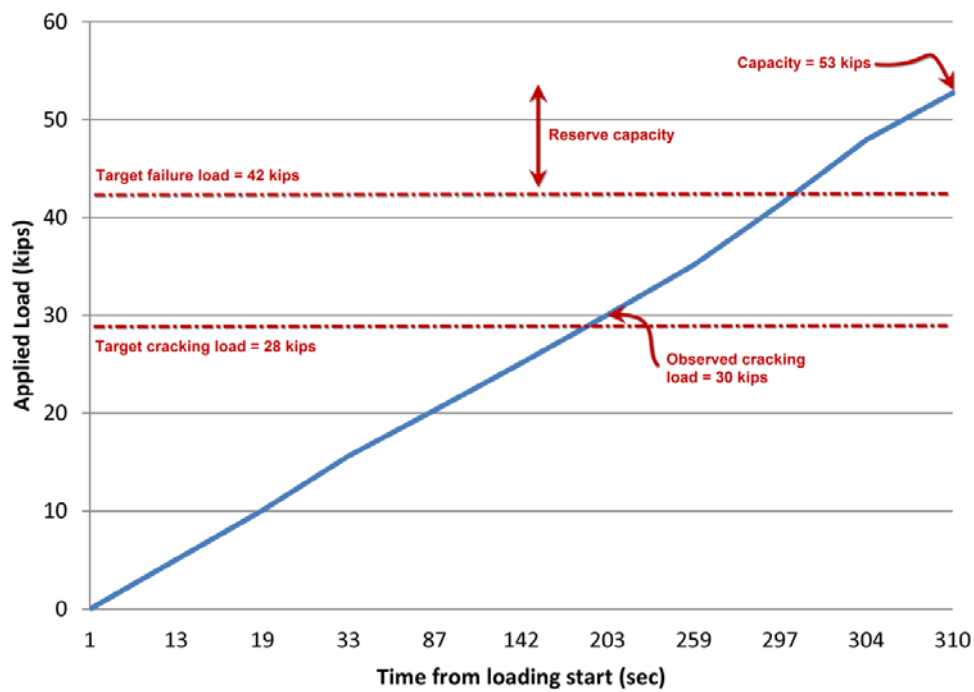
Figure 4-28: Loading and results of specimen A3

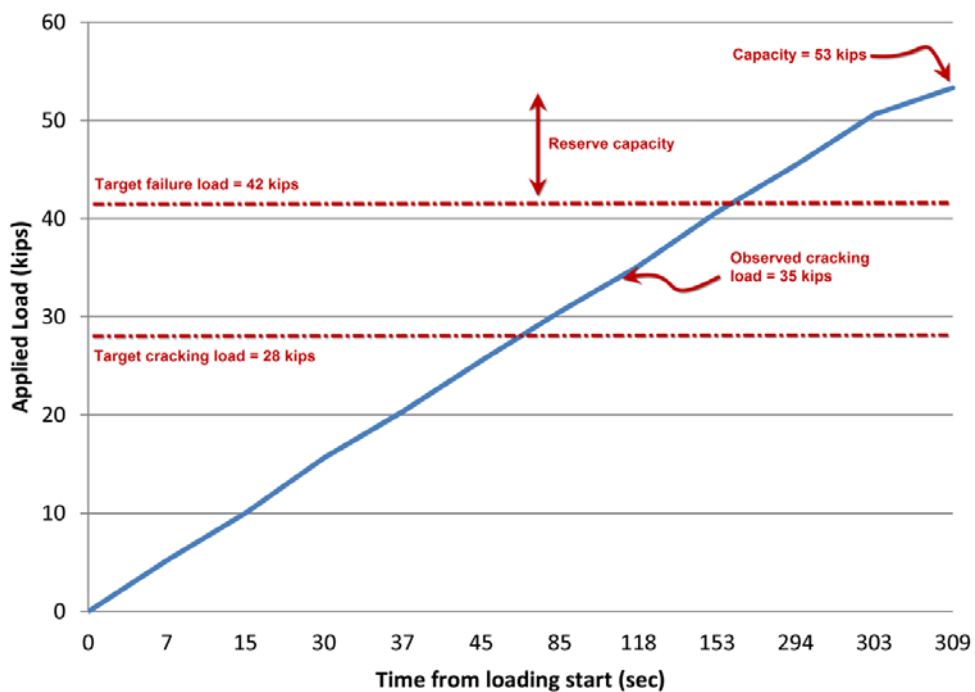
Figure 4-29: Loading and results of specimen A4

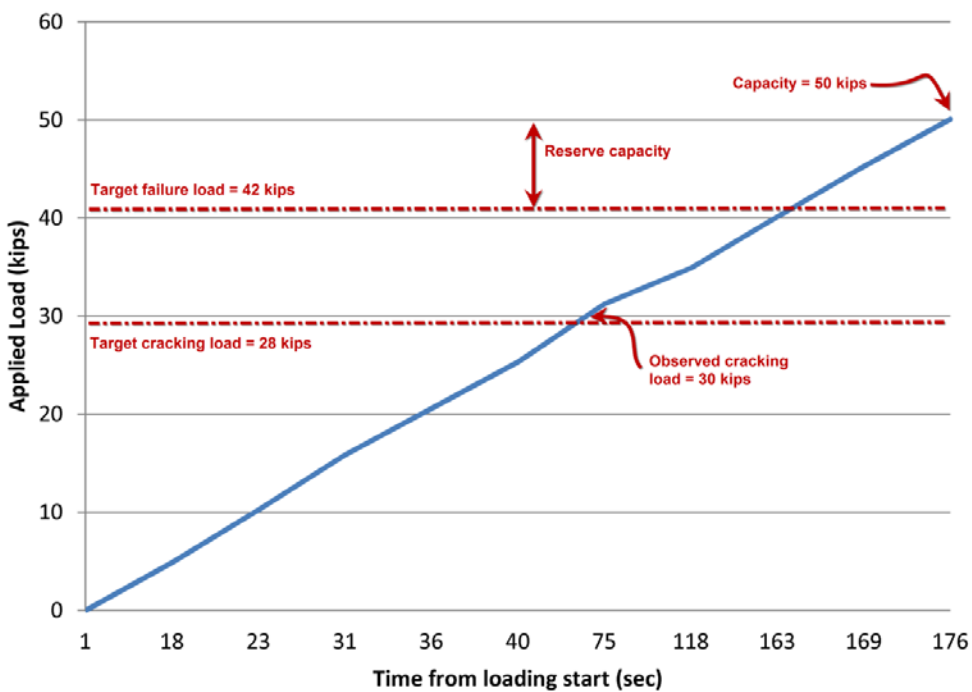
Figure 4-30: Loading and results of specimen A5
