External characteristics of houses prone to woodpecker damage

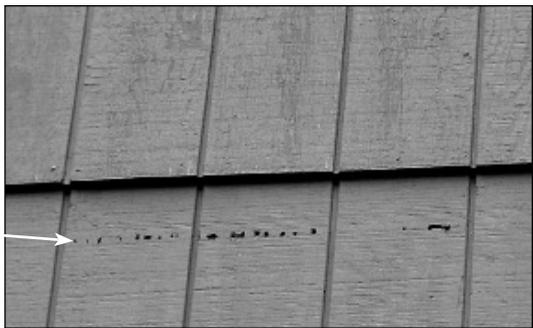
Figure 4. Examples of woodpecker damage to houses near Ithaca, New York, April 2001 to March 2002: (a) horizontal rows of foraging holes following core gaps in grooved plywood siding, (b) foraging damage on stained cedar shakes, (c) damage caused by foraging for carpenter bee larvae on fascia boards of a house, and (d) roosting or nesting holes in board-and-batten siding.

Effects of siding type on the form of damage. Siding types differed in their susceptibility to the 3 kinds of woodpecker damage (Table 3). In 28% of the houses with damage, woodpeckers had carried out some type of foraging behavior. Grooved plywood was the siding type most susceptible to foraging damage, which often took the form of small holes in horizontal lines (Figure 4a). Our observations indicated that woodpeckers were feeding on insects living in the siding. When the vertical grooves were cut into the upper layers of the plywood to create the board-and-batten look, core gaps in the middle layers were exposed. These narrow tunnels provide an attractive, egg-laying and over-wintering site for insects. We removed the insects and insect casings from the core gaps of 14 houses with grooved plywood siding and sent them to the Cornell University Entomology Lab for identification. We found larval casings of grass bagworms (*Psyche casta*) in 13 (93%) of

these samples, and larval casings of leafcutter bees (*Magachile* spp.) in 8 (57%). We also found sunflower seeds, most likely cached by black-capped chickadees (*Parus atricapillus*), as well as katydids (*Tettigoniidae*) and other unidentifiable matter in core gaps. Woodpeckers were clearly able to detect the insects hidden in core gaps, and they bored a series of holes into the wood to reach them.
