**Report to DOT/PHMSA Steering Committee on
Collaborative Demonstration of Guided Wave Ultrasonics
NYSEARCH**

Controlled Tests & Data Analyses

By
Daphne D'Zurko
Executive Director, NYSEARCH
Version for Public Release
April 2007

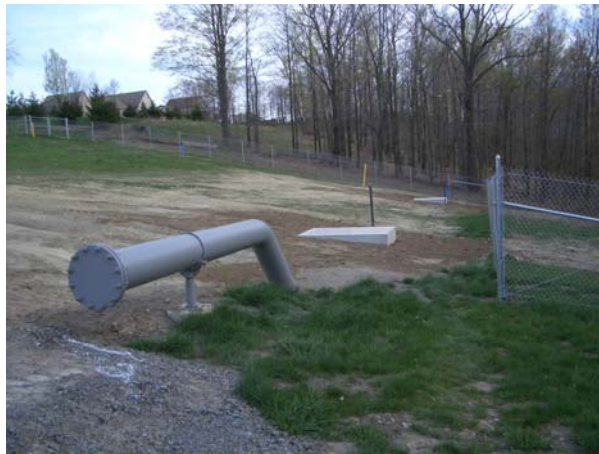
It is worthy of note that two of the three 100' cased pipe sections are above-ground sections. The third is a 12" carrier pipe in a 16" casing in an underground network. In the 12" carrier pipe case, the vendors were notified that the guided wave transducer belt could be applied above-ground near the access point but between two 45-degree bends OR at the same level as the overall cased pipe section because of underground excavation vaults that had been constructed on both the North and South ends of the 12" cased pipe for the purpose of integrity inspection tests. Figure 1 illustrated both access points; in the foreground is the above-ground access point to the 12" pipe and in the background is one of the two underground vaults for direct straight-pipe access.

Figure 1. Access points for 12" Cased Pipe

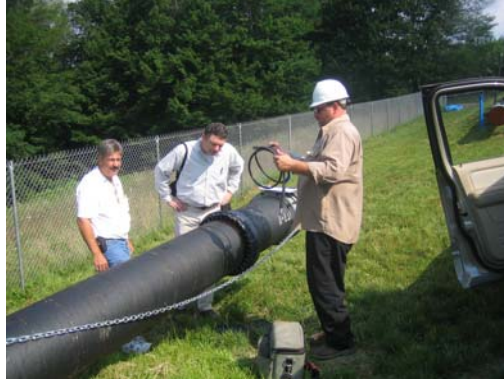
Figure 2 DOT and Industry Reps observe Application of transducer belt on 16" pipe

The tables below summarize the results from the findings of the tests performed on July 17 – 18. For illustration on one such test, see Figure 2. The detailed summaries, spreadsheets and layout drawings were provided to the Steering Committee as Confidential documents. The technology providers were also provided detailed results but the exact locations and sizes of defects that are present at the NYSEARCH/NGA test bed have not been provided to the vendors or any party who did not sign the NDA.
