A COMPARISON BETWEEN ULTRASONIC GUIDED WAVE LEAKAGE
AND HALF-CELL POTENTIAL METHODS IN DETECTION OF CORROSION IN
REINFORCED CONCRETE DECKS

Ahmad Shoaib Amiri

A THESIS

For the Degree of Master of Science

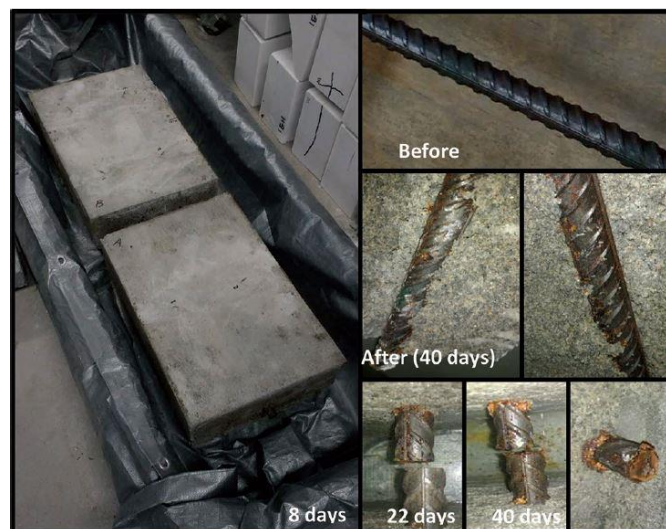
Figure 2.12 – Corrosion specimens (Eric Garcia et al., 2019)

capable of detecting the onset of various flaws in RC structures such as bridge decks. It was successfully demonstrated that this newly-developed method has the ability to identify the onset of delamination with widths as small as 0.2 mm (0.008 inches). In this method, the steel bar is used as a waveguide, and the energy is transmitted by a sensor attached to the rebar, and received by a sensor placed on desired locations on the test specimens. The study done by Garcia et al. (2019) demonstrated that the amplitude of leaked waves that radiates from the steel bar waveguide is sensitive to corrosion initiation and cracks. In their research, two different sets of RC specimens were cast for the assessment of corrosion and cracking. The first set of concrete specimens that measured 45.7 x 30.5 x 12.7 cm (18 x 12 x 5 in.) were cast with 5% NaCl solution to accelerate corrosion as shown in Figure 2.12. A #5 rebar was embedded at the center level, placed 6.3 cm (2.5 in.) from the top surface of concrete. These specimens were also submerged in the water to a depth just below the rebar. Measurements for corrosion monitoring were taken over a period of 40 days, and data was collected every 2 days. Measurements of the leaked energy using receivers on the concrete surface successfully identified the onset of various flaws such as corrosion, delamination, and cracking (Garcia et al., 2019).

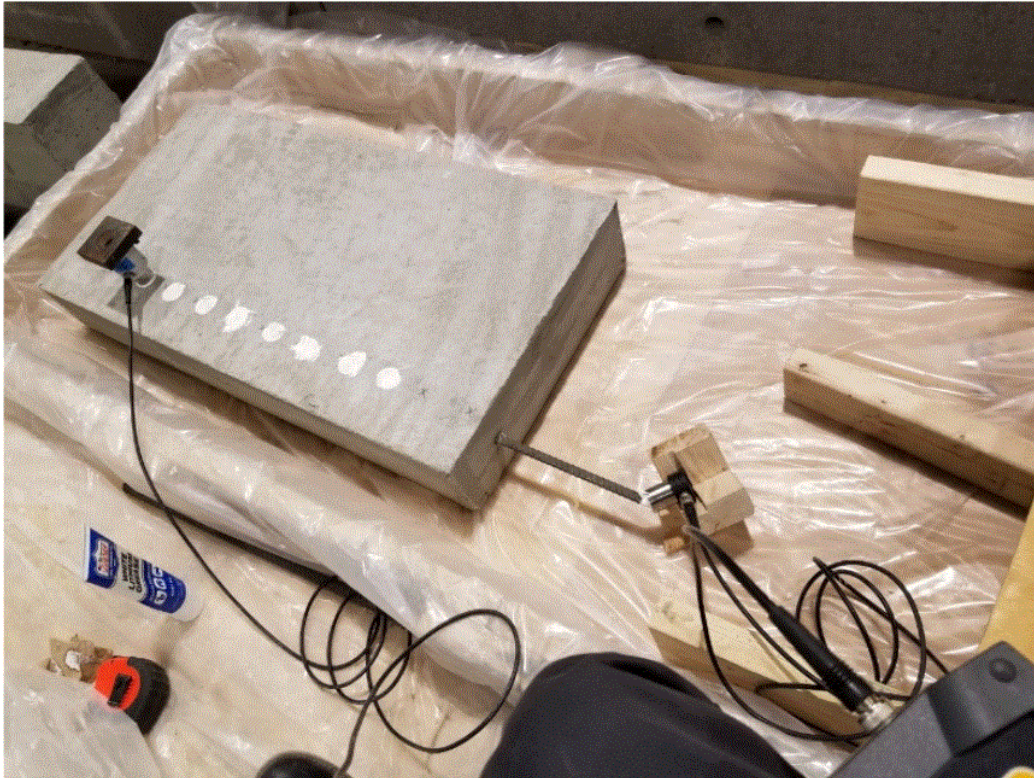
Figure 2.14 – UGWL test set-up (Erdogmus et al., 2020)

15 cm (6 in.) along the steel bar is recommended. Figure 2.14 shows the UGWL test set-up that was used by the Erdogmus et al. (2020), in which a transmitter is attached to one end of the rebar, and the leaked ultrasonic energy was recorded using an array of receiver on the surface of the concrete along the rebar.

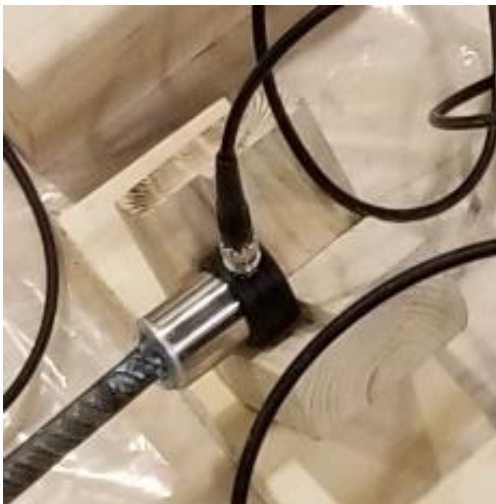
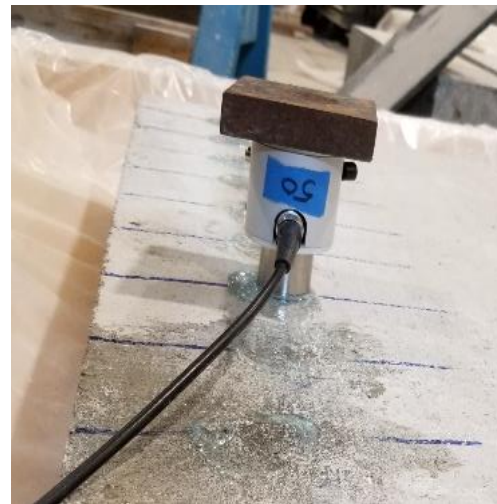
In order to collect data, the transmitter and receiver were attached onto the rebar and concrete, respectively, using a couplant. While the transmitter was coupled onto the steel throughout the testing period [see Figure 3.2 (a)], the receiver was moved to monitor several equally spaced spots on the surface of the reinforced concrete specimen as shown in Figure 3.2 (b). The desired locations on the surface of the concrete were marked to locate the receiver on the same position in each testing period.

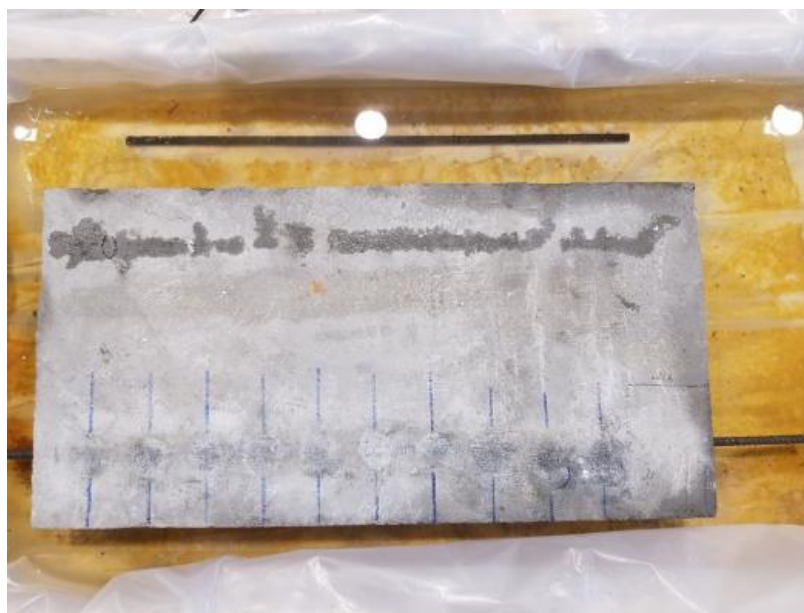
Figure 3.6 – Test specimen submerged inside 10% NaCl solution

Testified by these precedent in the literature, in this research, the concrete slabs were immersed in 10% NaCl solution. A No. 4 rebar was also immersed beside one of the test specimens to undergo corrosion as shown in Figure 3.6. Small plastic shims were placed beneath the concrete slabs to allow for the passage of NaCl solution under these specimens. A piece of lumber was placed inside the formwork to act as a water barrier to restrict the flow of NaCl to a smaller part in the formwork. During each testing period, this piece of wood was taken out so that the water level is dropped, allowing for the transmitter to be attached and coupled to the end of the rebar.

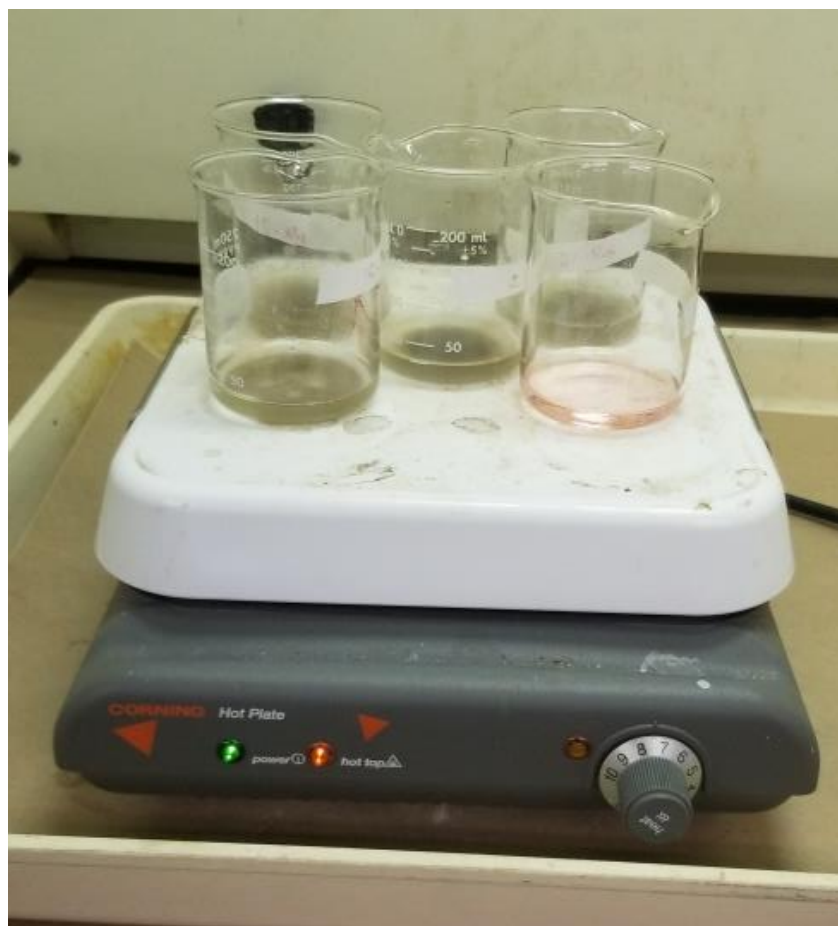
Figure 3.10 – Concrete samples on the heat plate

The concrete samples were then passed through No. 20 sieve (850 μm) as recommended by the ASTM C1152 that provides guidance on acid-soluble test to determine chloride content. After the sieving was done, the samples were mixed properly to get homogenized. To run the analysis, approximately 2 gm of each sample was taken and mixed with 5 mL of nitric acid, as well as Methyl Orange Indicator inside beakers. After observing a pink color for the samples, the samples were kept on a heat plate until the samples start boiling, as shown in Figure 3.10.

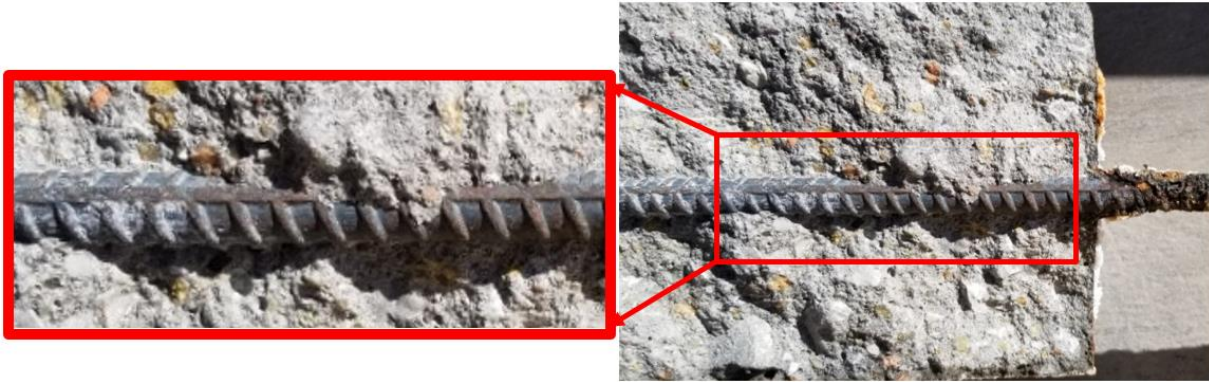
Figure 12 – Corrosion on the rebar embedded in 33-degree specimen

the 33-degree specimen. Figure 12 shows the rust formation on the rebar that was embedded in 33-degree specimen.
