**QUALITY CONTROL IN CONCRETE PAVEMENT:  
EARLY DETECTION OF NEAR-SURFACE  
HONEYCOMBING WITH GPR**

**A THESIS**

**Presented to the Faculty of  
The Graduate College at the University of Nebraska  
In Partial Fulfillment of Requirements  
For the Degree of Master of Science**

**Lincoln, Nebraska  
December 2020**

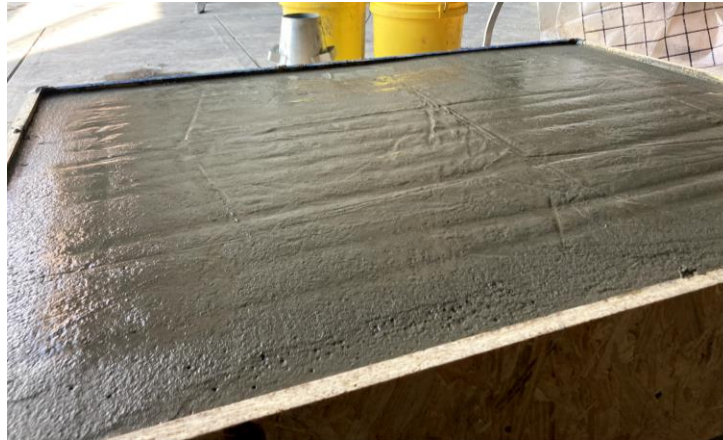
**Figure 26:** Slab 3 - Marked Slab Surface

However, the screws on the corners and the plywood itself repeatedly sunk into the slab's surface during the first 4.5 hours after casting, which destabilized the scanning surface and caused cosmetic damage. As this was most likely a result of the mix's high slump, the plastic stencil was used for the full 24 hours for scanning to circumvent this problem.

Even while delaying scanning to 1.5 hours after casting, the slab was not fully hardened, and as a result, the handheld cart and plastic sheet left marks on the top surface of the slab. The extent of this is due to the high slump of this specific specimen, so another specimen with lower slump (such as less than 4" (10.16 cm)) would not exhibit the same surface deterioration and the elevated stencil could be used without issue. The marks and indentations caused by the GPR handheld cart and plastic scanning sheet can be seen in Figure 26.
