Expedient airfield runway repair using folded fiberglass mat

Christopher Y. Tuan¹ and William C. Dass²

Abstract

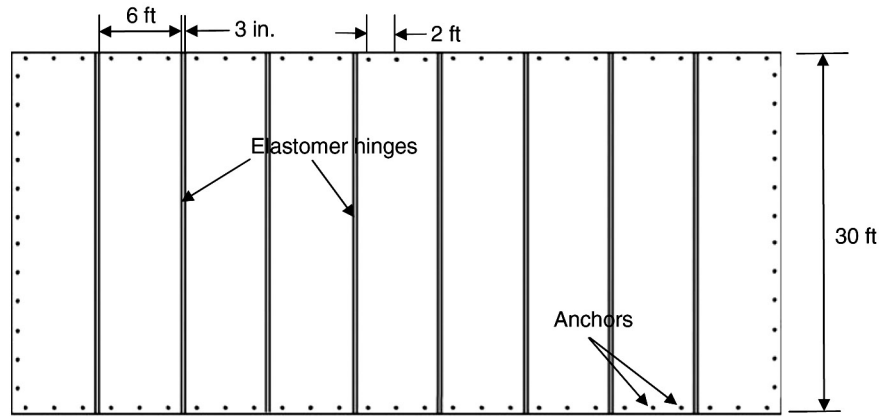
Figure 1. Typical layout of an FFM.

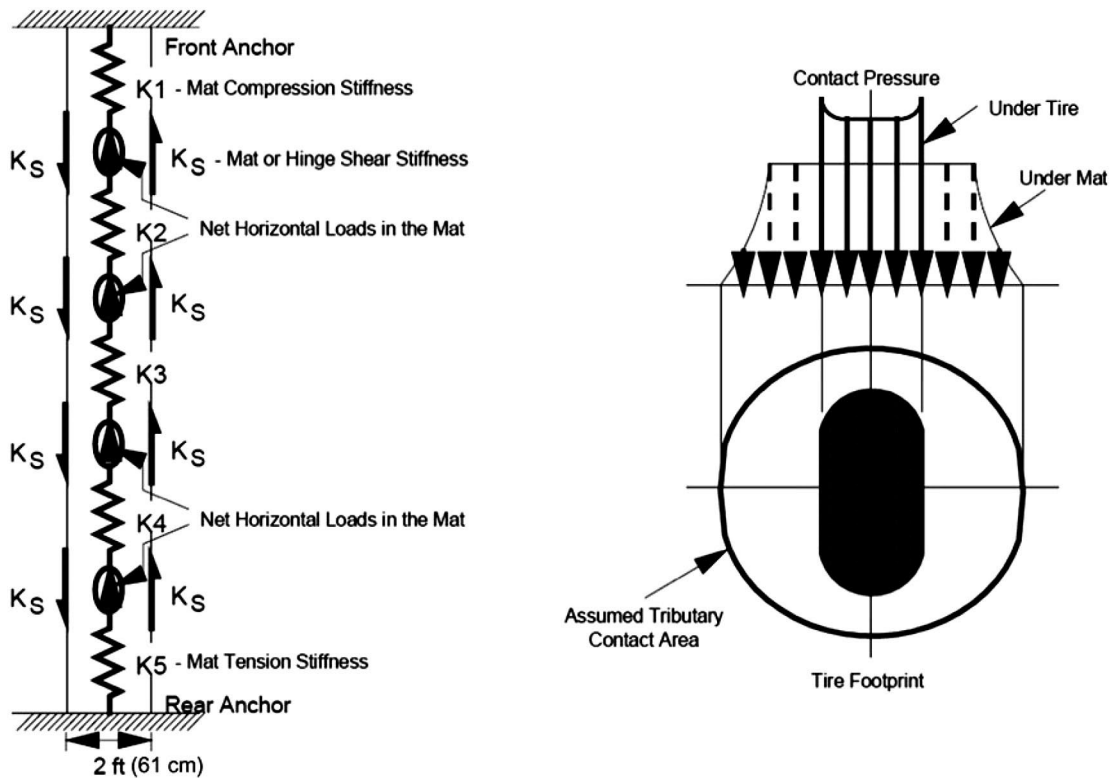
Figure 2. A lumped-parameter model for anchor load analysis.

The model, using a lumped-parameter approach (i.e. a spring-mass system), is illustrated in Figure 2. The fiberglass mat is divided into 27 61-cm (2-ft) wide, 9-m (30-ft) long strips, with four potential tire contact (or wheel load) locations on each strip. A linear spring at each end of the strip is used to model the anchor stiffness. Horizontal braking forces are applied at the appropriate wheel locations. These horizontal forces represent the net frictional forces applied on the mat, which is the tire/mat friction minus the mat/pavement friction. The horizontal forces are resisted by the shear forces in the fiberglass mat panels and elastomer hinges, the compressive forces in front of the tires and the tensile forces behind the tires in the plane of the mat. The mat-compressive stiffness is greatly reduced when the mat buckles in front of the tires. A system of 54 simultaneous algebraic equations, based on force equilibrium, was established to solve for the unknown front and rear anchor loads. This simple model has the flexibility to accommodate the footprint of any aircraft of interest and has proven to be very useful for quickly evaluating the effects of varying aircraft type, location and other important parameters.

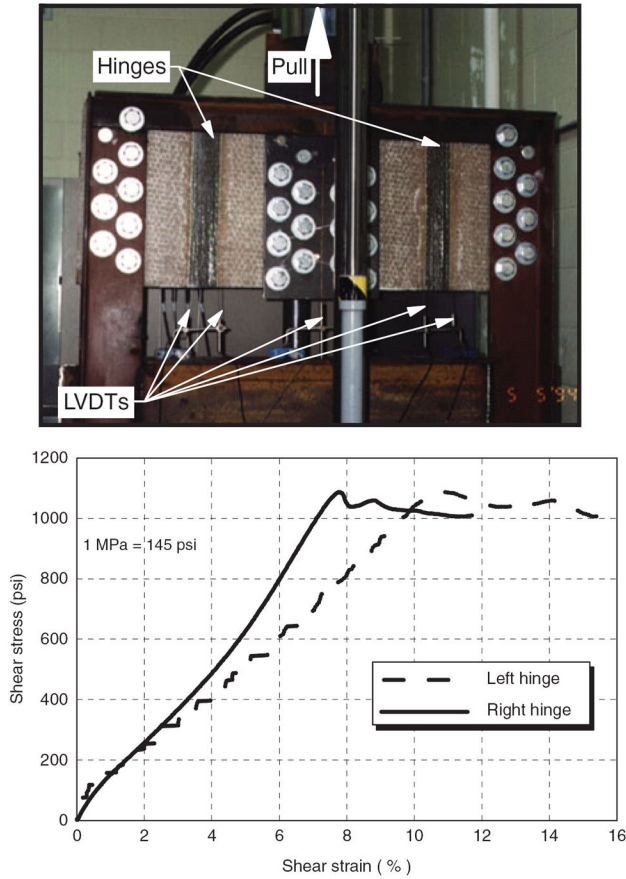
Figure 4. Direct shear test on elastomer hinges.

calculated from the resulting stress–strain curves was about 7 GPa (1,000,000 psi), which compares reasonably well with the 10 GPa (1,450,000 psi) value previously reported by Law Engineering (1988). A Poisson’s ratio of 0.426 was also reported by Law Engineering (1988) for the fiberglass mat. Even though the fiberglass mat may exhibit orthotropic material response, it is sufficiently accurate to assume linearly elastic behavior in the direction parallel to the hinges. In addition, a special test was conducted to determine the stiffness and the strength parameters of the elastomer hinges under shear. The set-up of this hinge shear test is illustrated in Figure 4. The hinges are approximately 8 cm (3 in) wide. Linear variable displacement transducers (LVDTs) were used to determine the relative displacements between the two edges of each hinge while the center fiberglass mat piece was pulled upward. The shear stiffness of the hinge was calculated directly from the linear portion of the load–displacement data to be about 1146 kN/m (6540 lbs/in). Average shear stress was determined by dividing half the applied load by the nominal hinge cross-sectional area, while the average shearing strain was determined by dividing the relative displacements by the width of the hinge. This shear stress–strain relation of the hinge material is presented in Figure 4.

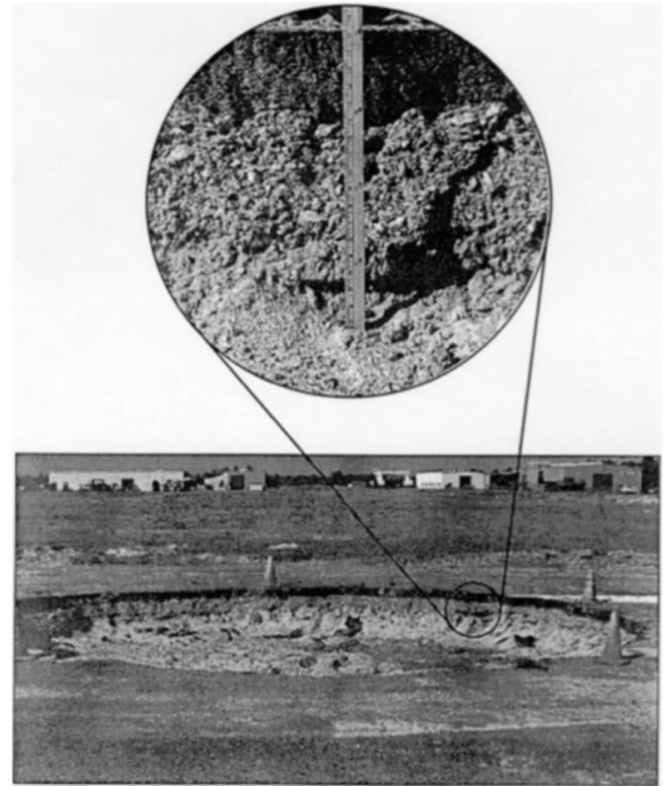
Figure 5. A 7.6-m diameter, 457-mm deep artificial crater in asphalt test pad.

Between fiberglass mat and asphalt pavement. An asphalt pavement test site located at Tyndall Air Force Base, Florida, USA, was selected for field tests. As shown in Figure 5, excavation of the test site revealed that the pavement consisted of a 107-mm (4.2-in) dense-graded asphalt surface layer over an oyster shell base course approximately 267mm (10.5 in) thick. The subgrade was free-draining beach sand with a fluctuating water table.

Between fiberglass mat and repaired crater. The asphalt test site was excavated to create a 7.6-m (25-ft) diameter, 457-mm (18-in) deep artificial crater and repaired according to standard procedures using a well-graded aggregate mix per ASTM D2940. The granular base material was well compacted by a road construction roller until the top of the repair was flush with the asphalt pavement. The 89,800-kg (198,000-lb) C-5 load cart was placed on an unanchored fiberglass mat over the repaired crater. Three static pull tests were conducted to determine the coefficient of friction between the fiberglass mat and the repaired crater. The peak forces measured when the unanchored mat slipped abruptly over the repaired crater are given in Table 2. It was

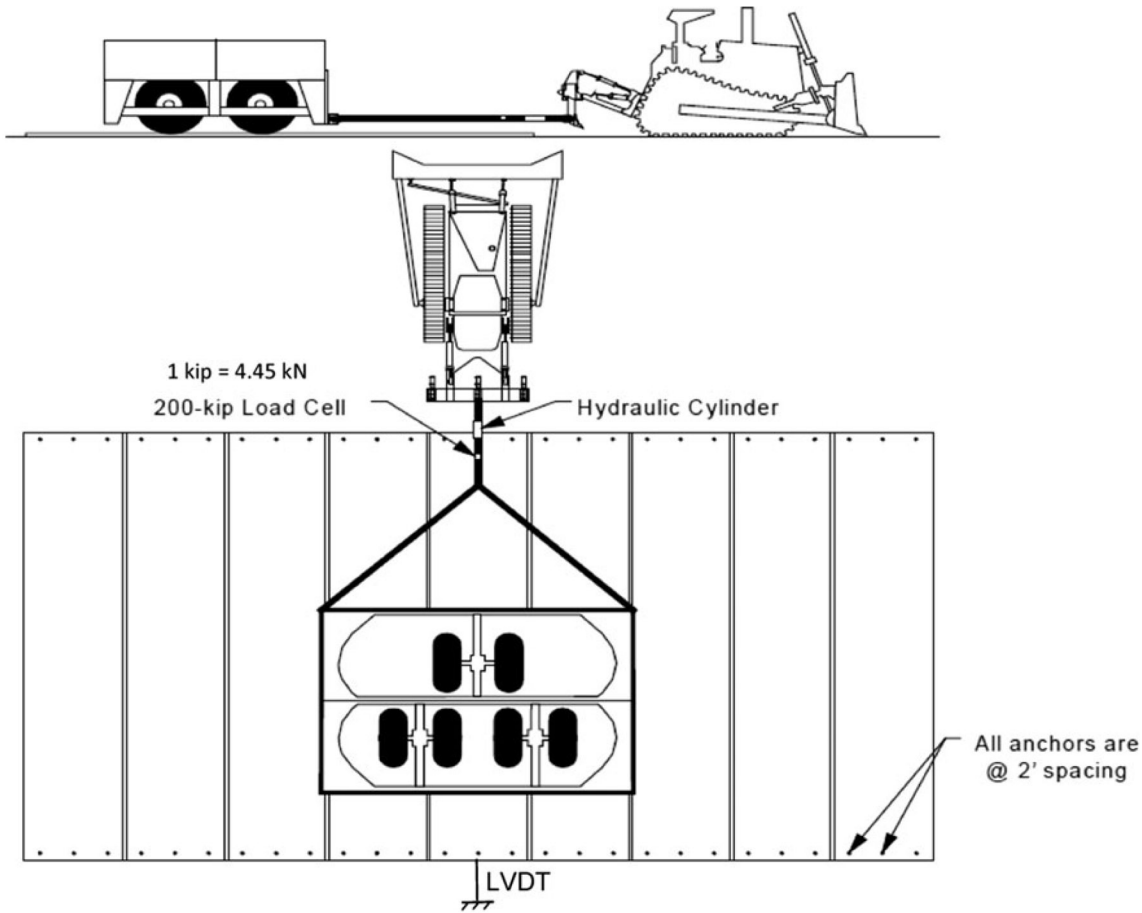
Figure 6. Load cart test set-up.

Static pull tests were conducted to determine the mat-to-asphalt pavement interface coefficient of friction, using an 89,800-kg (198,000-lb) C-5 load cart placed on the center of an unanchored fiberglass mat. The test set-up is shown in Figure 6, where the load cart has the footprint of a single C-5 main gear. Each wheel carried 147 kN (33,000 lbs) and the tire inflation pressure was 1 MPa (145 psi). All six wheels of the load cart were locked while a horizontal pulling force was gradually applied to the load cart until the mat slipped abruptly across the pavement. Bulldozers were chained in series with wire ropes and parked in a sand pit to provide

anchorage for the pulling force. The mat displacement was measured with an LVDT and the pulling force was measured with a load cell. The peak pulling forces along with the corresponding mat displacements measured are summarized in Table 1. As shown in Figure 2, friction forces only exist where there is contact pressure between the mat and the pavement. Thus, the frictional resistance in the interface can be treated as if they were concentrated at the tire locations. An “apparent” coefficient of friction may be calculated by dividing the peak pulling force by the total wheel loads (i.e. 881 kN (198,000 lbs)). The coefficients of friction thus obtained from the five pull tests, with an average value of 0.564, are also given in Table 1.

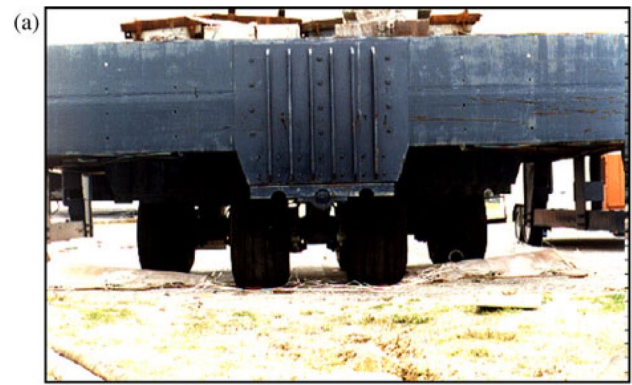
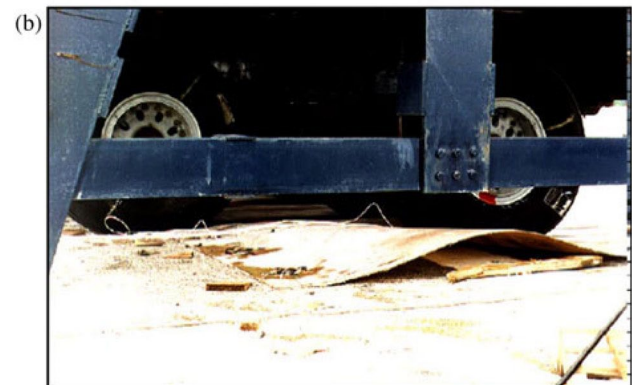
Figure 7. Bow wave formation under heavy wheel loads.

stopped when the bulge was about 195mm (7.65 in) which was close to that observed in a C-5 load cart test shown in Figure 7. The maximum uplifting force on the front anchors was estimated to be about 1.34 kN (300 lbs). The shape of the bulge predicted by NIKE3D (see Figure 9) bears remarkable similarities to that shown in Figure 7. The bulge would form when the compressive stresses in the mat in front of the tires were high to cause the mat to buckle.

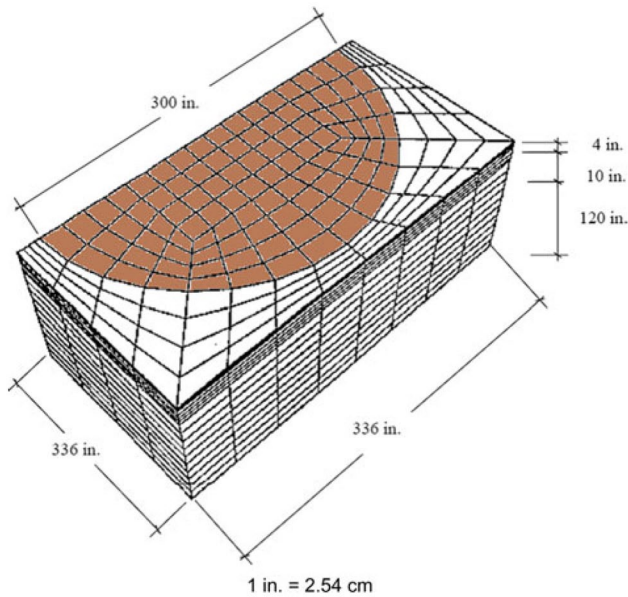
Figure 8. Finite element mesh of the deformable pavement.

and oyster shell base were modelled with eight-node solid elements, while the fiberglass mat and elastic hinges were modelled with four-node thin shell elements. A frictional sliding interface (coefficient of friction = 0.641) was used to model the contact surface between the fiberglass mat (shell elements) and the repaired crater (solid elements). All material properties were assumed to be elastic and isotropic, and the previously determined values were used in the model. The finite element mesh of the 102-mm (4-in) asphalt layer and the 254-mm (10-in) thick oyster shell base course on top of 3m (10 ft) of beach sand is shown in Figure 8, where the 7.6-m (300-in) diameter, 46-cm (18-in) deep repaired crater is marked by dark color. By changing the material properties of the elements within the crater, the effect of having an underlying crater on the anchor loads could be readily determined. The finite element mesh of the fiberglass mat is shown in Figure 9, where elliptically shaped tire footprints, each with a major axis of 54.6 cm (21.5 in) and a minor axis of 41.9 cm (16.5 in), are built in the mesh. The wheel loads were applied as a uniform contact pressure of 1 MPa (145 psi) on each of the three tire footprints. There were 57 nodes in a tire footprint mesh, and a horizontal force of $147 \times 0.662/57 = 1.71$ kN (383 lbs) was applied to each node due to skidding. This horizontal force causes the mat to slide towards the front anchors. The initial geometry of the mat was given a slight cylindrical arc in front of the wheels to initiate the bow wave formation. The nodes along the front edge of the mat were fixed to simulate anchors while the back edge of the mat was free to move. In the load cart test, as the tires moved towards the front anchors, the bulge in the mat would slip under the tires and gradually diminish due to constraints by the front anchors. Because the tire footprints were built in the mat mesh, there was no slippage between the tires and the mat. The simulation was

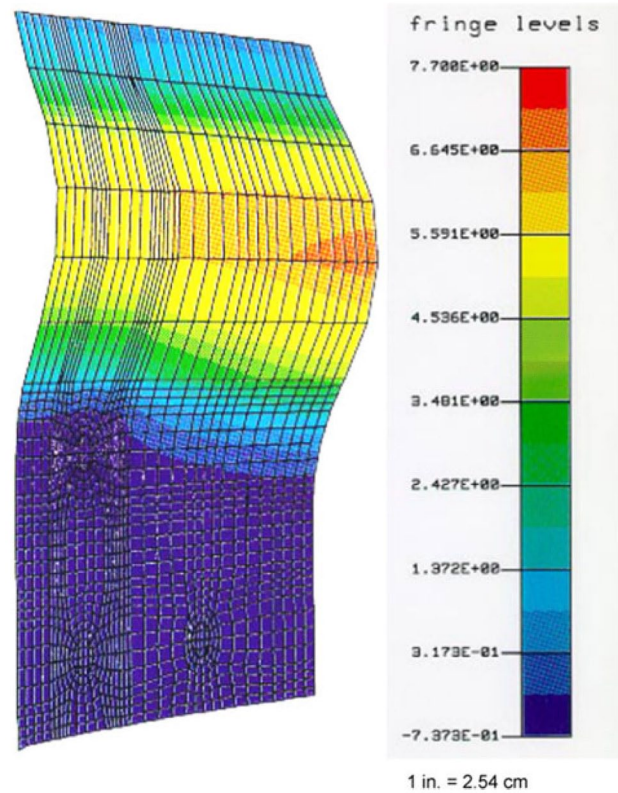
Figure 9. NIKE3D simulation of bow wave uplifting force on anchors.

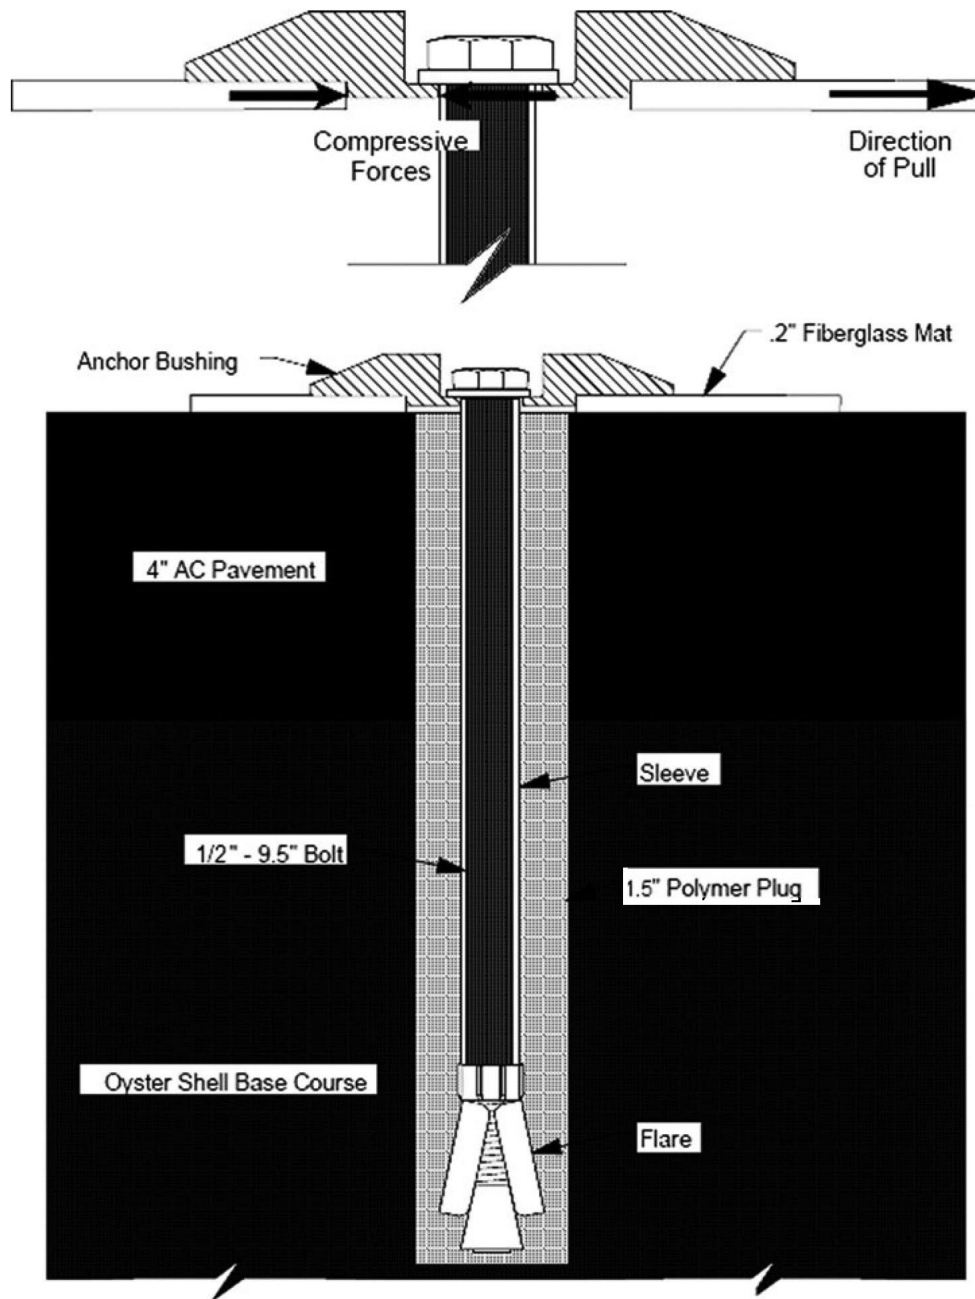
Figure 12. Bushing load cell concept.

Figure 12 shows loads acting on an anchor bushing. A horizontal load applied to the mat, such as that due to braking, is transferred as a horizontal compressive load on the anchor bushing, which, in turn, exerts a horizontal compressive

load on the anchor bolt. The anchor bolt in the current system is a 12.7-mm (0.5-in) diameter, 241-mm (9.5-in) long rock bolt, typically used for concrete pavements with up to 152mm (6 in) of asphalt overlay. The load on the bolt is reacted by the pavement acting on the embedded portion of the bolt. The force pair represented by the arrows is the only one measured by the anchor bushing load cell. If the bolt is torqued down, the compressive stress induced between the mat and the pavement would allow load transfer by friction. However, the anchor bushing load cell is intended for use with anchors in asphalt pavement, where the anchor bolt will be embedded in a polymer plug poured in a 38-mm (1.5-in) diameter hole in the pavement. In this case, the bolts are not to be torqued down. Thus, there will be no normal (compressive) force acting between the mat and the pavement, and the anchor loads will be carried in horizontal shear by the bolt and not by friction.

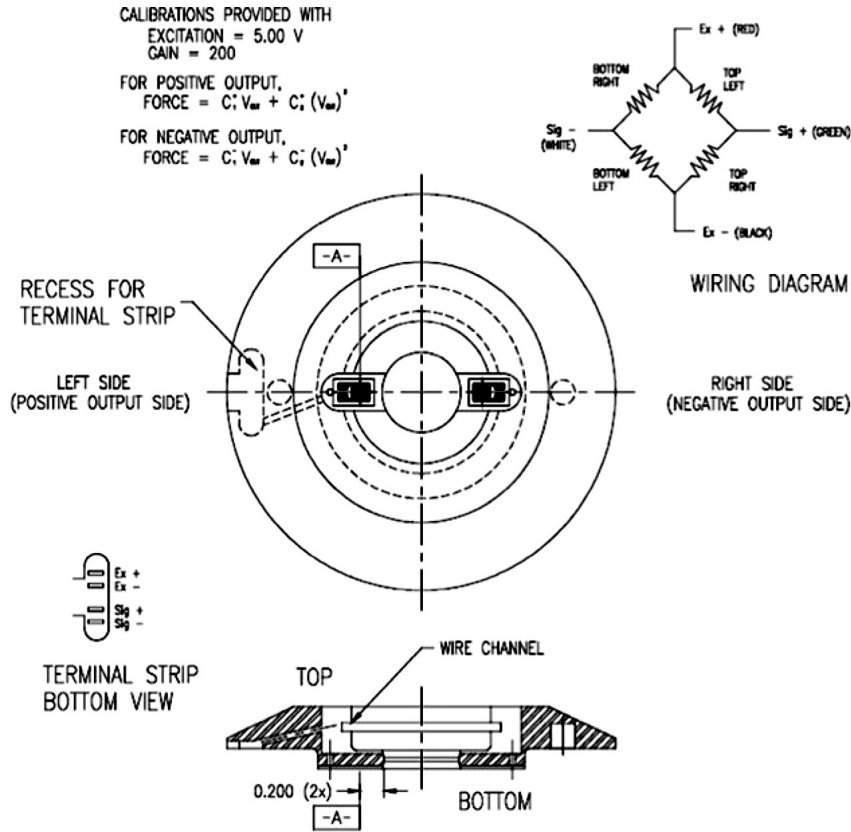
Figure 13. Bushing load cell strain gauge detail.

As shown in Figure 13, four strain gauges were installed on each bushing in a full bridge configuration. Only two of the gauges actually sense load at any one time, either the two on the right or the two on the left. The full bridge was

included for temperature compensation and for compensation for bending stresses in the bushing flange. Because of the inclusion of two gauge stations, the bushing load cell can be calibrated to measure load in either the positive or the negative direction along the gauged axis, a useful feature if trafficking were being performed in both directions. Because the strain-gauged section of the bushing is close to the contact points, the load cell output is influenced by the characteristics of the contact between the bushing and the bolt. The bushing load cells have a measurement uncertainty of approximately 890–1780N (200–400 lbs).

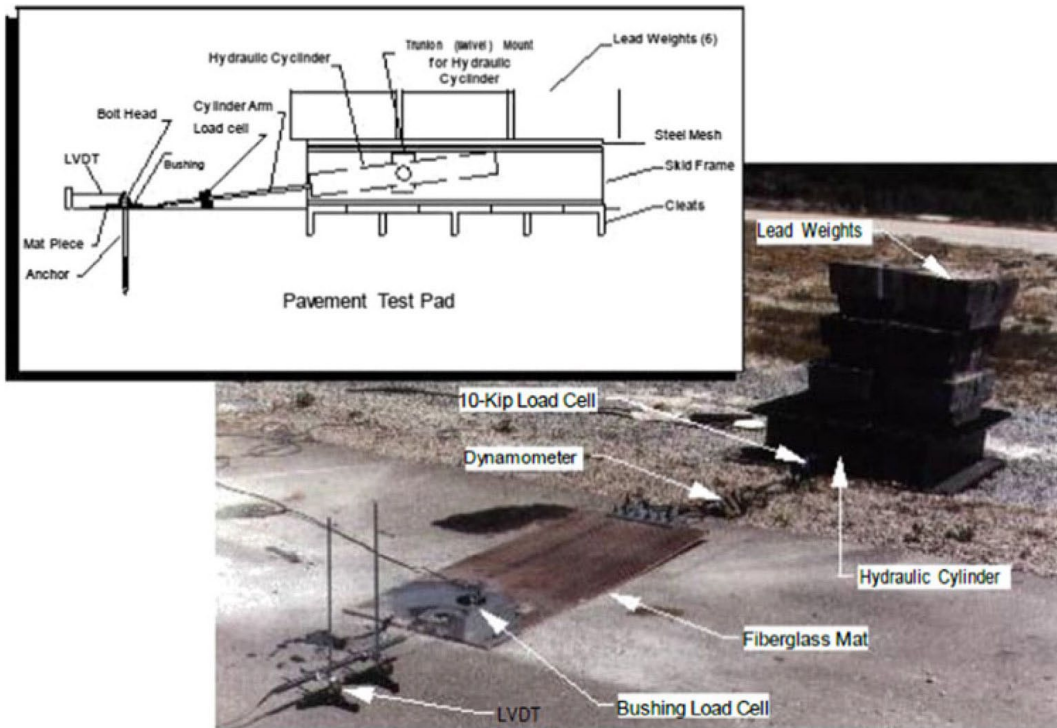
Figure 14. Single anchor pull test for bushing load cell validation.

A 1.2-m (4-ft) long, 46-cm (18-in) wide piece of fiberglass mat was used for a pull test to validate the bushing load cell, as shown in Figure 14. The anchor was installed in a concrete pavement to provide a targeted peak anchor load of 26.7 kN (6000 lbs) for validation. A load cell was placed in line to measure the pulling force. A hardened sleeve was placed in the bushing with its top flush with the top of the anchor bolt opening. A rock bolt was snugly fitted into the sleeve such that the washer was only in contact with the

sleeve and the bushing was still free to rotate after the bolt was torqued down. The bottom surface of the mat around the bushing hole was lubricated and a wood wedge was placed under the mat behind the bushing to prevent the mat from lodging underneath the bushing. A hydraulic cylinder was used to gradually apply a pulling force to the mat and the anchor. The bushing load cell and reference load cell data are compared in Figure 15. The bushing load cell traced the applied load very closely during loading. However, significant deviation from the reference load trace was noted during unloading. The bushing load cells relied on the pair of compressive forces shown in Figure 12 to sense anchor loads. In general, the bushing load cell underestimated the actual anchor load by about 14%. However,

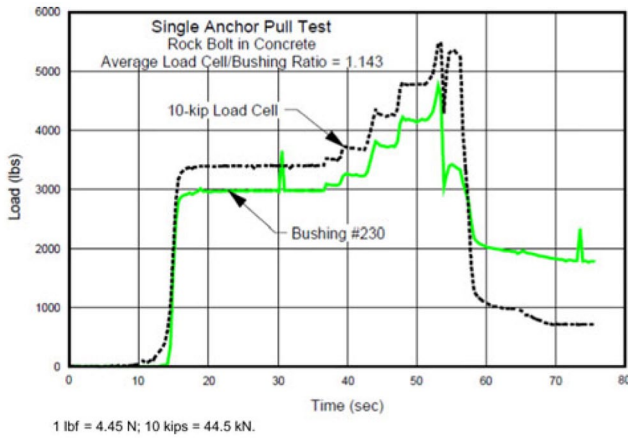
Figure 15. Field validation of bushing load cell.

these load cells became ineffective once the mat slipped underneath the bushing. As a result, there is no physical significance to the unloading portion of the load trace shown in Figure 15. A correction factor of 1.14 was applied to all load cell data.

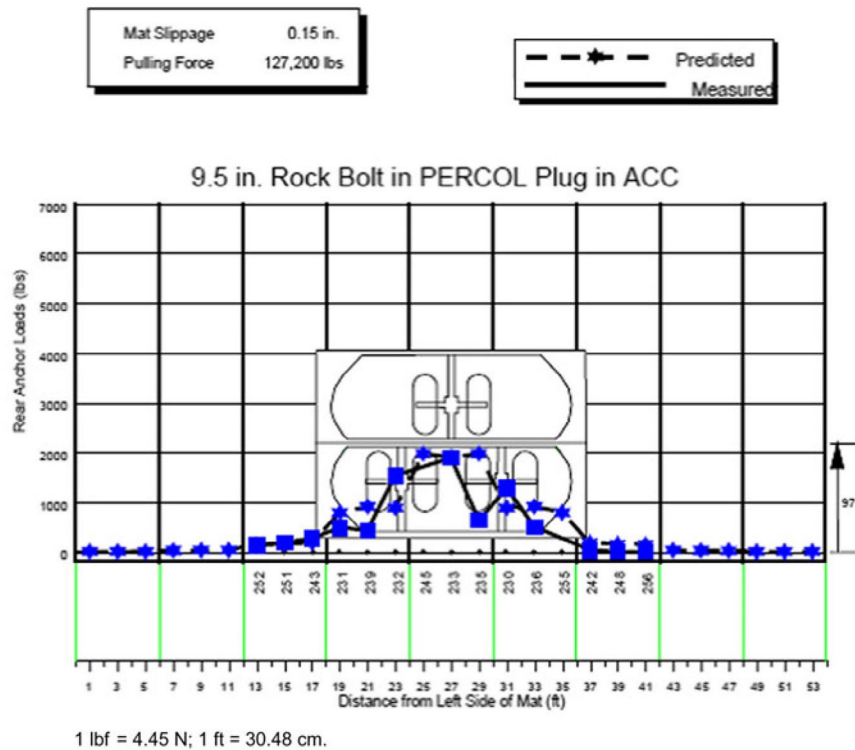
Figure 16. Peak anchor load distribution in load cart test #3.

A fiberglass mat was laid out and anchored with 38-cm (1.5-in) diameter polymer plugs. Six load cart skid tests were conducted at two locations on the mat. These tests were conducted when the asphalt pavement temperature was about 16°C (60°F). The pulling forces on the load cart were applied at one-third, two-thirds and full extent of the 579-kN (130,000-lb) braking force. Reduced pulling forces were used to simulate the anchor loads produced by an anti-skid brake system. In addition to 28 instrumented bushings and the load cell, a string potentiometer was tacked on the mat under the rear axles of the load cart to detect mat slippage. Because the static coefficient of friction between the mat and the asphalt pavement was determined to be 0.564, no mat slippage was expected until the pulling force reached about $881 \times 0.564 \cong 497$ kN (112,000 lbs) when sudden increases in anchor forces occurred as soon as the mat slipped. The front anchors were not subject to significant horizontal loads due to bow wave formation. The bushing load cells along the leading edge of the mat were unable to sense the uplifting forces due to mat buckling. The peak horizontal loads measured by the load cells along the back edge of the mat are compared with the values predicted by the simplified model in Figures 16 and 17.

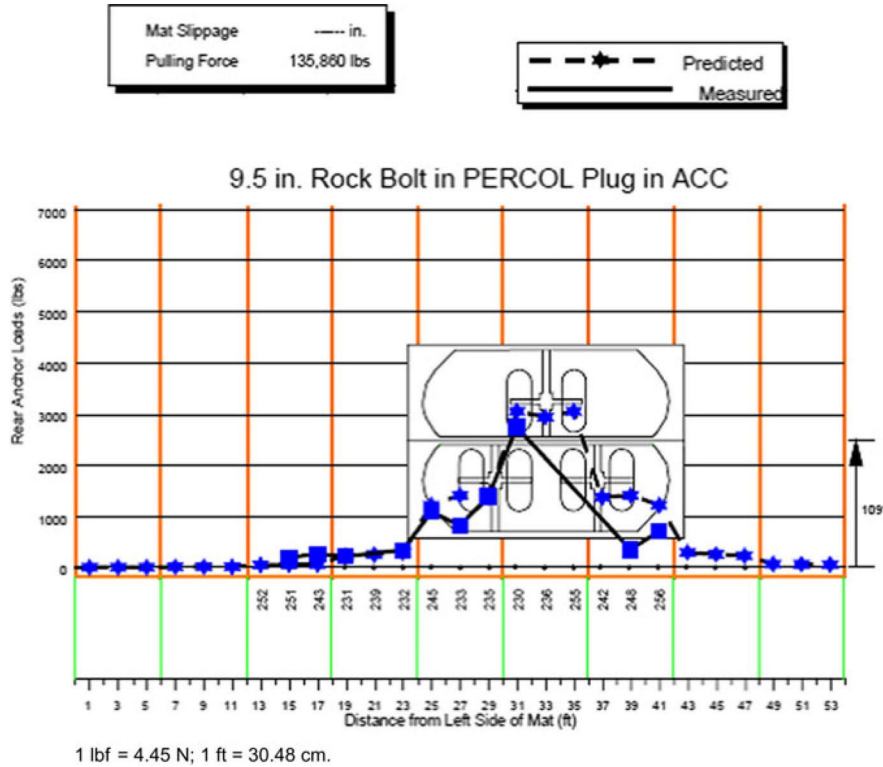
Figure 17. Peak anchor load distribution in load cart test #6.

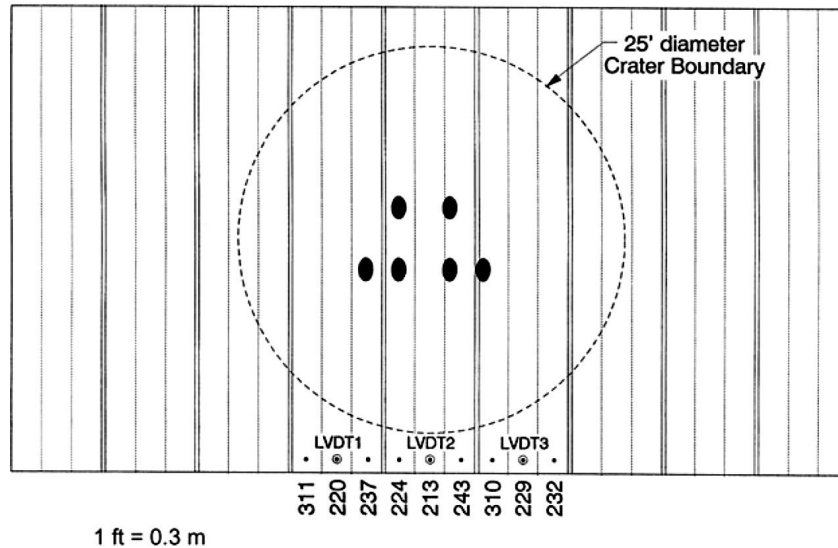
Figure 18. Location of bushing load cells and LVDTs for load cart tests on a repaired crater.

were measured at 4m (157 in) from the rear anchors. Only the rear anchors of the middle three fiberglass panels were instrumented to measure horizontal anchor loads. The displacement of the middle anchor in each of the three panels was monitored with an LVDT. These tests were conducted when the asphalt pavement temperature was about 16°C (60°F).

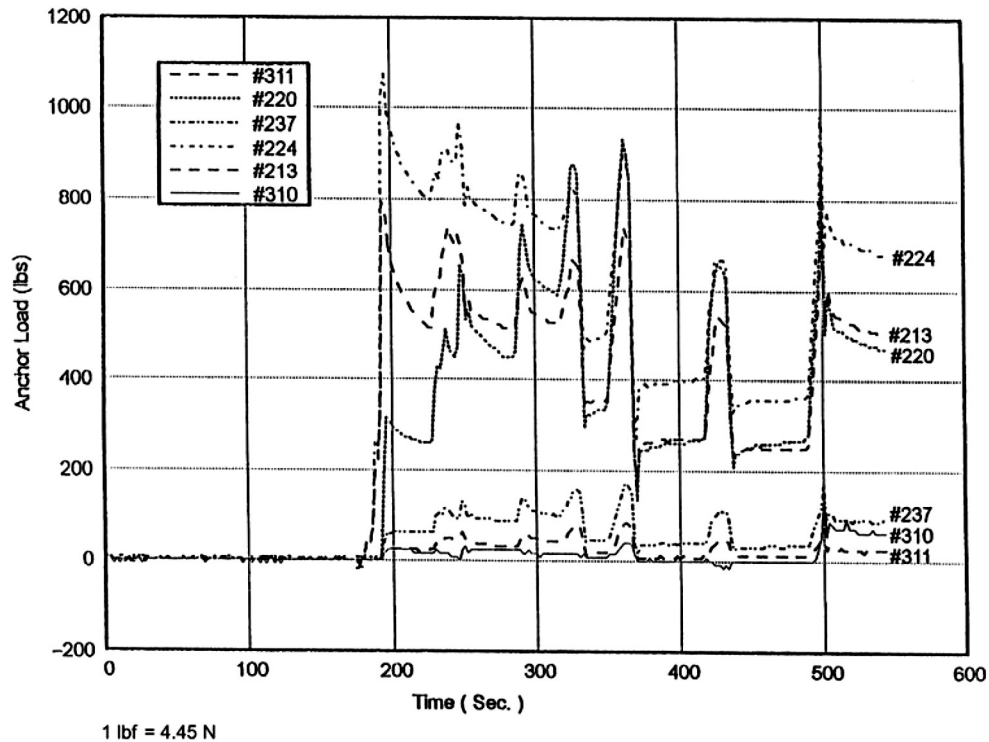
Figure 19. Anchor loads due to C-5 load cart rolling onto the mat.

The transient anchor loads resulting from rolling the load cart onto the mat over the repaired crater are shown in Figure 19. The average load data indicate that anchor loads would be around 2.2 kN (500 pounds), after the load cart was rolled on the mat. This value occurred during the initial settlement in the repaired crater under wheel loads at about 550 s. These horizontal anchor loads are caused by the instantaneous settlement under the heavy wheel loads. Although an instantaneous peak horizontal load of about 4.9 kN (1100 lbs) was measured, the average load on the anchors under the initial settlement would be around 2.2 kN (500 lbs).
