Two Test Level 4 Bridge Railing and Transition Systems for Transverse Timber Deck Bridges

Ronald K. Faller, Michael A. Ritter, Barry T. Rosson, Michael D. Fowler, and Sheila R. Duwadi

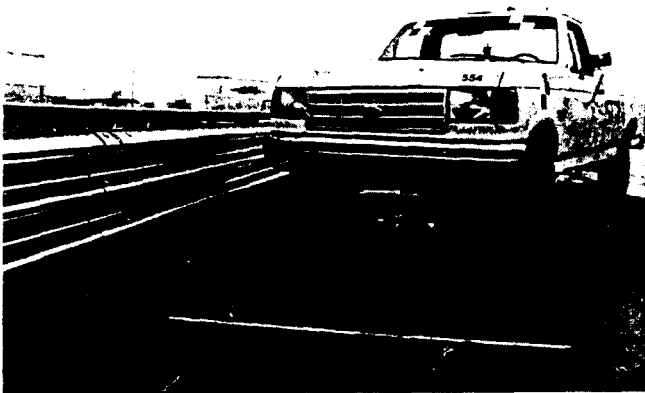
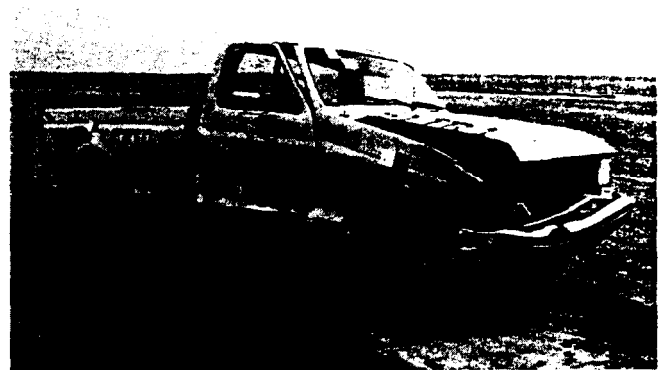
FIGURE 11 Test STTR-1: (a) impact location, (b) vehicle damage, and (c) bridge railing damage.

The first crash test, Test STTR-1, was successfully performed with a 1990 Ford F-250, ¾-ton pickup truck with a test inertial mass of 1994 kg and at impact conditions of 93.7 km/h and at an angle of 25.5 degrees. During impact, the vehicle exited the railing system at a speed of 62.3 km/h and at an angle of 1.5 degrees. The maximum lateral permanent set deflection and the dynamic rail deflection were observed to be 92 and 137 mm, respectively. The location of vehicle impact with the bridge railing, vehicle damage, and barrier damage are shown in Figure 11.

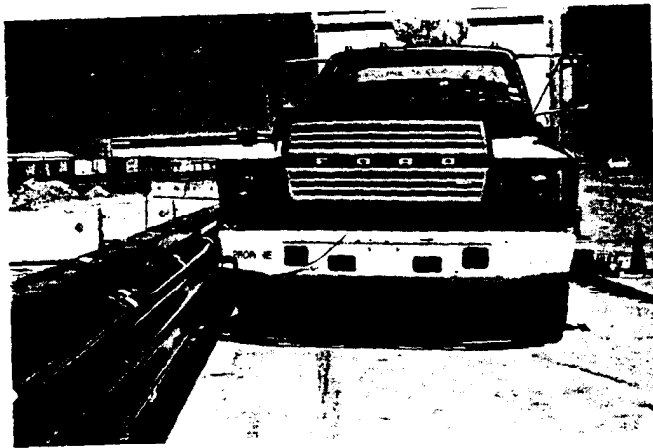
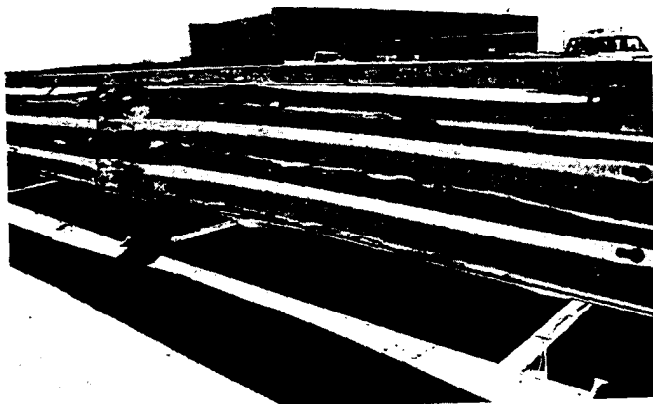
FIGURE 12 Test STTR-2: (a) impact location. (b) vehicle damage, and (c) bridge railing damage

The second crash test, Test STTR-2, was successfully performed with a 1985 Ford F-800 Series, single-unit truck with a test inertial mass of 8067 kg and at impact conditions of 76.1 km/h and at angle of 14.6 degrees. During the impact, the vehicle exited the railing system at a speed of 63.6 km/h and at an angle of less than 1 degree. The deflection of the maximum lateral permanent set rail was observed to be 136 mm. The location of the vehicle impact with the bridge railing, vehicle damage, and barrier damage are shown in Figure 12

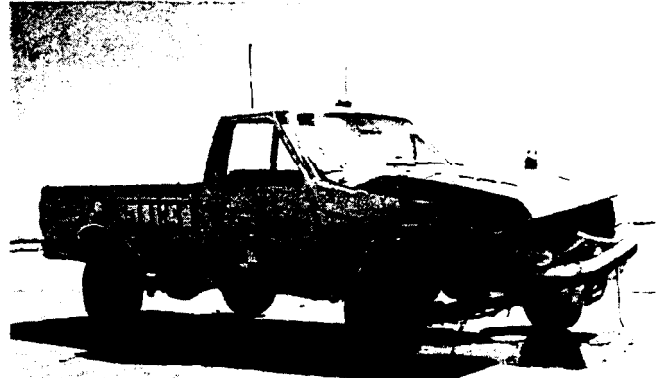
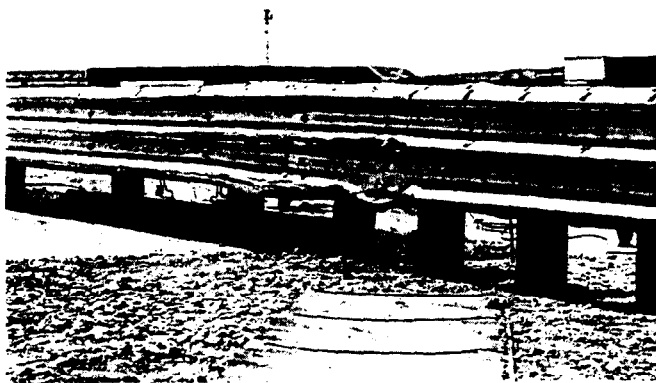
FIGURE 13 Test STTR-3: (a) impact location, (b) vehicle damage, and (c) approach guardrail transition damage.

The first crash test, Test STTR-3, was successfully performed with a 1985 Ford F-250, $\frac{3}{4}$ -ton pickup truck with a test inertial mass of 1997 kg and at impact conditions of 101 km/h and at an angle of 25.6 degrees. During impact, the vehicle exited the transition system at a speed of 73.5 km/h and at an angle of 4.9 degrees. The maximum lateral permanent set deflection and the dynamic rail deflection were observed to be 67 and 143 mm, respectively. The location of vehicle impact with the approach guardrail transition, vehicle damage, and barrier damage are shown in Figure 13.

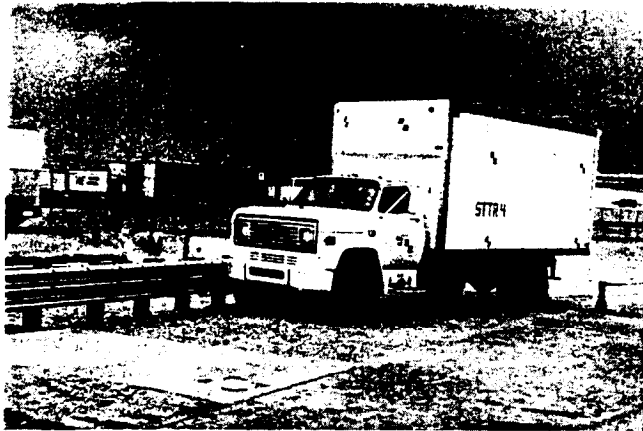
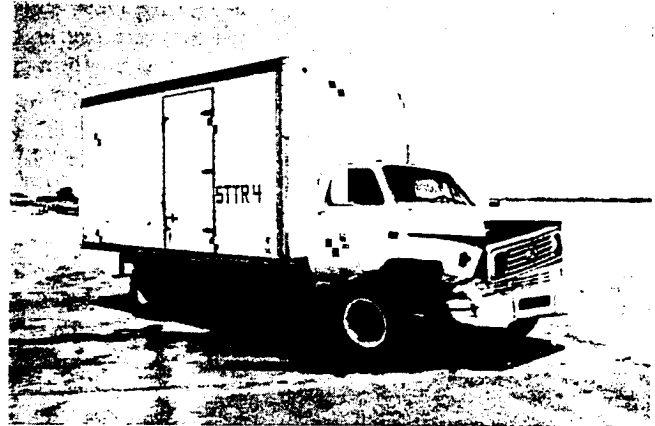
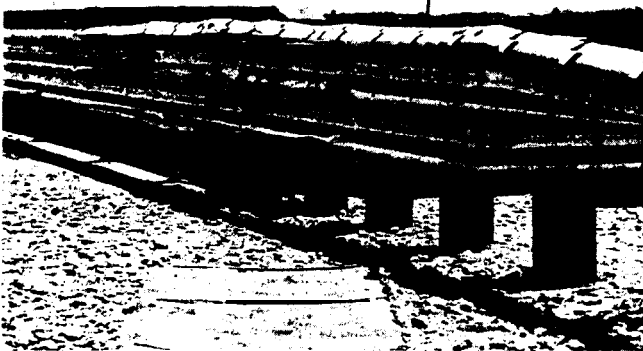
FIGURE 14 Test STTR-4: (a) impact location, (b) vehicle damage, and (c) approach guardrail transition damage.

The second crash test, Test STTR-4, was successfully performed with a 1988 Chevrolet C60, single-unit truck with a test inertial mass of 8006 kg and at impact conditions of 81.8 km/h and at an angle of 15.2 degrees. During impact, the vehicle exited the transition system at a speed of 65.2 km/h and at an angle of 7.8 degrees. The maximum

lateral permanent set deflection and the dynamic rail deflection were observed to be 38 and 93 mm, respectively. The location of vehicle impact with the approach guardrail transition, vehicle damage, and barrier damage are shown in Figure 14.
