Design of Cable-to-Post Attachments for Use in a Non-Proprietary, High-Tension, Cable Median Barrier

*Midwest States Regional Pooled Fund Research Program
Fiscal Years 2009-2012 (Years 19 and 22)
Research Project Number TPF-5(091) and TPF-5(193)
NDOR Sponsoring Agency Code RFPF-09-01 and RFPF-12-CABLE 1&2*

DESIGN OF CABLE-TO-POST ATTACHMENTS FOR USE IN A NON-PROPRIETARY, HIGH-TENSION, CABLE MEDIAN BARRIER

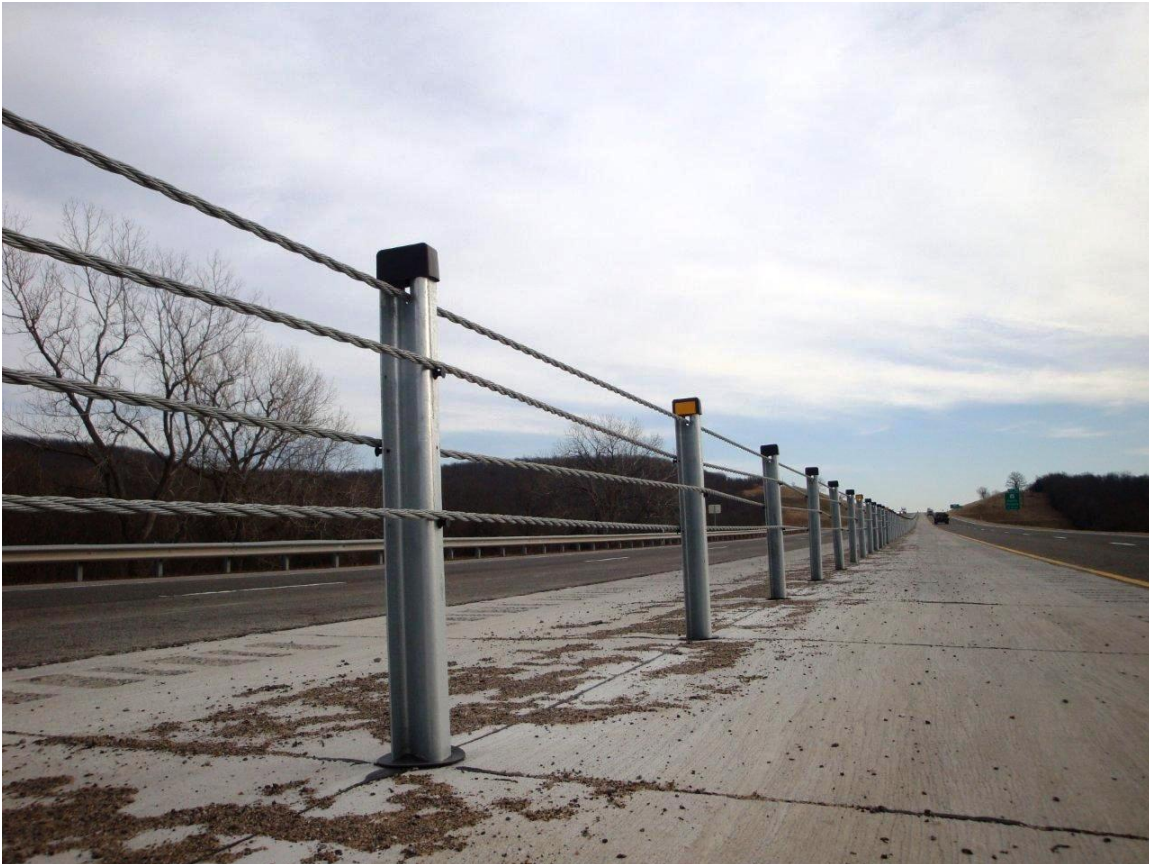
Figure 4. Typical Brifen WRSF

The Brifen Wire Rope Safety Fence (WRSF) is a high-tension, cable barrier system [16]. It has different configurations (both 3- and 4-strand) which have been successfully crash tested according to the NCHRP Report No. 350 TL-3 and TL-4 requirements. More detailed information is provided in FHWA eligibility letter nos. B-82 [17], B-82B [18], B-82C [19], B-82C1 [20], and B-82B1 [21]. For the common Brifen system, the top cable is placed in a slot located in the center of a Z-shaped post and covered with a post cap. The other cables sit on

exterior locating pegs and are weaved around the line posts. Typical Brifen systems are shown in Figures 4 and 5 with the express written consent of Brifen USA, Inc.

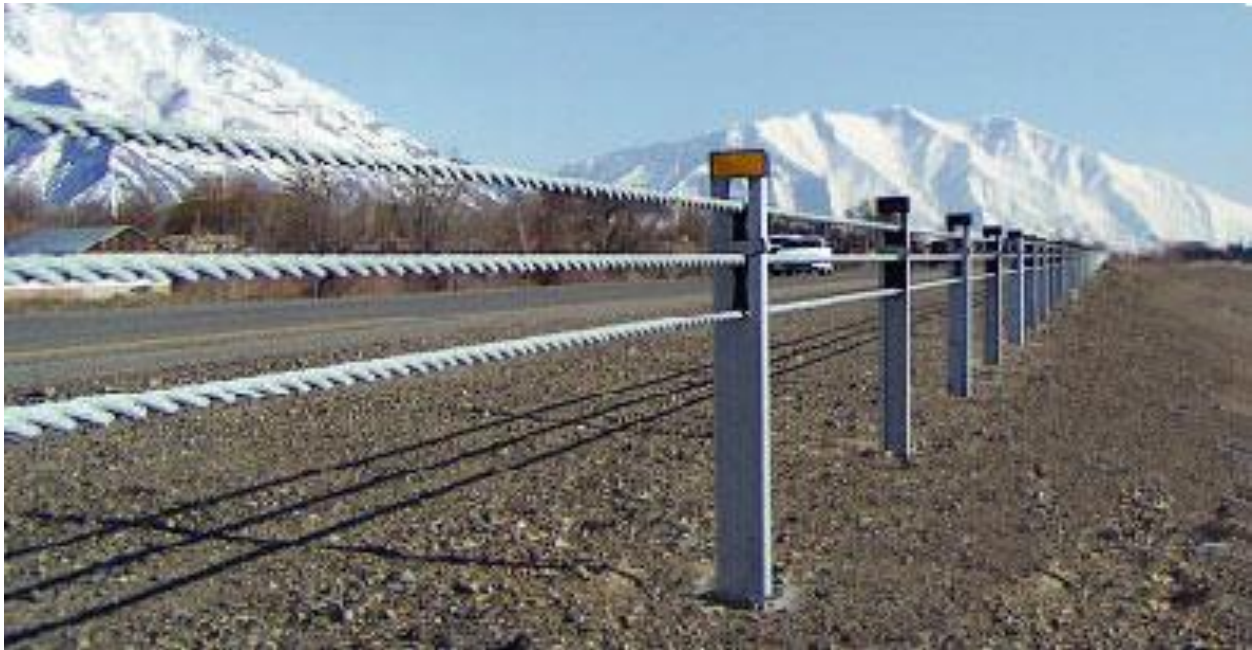
Figure 12. Trinity Highway Products' CASS [62]

Trinity Highway Products manufactures the Cable Safety System (CASS). CASS is a high-tension, cable barrier system which has different configurations (both 3- and 4-strand) and

has been successfully crash tested according to the NCHRP Report No. 350 TL-3 and TL-4 requirements [50]. More detailed information is provided in FHWA eligibility letter nos. B-119 [51], B-119A [52], B-119B [53], B-141 [54], B-141A [55], B-141B [56], B-157 [57], B-141C [58], B-141E [59], B-141D [60], and B-232 [61]. The line posts have a wave-shaped slot in the center of the post. For the typical CASS system, all of the cables are placed in the slot and separated by plastic spacers. For the TL-3 CASS system for placement on 4V:1H side slopes, the bottom cable is attached to the side of the post with a cable lock bolt. The support posts that are located closer to the end terminal are different. These posts use hook bolts to attach the cables to the flanges. A typical CASS system is shown in Figure 12. The wave shape of the upper slot is shown in Figure 13, while the CASS hook bolts, used on the posts closer to the terminals, are depicted in Figure 14.

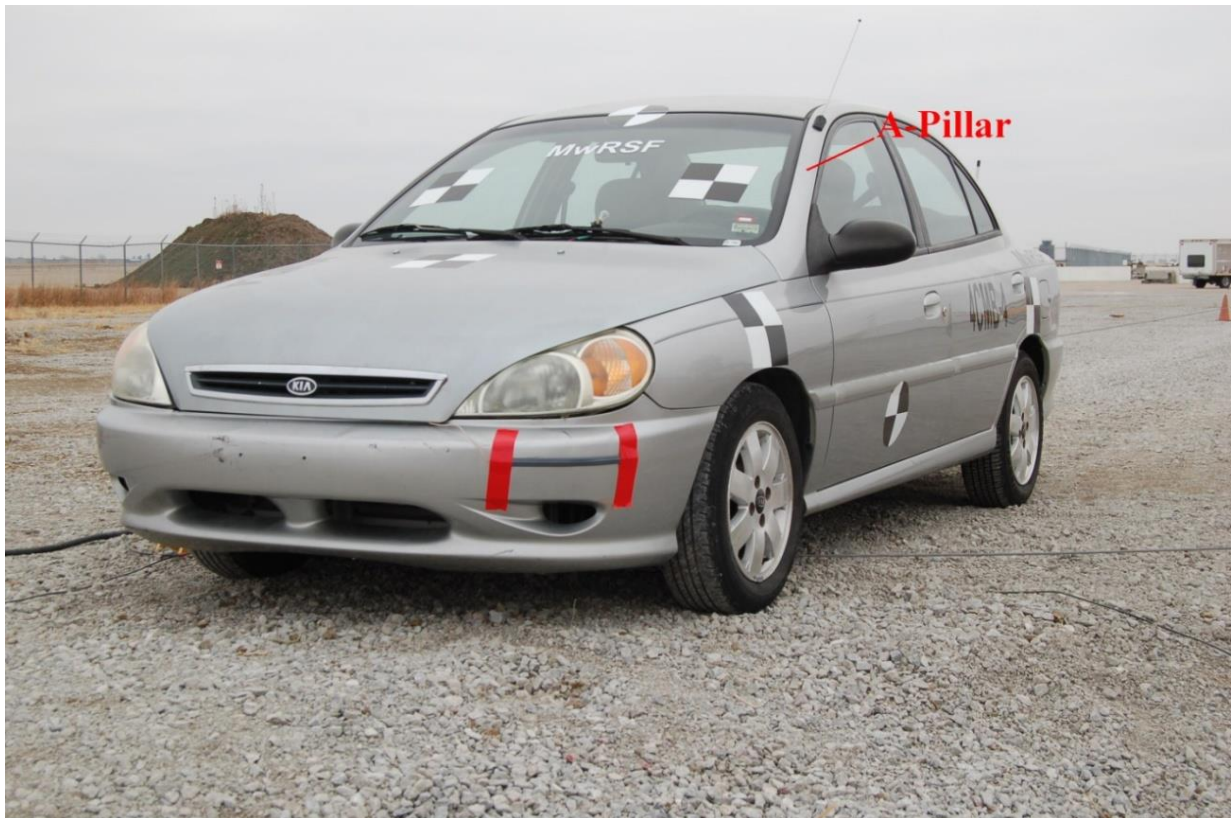
Figure 17. Typical A-Pillar

A-pillars are the front-most structural members which support the roof of a vehicle, as shown in Figure 17. B- and C-pillars are also used to support the roof structure. The roof and its supporting pillars are configured to mitigate concerns for excessive crush of the occupant compartment during vehicle rollovers. As such, vehicles must comply with roof crush testing standards.

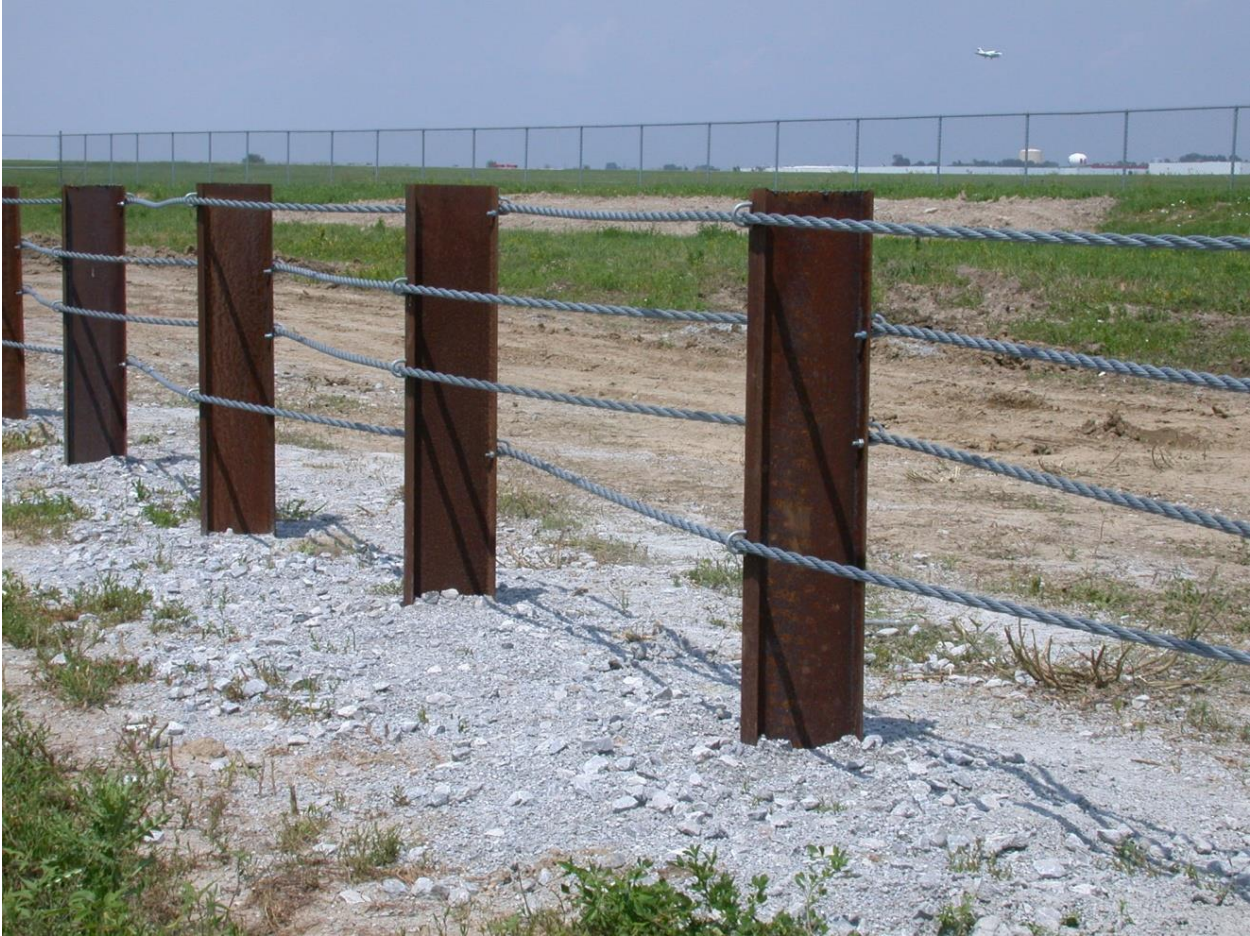
Figure 18. Cable Barrier System, Test No. CMB-1

The first design, tested in full-scale crash test no. CMB-1, used M8x6.5 (M203x9.7) line posts, spaced at 6 ft (1.8 m) centers. The system was 486 ft (148 m) in length, consisted of 80 posts, and was placed on level terrain. Standard cable hook bolts, as shown in Figure 3 in the previous chapter, attached the cables to the posts. From post to post, the cables alternated from the front flange to the back flange, creating a woven pattern. A pre-test photograph from test no. CMB-1 is shown in Figure 18.

For test no. CMB-1, a 1,969-lb (893-kg) small car (820C vehicle) impacted the barrier at a speed of 60.6 mph (97.6 km/h) and at a 19.7-degree angle. The impact point was 33 in. (846 mm) upstream from post no. 41. The vehicle was contained, but it rolled over as it was redirecting. The cable barrier was determined to be unacceptable according to the TL-3 safety performance criteria for test designation no. 3-10 found in NCHRP Report No. 350. More information about the prototype barrier system and the test, including the test summary sheet, is provided in Appendix B, Figure B-1.

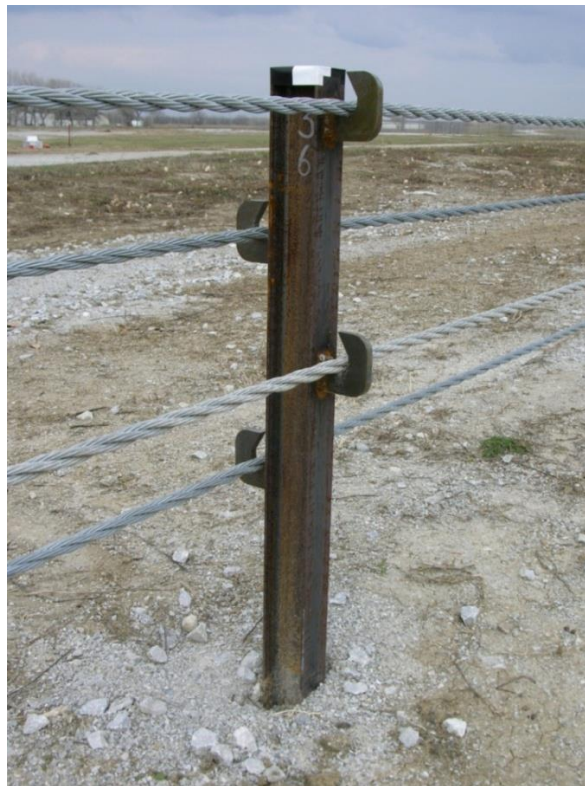
Figure 20. Cable Barrier System, Test No. CMB-2

For test no. CMB-2, a 1,960-lb (889-kg) small car (820C vehicle) impacted the system at a speed of 62.8 mph (101.1 km/h) and at a 19.7-degree angle. The impact point was 48 in. (1,219 mm) upstream from post 31. The vehicle was adequately contained. The left-front tire became snagged on a post as the vehicle was being redirected. As a result of the snag, the vehicle yawed counterclockwise away from the barrier before coming to rest. In spite of this motion, the vehicle intrusion into adjacent traffic lanes was minimal. The cable barrier was determined to be acceptable according to the TL-3 safety performance criteria for test designation no. 3-10 found in NCHRP Report No. 350. More information about the prototype barrier system and the test, including the test summary sheet, is provided in Appendix B, Figure B-2.

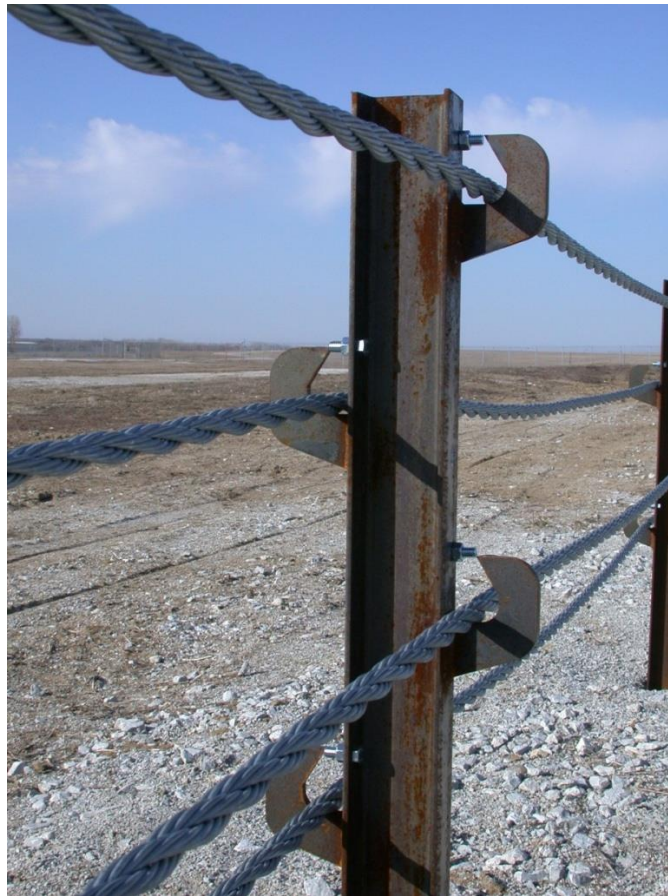
Figure 22. Cable Barrier System, Test No. CMB-3

For test no. CMB-3, a 4,459-lb (2,023-kg) pickup truck (2000P vehicle) impacted the system at a speed of 60.8 mph (97.8 km/h) and at a 25.4-degree angle. The impact point was 48

in. (1,219 mm) upstream from post no. 31. The vehicle was adequately contained and safely redirected. Because of the retainer bolts, the top two cables were retained on the posts that were outside of the impact region. The cable barrier was determined to be acceptable according to the TL-3 safety performance criteria for test designation no. 3-11 found in NCHRP Report No. 350. More information about the prototype barrier system and the test, including the test summary sheet, is provided in Appendix B, Figure B-3.

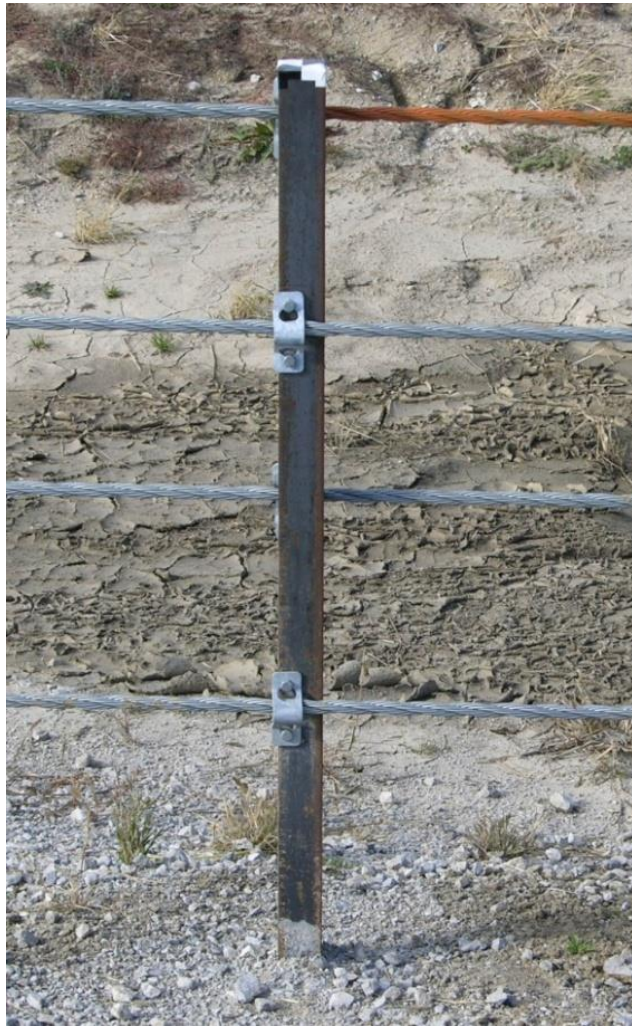
Figure 26. Curved Keyway Brackets Installed on Post

Since the cable-to-post attachments would be loaded dynamically during an impact event, dynamic component tests were an especially important part of the evaluation process. The curved keyway brackets had lateral and vertical release loads of 5.72 kips (25.4 kN) and 1.17 kips (5.20 kN), respectively. It was believed that this would provide sufficient lateral strength to develop the full moment capacity of the post, and a sufficiently low vertical strength to prevent cables from being pulled down too far by rotating posts or clamping down and crushing a vehicle's A-pillar.

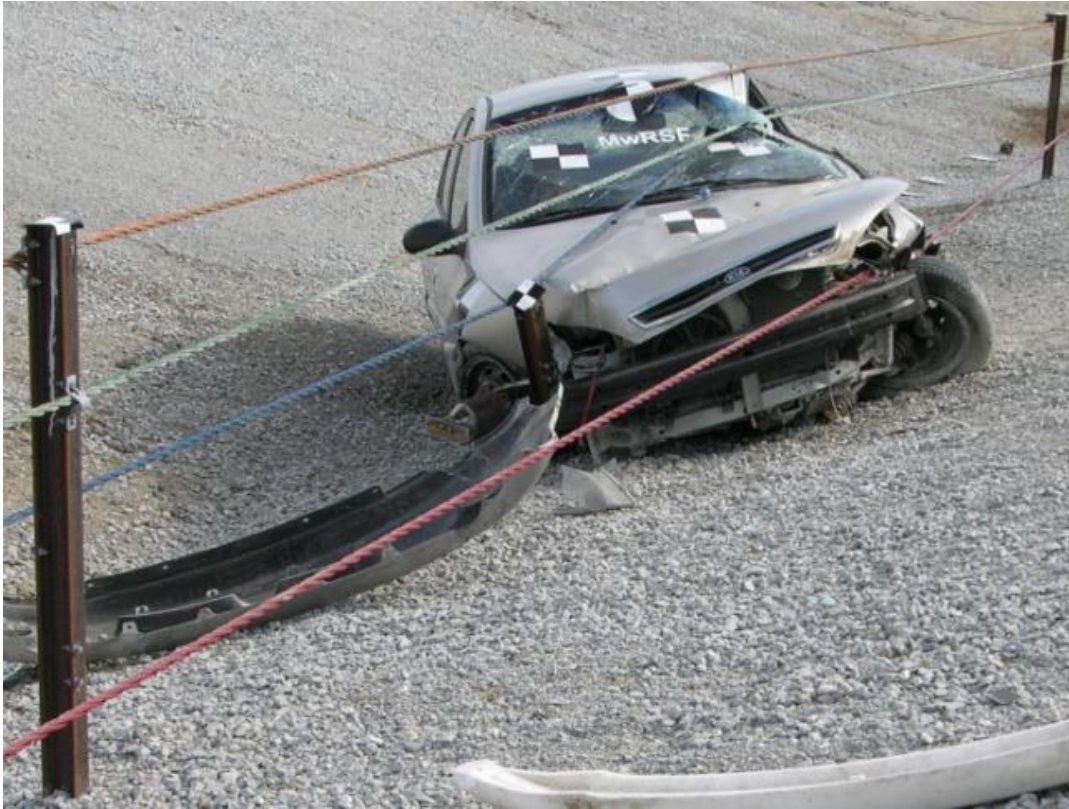
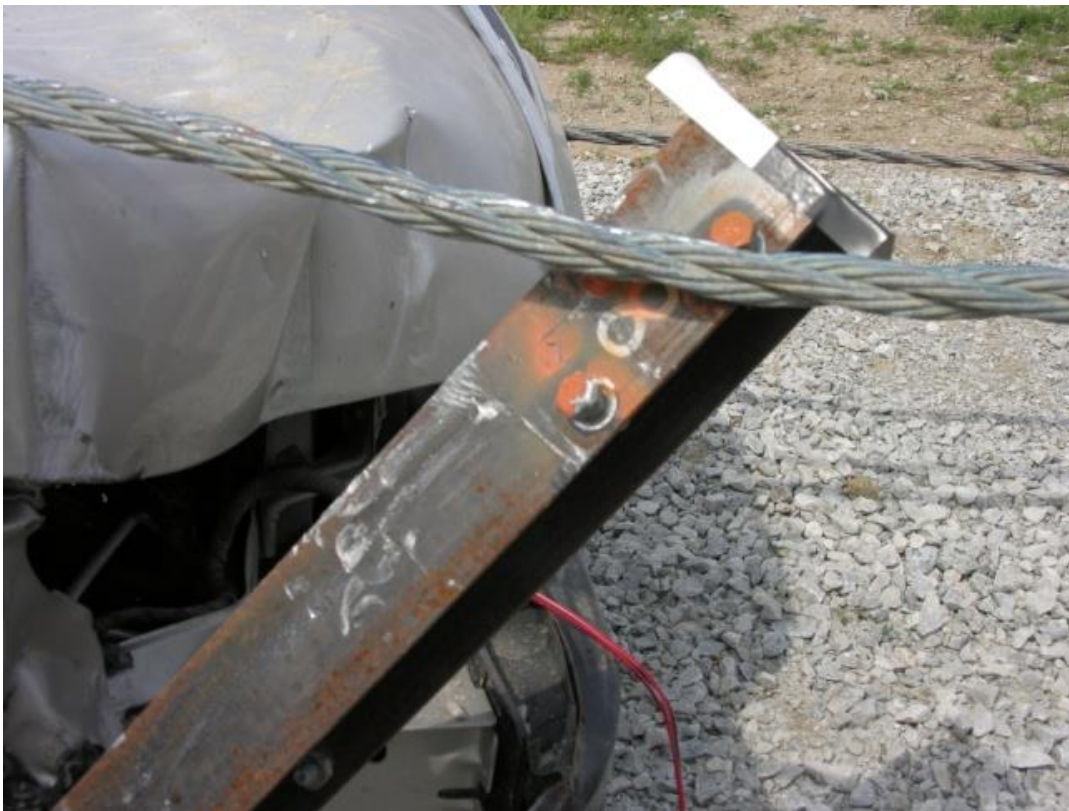
Figure 27. Cable Snag Resulting in Crushed A-Pillar, Test No. 4CMB-3

For test no. 4CMB-3, a 2,586-lb (1,173-kg) small car (1100C vehicle) impacted the high-tension, 4-cable median barrier at a speed of 62.0 mph (99.8 km/h), at a 27.2-degree angle. The barrier system was located on the back slope of the V-ditch, 4 ft (1.2 m) laterally away from the bottom of the ditch. The point of impact was 64 in. (1,626 mm) downstream from post no. 16. In contrast to the soft soil condition of test no. 4CMB-2, the soil at the bottom of the ditch was heavily compacted for this test. Similar to the previous test, the vehicle made contact with the back slope before making contact with the barrier. Upon impact with the barrier, the vehicle was adequately contained and remained upright, but the A-pillar was crushed by a cable, resulting in significant damage to the roof, windshield, and penetration into the occupant compartment. The cable crushed the A-pillar, because it was snagged on one of the shoulder bolts that corresponded to the curved keyway brackets, as shown in Figure 27. Therefore, due to the excessive occupant compartment penetrations, the test did not meet the TL-3 safety performance criteria for test designation no. 3-10 found in MASH when the barrier was placed near the ditch bottom with a strong/stiff soil condition. More information about the prototype barrier system and the test, including the test summary sheet, is provided in Appendix B, Figure B-6.

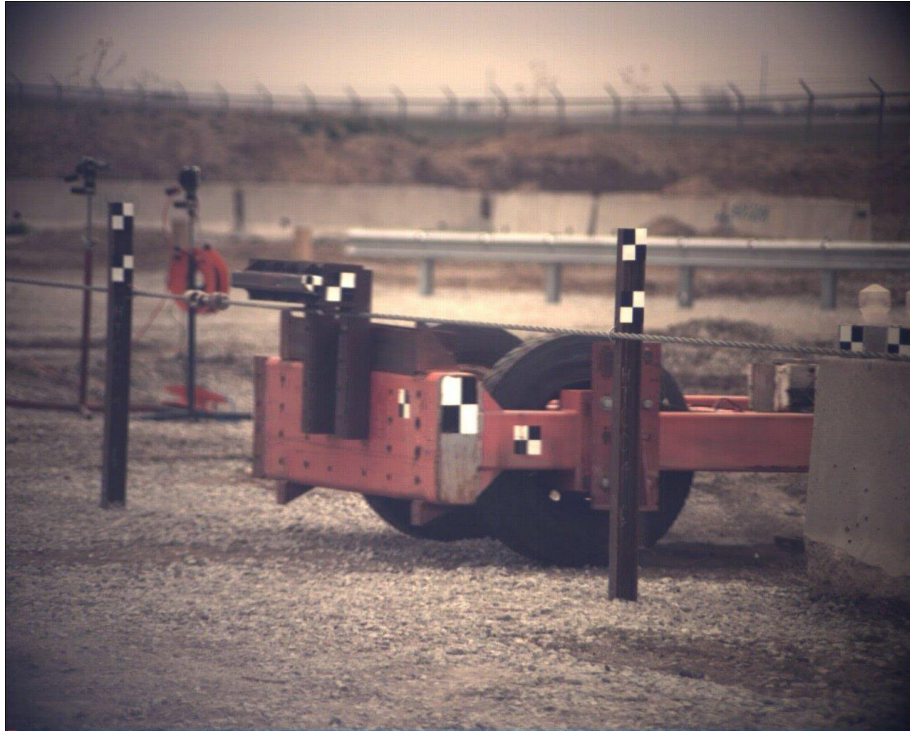
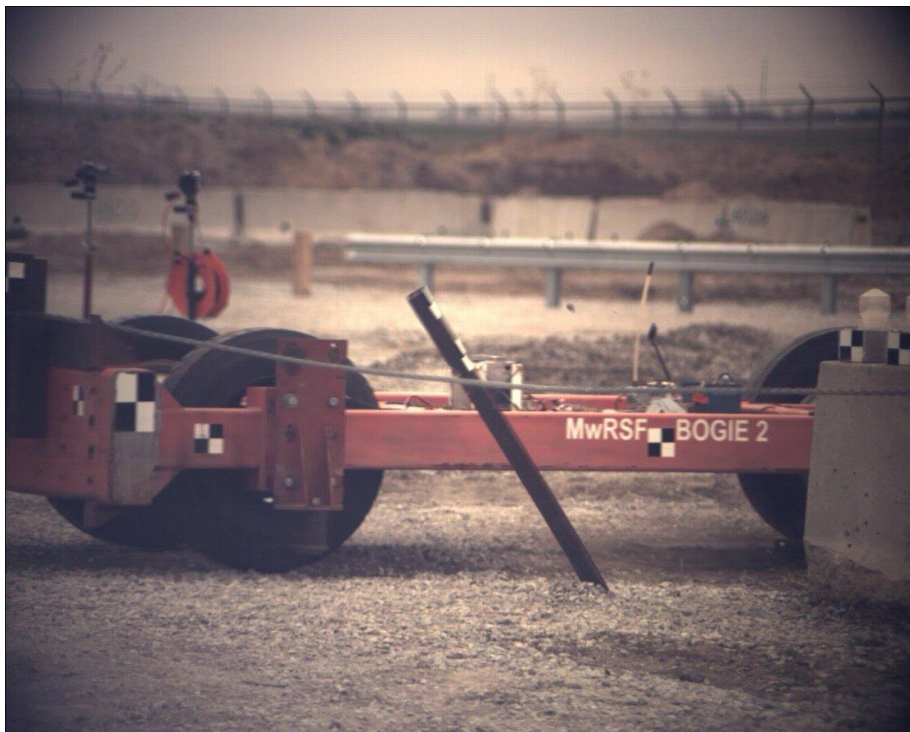
Figure 31. Post Rotation Test with A449 Keyway Bolts, Test No. HTCC-4

Bogie Impacts Cable

Cable Releases from Post

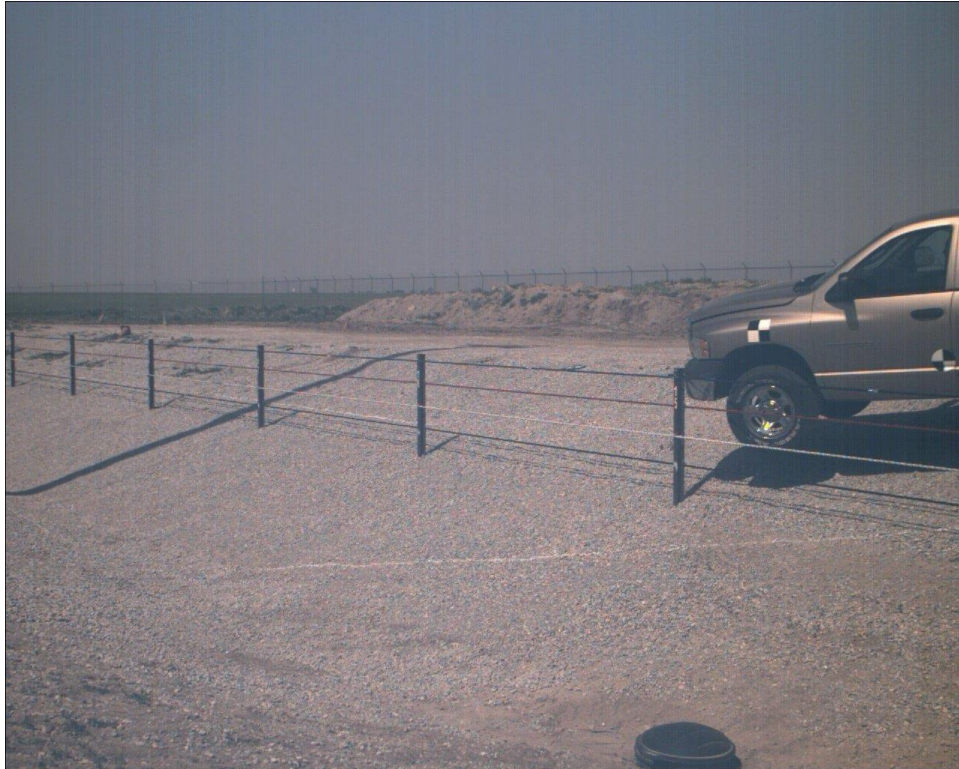
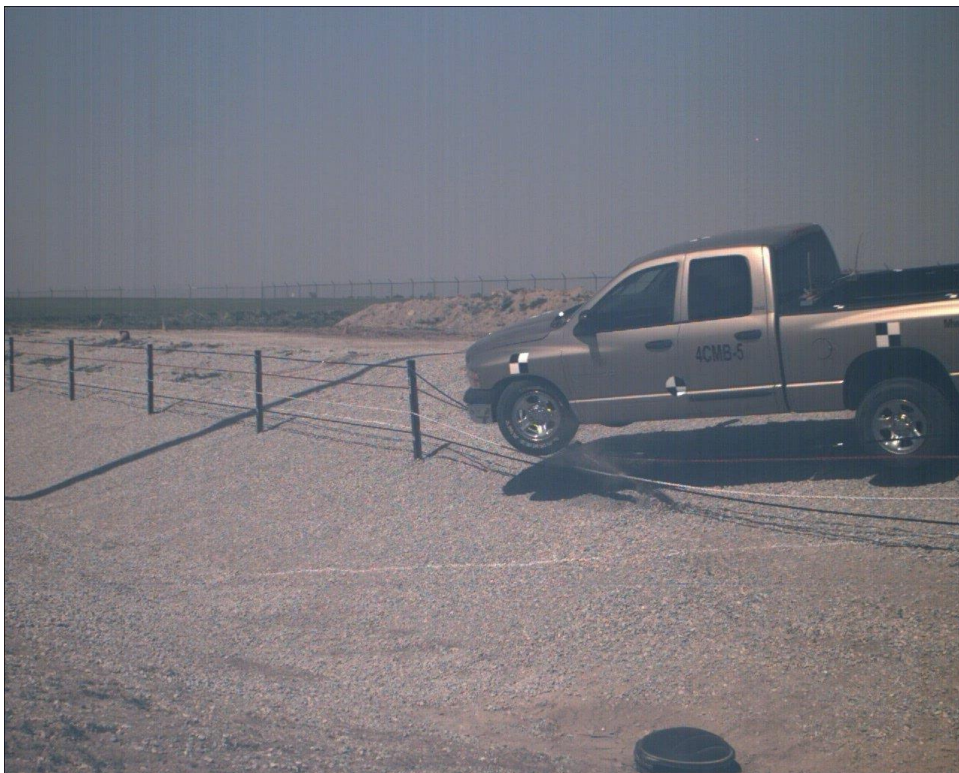
Figure 32. Impact with Post and Barrier Override, Test No. 4CMB-5

For test no. 4CMB-5, a 5,149-lb (2,336-kg) pickup truck (2270P vehicle) impacted the high-tension, 4-cable median barrier at a speed of 61.8 mph (99.5 km/h) and at a 26.5-degree angle. The barrier was located on the front slope of the V-ditch, 12 ft (3.6 m) laterally from the front slope break point. The point of impact was 12 in. (305 mm) upstream of post no. 15. The left-front bumper impacted the post, causing it to begin to rotate downward. As the post rotated, all of the cables were pulled down with it, including the top cable. This action allowed the vehicle to completely override the barrier, as shown in Figure 32. Only the right-rear wheel was snagged by a cable. As a result, the vehicle impacted the back slope and rolled over. The test failed to meet the TL-3 safety performance criteria for test designation no. 3-10 found in MASH. More information about the prototype barrier system and the test, including the test summary sheet, is provided in Appendix B, Figure B-8.

Impact, Time = 0.000 sec

Override, Time = 0.090 sec

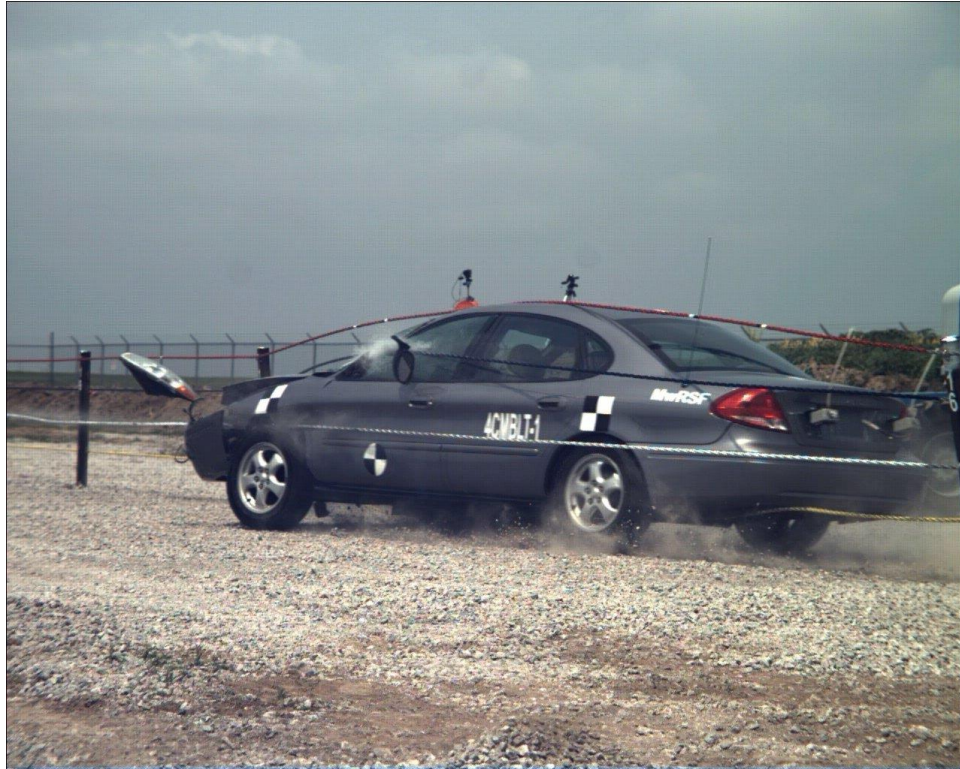
Figure 33. A-Pillar Beginning to Crush, Test No. 4CMBLT-1

In test no. 4CMBLT-1 [4], a 3,470-lb (1,574-kg) passenger car (1500A vehicle) impacted the cable barrier system at a speed of 62.2 mph (100.1 km/h) and at a 25.3-degree angle. For this scenario, the barrier system was placed on level terrain. The critical impact point was determined to occur between two posts. As the vehicle was being redirected, the third cable from the ground heavily interacted with the vehicle and crushed the A-pillar, thus resulting in a failure of the barrier system due to excessive penetration into the vehicle's occupant compartment. Of particular note, the third cable was still attached to the post immediately downstream from the vehicle when it began to crush the A-pillar.

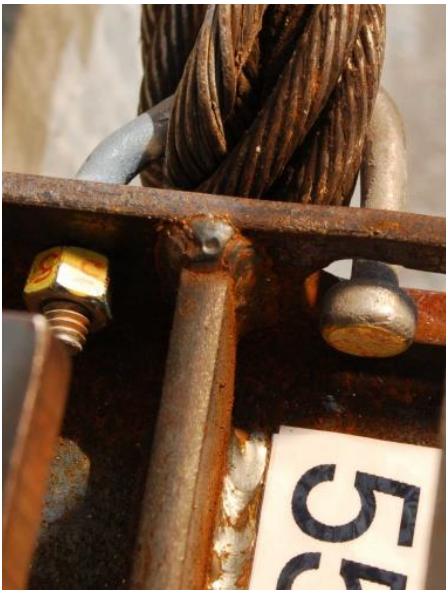
Figure 46. Modified Keyway Bolt—(a) Dimensions and (b) Installed in Large Oversized Keyway

The last concept that would be tested in the first round of modifications was the modified keyway bolt placed in the large oversized keyway. Originally, the modified keyway bolt would be tested with both oversized keyways. However, it was apparent that the small oversized keyway performed inconsistently when the bolt was loaded laterally. Thus, the modified keyway bolt was only tested with the large oversized keyway. The modified keyway bolt, as shown in Figure 46, was designed and tested with the dual-width keyway that was used in the previous cable-to-post attachment testing program [71]. Only the AISI C1018 modified keyway bolts were tested.

b) Installed in Large Oversized Keyway

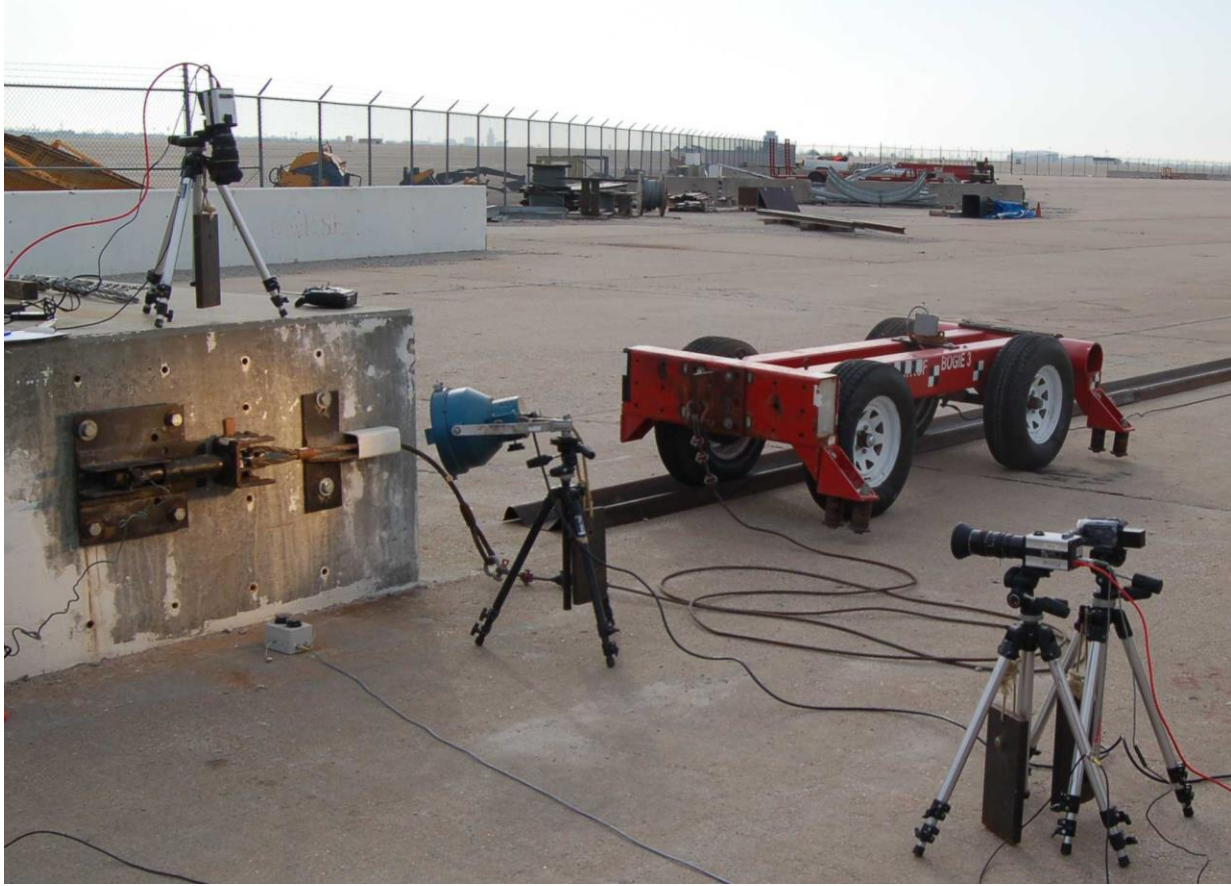
Figure 47. Rigid Frame Bogie on Guidance Track

A rigid-frame bogie was used to pull on a cable which was anchored to the cable-to-post attachment. The bogie with the test setup is shown in Figure 47. The bogie weights were different for each round of tests, as shown in Table 4. A pickup truck, with a reverse cable tow system, was used to propel the bogie along a guidance track to a target speed of 5.0 mph (8.0 km/h). The pickup truck braked allowing the bogie to be free rolling as the bogie approached the end of the guidance system and applied the load to the cable-to-post attachment.

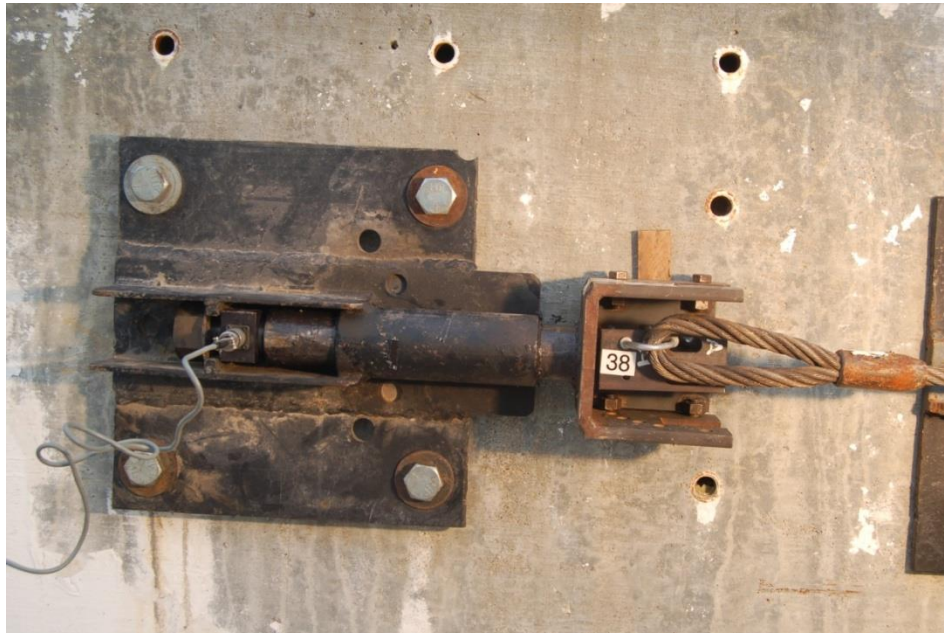
Figure 48. Test Jig

The test jig was mounted to a small section of steel post as well as a steel shaft, which was anchored to a mounting plate placed on the side of a rigid block. The test article (either a

keyway bolt or tabbed bracket) was attached to the post section. The test jig could be adjusted to change the angle at which the cable pulled on the test article. The steel tube or shaft was attached to the mounting plate by a cylindrical joint which allowed a tension load cell to be used to measure the loads. A looped cable was placed through the test article, as shown in Figure 48. The other end of the cable was attached to the bogie, which was towed to a speed of approximately 5 mph (8 km/h).

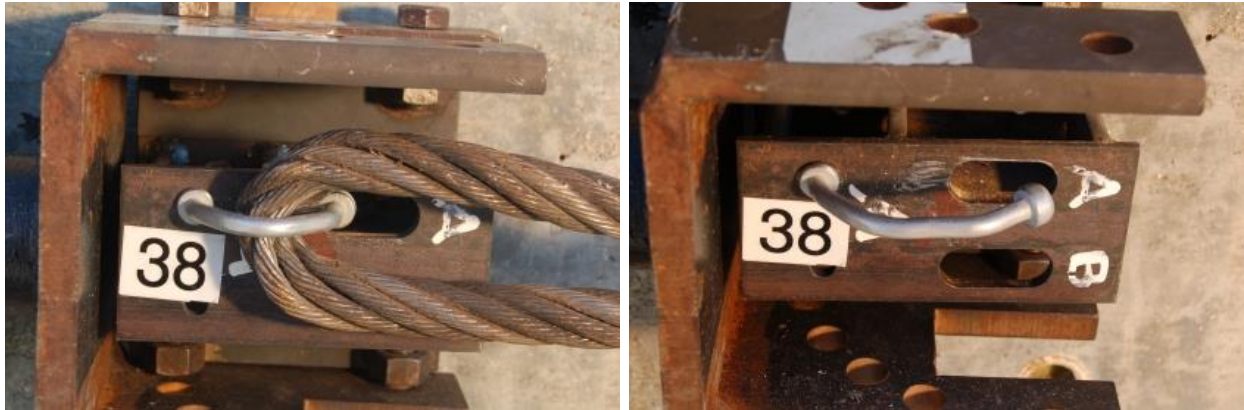
Figure 60. Pre-Test and Post-Test Photographs, Test No. HTCUB-38

For test no. HTCUB-38, the cable pulled on the ASTM A449 keyway bolt at an angle of 0 degrees, parallel to the front face of the flange, thus imparting a vertical load. The keyway bolt was attached to the front flange with one grade 8 nut. The small oversized keyway was used for this test. As the cable pulled on the bolt, the bolt was bent upward and out of the keyway freely with a maximum release load of 494 lb (2.20 kN). A peak load of 932 lb (4.15 kN) occurred as the cable became snagged on the button head, after the button head had already cleared the keyway. The force versus time plot is shown in Figure 59. Pre- and post-test photographs are shown in Figure 60. Sequential photographs are shown in Figure 61.

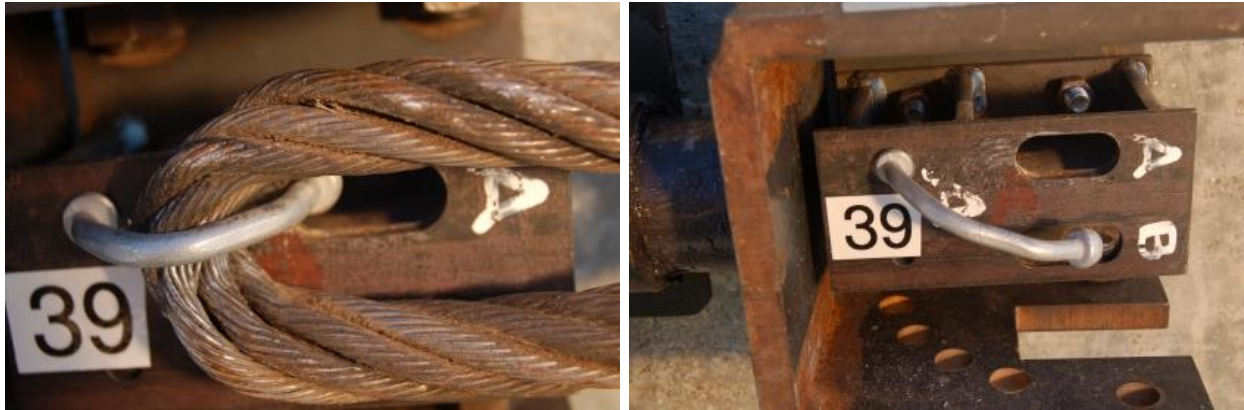
Figure 63. Pre-Test and Post-Test Photographs, Test No. HTCUB-39

For test no. HTCUB-39, the cable pulled on the ASTM A449 keyway bolt at an angle of 0 degrees, parallel to the front face of the flange, thus imparting a vertical load. The keyway bolt was attached to the front flange with one grade 8 nut. The small oversized keyway was used for this test. As the cable pulled on the bolt, the bolt was bent upward and out of the keyway freely with a maximum release load of 459 lb (2.04 kN). A peak load of 844 lb (3.75 kN) occurred as the cable became snagged on the button head, after the button head had already cleared the keyway. The force versus time plot is shown in Figure 62. Pre- and post-test photographs are shown in Figure 63. Sequential photographs are shown in Figure 64.

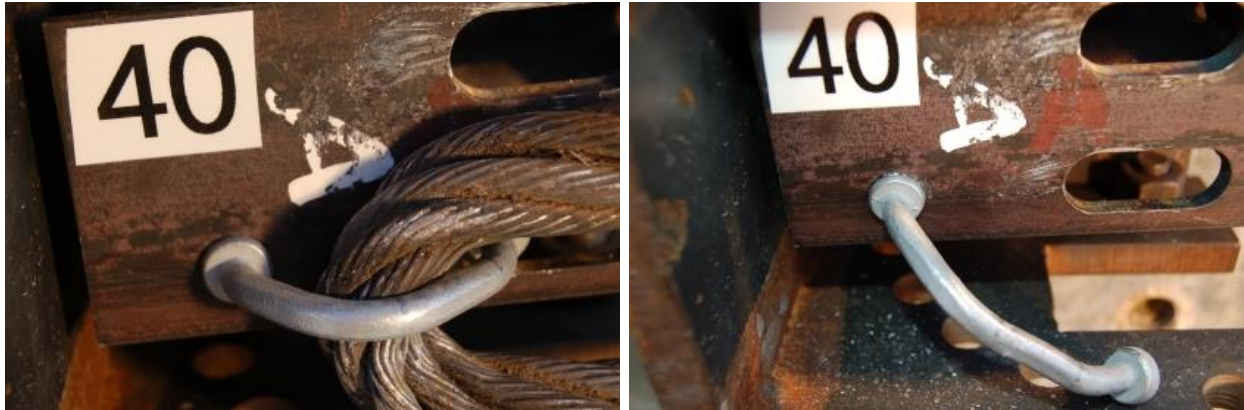
Figure 66. Pre-Test and Post-Test Photographs, Test No. HTCUB-40

For test no. HTCUB-40, the cable pulled on the ASTM A449 keyway bolt at an angle of 0 degrees, parallel to the front face of the flange, thus imparting a vertical load. The keyway bolt was attached to the front flange with one grade 8 nut. The large oversized keyway was used for this test. As the cable pulled on the bolt, the bolt was bent upward and out of the keyway freely with a maximum release load of 489 lb (2.18 kN). A peak load of 879 lb (3.91 kN) occurred as the cable became snagged on the button head, after the button head had already cleared the keyway. The force versus time plot is shown in Figure 65. Pre- and post-test photographs are shown in Figure 66. Sequential photographs are shown in Figure 67.

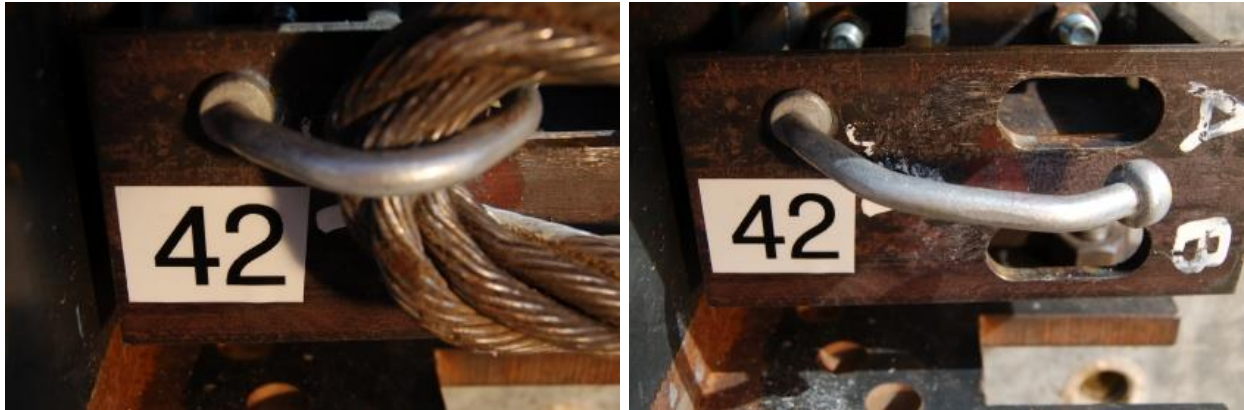
Figure 72. Pre-Test and Post-Test Photographs, Test No. HTCUB-42

For test no. HTCUB-42, the cable pulled on the AISI C1018 keyway bolt at an angle of 0 degrees, parallel to the front face of the flange, thus imparting a vertical load. The keyway bolt was attached to the front flange with one grade 8 nut. The small oversized keyway was used for this test. As the cable pulled on the bolt, the bolt was bent upward and out of the keyway freely with a maximum release load of 305 lb (1.36 kN). A peak load of 533 lb (2.37 kN) occurred as the cable became snagged on the button head, after the button head had already cleared the keyway. The force versus time plot is shown in Figure 71. Pre- and post-test photographs are shown in Figure 72. Sequential photographs are shown in Figure 73.

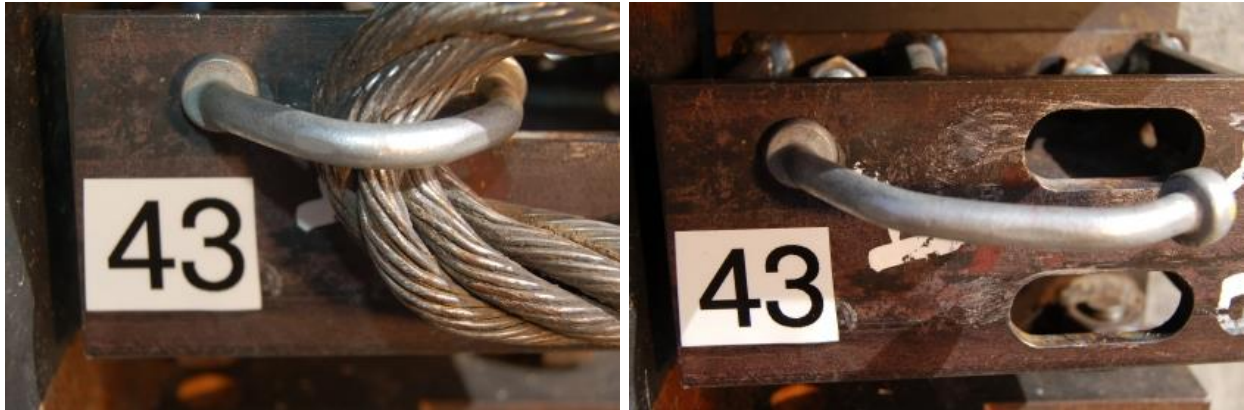
Figure 75. Pre-Test and Post-Test Photographs, Test No. HTCUB-43

For test no. HTCUB-43, the cable pulled on the AISI C1018 keyway bolt at an angle of 0 degrees, parallel to the front face of the flange, thus imparting a vertical load. The keyway bolt was attached to the front flange with one grade 8 nut. The small oversized keyway was used for this test. As the cable pulled on the bolt, the bolt was bent upward and out of the keyway freely with a maximum release load of 390 lb (1.73 kN). A peak load of 516 lb (2.30 kN) occurred as the cable became snagged on the button head, after the button head had already cleared the keyway. The force versus time plot is shown in Figure 74. Pre- and post-test photographs are shown in Figure 75. Sequential photographs are shown in Figure 76.

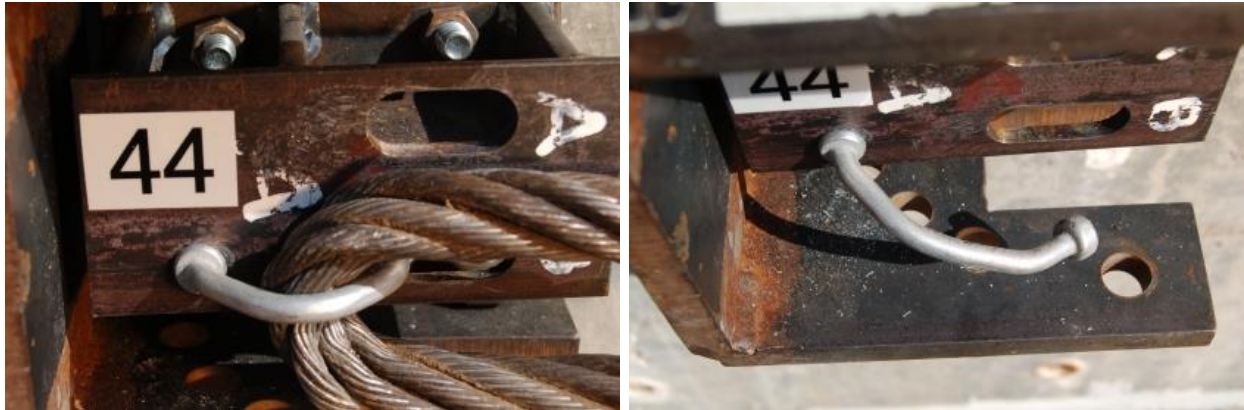
Figure 78. Pre-Test and Post-Test Photographs, Test No. HTCUB-44

For test no. HTCUB-44, the cable pulled on the AISI C1018 keyway bolt at an angle of 0 degrees, parallel to the front face of the flange, thus imparting a vertical load. The keyway bolt was attached to the front flange with one grade 8 nut. The large oversized keyway was used for this test. As the cable pulled on the bolt, the bolt was bent upward and out of the keyway freely with a maximum release load of 282 lb (1.25 kN). A peak load of 475 lb (2.11 kN) occurred as the cable became snagged on the button head, after the button head had already cleared the keyway. The force versus time plot is shown in Figure 77. Pre- and post-test photographs are shown in Figure 78. Sequential photographs are shown in Figure 79.

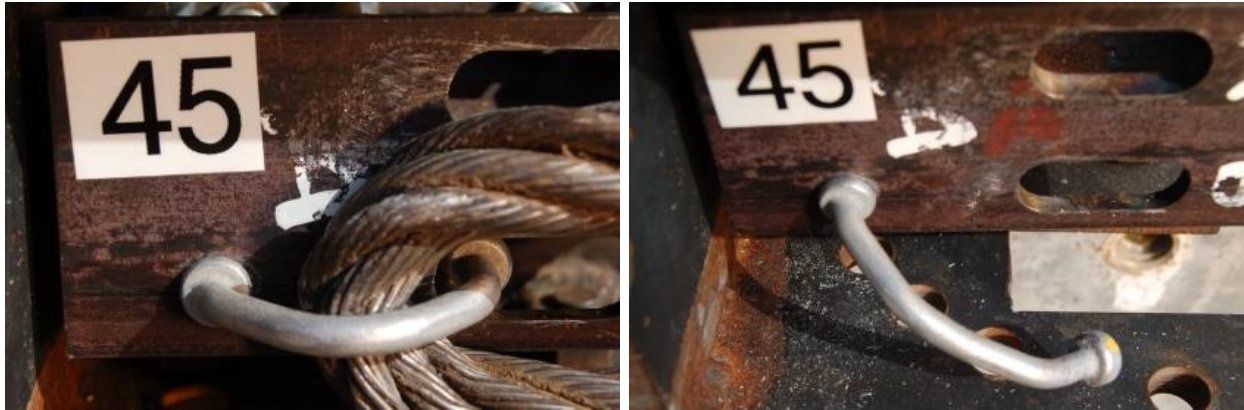
Figure 81. Pre-Test and Post-Test Photographs, Test No. HTCUB-45

For test no. HTCUB-45, the cable pulled on the AISI C1018 keyway bolt at an angle of 0 degrees, parallel to the front face of the flange, thus imparting a vertical load. The keyway bolt was attached to the flange with one grade 8 nut. The large oversized keyway was used for this test. As the cable pulled on the bolt, the bolt was bent upward and out of the keyway freely with a maximum release load of 379 lb (1.69 kN). The peak load of 601 lb (2.67 kN) occurred as the cable became snagged on the button head, after the button head had already cleared the keyway. The force versus time plot is shown in Figure 80. Pre- and post-test photographs are shown in Figure 81. Sequential photographs are shown in Figure 82.

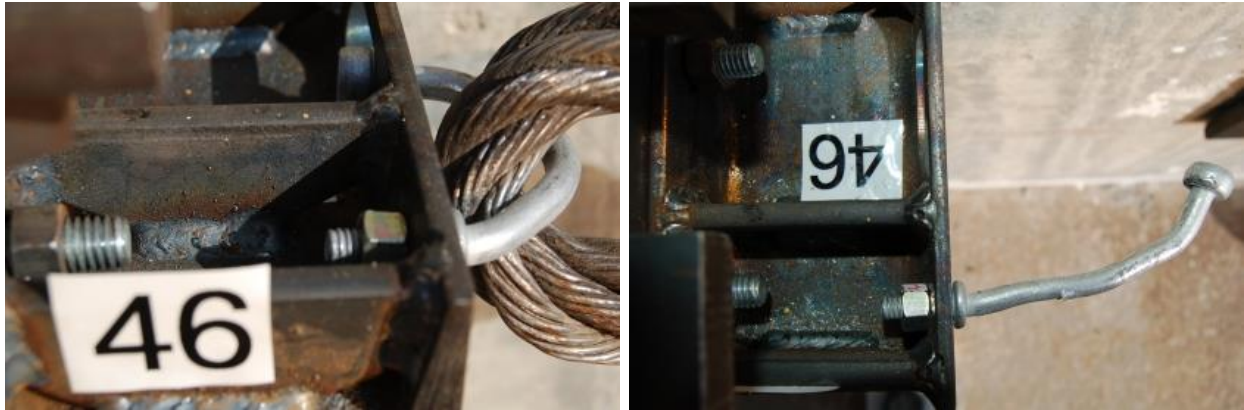
Figure 84. Pre-Test and Post-Test Photographs, Test No. HTCUB-46

For test no. HTCUB-46, the cable pulled on the ASTM A449 keyway bolt at an angle of 90 degrees, perpendicular to the front face of the flange, thus imparting a lateral load. The keyway bolt was attached to the front flange with one grade 8 nut. The small oversized keyway was used for this test. As the cable began to pull on the bolt, the button head was not caught or snagged on the bottom or side of the keyway but released through the keyway freely. A peak load of 1.14 kips (5.07 kN) occurred as the bolt was bent straight out by the cable. The force versus time plot is shown in Figure 83. Pre- and post-test photographs are shown in Figure 84. Sequential photographs are shown in Figure 85.

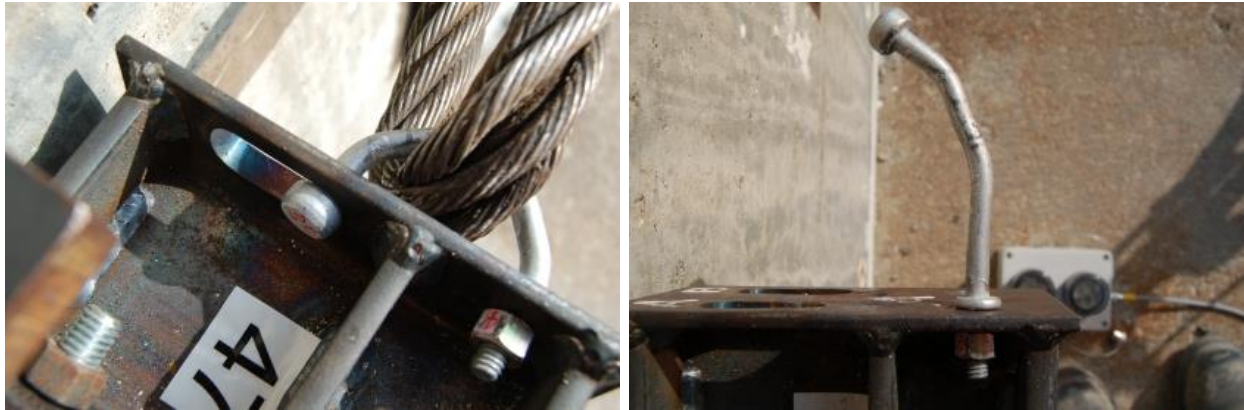
Figure 87. Pre-Test and Post-Test Photographs, Test No. HTCUB-47

For test no. HTCUB-47, the cable pulled on the ASTM A449 keyway bolt at an angle of 90 degrees, perpendicular to the front face of the flange, thus imparting a lateral load. The keyway bolt was attached to the front flange with one grade 8 nut. The small oversized keyway was used for this test. As the cable began to pull on the bolt, the button head was caught on the bottom of the keyway. A peak load of 5.05 kips (22.5 kN) occurred while the button head was caught on the bottom of the keyway, as the cable continued to pull on the bolt. Finally, the button head slipped off, and the cable released as it straightened out the bolt. The force versus time plot is shown in Figure 86. Pre- and post-test photographs are shown in Figure 87. Sequential photographs are shown in Figure 88.
