Design of Cable-to-Post Attachments for Use in a Non-Proprietary, High-Tension, Cable Median Barrier

*Midwest States Regional Pooled Fund Research Program
Fiscal Years 2009-2012 (Years 19 and 22)
Research Project Number TPF-5(091) and TPF-5(193)
NDOR Sponsoring Agency Code RFPF-09-01 and RFPF-12-CABLE 1&2*

DESIGN OF CABLE-TO-POST ATTACHMENTS FOR USE IN A NON-PROPRIETARY, HIGH-TENSION, CABLE MEDIAN BARRIER

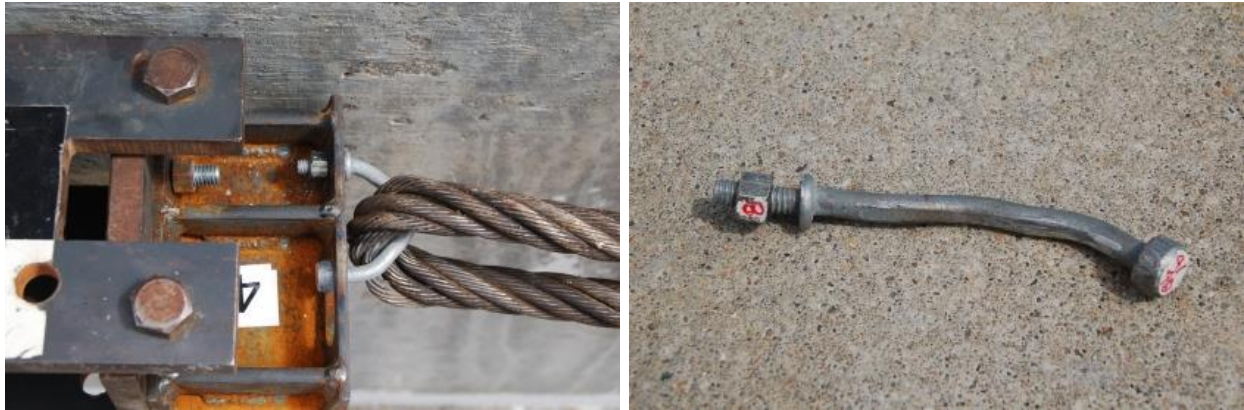
Figure 90. Pre-Test and Post-Test Photographs, Test No. HTCUB-48

For test no. HTCUB-48, the cable pulled on the ASTM A449 keyway bolt at an angle of 90 degrees, perpendicular to the front face of the flange, thus imparting a lateral load. The keyway bolt was attached to the front flange with one grade 8 nut. The large oversized keyway was used for this test. As the cable began to pull on the bolt, the button head was not caught or snagged on the bottom or side of the keyway but released through the keyway freely. A peak load of 840 lb (3.74 kN) occurred as the bolt was bent straight out by the cable. The force versus time plot is shown in Figure 89. Pre- and post-test photographs are shown in Figure 90. Sequential photographs are shown in Figure 91.

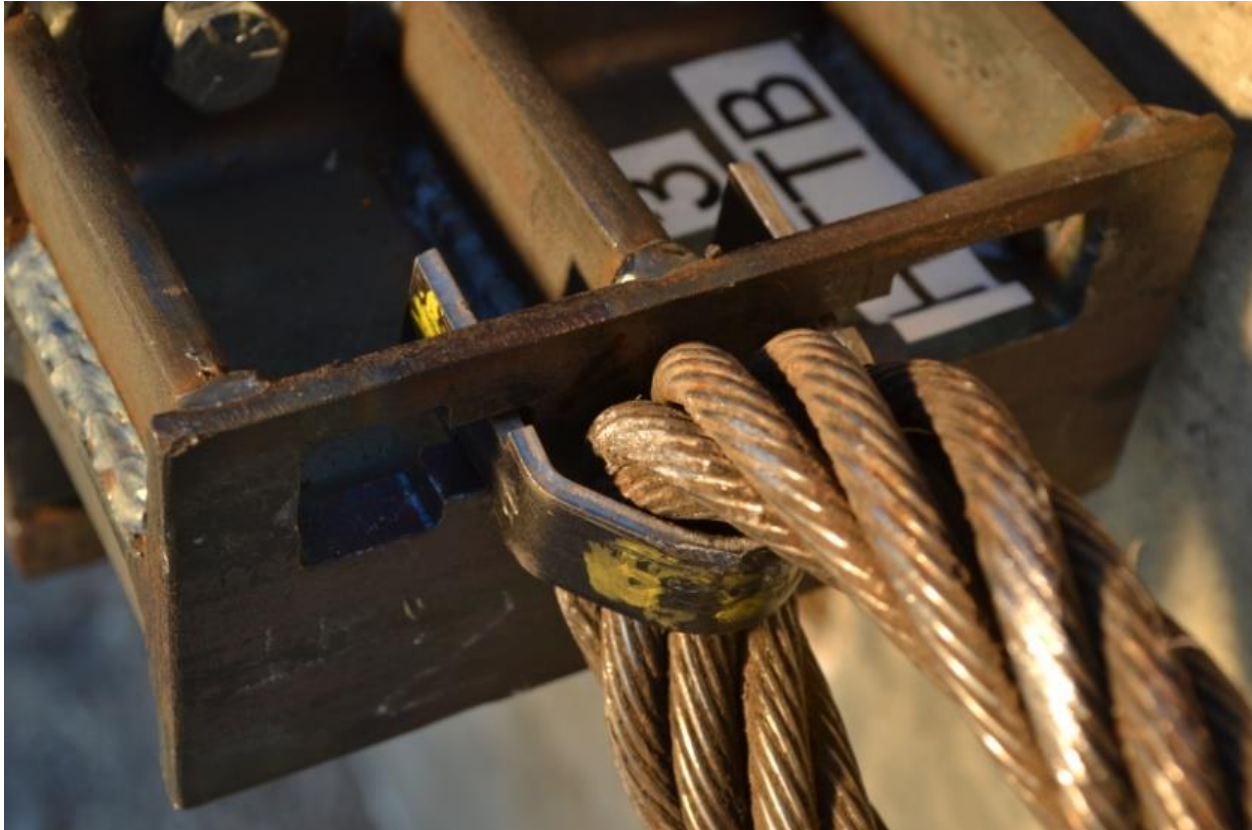
Figure 154. Installed Crimp-In-Place Tabbed Bracket

“Crimp-in-place” refers to the method of attachment to the support posts following cable insertion. The crimp-in-place tabbed brackets consisted of only one part. These brackets were inserted into the top and bottom keyways and crimped into place with channel-lock pliers, thus eliminating the need for extra parts, such as bolts, nuts, and washers. An example of an installed crimp-in-place tabbed bracket is shown in Figure 154.

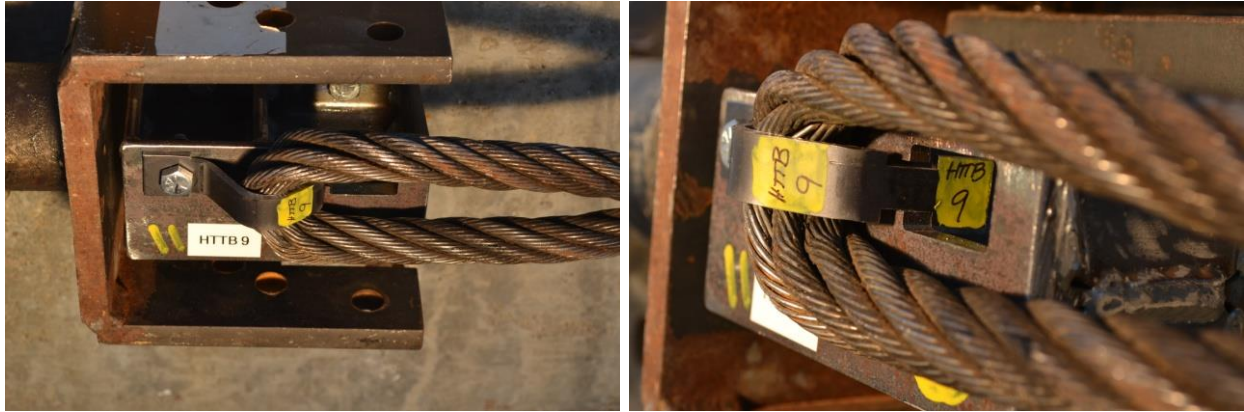
Figure 228. Installed Bolted Tabbed Bracket

The bolted tabbed brackets consisted of three pieces—a non-symmetric tabbed bracket, a bolt, and a nut. While there were three parts versus two parts for the extended keyway bolt concept or common J bolts used in existing low-tension cable barriers, hardware installation was considered to be rather straight forward and easy. An installed bolted tabbed bracket is shown in Figure 228.

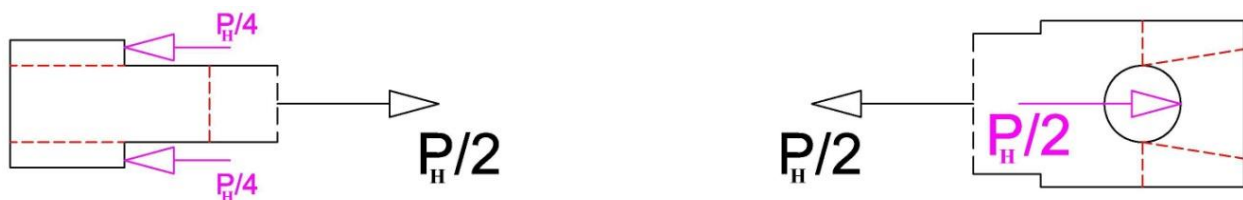
Figure 231. End Reactions for Use in the Design Equations

For the lateral loading condition, as shown in Figure 229a, four failure locations were assumed in the bracket, as shown in Figure 231, thus resulting in four separate equations. It should be noted that dynamic magnification factors were not used in the second round of equations as they were not deemed necessary. One half of the horizontal load, P_H , was assumed to be distributed to each end of the tabbed bracket, as shown in Figure 231.

Failure location 1 was assumed to be a pure shear fracture. For pure shear, the shear yield strength is the tensile yield strength divided by the square root of three. This result corresponds to the maximum octahedral shear stress condition [75]. The same factor can be used with the ultimate tensile strength to obtain the ultimate shear strength. The lateral load needed to cause

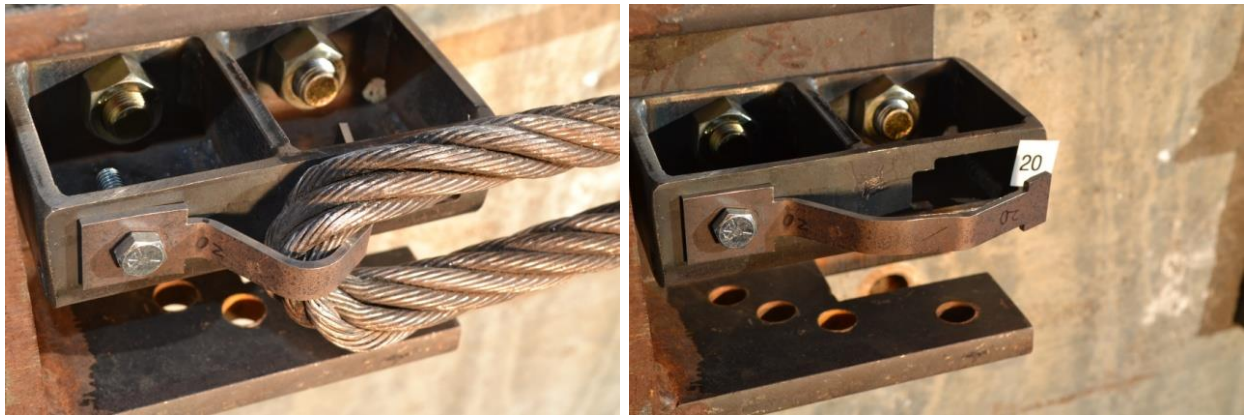
Figure 299. Pre-Test and Post-Test Photographs, Test No. HTTPB-20

For test no. HTTB-20, the cable pulled on the 12-gauge, grade 50 steel, bolted tabbed bracket Version 8 at an angle of 0 degrees, parallel to the front face of the flange, thus imparting a vertical load. The post consisted of a 5-½-in. (140-mm) long, folded C-section, fabricated from 7-gauge, grade 50 sheet steel. The top end of the tabbed bracket rested in the keyway, while the bottom end was secured to the flange with a 5/16-in. (8-mm), grade 5, hex cap screw and nut. The bracket began to bend as the cable began to pull on it. As the bracket bent, the head rotated out of the keyway freely with a maximum release load of 283 lb (1.26 kN). A peak load of 362 lb (1.61 kN) occurred as the cable became snagged on the head, after it had already cleared the keyway. The force versus time plot is shown in Figure 298. Pre- and post-test photographs are shown in Figure 299. Sequential photographs are shown in Figure 300.

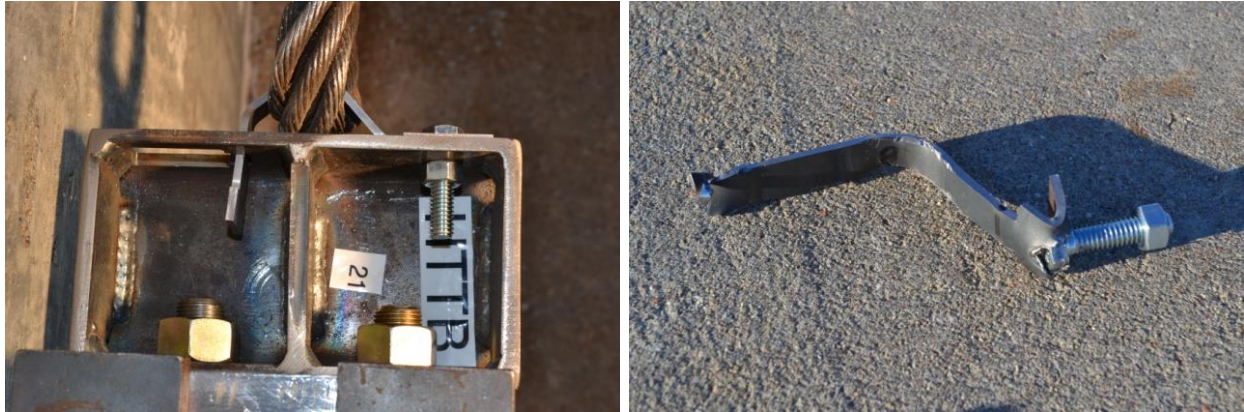
Figure 302. Pre-Test and Post-Test Photographs, Test No. HTTPB-21

For test no. HTTB-21, the cable pulled on the 12-gauge, grade 50 steel, bolted tabbed bracket Version 8 at an angle of 90 degrees, perpendicular to the front face of the flange, thus imparting a lateral load. The post consisted of a 5-½-in. (140-mm) long, folded C-section, fabricated from 7-gauge, grade 50 sheet steel. The top end of the tabbed bracket rested in the keyway, while the bottom end was secured to the flange with a 5/16-in. (8-mm), grade 5, hex cap screw and nut. As the cable began to pull on the bracket, the head became caught in the narrow part of the keyway. The cable continued to pull until the tabs were sheared off (failure location 1). There was also significant cracking at the location of the bolt hole, indicating that tensile fracture (failure location 3) was imminent at that location. A peak load of 5.71 kips (25.4 kN) occurred as the head was pulled against the inside of the keyway, just before shear failure. Due to technical difficulties, there was no high-speed video, but the standard speed video was useful nonetheless. The force versus time plot is shown in Figure 301. Pre- and post-test photographs are shown in Figure 302. Sequential photographs are shown in Figure 303.

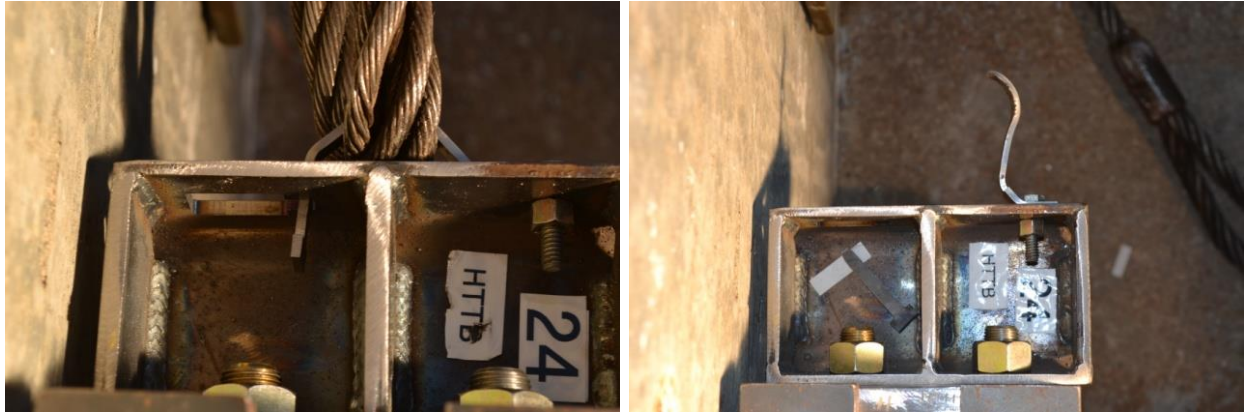
Figure 311. Pre-Test and Post-Test Photographs, Test No. HTTPB-24

For test no. HTTB-24, the cable pulled on the 12-gauge, grade 50 steel, bolted tabbed bracket Version 5 at an angle of 90 degrees, perpendicular to the front face of the flange, thus imparting a lateral load. The post consisted of a 5-½-in. (140-mm) long, folded C-section, fabricated from 7-gauge, grade 50 sheet steel. The top end of the tabbed bracket rested in the keyway, while the bottom end was secured to the flange with a ¼-in. (6-mm), grade 5, hex cap screw and nut. As the cable began to pull on the bracket, the head became caught in the narrow part of the keyway. The cable continued to pull until fracture occurred through the narrow part of the bracket (failure location 2). A peak load of 2.97 kips (13.2 kN) occurred as the head was pulled against the inside of the keyway, just before fracture. The force versus time plot is shown in Figure 310. Pre- and post-test photographs are shown in Figure 311. Sequential photographs are shown in Figure 312.

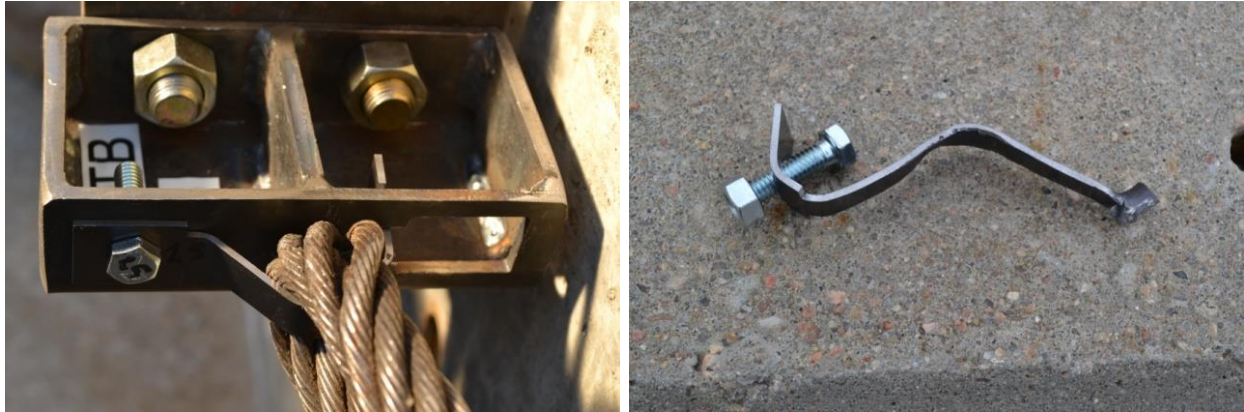
Figure 314. Pre-Test and Post-Test Photographs, Test No. HTTB-25

For test no. HTTB-25, the cable pulled on the 14-gauge, grade 50 steel, bolted tabbed bracket Version 6 at an angle of 90 degrees, perpendicular to the front face of the flange, thus imparting a lateral load. The post consisted of a 5-½-in. (140-mm) long, folded C-section, fabricated from 7-gauge, grade 50 sheet steel. The top end of the tabbed bracket rested in the keyway, while the bottom end was secured to the flange with a 5/16-in. (8-mm), grade 5, hex cap screw and nut. As the cable began to pull on the bracket, the head became caught in the narrow part of the keyway. The cable continued to pull until cracks began to form along the shear planes of the tabs. As the cracks grew, the entire head bent out of plane, until slipping through the keyway (failure location 1). There was also yielding of the steel at the location of the bolt hole, indicating that tensile fracture (failure location 3) was imminent at that location. A peak load of 3.50 kips (15.6 kN) occurred as the head was pulled against the inside of the keyway, just before shear failure. The force versus time plot is shown in Figure 313. Pre- and post-test photographs are shown in Figure 314. Sequential photographs are shown in Figure 315.

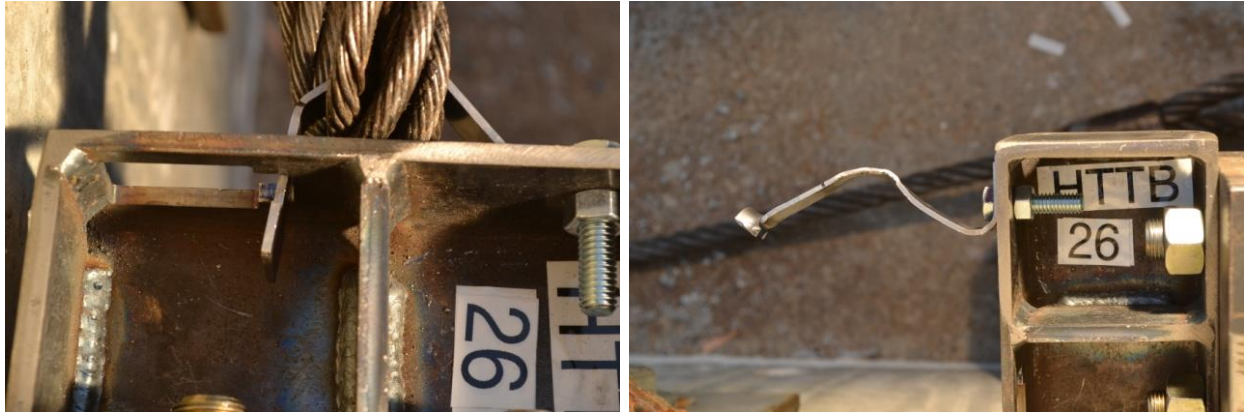
Figure 317. Pre-Test and Post-Test Photographs, Test No. HTTPB-26

For test no. HTTB-26, the cable pulled on the 14-gauge, grade 50 steel, bolted tabbed bracket Version 6 at an angle of 90 degrees, perpendicular to the front face of the flange, thus imparting a lateral load. The post consisted of a 5-½-in. (140-mm) long, folded C-section, fabricated from 7-gauge, grade 50 sheet steel. The top end of the tabbed bracket rested in the keyway, while the bottom end was secured to the flange with a 5/16-in. (8-mm), grade 5, hex cap screw and nut. As the cable began to pull on the bracket, the head became caught in the narrow part of the keyway. The cable continued to pull until cracks began to form along the shear planes of the tabs. As the cracks grew, the entire head bent out of plane, until slipping through the keyway (failure location 1). There was also yielding of the steel at the location of the bolt hole, indicating that tensile fracture (failure location 3) was imminent at that location. A peak load of 3.44 kips (15.3 kN) occurred as the head was pulled against the inside of the keyway, just before shear failure. The force versus time plot is shown in Figure 316. Pre- and post-test photographs are shown in Figure 317. Sequential photographs are shown in Figure 318.

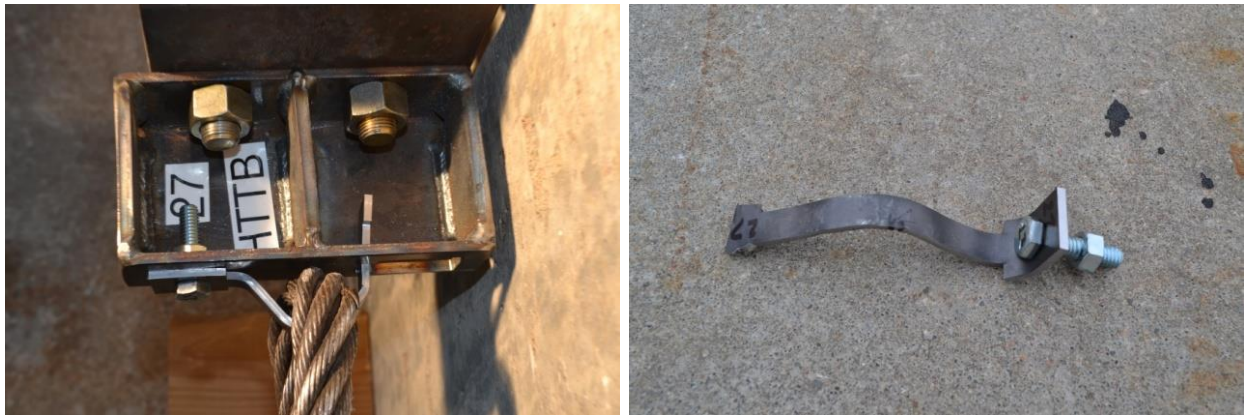
Figure 320. Pre-Test and Post-Test Photographs, Test No. HTTPB-27

For test no. HTTB-27, the cable pulled on the 11-gauge, grade 50 steel, bolted tabbed bracket Version 7 at an angle of 90 degrees, perpendicular to the front face of the flange, thus imparting a lateral load. The post consisted of a 5-½-in. (140-mm) long, folded C-section, fabricated from 7-gauge, grade 50 sheet steel. The top end of the tabbed bracket rested in the keyway, while the bottom end was secured to the flange with a 5/16-in. (8-mm), grade 5, hex cap screw and nut. As the cable began to pull on the bracket, the head became caught in the narrow part of the keyway. The cable continued to pull until the corner of one of the tabs sheared off. As this happened, the bracket began to twist, allowing the head to slip through the narrow part of the keyway. This type of failure was not anticipated. A peak load of 4.04 kips (18.0 kN) occurred as the head was pulled against the inside of the keyway, just before the corner of the one tab sheared off. The force versus time plot is shown in Figure 319. Pre- and post-test photographs are shown in Figure 320. Sequential photographs are shown in Figure 321.

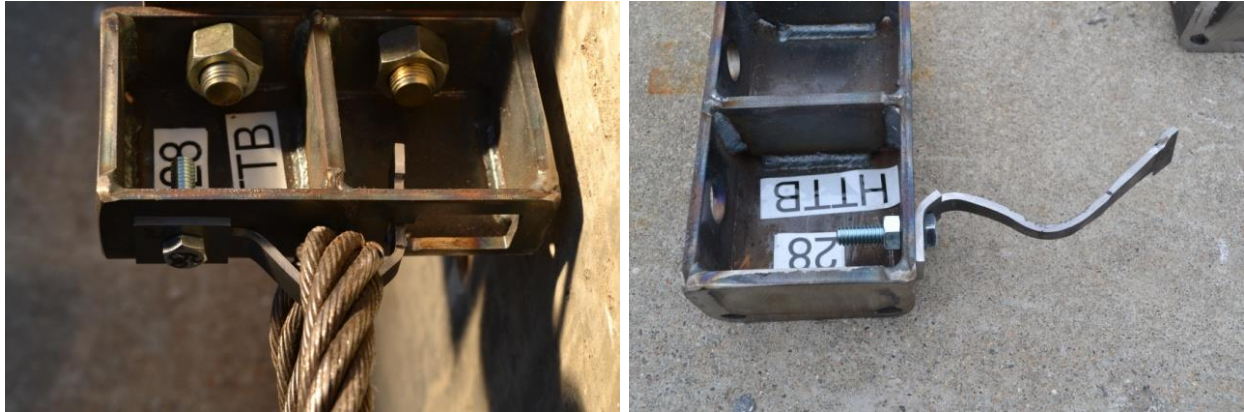
Figure 323. Pre-Test and Post-Test Photographs, Test No. HTTPB-28

For test no. HTTB-28, the cable pulled on the 11-gauge, grade 50 steel, bolted tabbed bracket Version 7 at an angle of 90 degrees, perpendicular to the front face of the flange, thus imparting a lateral load. The post consisted of a 5-½-in. (140-mm) long, folded C-section, fabricated from 7-gauge, grade 50 sheet steel. The top end of the tabbed bracket rested in the keyway, while the bottom end was secured to the flange with a 5/16-in. (8-mm), grade 5, hex cap screw and nut. As the cable began to pull on the bracket, the head became caught in the narrow part of the keyway. The cable continued to pull until the corner of one of the tabs sheared off. As this happened, the bracket began to twist, allowing the head to slip through the narrow part of the keyway. This type of failure was not anticipated. A peak load of 4.88 kips (21.7 kN) occurred as the head was pulled against the inside of the keyway, just before the corner of the one tab sheared off. The force versus time plot is shown in Figure 322. Pre- and post-test photographs are shown in Figure 323. Sequential photographs are shown in Figure 324.

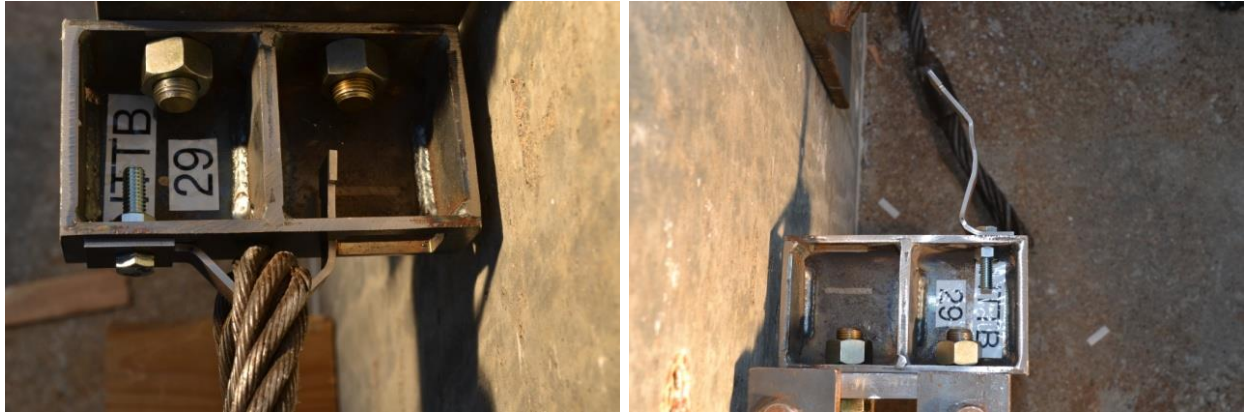
Figure 326. Pre-Test and Post-Test Photographs, Test No. HTTPB-29

For test no. HTTB-29, the cable pulled on the 12-gauge, grade 50 steel, bolted tabbed bracket Version 9 at an angle of 90 degrees, perpendicular to the front face of the flange, thus imparting a lateral load. The post consisted of a 5-½-in. (140-mm) long, folded C-section, fabricated from 7-gauge, grade 50 sheet steel. The top end of the tabbed bracket rested in the keyway, while the bottom end was secured to the flange with a 5/16-in. (8-mm), grade 5, hex cap screw and nut. As the cable began to pull on the bracket, the head was not caught in the narrow part of the keyway. Instead of becoming caught in the narrow part of the keyway, the head released through the wide part freely. A peak load of 768 lb (3.42 kN) occurred as the bracket bent straight out by the cable. The force versus time plot is shown in Figure 325. Pre- and post-test photographs are shown in Figure 326. Sequential photographs are shown in Figure 327.

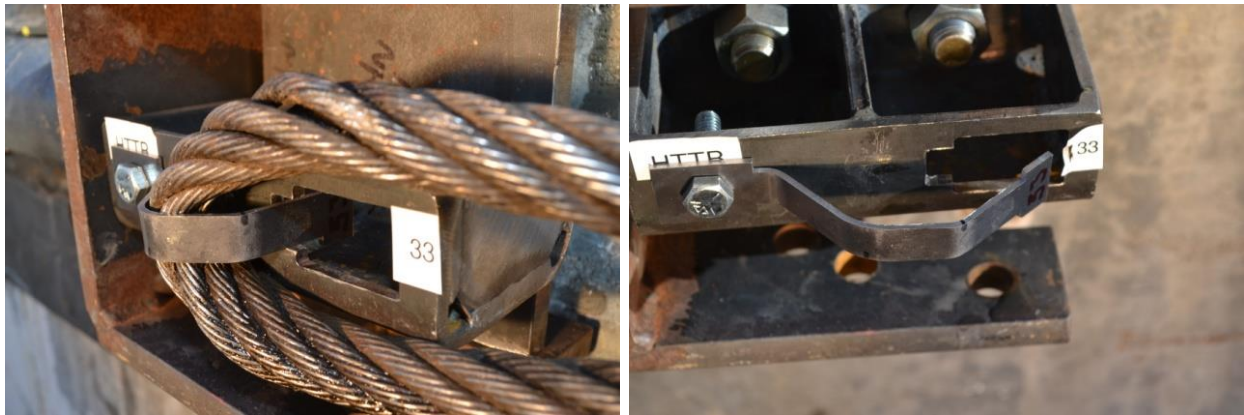
Figure 337. Pre-Test and Post-Test Photographs, Test No. HTTP-33

For test no. HTTB-33, the cable pulled on the 14-gauge, grade 50 steel, bolted tabbed bracket Version 6 at an angle of 0 degrees, parallel to the front face of the flange, thus imparting a vertical load. The post consisted of a 5-½-in. (140-mm) long, folded C-section, fabricated from 7-gauge, grade 50 sheet steel. The top end of the tabbed bracket rested in the keyway, while the bottom end was secured to the flange with a 5/16-in. (8-mm), grade 5, hex cap screw and nut. The bracket began to bend as the cable began to pull on it. As the bracket bent, the edge of one of the tabs snagged the side of the keyway before the head finally released through it. The load cell data was not usable. Therefore, the peak forces were not known. Pre- and post-test photographs are shown in Figure 337. Sequential photographs are shown in Figure 338.

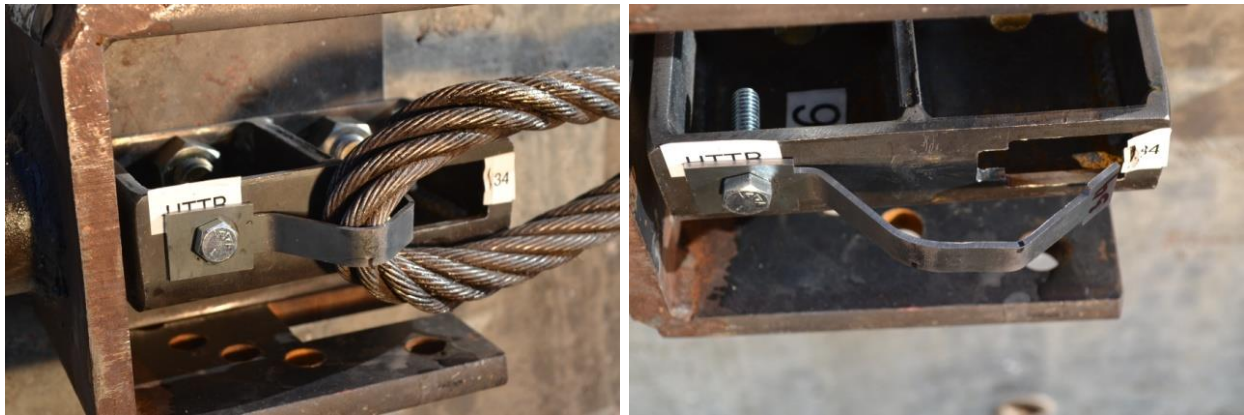
Figure 339. Pre-Test and Post-Test Photographs, Test No. HTTP-34

For test no. HTTB-34, the cable pulled on the 14-gauge, grade 50 steel, bolted tabbed bracket Version 6 at an angle of 0 degrees, parallel to the front face of the flange, thus imparting a vertical load. The post consisted of a 5-½-in. (140-mm) long, folded C-section, fabricated from 7-gauge, grade 50 sheet steel. The top end of the tabbed bracket rested in the keyway, while the bottom end was secured to the flange with a 5/16-in. (8-mm), grade 5, hex cap screw and nut. The bracket began to bend as the cable began to pull on it. As the bracket bent, the edge of one of the tabs snagged the side of the keyway before the head finally released through it. The load cell data was not usable. Therefore, the peak forces were not known. Pre- and post-test photographs are shown in Figure 339. Sequential photographs are shown in Figure 340.

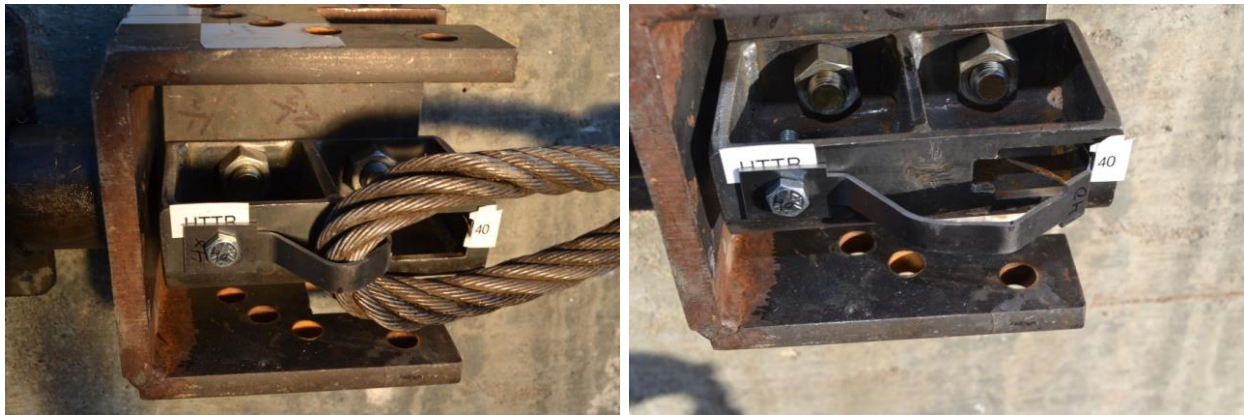
Figure 356. Pre-Test and Post-Test Photographs, Test No. HTTP-40

Test no. HTTPB-40 was a re-trial of test no. HTTPB-34; since, the data was not usable for that test. For test no. HTTPB-40, the cable pulled on the 14-gauge, grade 50 steel, bolted tabbed bracket Version 6 at an angle of 0 degrees, parallel to the front face of the flange, thus imparting a vertical load. The post consisted of a 5-½-in. (140-mm) long, folded C-section, fabricated from 7-gauge, grade 50 sheet steel. The head rested in the keyway, while the bottom end was secured to the flange with a 5/16-in. (8-mm), grade 5, hex cap screw and nut. Due to technical difficulties, there was no high-speed video for this test. From the standard speed video, it was clear that the head released through the keyway as the cable pulled on the bracket. The load cell data was not usable. Therefore, the peak loads were not known. Pre- and post-test photographs are shown in Figure 356. Sequential photographs are shown in Figure 357.

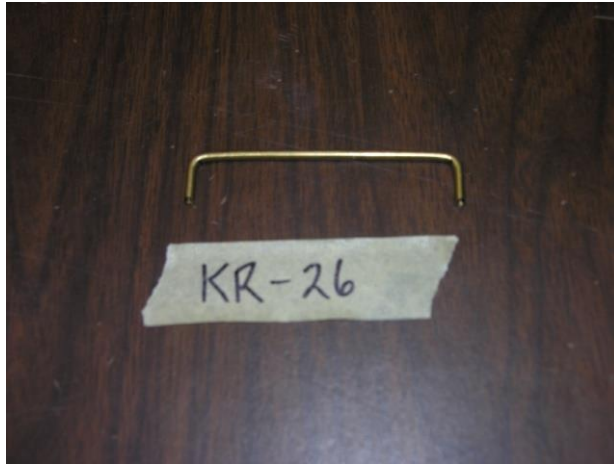
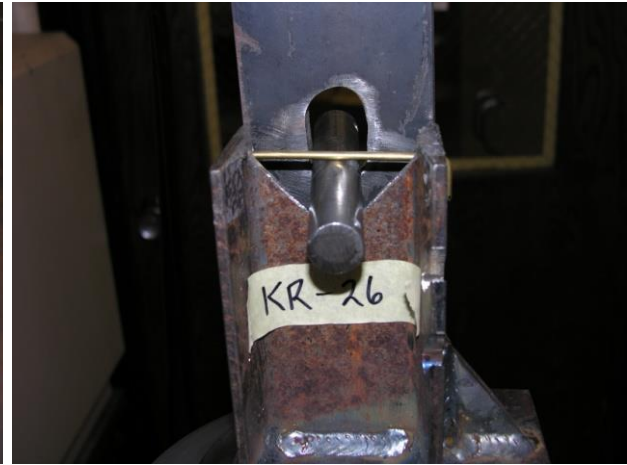
Figure 364. Straight Rod Example

For the final design concept, a straight rod with bent ends was positioned over a cable which was placed in the bottom of a v-notch in the web. The straight rod with bent ends was inserted through a hole and slot in the flanges. Six different variations were fabricated and tested. These variations included C360 brass and T-304 stainless steel rods with diameters of 1/8 in. (3.2 mm), 3/16 in. (4.8 mm), and 1/4 in. (6.4 mm). An example of one of these variations is shown in Figure 364. For all of the concepts denoted in Chapter 17, the straight brass rods with bent ends were the easiest to install.

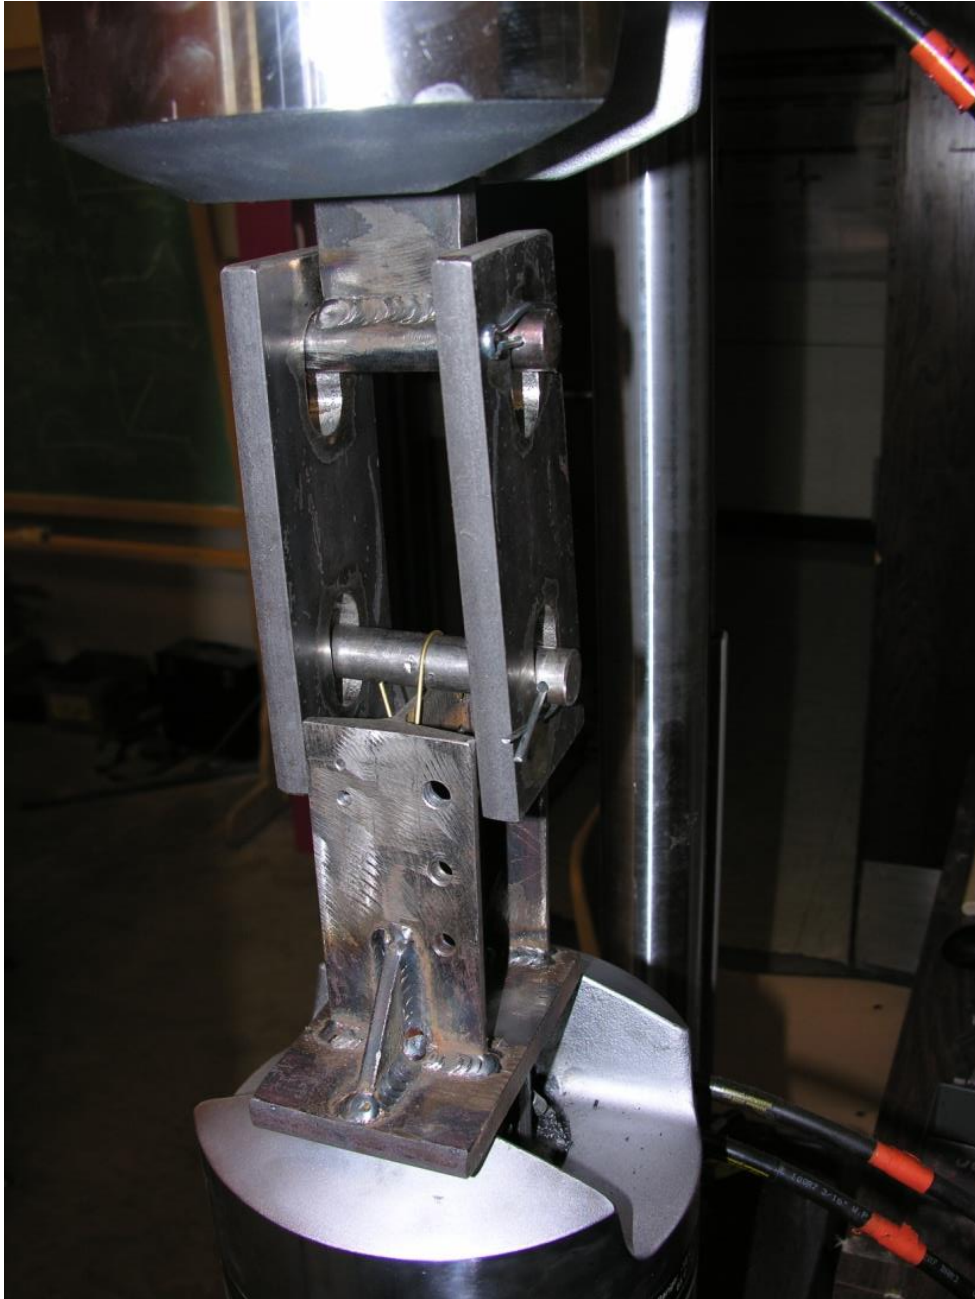
Figure 365. Test Jig for Static Tests

The test jig consisted of a top assembly and a bottom assembly. The bottom assembly was one piece, consisting of a section of S3x5.7 (S76x8.5) steel post, welded on the bottom to a ½-in. (13-mm) thick steel plate. On the bottom of that steel plate, another ½-in. (13-mm) thick steel plate was welded perpendicular to it, which allowed the bottom clamp of the MTS 810 to secure it.

The top assembly consisted of four pieces. The top-most piece consisted of a ½-in. (13-mm) thick steel plate, which allowed the top clamp of the MTS 810 to secure it, and a ¾-in. (19-mm) diameter steel bar was welded to its bottom. Two, identical, symmetric, ½-in. (13-mm) thick steel plates—one on each end—were hung from the steel bar of the top-most piece of the assembly. Each of these plates had two slots. The slots were used to hang the plates from the top-most piece and to provide a place to set the bottom-most piece. The bottom-most piece was a ¾-in. (19-mm) diameter steel bar, used to simulate the cable. A photograph of the test jig is shown in Figure 365.

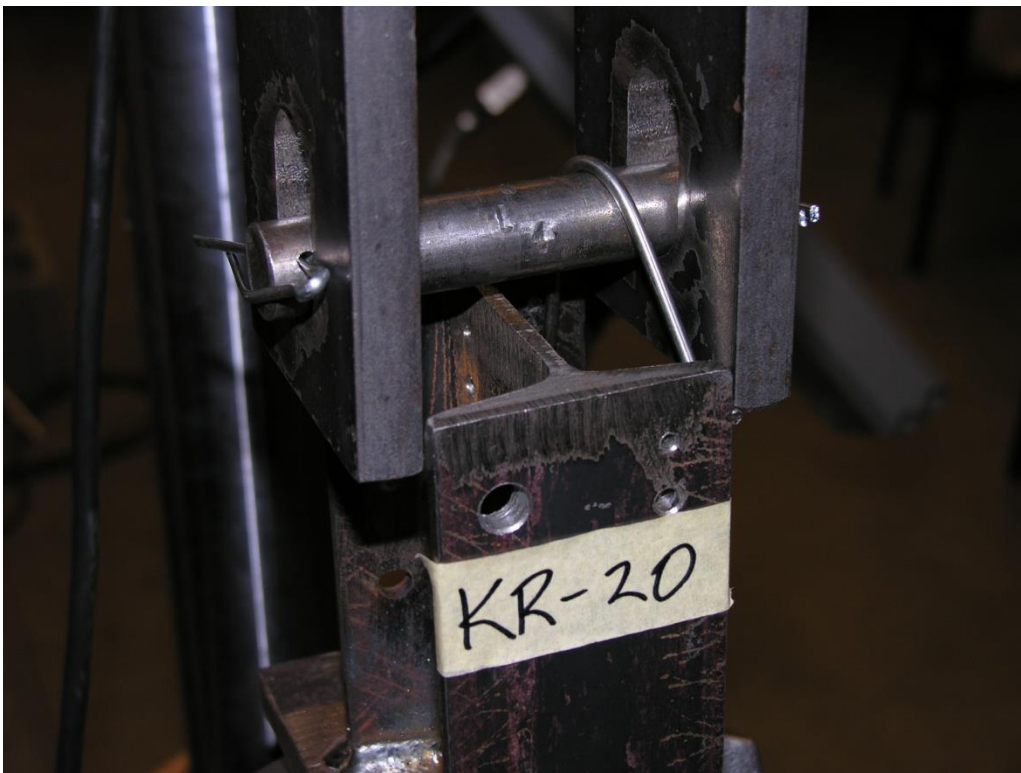
Figure 382. Example of Squeeze-In-Place Curved Rod Test

Squeeze-in-place curved rod concepts were tested in test nos. KR-11 through KR-20. The test matrix and results are summarized in Table 19. Before and after photographs for one of the tests, as shown in Figure 382, are provided for a squeeze-in-place curved rod.

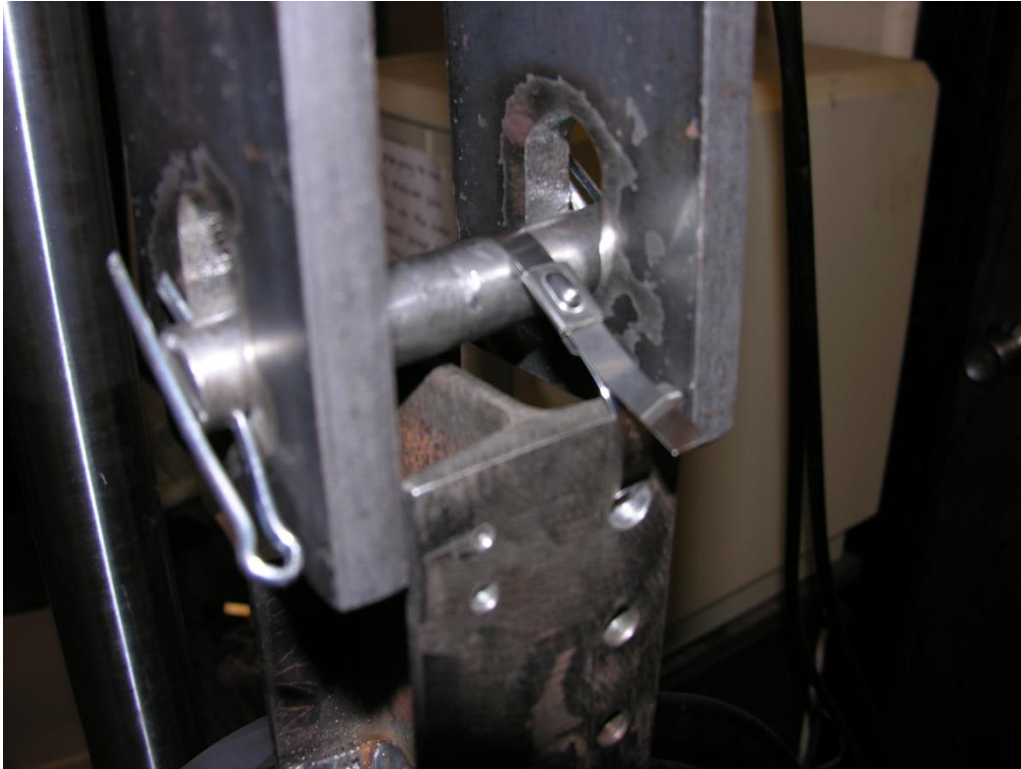
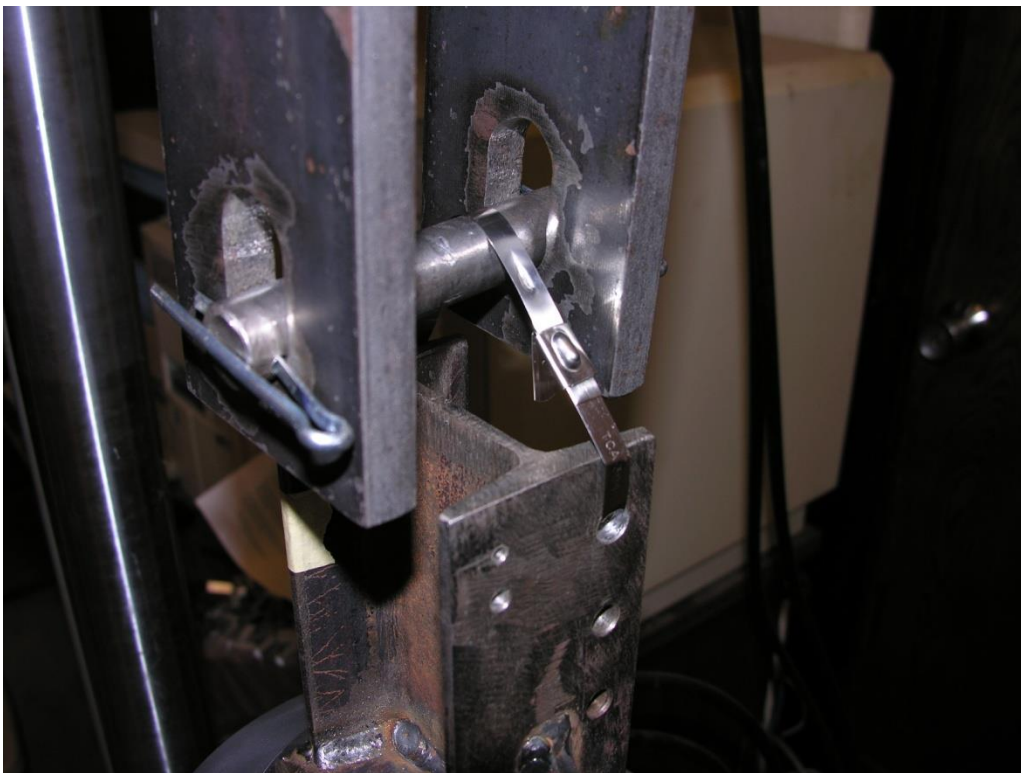
Figure 398. Example of HellermannTyton Stainless Steel Cable Tie Test

Test No.	Material	Cross-Section in. (mm)		Rate in./min (mm/min)	Peak Load lb (N)	Notes
		Width	Thickness			
TCT-4	Stainless Steel 304	0.31 (7.9)	0.012 (0.30)	0.4 (10)	353 (1,572)	Locking mechanism failure
TCT-6	Stainless Steel 304	0.31 (7.9)	0.012 (0.30)	0.4 (10)	349 (1,554)	Locking mechanism failure
TCT-7	Stainless Steel 304	0.31 (7.9)	0.012 (0.30)	0.4 (10)	274 (1,217)	Locking mechanism failure
TCT-8	Stainless Steel 304	0.18 (4.6)	0.012 (0.30)	0.4 (10)	133 (593)	Locking mechanism failure
TCT-9	Stainless Steel 304	0.18 (4.6)	0.012 (0.30)	0.4 (10)	182 (809)	Locking mechanism failure

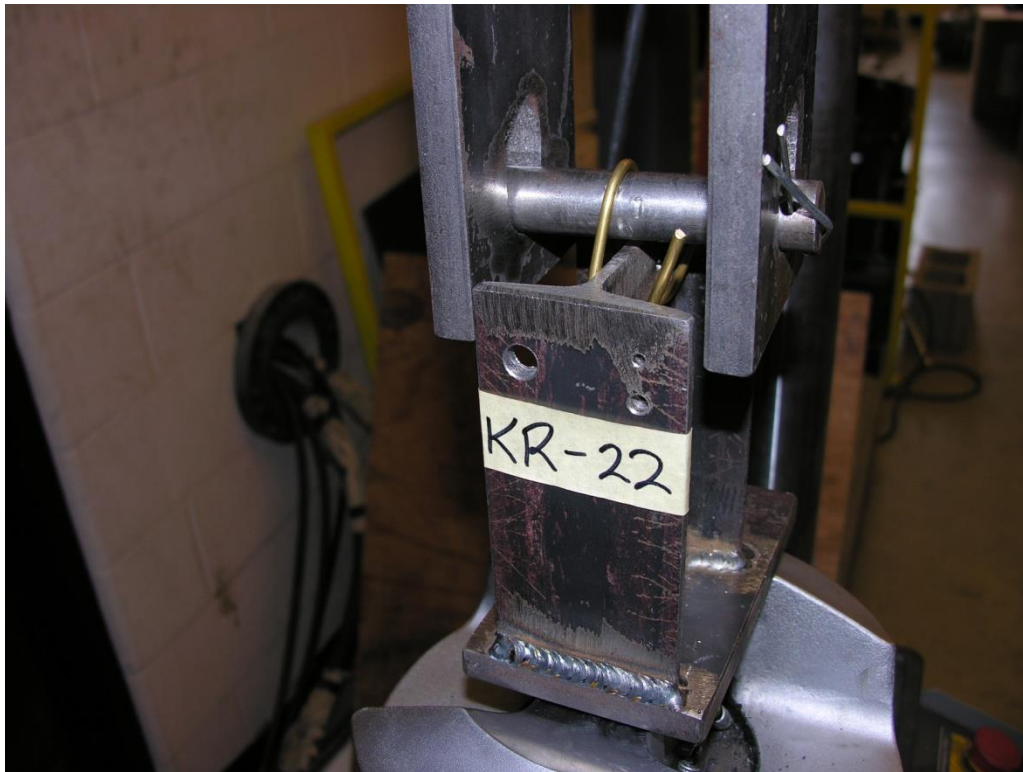
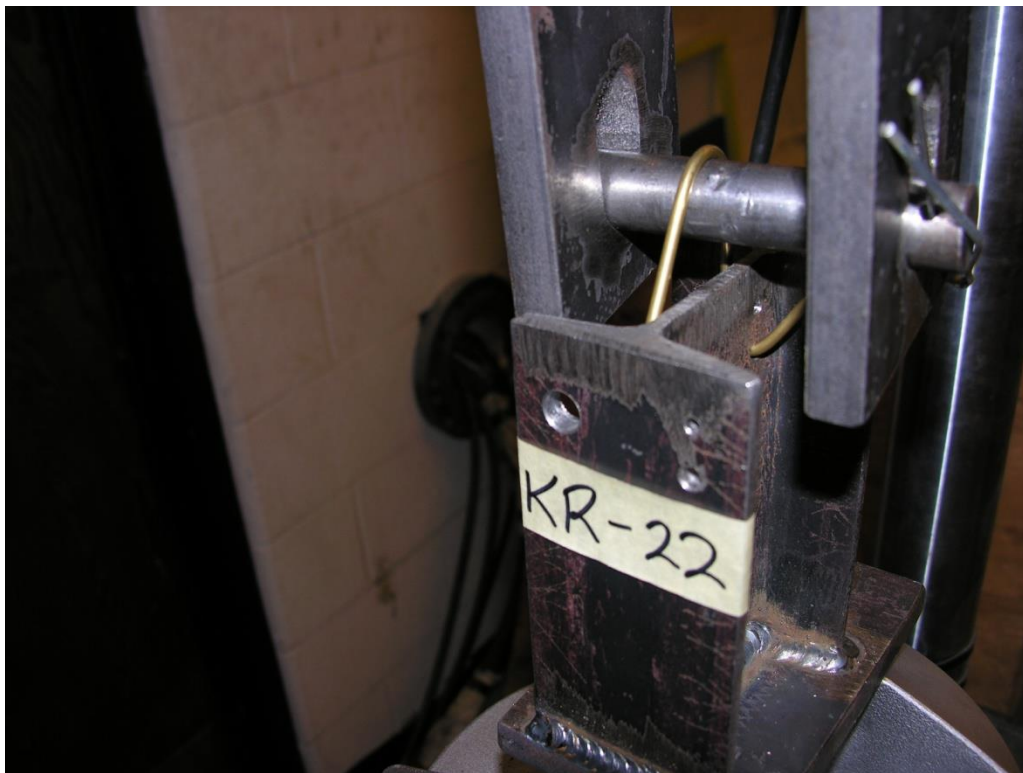
Figure 406. Example Revised Web-Inserted Curved Rod Test

Revised web-inserted curved rod concepts were tested in test nos. KR-21 through KR-24. The test matrix and results are summarized in Table 21. Before and after photographs for one for the tests, as shown in Figure 406, are provided for a revised web-inserted curved rod.

Test No.	Material	Diameter in. (mm)	Rate in./min (mm/min)	Peak Load lb (N)	Notes
KR-21	C360 Brass	1/8 (3.2)	0.2 (5)	567 (2,520)	Bent and fractured at hole
KR-22	C360 Brass	1/8 (3.2)	0.2 (5)	545 (2,426)	Bent and fractured at hole
KR-23	T-304 Stainless Steel	1/8 (3.2)	0.2 (5)	799 (3,554)	Bent and slipped out of hole
KR-24	T-304 Stainless Steel	1/8 (3.2)	0.2 (5)	884 (3,930)	Bent and slipped out of hole

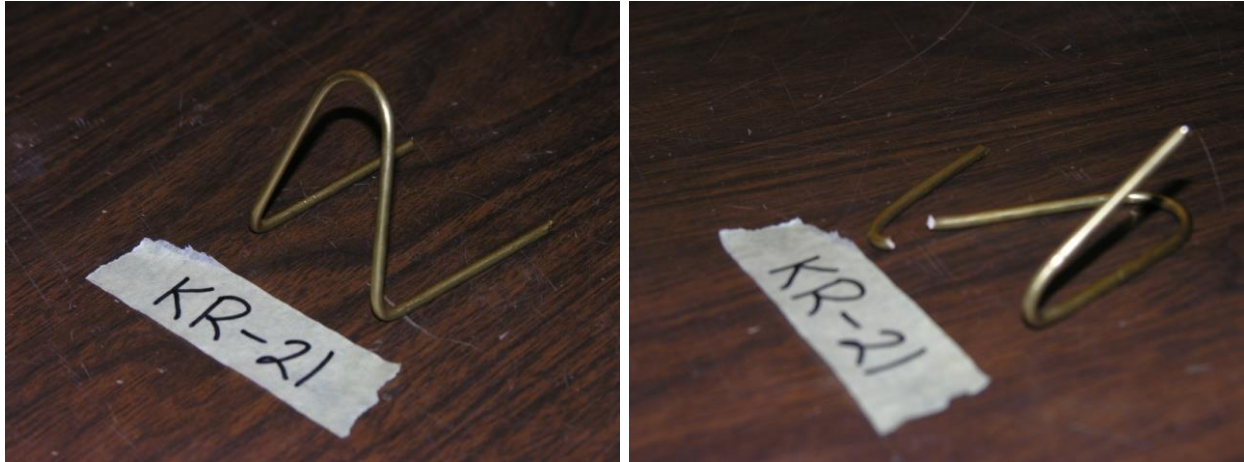
Figure 408. Pre-Test and Post-Test Photographs, Test No. KR-21

For test nos. KR-21 and KR-22, revised web-inserted curved rods, fabricated from 1/8-in. (3.2-mm) diameter, C360 brass, were vertically loaded at a displacement rate of 0.2 in./min (5 mm/min). In both tests, the rods began to bend, before finally fracturing at the location of one of the holes. The peak loads for test nos. KR-21 and KR-22 were 567 lb (2,520 N) and 545 lb (2,462 N), respectively. The force versus displacement curve for test nos. KR-21 and KR-22 is shown in Figure 407. Pre- and post-test photographs are shown in Figures 408 and 409.

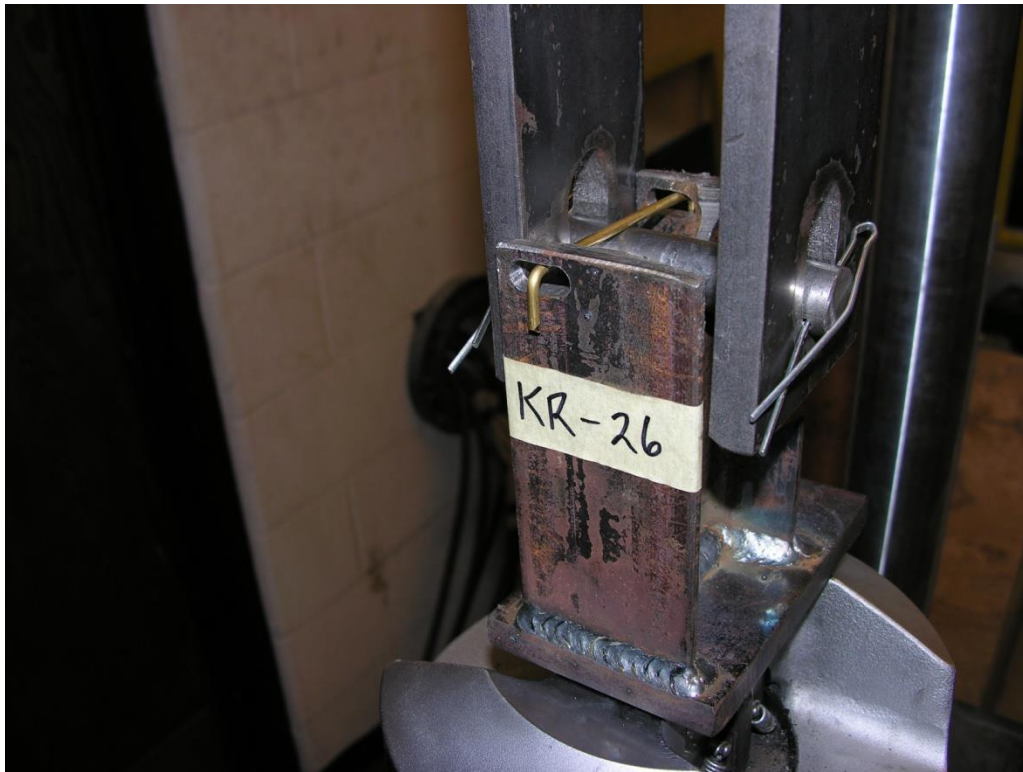
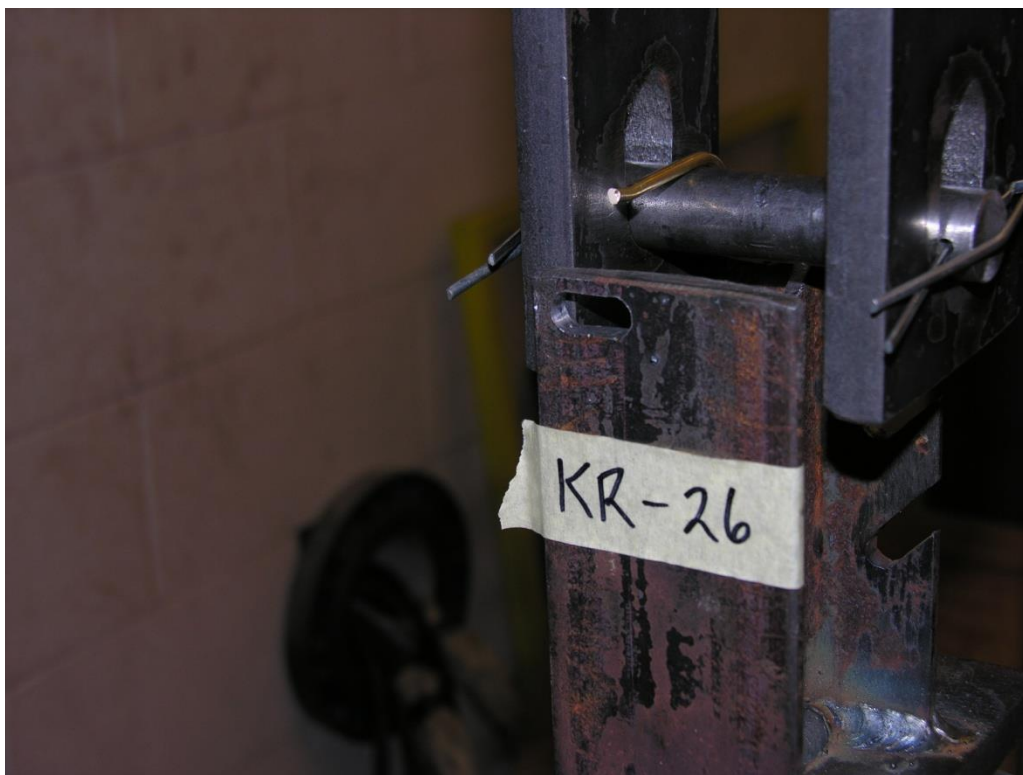
Figure 413. Example of Straight Rod Test

Straight rod concepts were tested in test nos. KR-25 through KR-36. The test matrix and results are summarized in Table 22. Before and after photographs for one of the tests, as shown in Figure 413, are provided for a straight rod.

Test No.	Material	Diameter, in. (mm)	Rate, in./min (mm/min)	Peak Load, lb (N)	Notes
KR-25	C360 Brass	1/8 (3.2)	0.2 (5)	169 (753)	Timed out twice, slipped out on 3rd run
KR-26	C360 Brass	1/8 (3.2)	0.8 (20)	181 (806)	Bent and fractured at location of hole
KR-27	T-304 Stainless	1/8 (3.2)	0.8 (20)	360 (1,603)	Bent and slipped out of hole
KR-28	T-304 Stainless	1/8 (3.2)	0.8 (20)	412 (1,833)	Bent and slipped out of hole
KR-29	C360 Brass	3/16 (4.8)	0.8 (20)	732 (3,254)	Bent and fractured at location of hole
KR-30	C360 Brass	3/16 (4.8)	0.8 (20)	681 (3,030)	Bent and slipped out of hole
KR-31	T-304 Stainless	3/16 (4.8)	0.8 (20)	1,465 (6,517)	Bent and slipped out of hole, local yielding caused hole to warp
KR-32	T-304 Stainless	3/16 (4.8)	0.8 (20)	1,234 (5,489)	Bent and slipped out of hole, local yielding caused hole to warp
KR-33	C360 Brass	1/4 (6.4)	0.8 (20)	1,301 (5,787)	Bent and fractured at location of hole

KR-34	C360 Brass	1/4 (6.4)	0.8 (20)	1,313 (5,840)	Bent and fractured at location of hole
KR-35	T-304 Stainless	1/4 (6.4)	0.8 (20)	2,858 (12,710)	Bent and slipped out of hole, local yielding caused hole to warp
KR-36	T-304 Stainless	1/4 (6.4)	0.8 (20)	2,503 (11,130)	Bent and slipped out of hole, local yielding caused hole to warp

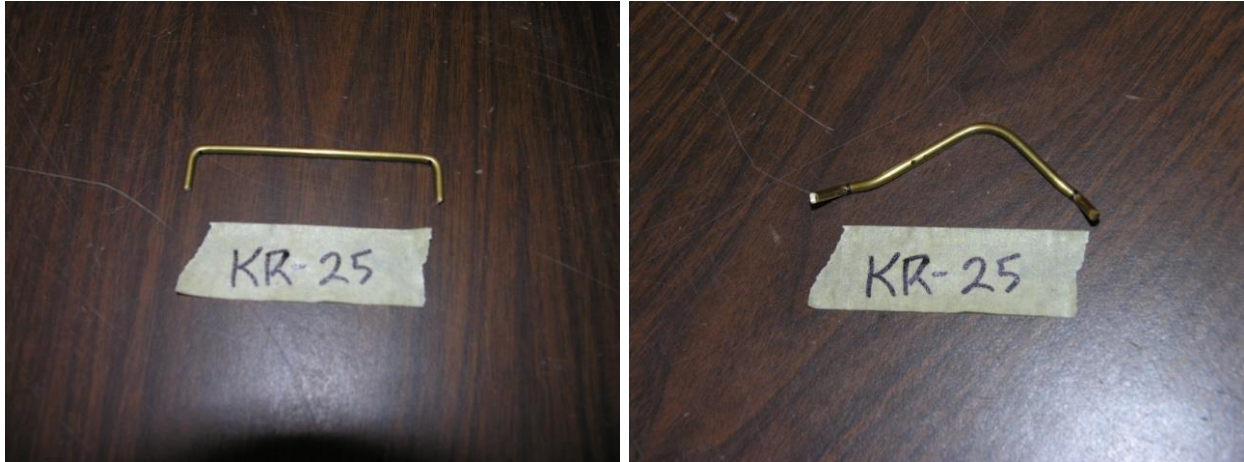
Figure 415. Pre-Test and Post-Test Photographs, Test No. KR-25

For test no. KR-25, a straight rod, fabricated from 1/8-in. (3.2-mm) diameter, C360 brass, was vertically loaded at a displacement rate of 0.2 in./min (5 mm/min). The MTS timed out twice. On the third run, one end of the straight rod finally slipped out of the hole. The peak load for test no. KR-25 occurred in the second run and was 169 lb (753 N). The force versus displacement curve for test no. KR-25 is shown in Figure 414. Pre- and post-test photographs are shown in Figure 415.
