Design of Cable-to-Post Attachments for Use in a Non-Proprietary, High-Tension, Cable Median Barrier

*Midwest States Regional Pooled Fund Research Program
Fiscal Years 2009-2012 (Years 19 and 22)
Research Project Number TPF-5(091) and TPF-5(193)
NDOR Sponsoring Agency Code RFPF-09-01 and RFPF-12-CABLE 1&2*

DESIGN OF CABLE-TO-POST ATTACHMENTS FOR USE IN A NON-PROPRIETARY, HIGH-TENSION, CABLE MEDIAN BARRIER

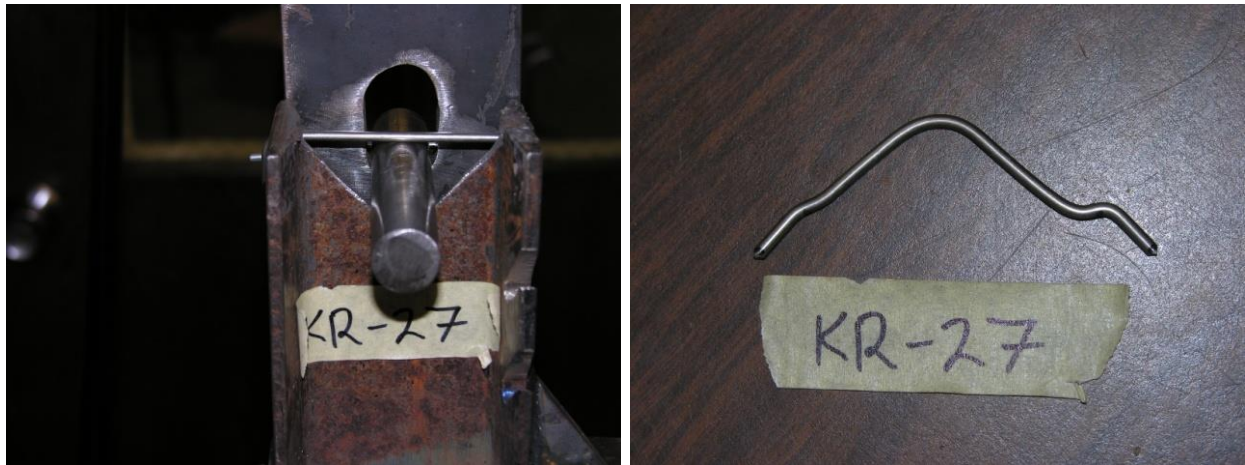
Figure 419. Pre-Test and Post-Test Photographs, Test No. KR-27

For test nos. KR-27 and KR-28, straight rods, fabricated from 1/8-in. (3.2-mm) diameter, T-304 stainless steel, were vertically loaded at a displacement rate of 0.8 in./min (20 mm/min). In both tests, the rods bent significantly before one end finally slipped out of its hole. The peak loads for test nos. KR-27 and KR-28 were 360 lb (1,603 N) and 412 lb (1,833 N), respectively. The force versus displacement curve for test nos. KR-27 and KR-28 is shown in Figure 418. Pre- and post-test photographs are shown in Figures 419 and 420.

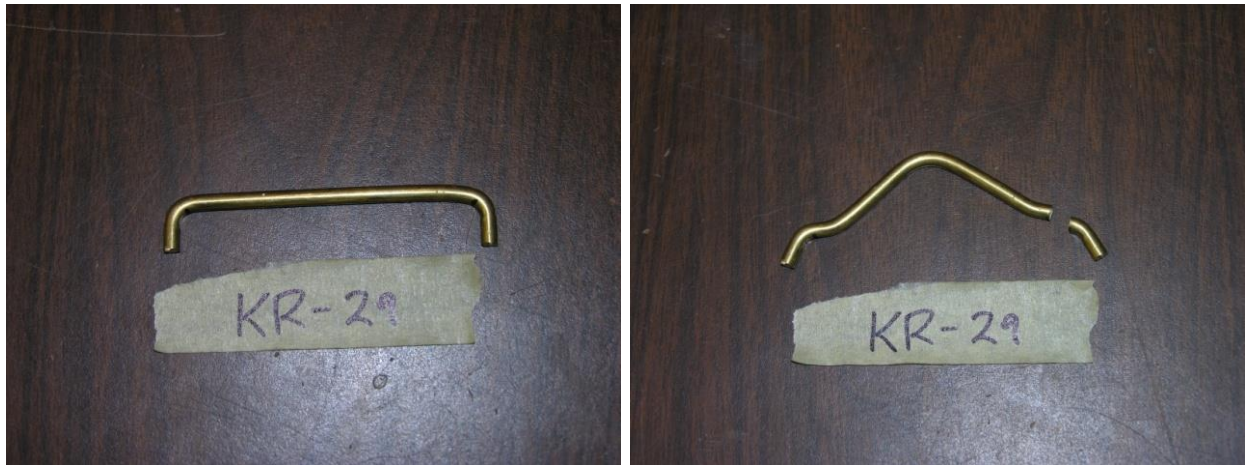
Figure 422. Pre-Test and Post-Test Photographs, Test No. KR-29

For test nos. KR-29 and KR-30, straight rods, fabricated from 3/16-in. (4.8-mm) diameter, C360 brass, were vertically loaded at a displacement rate of 0.8 in./min (20 mm/min). In test no. KR-29, the rod bent significantly before one end fractured at the location of its hole. In test no. KR-30, the rod bent significantly before one end finally slipped out of its hole. The peak loads for test nos. KR-29 and KR-30 were 732 lb (3,254 N) and 681 lb (3,030 N), respectively. The force versus displacement curve for test nos. KR-29 and KR-30 is shown in Figure 421. Pre- and post-test photographs are shown in Figures 422 and 423.

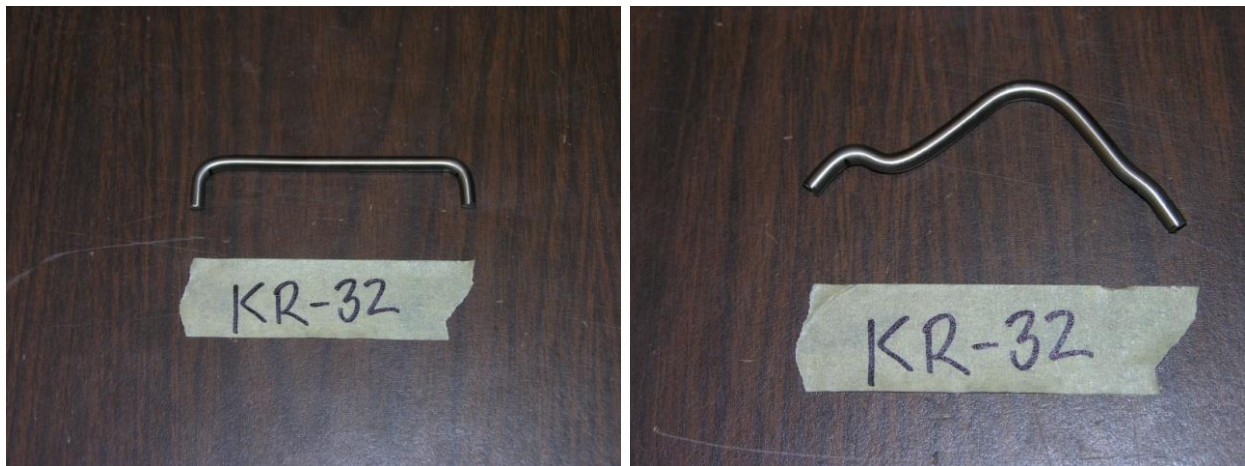
Figure 426. Pre-Test and Post-Test Photographs, Test No. KR-32

For test nos. KR-31 and KR-32, straight rods, fabricated from 3/16-in. (4.8-mm) diameter, T-304 stainless steel, were vertically loaded at a displacement rate of 0.8 in./min (20 mm/min). In both tests, the rods bent significantly before one end finally slipped out of its hole. There was also some local yielding of the flange around the holes. The peak loads for test nos. KR-31 and KR-32 were 1,465 lb (6,517 N) and 1,234 lb (5,489 N), respectively. The force versus displacement curve for test nos. KR-31 and KR-32 is shown in Figure 424. Pre- and post-test photographs are shown in Figures 425 and 426.

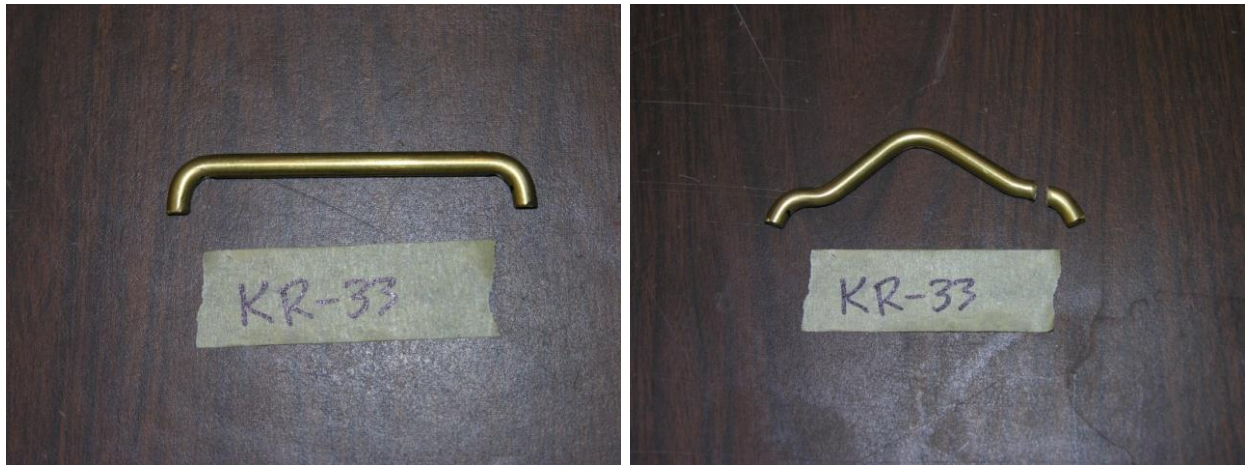
Figure 428. Pre-Test and Post-Test Photographs, Test No. KR-33

For test nos. KR-33 and KR-34, straight rods, fabricated from 1/4-in. (6.4-mm) diameter, C360 brass, were vertically loaded at a displacement rate of 0.8 in./min (20 mm/min). In both tests, the rods bent significantly before one end fractured at the location of its hole. There was also some local yielding of the flange around the holes. The peak loads for test nos. KR-33 and KR-34 were 1,301 lb (5,787 N) and 1,313 lb (5,840 N), respectively. The force versus displacement curve for test nos. KR-33 and KR-34 is shown in Figure 427. Pre- and post-test photographs are shown in Figures 428 and 429.

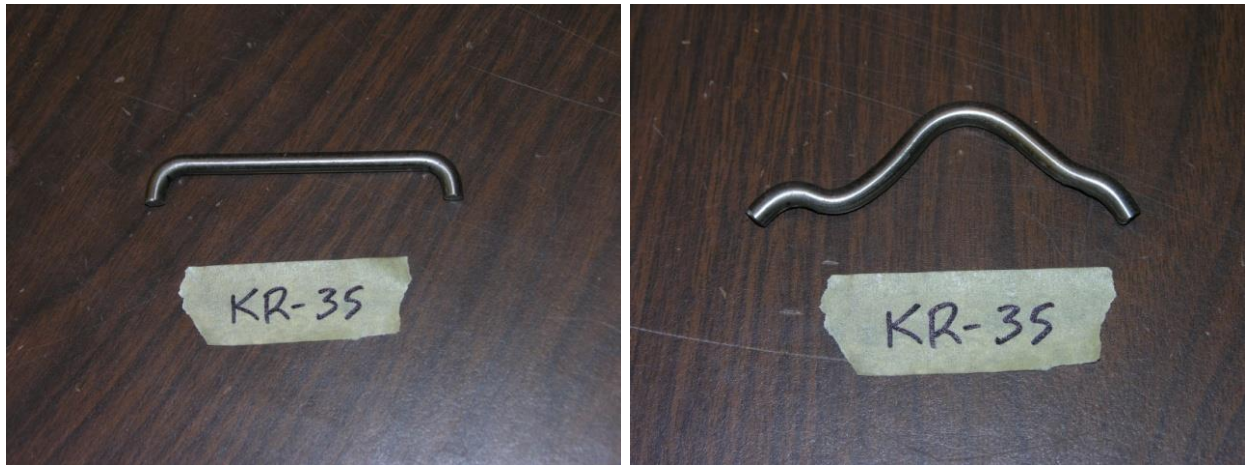
Figure 431. Pre-Test and Post-Test Photographs, Test No. KR-35

For test nos. KR-35 and KR-36, straight rods, fabricated from 1/4-in. (6.4-mm) diameter, T-304 stainless steel, were vertically loaded at a displacement rate of 0.8 in./min (20 mm/min). In both tests, the rods bent significantly before one end finally slipped out of its hole. There was also significant local yielding of the flange around the holes. The peak loads for test nos. KR-35 and KR-36 were 2,858 lb (12,710 N) and 2,503 lb (11,130 N), respectively. The force versus displacement curve for test nos. KR-35 and KR-36 is shown in Figure 430. Pre- and post-test photographs are shown in Figures 431 and 432.

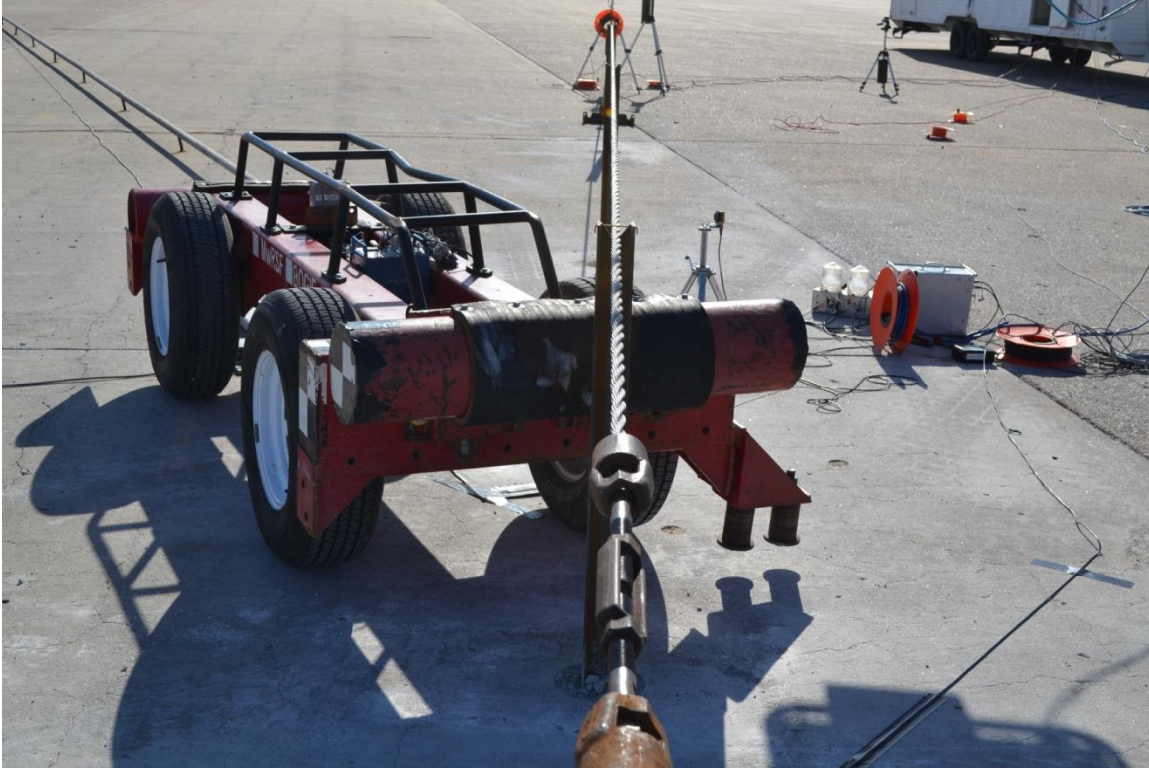
Figure 447. Rigid-Frame Bogie Aligned for Test No. HTTC-1

A rigid-frame bogie vehicle was used for this test. A variable-height, detachable impact head was used in the testing. The bogie head was constructed of 8-in. (203-mm) diameter, 1/2-in. (13-mm) thick standard steel pipe, with 3/4-in. (19-mm) neoprene belting wrapped around the pipe. The impact head was bolted to the bogie vehicle, thus creating a rigid frame with an impact height of 26-3/4 in. (673 mm). The bogie with the impact head is shown in Figure 447. The weight of the bogie with the addition of the mountable impact head and accelerometers was 1,877 lb (851 kg).

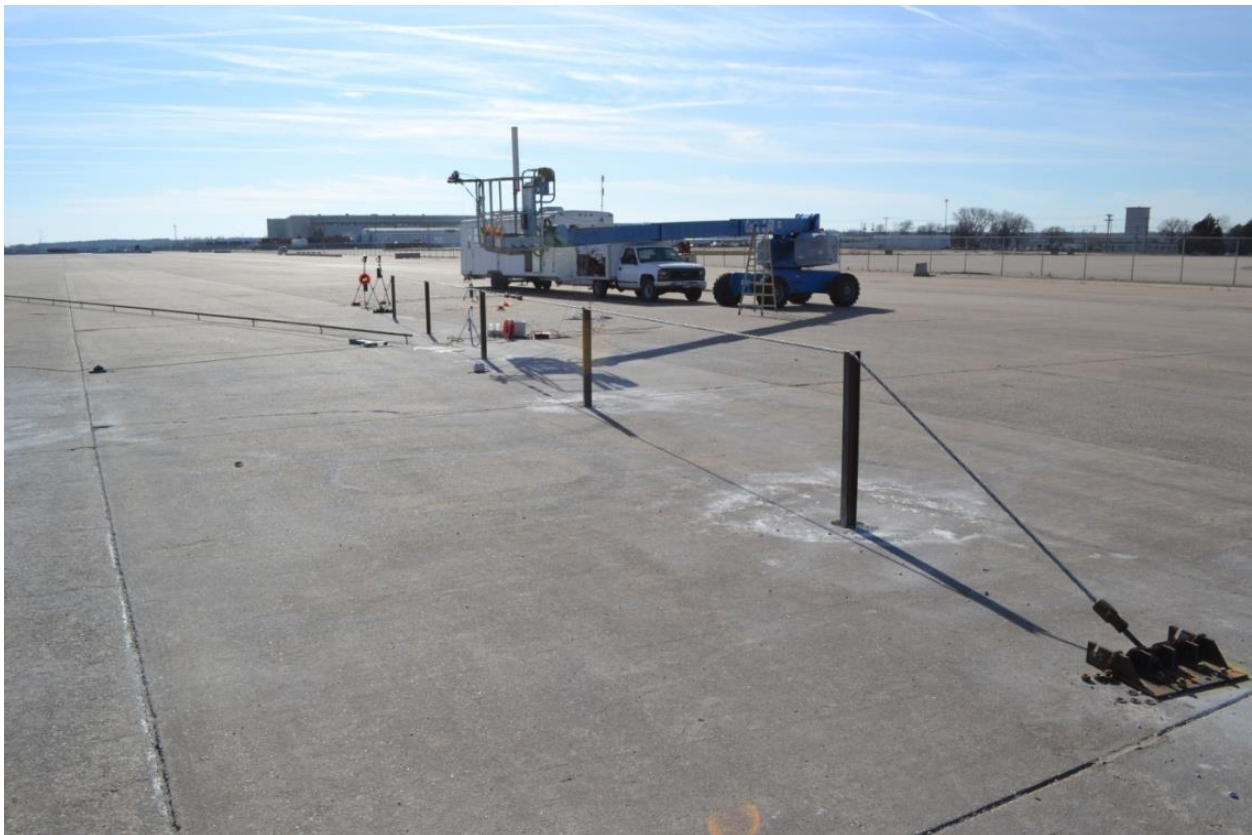
Figure 448. Pre-Test Photograph of Cable Barrier System, Test No. HTTC-1

One bogie impact test was performed to evaluate the performance of 1/8-in. (3.2-mm) diameter, C360 brass, straight rods with bent ends as top cable-to-post attachment for the high-tension, cable barrier system. The small-scale cable barrier system consisted of five S3x5.7 (S76x8.5) steel posts, two cable terminals—one at each end—and a cable. A pre-test photograph of the entire system is shown in Figure 448.

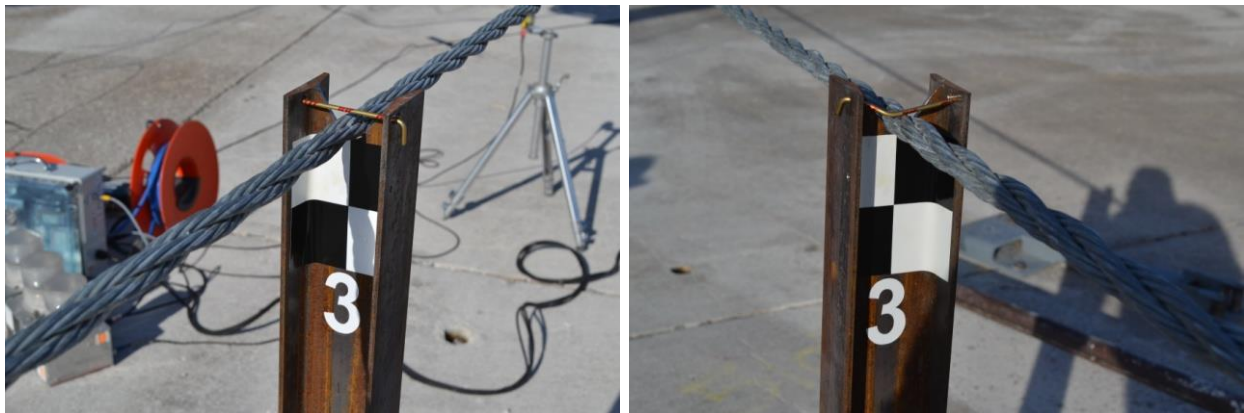
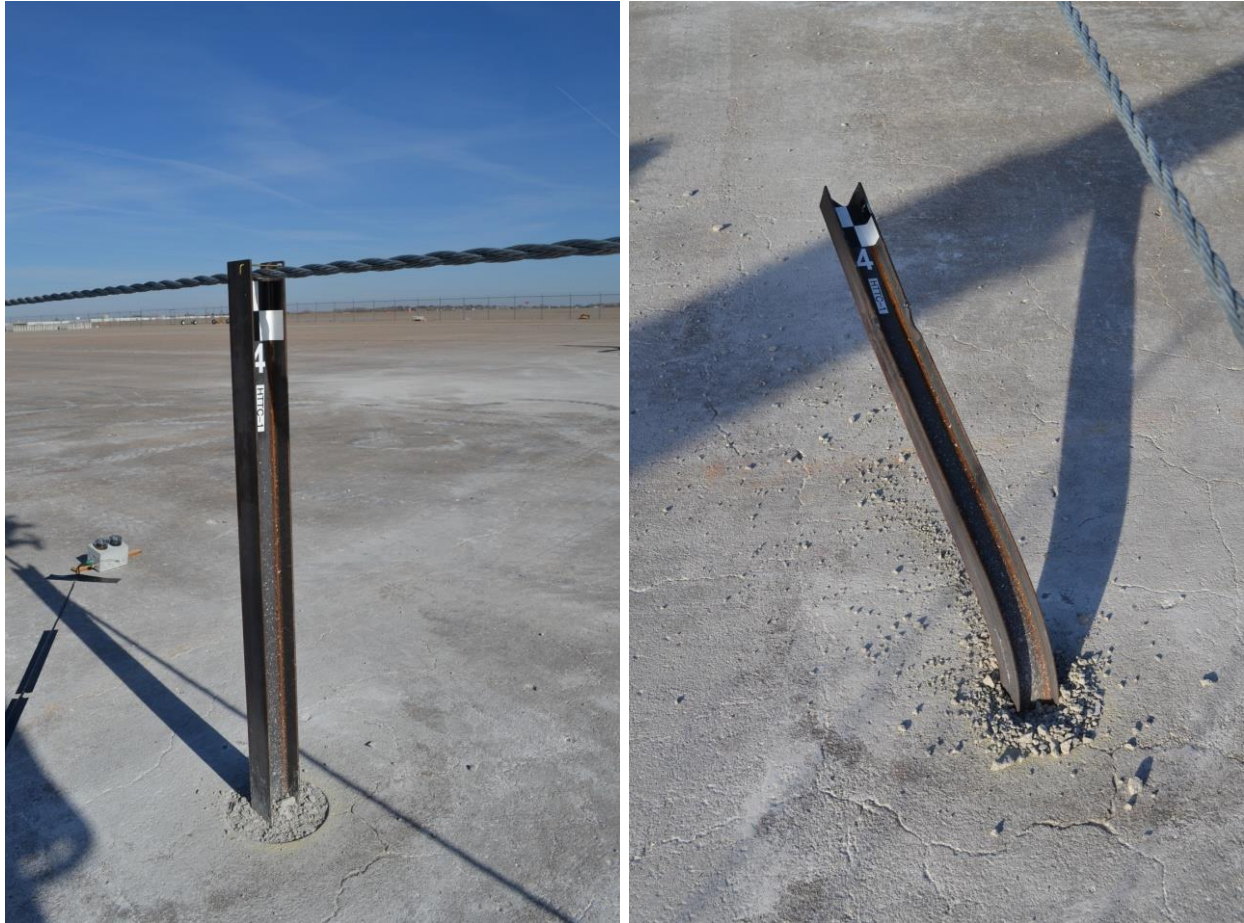
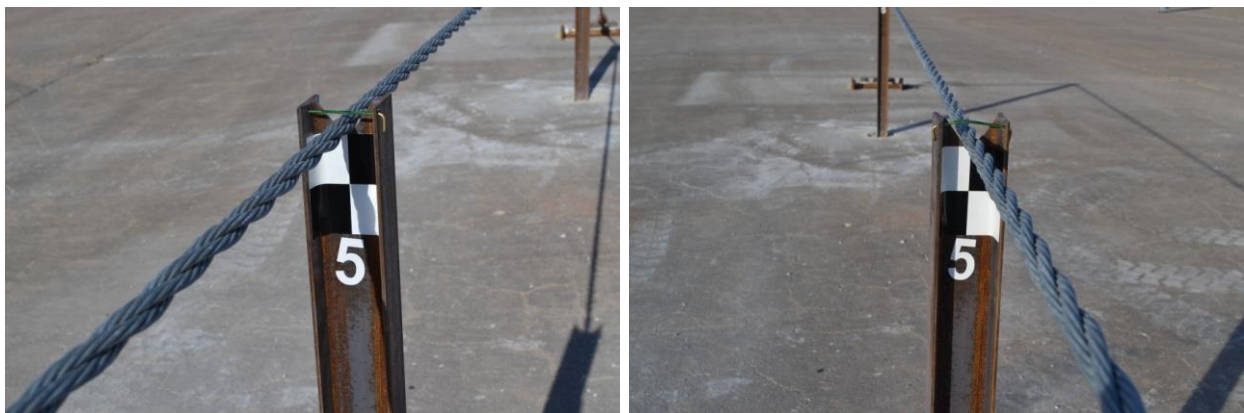
For test no. HTTC-1, the 1,877-lb (851-kg) steel-framed bogie impacted the barrier system at the center post, traveling 49.4 mph (79.5 km/h) and at a 25-degree angle. The post began to rotate backward immediately. High-speed video footage clearly showed that the cable was free from the post at a time of 0.008 sec after impact. The cable deflected slightly before

releasing away from the post, thus causing a wave to propagate along the length of the cable. As a result of the wave, the top cable-to-post attachments immediately upstream and downstream of the post sustained some damage, but they did not allow the cable to release from the posts. The impacted post yielded at the ground line and bent all the way over as the bogie overran it. The bogie went under the released cable. The test was considered a success. Pre- and post-test photographs for the posts that were impacted are shown in Figures 449 through 451. Sequential photographs from each of the high-speed video cameras are shown in Figures 452 through 454.

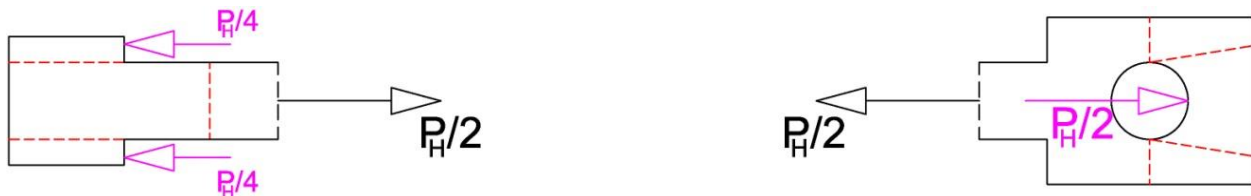
Figure 458. End Reactions for Use in the Design Equations

derivation of the following equations, one half of the applied lateral load, P_H , was assumed to be distributed to each end, as shown in Figure 458. It should be noted that dynamic magnification factors were not used in the derivation of the lateral load equations as they were not deemed necessary.

The applied lateral load needed to cause failure at location 1 was calculated using Equation 14.1. Failure location 1 was assumed to be a pure shear fracture in which two surfaces provided shear resistance to the end reaction of $P_H/2$. The right side of the equation includes a factor of 5/6 to account for the difference in the predicted versus observed lateral loads from the bolted tabbed brackets in Round 2.
