Anchoring and Stiffening Techniques for Portable Concrete Barriers

ANCHORING AND STIFFENING TECHNIQUES FOR PORTABLE CONCRETE
BARRIERS

A THESIS

Presented to the Faculty of
The Graduate College at the University of Nebraska
In Partial Fulfillment of Requirements
For the Degree of Master of Science

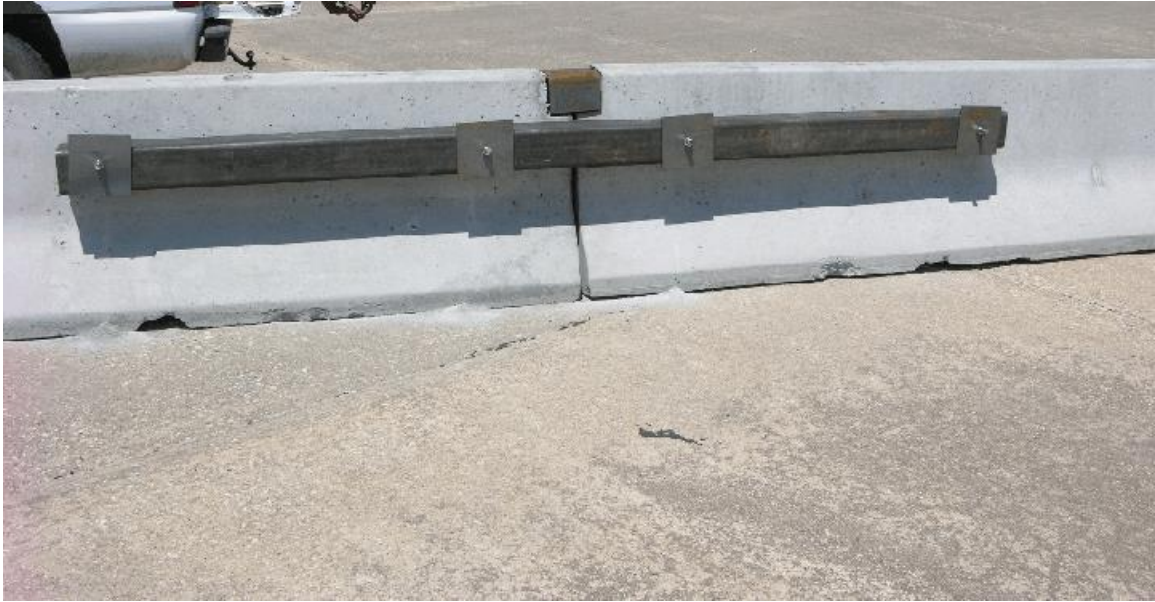
The PCB system was stiffened using box beams bolted across barrier joints on the backside of the system in order to limit system deflections, as shown in Figure 2. Anchoring of PCB systems with pins or bolted-through connections had been previously tested, but this process is time consuming and may result in damage to the bridge. NYSDOT personnel developed a concept of using box-beam stiffener that would minimize barrier deflections while preventing bridge deck damage.

Figure 2. PCBs with Box-Beam Stiffener

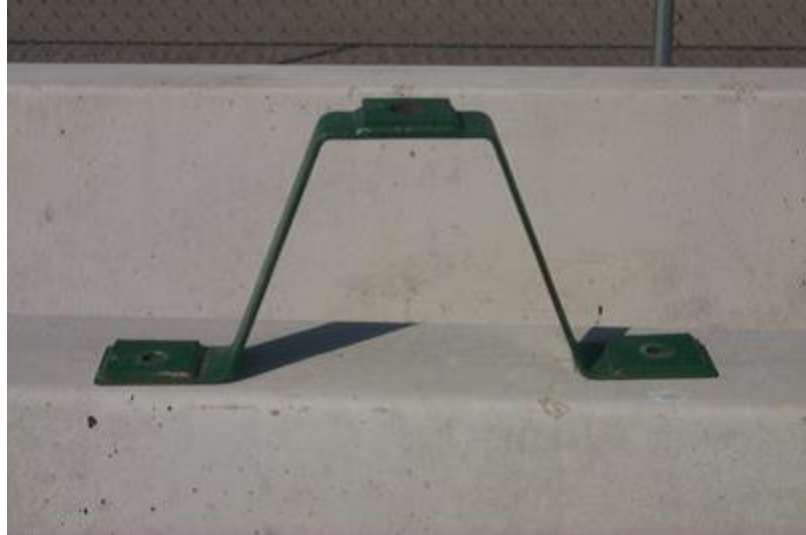
In 2002, a tie-down system for PCBs was developed and tested by MwRSF [12]. Free-standing PCB systems near vertical drop-offs are at risk of being displaced off of the bridge deck when impacted by an errant vehicle. In order to decrease this risk, MwRSF developed a steel tie-down strap that could be placed on the connection pin at the PCB joints and anchored to the bridge deck using drop-in anchors. The design consisted of a 3-in. wide \times ¼-in. thick \times 36-in. long piece of ASTM A36 steel bent into a trapezoidal shape. The straps were attached to the bridge deck using two ¾-in. diameter drop-in anchors and ¾-in. diameter \times 2¼-in. long ISO Class 8.8 bolts, as shown in Figure 5.

Figure 5. Steel Tie-Down Strap

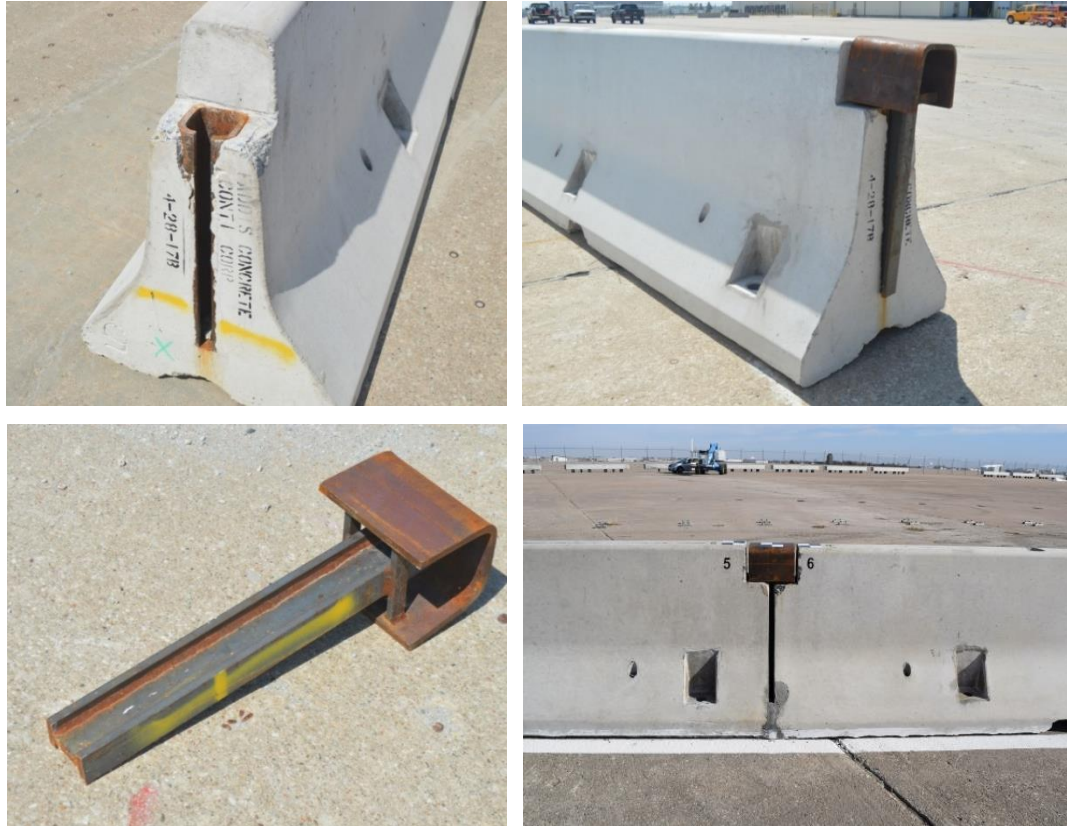
Figure 10. Connection between barriers

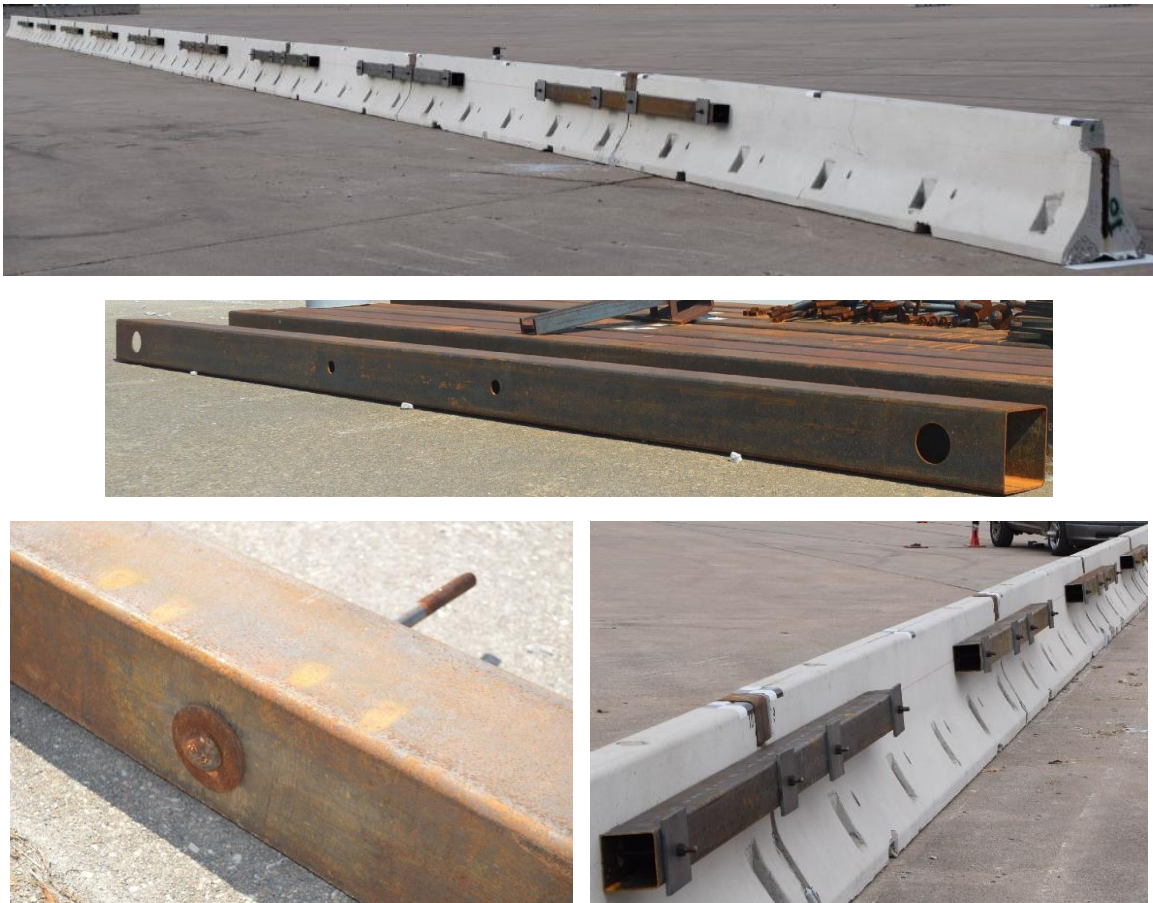
Box beam rail stiffeners were mounted on the back face of the system at each joint, as shown in Figure 13 [24]. Box beam stiffeners are believed to be capable of reducing lateral deflections and preventing separation of the barriers when deflected and suspended over the edge of a bridge deck [5]. This is due to the high tensile capacity of the steel, which allows the barrier and the box beam to act as a composite bending member, with the concrete in compression on the traffic face of the barrier and the steel in tension. Each box beam stiffener consisted of a 6-in. \times 6-in. \times $\frac{3}{16}$ -in. ASTM A500 Grade C box beam. The box beam rails were mounted on barriers with $\frac{3}{4}$ in. diameter by 17 in. long ASTM A307 Grade A bolts. Box Beam rails mounting details are in test report.

Figure 13. Box Beam Stiffeners

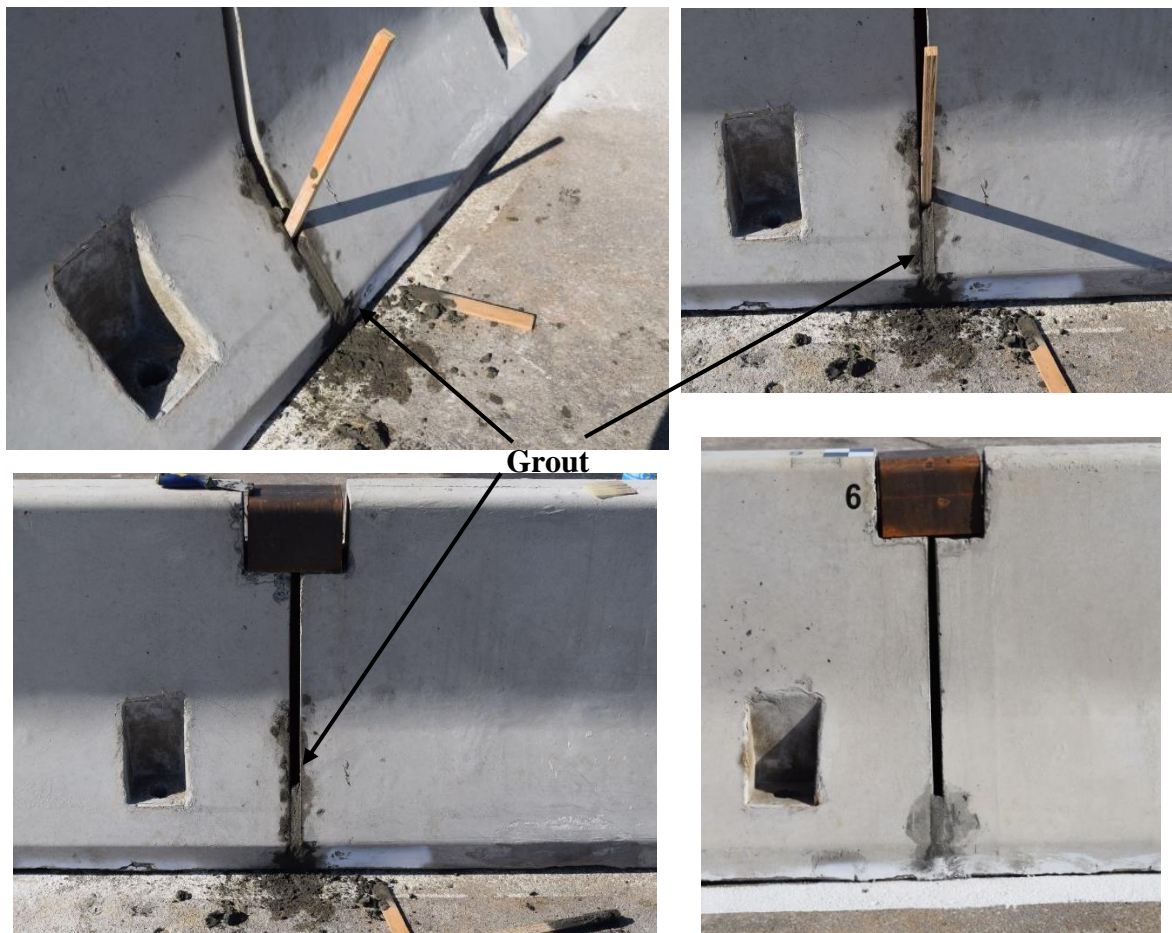
Non-shrink grout is a construction material with a high compressive strength commonly used to fill voids in areas of high concentrated loads. Grout was used to limit the rotation within the connection between barriers. Grout wedges between barriers allow the entire barrier system to act as a continuous element, so that the load disperses throughout all barrier segments rather than being concentrated on those in the impact zone. Non-shrink grout wedges were placed at the toe between adjacent barriers, as shown in Figure 14. Non-shrink grout wedges consisted of a grout mix with a minimum 1-day compressive strength of 1,000 psi.

Figure 14. Non-Shrink Grout between barriers

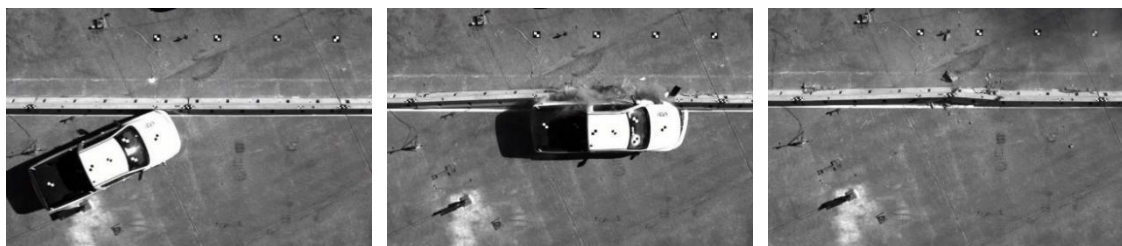
The barrier system experienced a maximum lateral dynamic deflection of 13.5 in. and a permanent set deflection of 6¼ in., as shown in Figure 18.

Figure 18. Barrier Deflection (Impact location, during impact, and Post Impact)

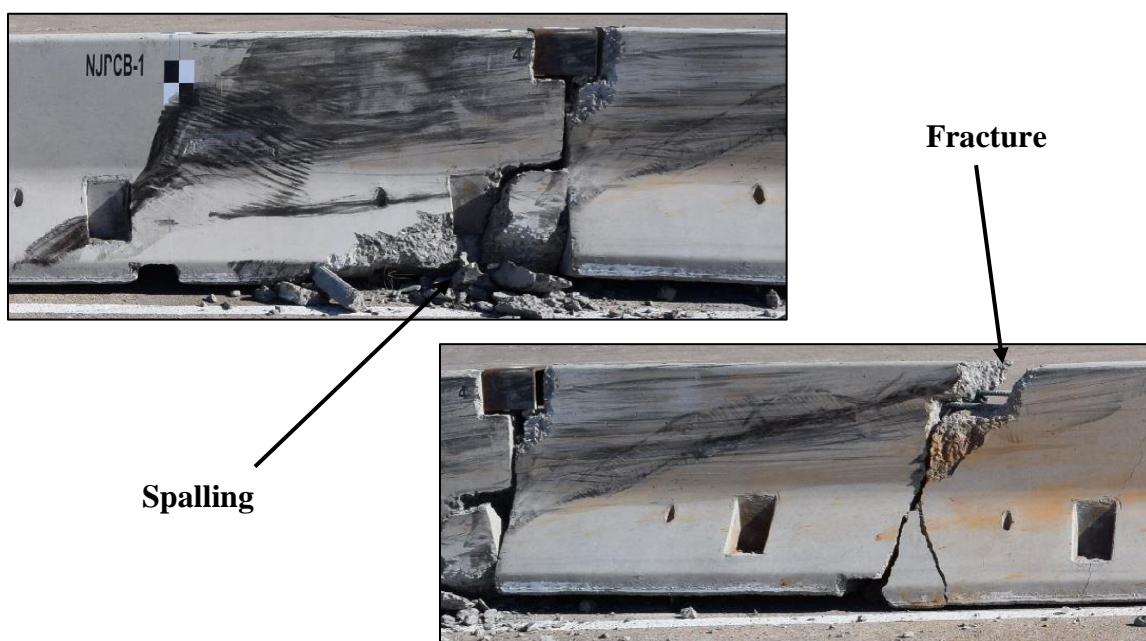
Scuff marks, cracks, and spalling near the barrier toe occurred on barriers 3, 4, 5 and 6. Barriers 3 and 6 had minor cracks and spalling, which would make them reusable with minor repairs. Severe damage occurred to barriers 4 and 5 rendering them non-reusable (see Figure 19). Barrier 4 had major spalling on ends at the barrier toe and below connection key, damage near connection key meant the steel reinforcement is no longer intact, and was deemed non-reusable. Barrier 5 experienced a fracture extending through its entire height and exposing its steel reinforcement near the top.

Figure 19. Barrier Damage – Barrier 4 (Top) and Barrier 5 (Bottom)

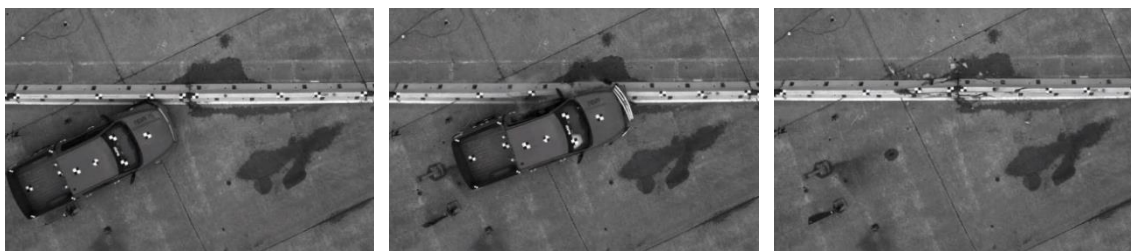
The barrier system experienced a maximum lateral dynamic deflection of 5 in. and a permanent set deflection of $-1/2$ in., as shown in Figure 22.

Figure 22. Barrier Deflection (Impact location, during impact, and Post Impact)

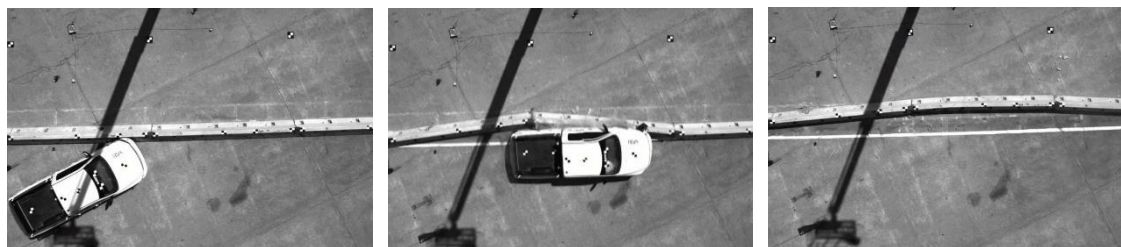
The barrier system experienced a maximum lateral dynamic deflection of 38.1 in. and a permanent set deflection of 36 $\frac{5}{8}$ in., as shown in Figure 26.

Figure 26. Barrier Deflection (Impact location, during impact, and Post Impact)

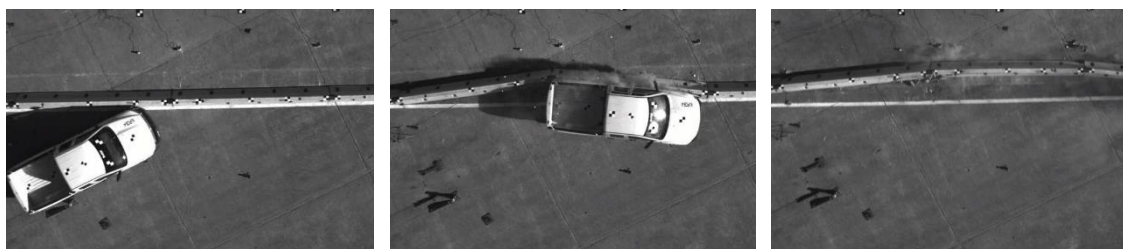
The barrier system experienced a maximum lateral dynamic deflection of 40.7 in. and a permanent set deflection of 38 in., as shown in Figure 30.

Figure 30. Barrier Deflection (Impact location, during impact, and Post Impact)

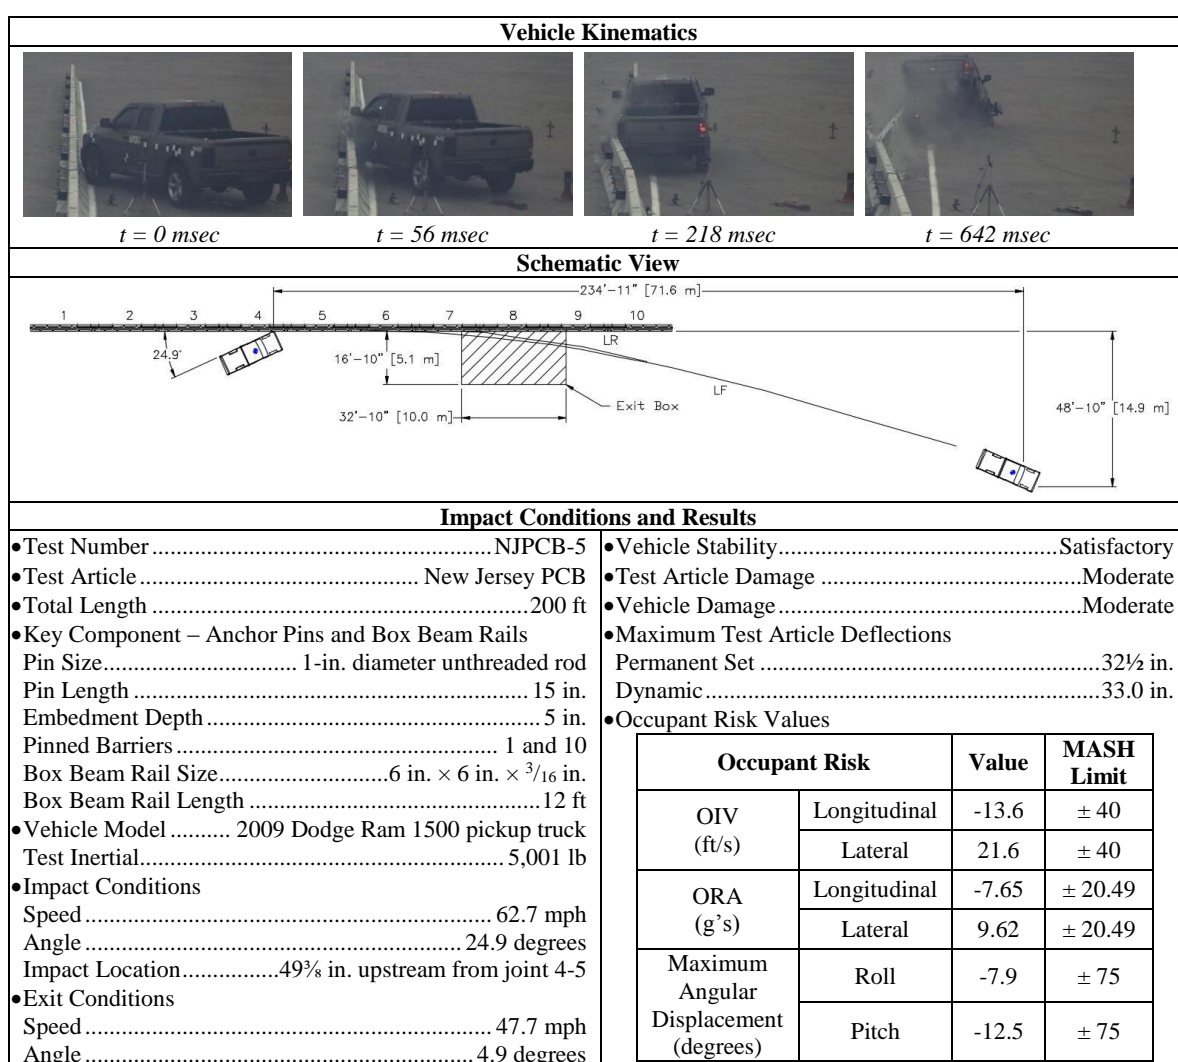
NJPCB-5 was conducted with Barriers 1 and 10 pin anchored to concrete tarmac, and box beam rails mounted on back side of barriers at each joint, a class B joint (modified Joint Class B). Summary of the results are provided in Figure 32, details of NJPCB-5 are in test report [24]. NJPCB-5 was determined to be successful according to MASH requirements.

Figure 32. Results Summary of full-scale crash test – NJPCB-5

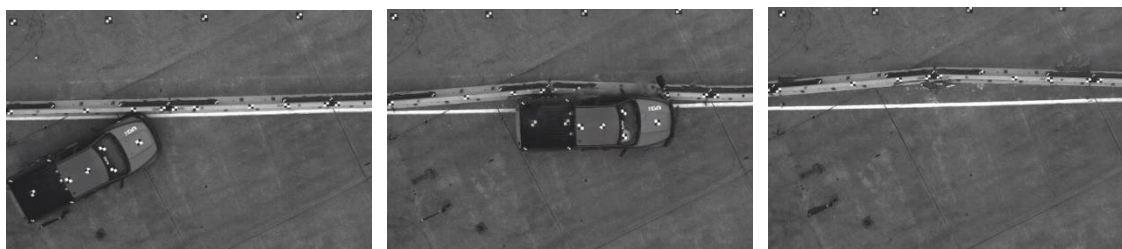
The barrier system experienced a maximum lateral dynamic deflection of 33.0 in. and a permanent set deflection of 32½ in., as shown in Figure 34.

Figure 34. Barrier Deflection (Impact location, during impact, and Post Impact)

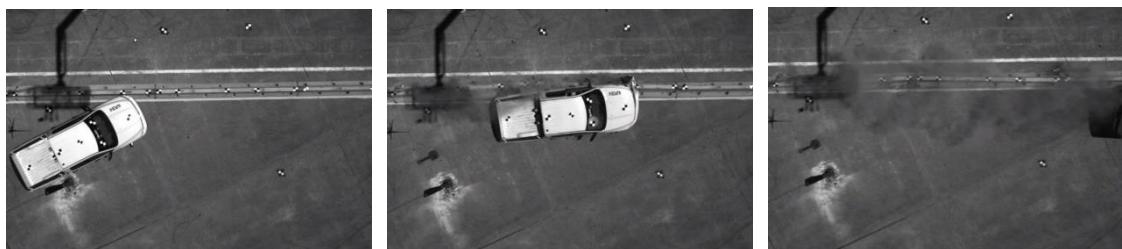
The barrier system experienced a maximum lateral dynamic deflection of 15.2 in. and a permanent set deflection of 3¾ in., as shown in Figure 38.

Figure 38. Barrier Deflection (Impact location, during impact, and Post Impact)

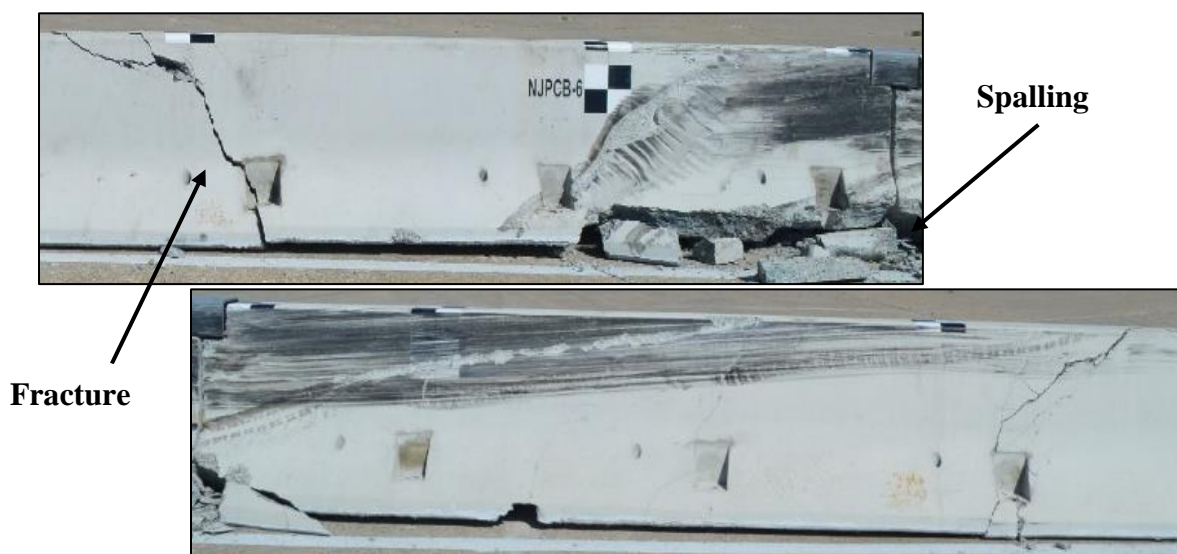
Scuff marks, cracks, and spalling near the barrier toe occurred on barriers 2, 3, 4, 5, 6, and 7. Barriers 2, 3, and 7 had minor cracks and spalling, which would make them reusable with minor repairs. Severe damage occurred to barriers 4 and 5 rendering them as non-reusable (see Figure 39). Barriers 4 and 5 experienced fracture extending through their entire height and toward joint connection between them, which exposed steel reinforcement near the top on both barriers. Barrier 6 had vertical cracks and spalling near pin anchors on its back face and near connection key, which meant the steel reinforcement was no longer intact, and the barrier was deemed non-reusable.

Figure 39. Barrier Damage – Barrier 4 (Top) and Barrier 5 (Bottom)

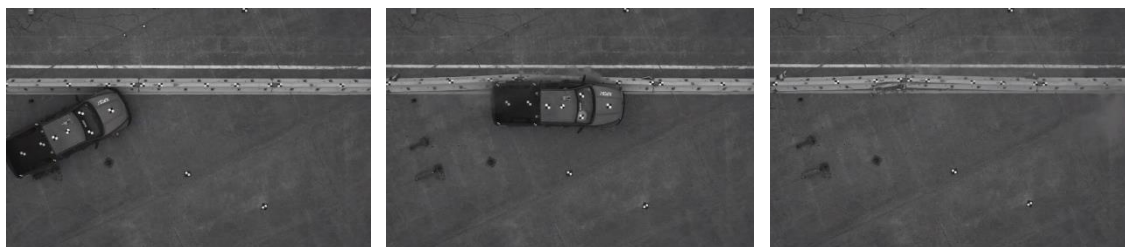
The barrier system experienced a maximum lateral dynamic deflection of 11.4 in. and a permanent set deflection of 6¼ in., as shown in Figure 42.

Figure 42. Barrier Deflection (Impact location, during impact, and Post Impact)

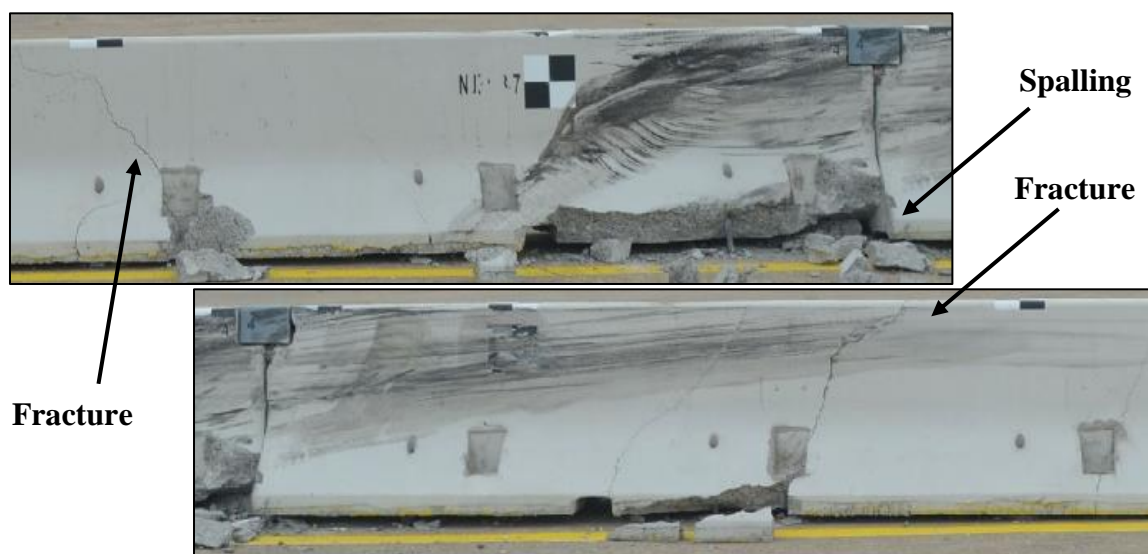
Scuff marks, cracks, and spalling near the barrier toe occurred on barriers 3, 4, 5, and 6. Barrier 3 had minor cracks and spalling, which would make them reusable with minor repairs. Severe damage occurred to barriers 4 and 5 rendering them as non-reusable (see Figure 43). Barriers 4 and 5 experienced fracture extending through their entire height and toward joint connection between them, which exposed steel reinforcement near the top on both barriers. Barrier 6 had vertical cracks and spalling near pin anchors on its back face and near connection key, which meant the steel reinforcement was no longer intact, and the barrier was deemed non-reusable.

Figure 43. Barrier Damage – Barrier 4 (Top) and Barrier 5 (Bottom)
