Design and Evaluation of an Energy-Absorbing, Reusable Roadside/Median Barrier

NDOR Sponsoring Agency Contract No. DPU-STWD (94)

DESIGN AND EVALUATION OF AN ENERGY- ABSORBING, REUSABLE ROADSIDE/MEDIAN BARRIER

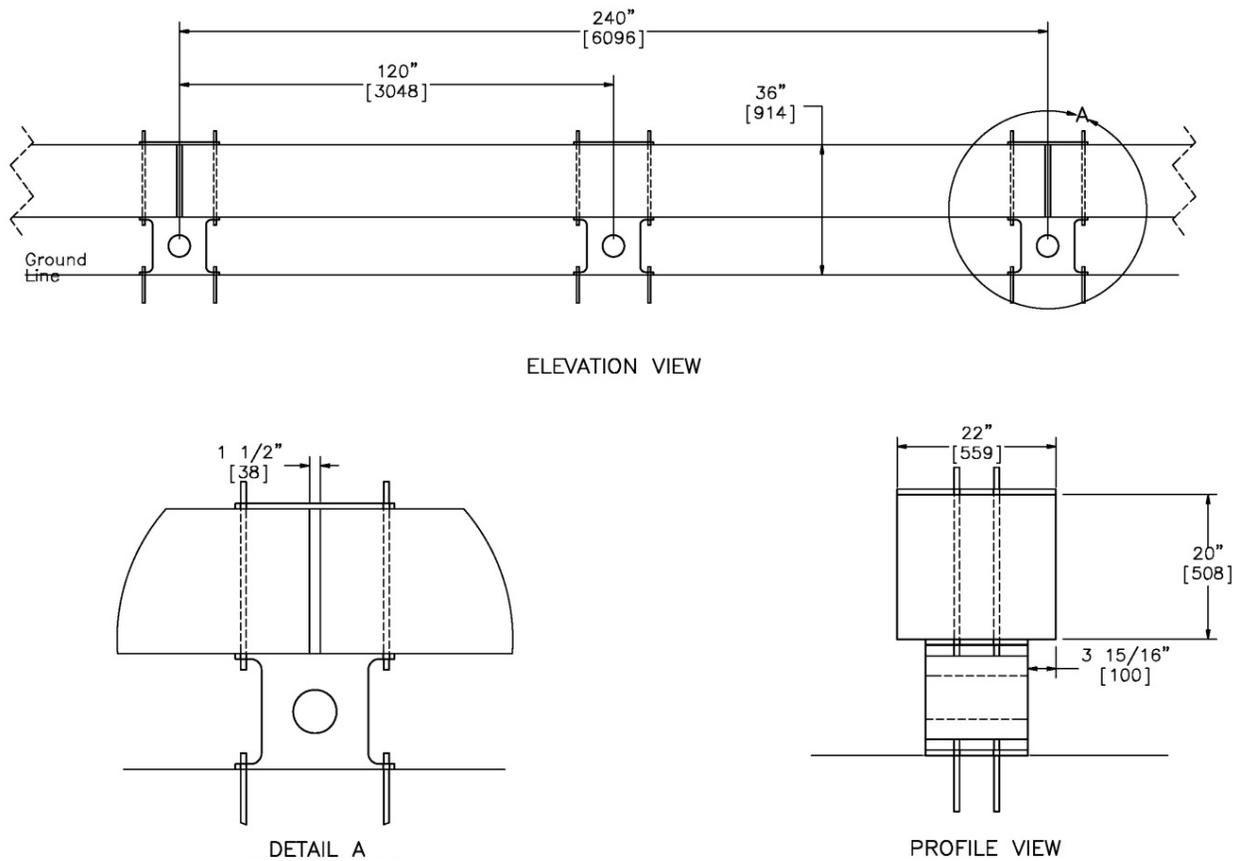
Figure 1. Initial Barrier Concept [1]

The initial concept had discrete elastomer posts with a segmented concrete rail on top of the posts, as shown in Figure 1 [1]. The posts were 16 in. (406 mm) tall x 22 in. (559 mm) wide x 14 in. (356 mm) long, spaced at 10 ft (3.0 m). The concrete beam was 20 in. (508 mm) tall x 22 in. (559 mm) wide and was spliced at post locations. A material model of the rubber posts was developed for use in LS-DYNA finite element analysis by Schmidt, et al. [1]. A model of the barrier concept was created in LS-DYNA, and simulations of 1100C, 2270P, and 10000S vehicle models impacting the barrier were conducted. The initial simulation results indicated that the barrier had the potential to satisfy the design criteria.

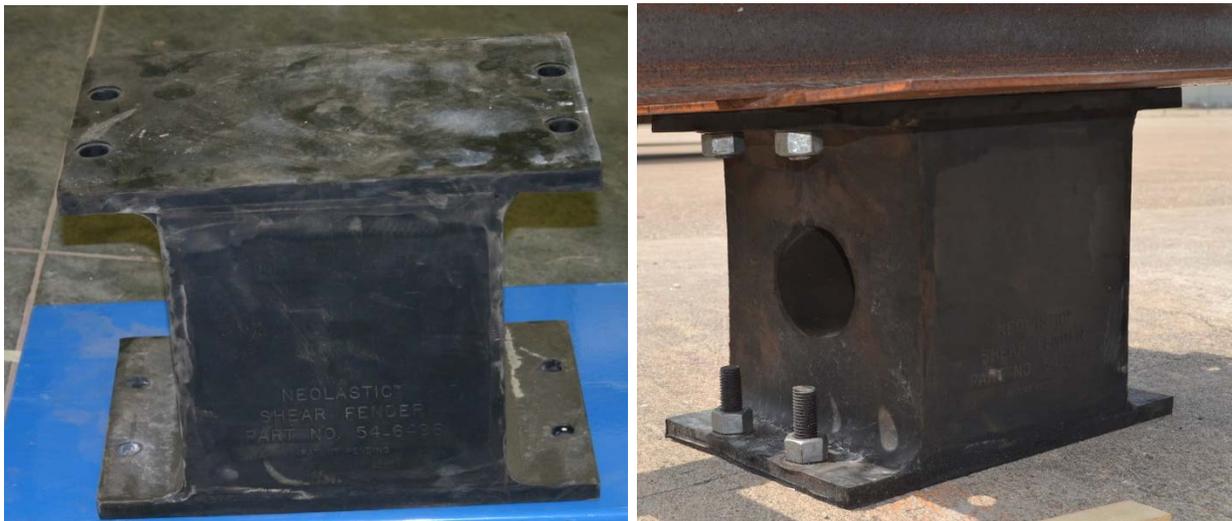
Figure 3. 11⁵/₈-in. (295-mm) Tall Shear Fender

Dynamic bogie tests were conducted on 11⁵/₈-in. (295-mm) tall rubber shear fenders manufactured by Morse Rubber, as shown in Figure 3, to determine their energy vs. deflection properties and evaluate their use as posts. Two tests (SF10-1 and SF10-2) were conducted to get the initial behavior of the posts. An additional five tests (SFD-1 through SFD-5) were conducted as repeatability tests to determine if the properties change with repeated impacts. Two more tests (SF10P-1 and SF10P-2) were conducted with a steel pipe inserted in the lengthwise hole in the post to determine if the steel pipe influenced the shear behavior of the post.

A total of nine dynamic bogie tests were conducted on an E46496 shear fender with dimensions of 11⁵/₈ in. (295 mm) tall x 10 in. (254 mm) wide x 15³/₄ in. (400 mm) long with a 4-in. (102-mm) diameter hole lengthwise through the shear fender. The bogie tests were conducted with the post loaded longitudinally, which is parallel to the length of the hole. The target impact conditions for tests SF10-1, SF10-2, SF10P-1, and SF10P-2 were a speed of 5 mph (8 km/h) and

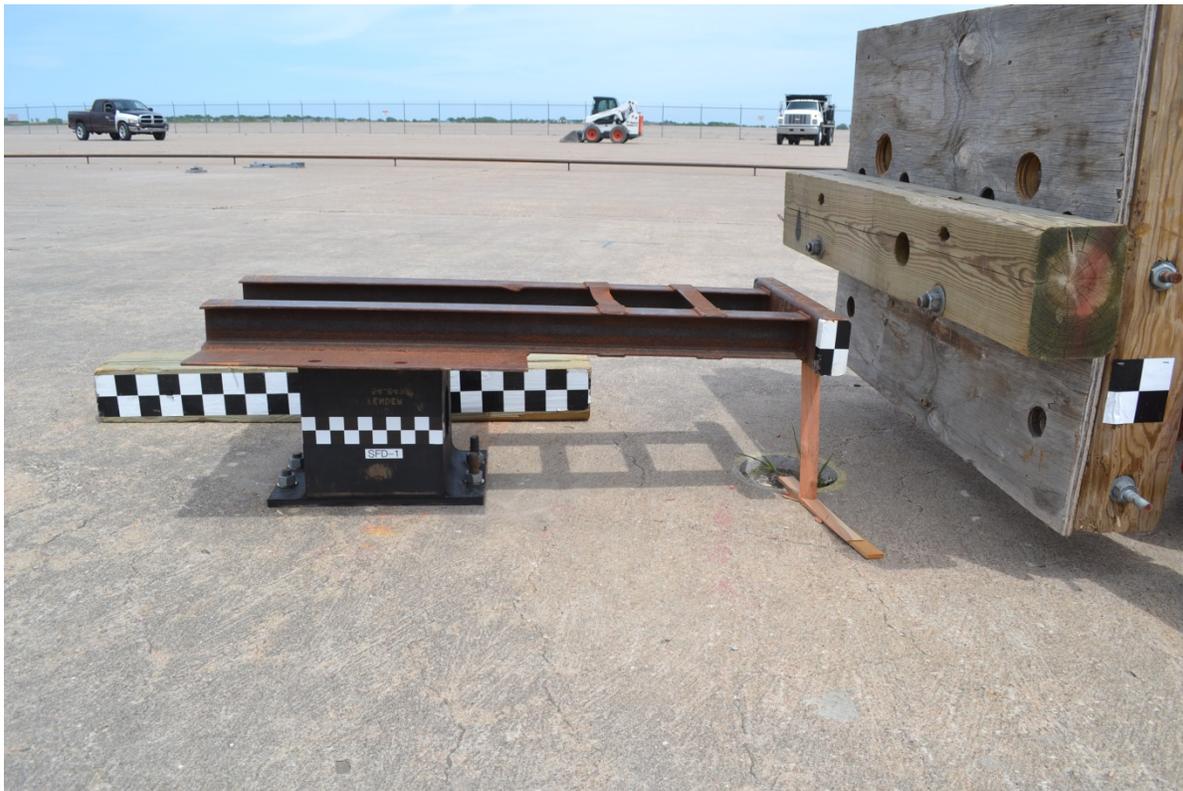
Figure 4. Bogie Test Setup, All Tests

an angle of 0 degrees, while the target impact conditions for tests SFD-1 through SFD-5 were a speed of 8 mph (13 km/h) and an angle of 0 degrees. The impact height for all dynamic bogie tests was 13³/₈ in. (340 mm) above the groundline. A steel-frame structure was bolted to the top of the post to transfer a shear load to the post and prevent direct contact between the bogie and the post. The bottom of the post was attached to the ground with ¾-in. (19-mm) diameter threaded rods embedded 8 in. (203 mm) into the concrete tarmac and anchored with a minimum bond strength of 1,300 psi (8.96 MPa). A test setup photograph is shown in Figure 4. The test matrices and test setup are shown in Figures 5 through 10 for test nos. SF10-1 and SF10-2, Figures 11 through 16 for test nos. SFD-1 through SFD-5, and Figures 17 through 22 for test nos. SF10P-1 and SF10P-2. A certificate of conformity for the posts is shown in Appendix A.

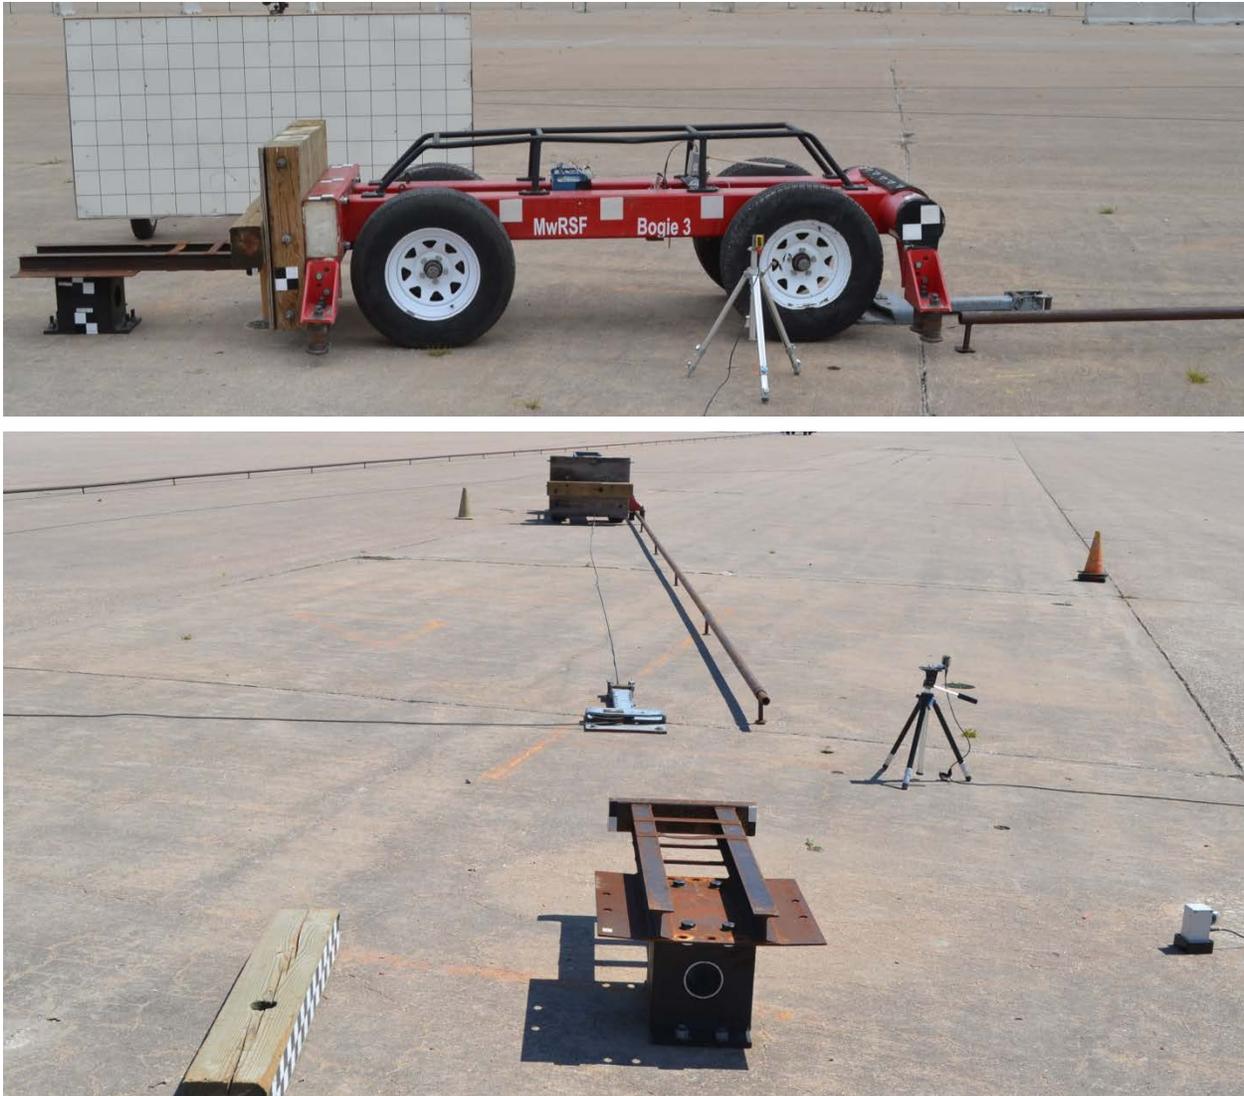
Figure 23. Rigid-Frame Bogie on Guidance Track

A rigid-frame bogie was used to impact the posts. A variable-height, detachable impact head was used in the testing. The bogie head was constructed of six 6-in. (152-mm) wide x 8-in. (203-mm) deep x 34-in. (864-mm) tall timbers covered with plywood. An additional 6-in. (152-mm) x 8-in. (203-mm) timber beam was attached horizontally to the impact head, so that the steel frame attached to the top of the post would impact just under the additional timber beam and not slide up the face of the impact head. The bogie with the impact head is shown in Figure 23. The weight of the bogie with the addition of the mountable impact head and accelerometers was 1,854 lb (841 kg) in test nos. SF10-1 and SF10-2 and 1,886 lb (85 kg) in test nos. SFD-1 through SFD-5, SF10P-1, and SF10P-2.

A steel-pipe guidance track was used to guide the bogie vehicle for the tests, as shown in Figure 23. A pickup truck with a reverse cable tow system was used to propel the bogie to the target impact speed. When the bogie approached the end of the guidance system, it was released from the tow cable, allowing it to be free-rolling when it impacted the post. A remote braking system was installed on the bogie, allowing it to be brought safely to rest after the test.

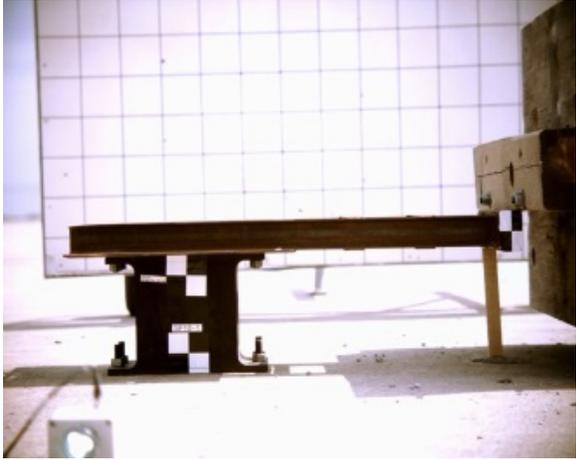
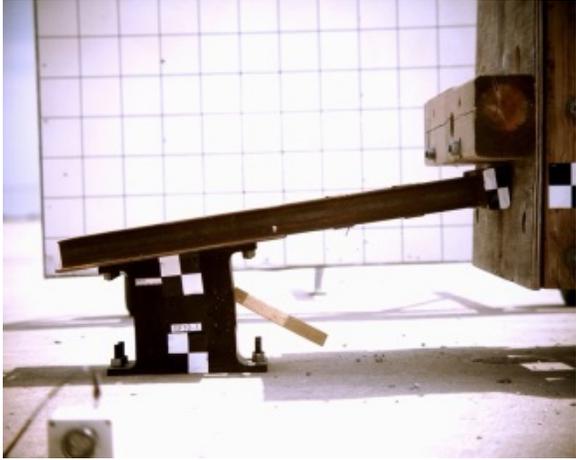
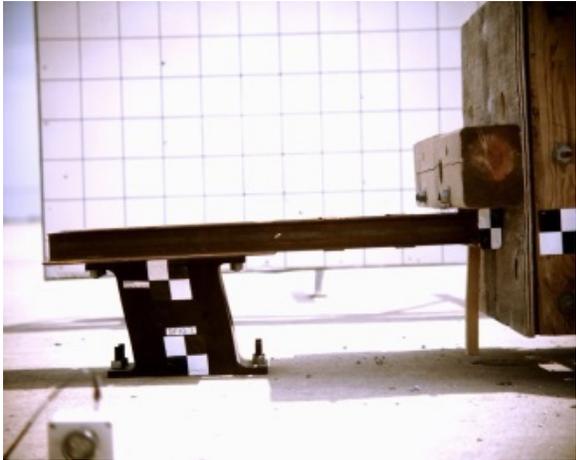
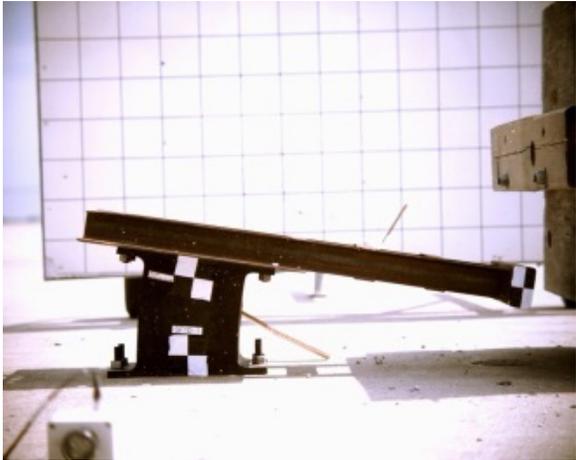
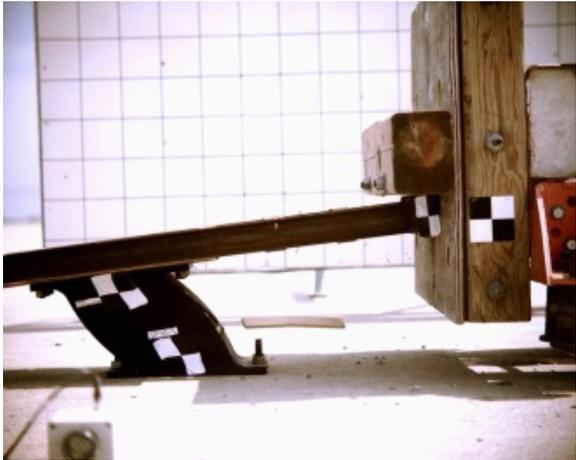
Figure 25. Time-Sequential Photographs, Test No. SF10-1

shear until it reached a maximum deflection, and then the upper steel impact assembly began rotating upward which the bogie to pitch slightly as it rebounded. Sequential photographs are shown in Figure 25. The bogie and post behavior were very similar in all seven of the post tests, except test no. SFD-4. Therefore, force vs. deflection and energy vs. deflection curves and sequential photographs are not shown independently for each test.

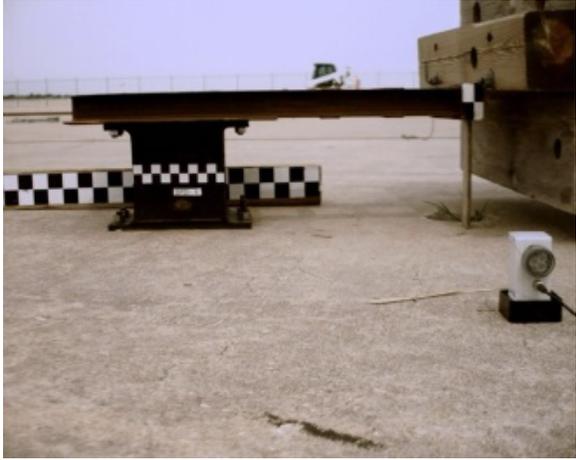
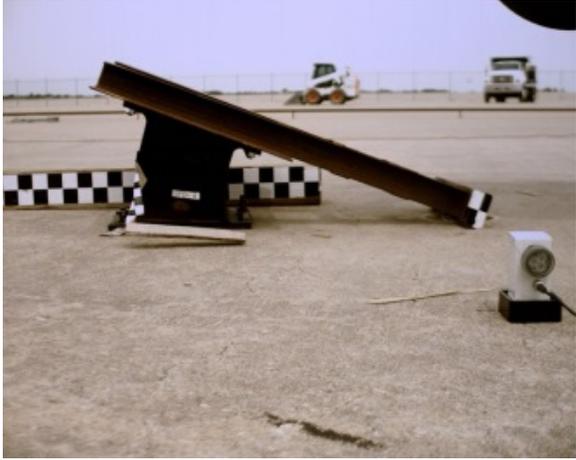
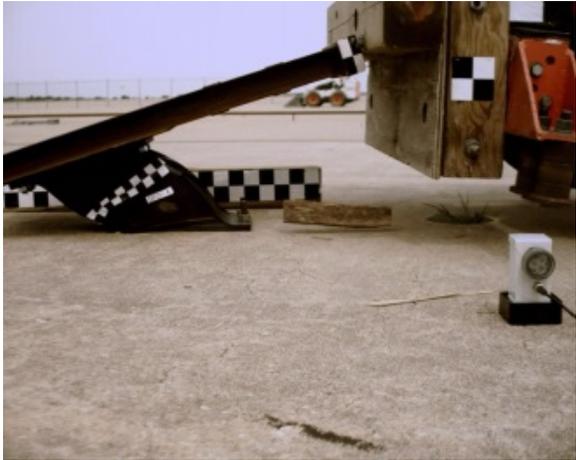
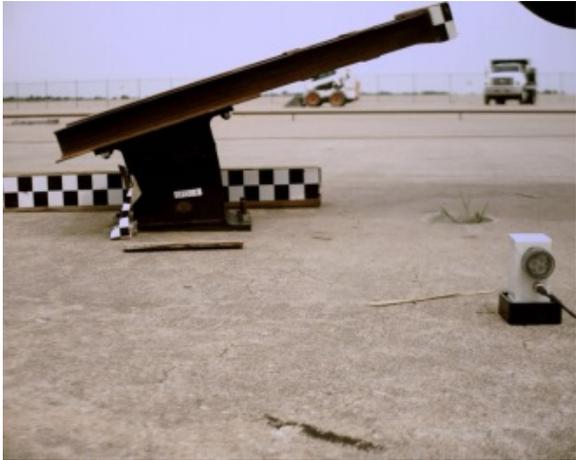
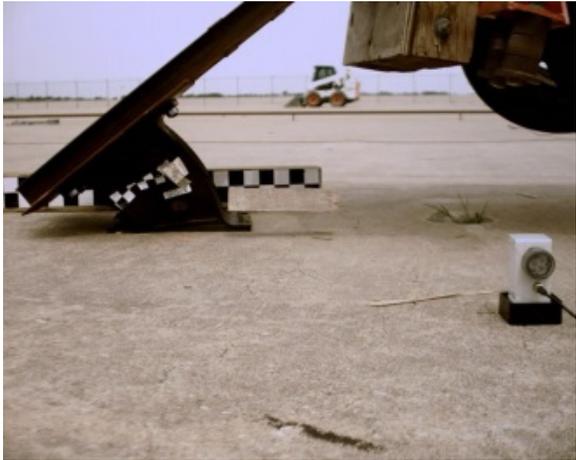
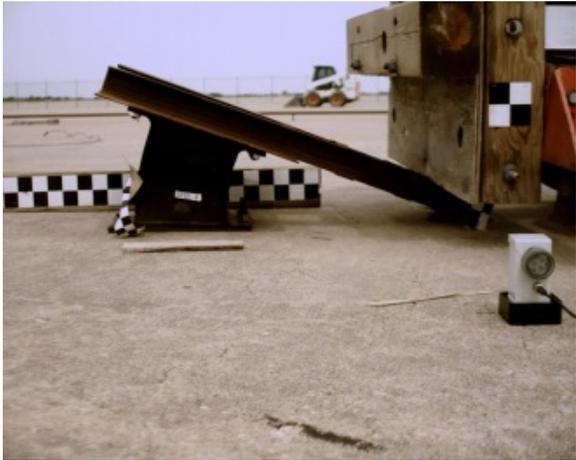
Figure 26. Time-Sequential Photographs, Test No. SFD-4

In test no. SFD-4, the bogie was bouncing prior to the impact. As a result, the structure was impacted higher on the bogie head than the other tests. Due to the high impact, post rotation and front-end lift of the bogie increased. The largest displacement recorded by the accelerometer was 15.1 in. (384 mm) and occurred at the end of the event when the bogie lost contact with the impact structure. However, the maximum deflection that the post obtained was approximately 13.5 in. (343 mm) at approximately 0.150 seconds, as determined from high-speed film analysis. Sequential photographs of test no. SFD-4 are shown in Figure 26.

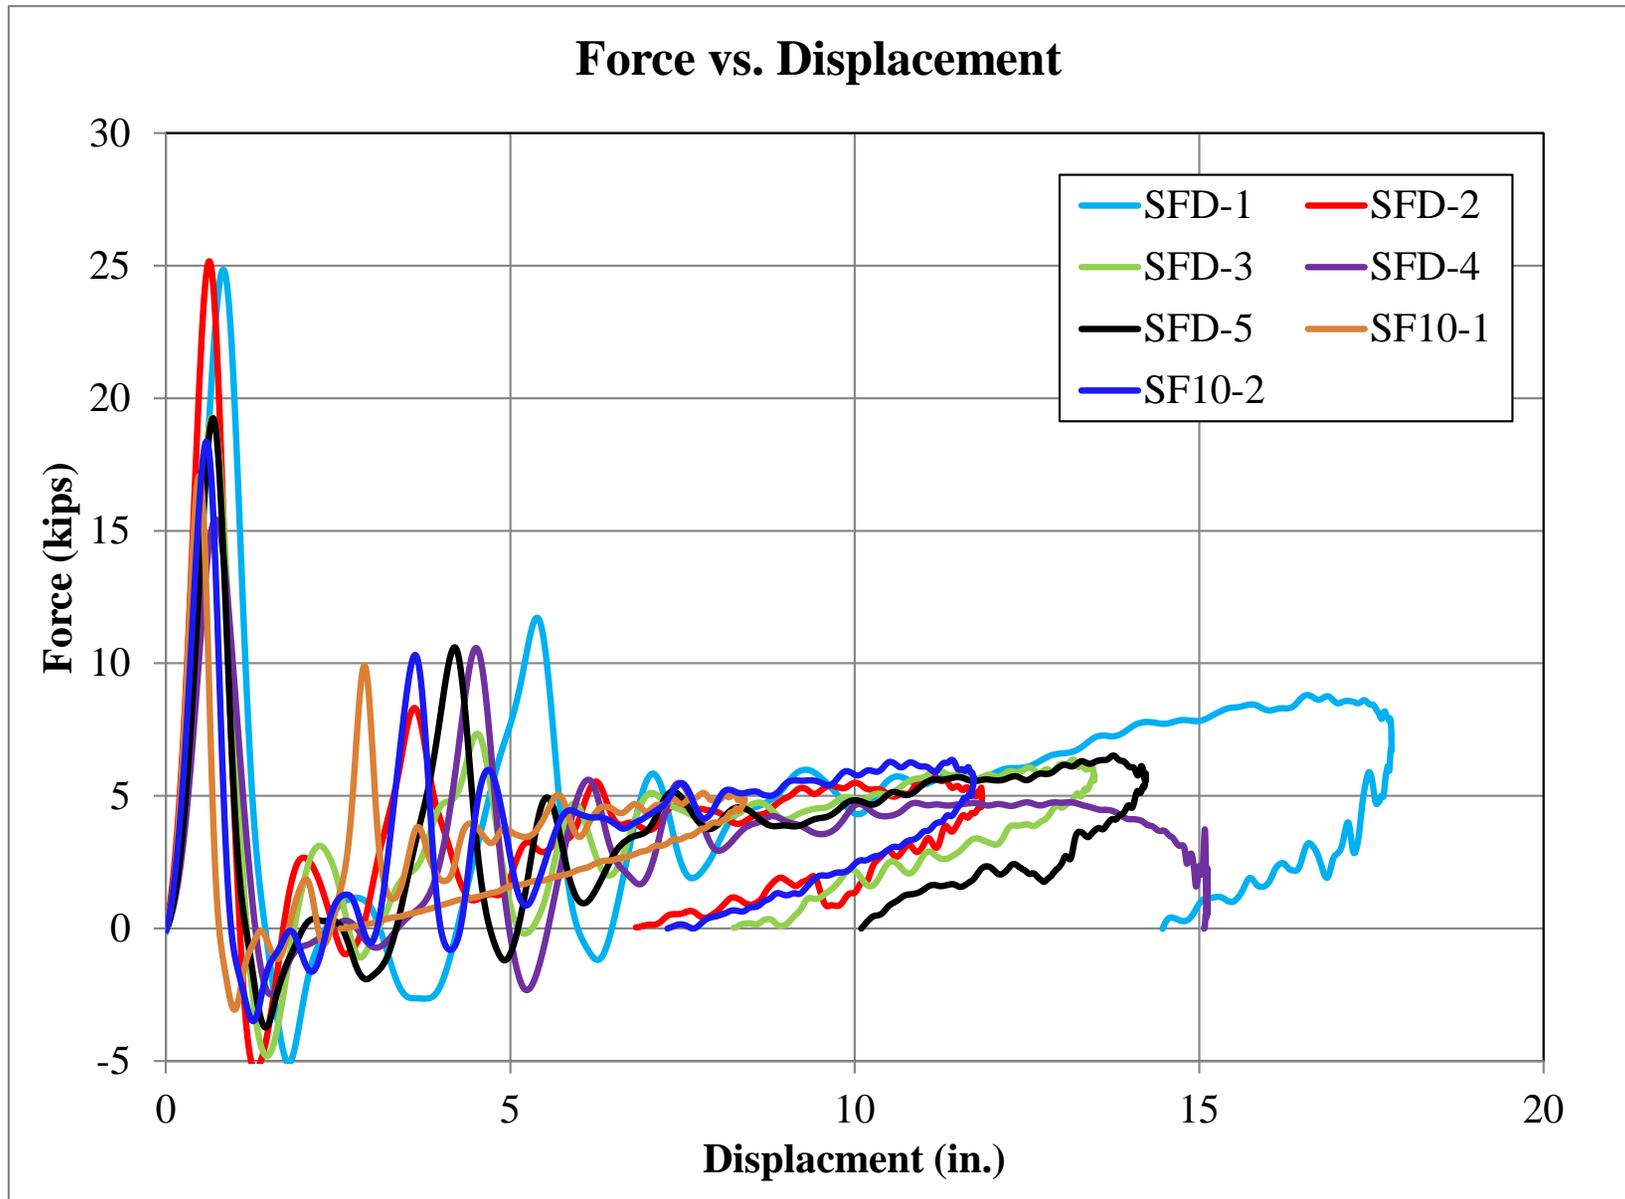
Figure 27. Force vs. Deflection Comparison, All Bogie Tests Without Steel Pipe

A total of seven dynamic bogie tests were conducted on the 11⁵/₈-in. (295-mm) tall posts with a targeted angle of 0 degrees and a speed of 5 mph (8 km/h) for test nos. SF10-1 and SF10-2 and 8 mph (12.9 km/h) for test nos. SFD-1 through SFD-5. Test nos. SF10-1 and SF10-2 were conducted on the same post on the same day. Test nos. SFD-1 through SFD-5 were conducted on the same post on the same day. Upon post-test examination, none of the shear fenders were damaged and had no permanent set. The impact conditions and results of these tests are summarized in Table 2.

The results from the bogie testing matrix are summarized in Table 4. When examining the SFD-1 through SFD-5 test series, the energy absorbed at each deflection overall tended to decrease with repetitive impacts. However, this was not always the case. The differences seen in energy absorbed may be contributed to slight changes in how the bogie interacted with the post and if the post deformed in shear or rotated more. The energy absorbed may also degrade slightly with each impact after being subjected to an extreme deflection, similar to the 17.8 in. (452 mm) that occurred in test no. SFD-1. However, the posts are not expected to be loaded above 10 in. (254 mm) of deflection for impact events up to 62 mph (100 km/h) and 25 degrees for passenger vehicles, so they may only experience more extreme deflections during rare larger truck impact events. So, the posts should maintain adequate energy absorption for repeated impact events.

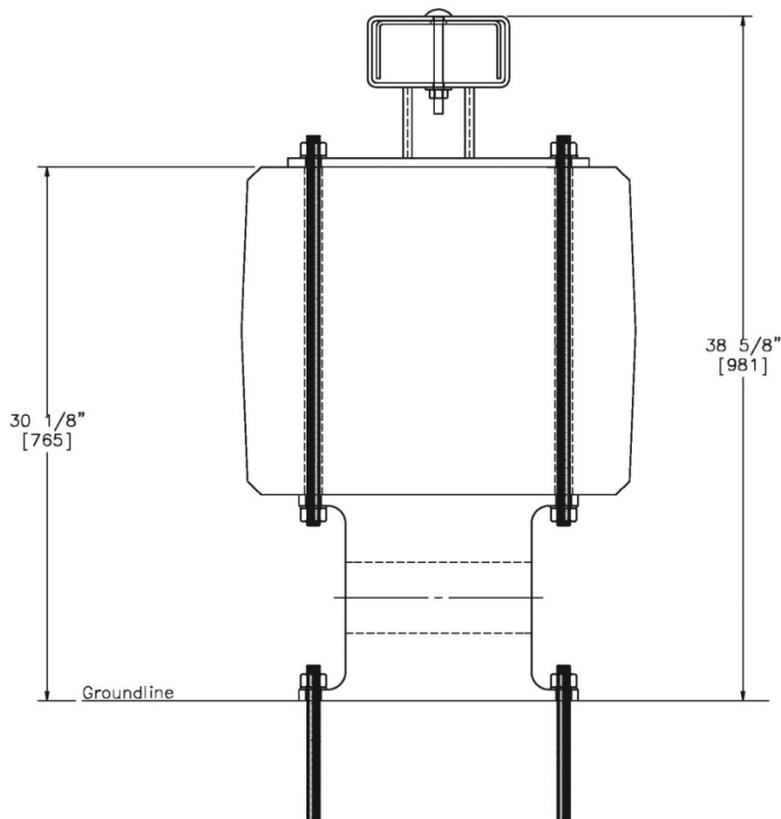
Figure 36. Optimized Rail Cross Section

Based on several previous TL-3 rigid barrier crash tests, the height to the top of the concrete beam should be approximately 29 to 30 in. (737 to 762 mm) above the ground to capture the 2270P pickup truck. Approximately ½ in. (13 mm) of settlement was estimated due to a 320-lb/ft (476-kg/m) static dead load of the rail [2], so the height of the concrete beam needed to be approximately 18½ in. (470 mm) tall. Vertical deflection may occur during a single-unit truck impact from the box leaning on the rail, as noted in previous simulations [1], so the overall height was targeted at approximately 38½ in. (978 mm) to allow for settling due to self-weight and some of the vertical deflection that may occur from box lean and the barrier translating and/or rotating.

Vertical holes in the interior sections of the concrete were utilized to reduce weight. However, they had to be small enough and selectively placed to maintain capacity of the section.

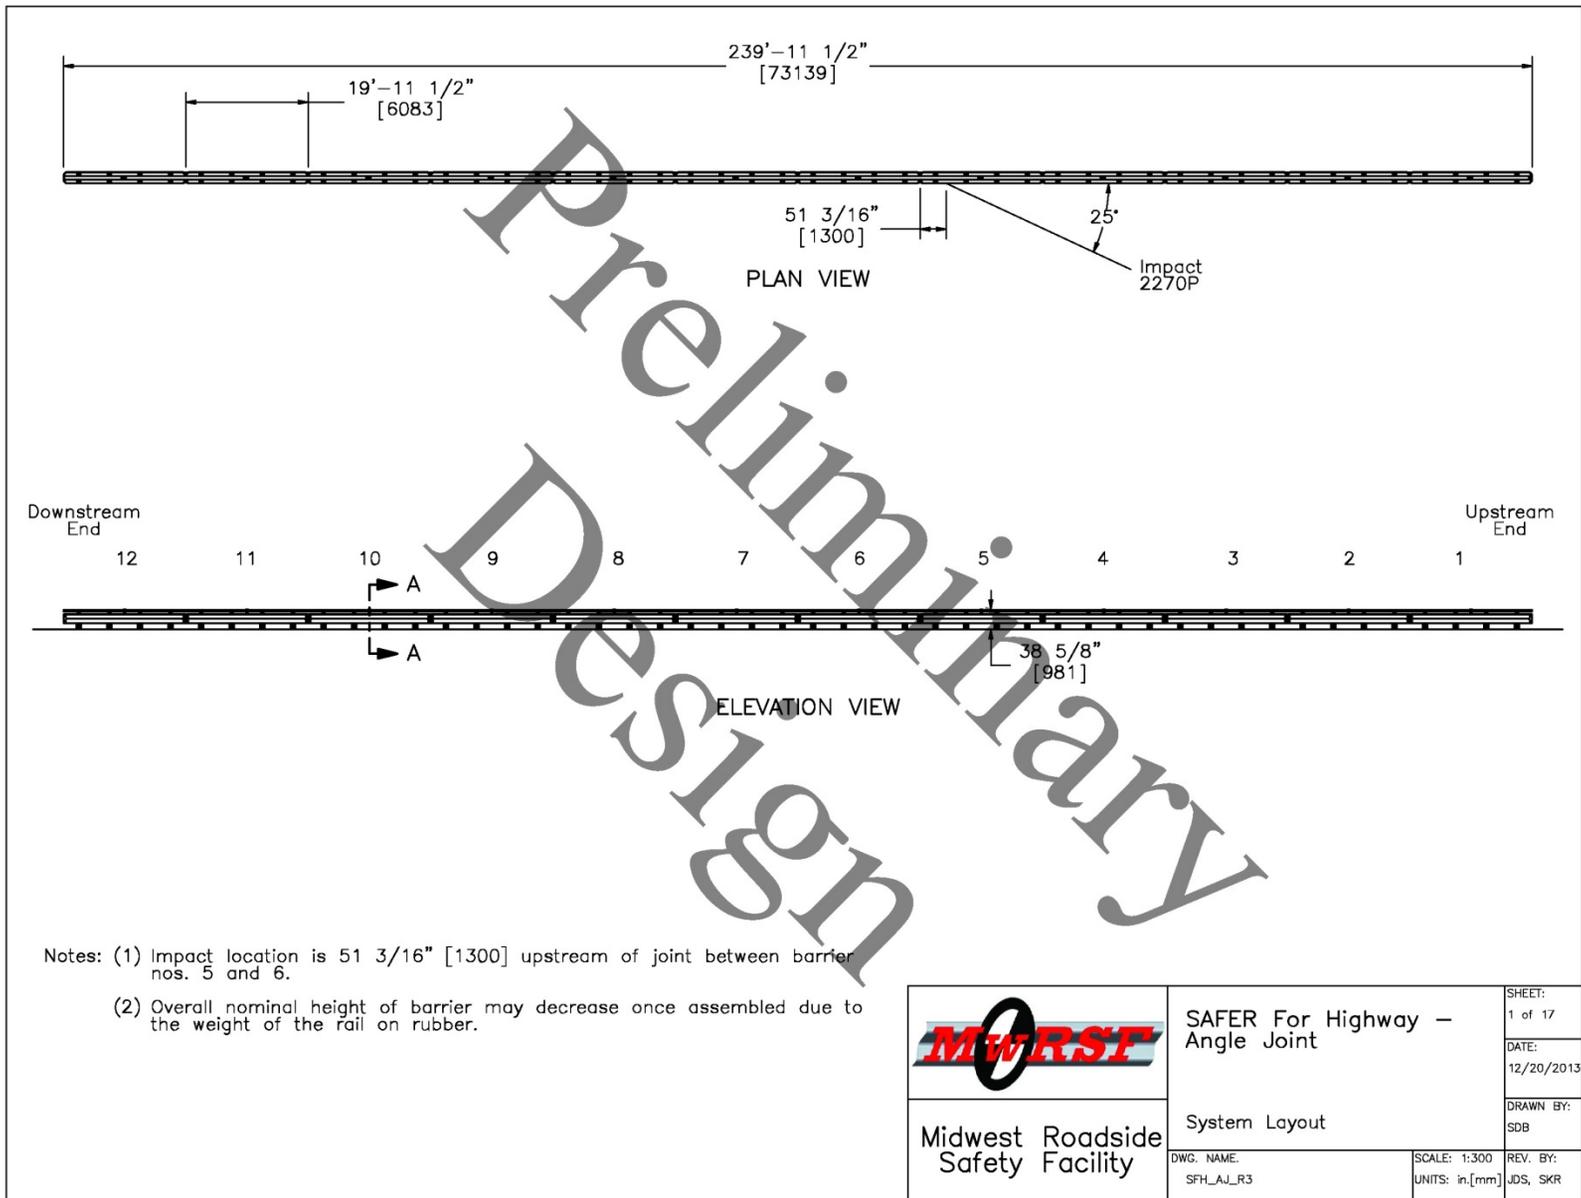
Figure 43. Preliminary Barrier Design, System Layout

The rubber posts were 11⁵/₈ in. (295 mm) tall x 10 in. (254 mm) wide x 15³/₄ in. (400 mm) long, with four vertical holes to accommodate ¾-in. (19-mm) diameter bolts. The bases of the rubber posts were attached to the foundation with ¾-in. (19-mm) threaded rods and a chemical epoxy adhesive. The upper tube assembly was comprised of 4-in. x 8-in. x ¼ in. (102-mm x 203-mm x 6.4-mm) steel tube supported by 4-in. x 4-in. x ¼-in. (102-mm x 102-mm x ¼-in.) steel tube posts on steel base plates every 5 ft (1.5 m). The steel tubes were spliced every 20 ft (6.1 m) with bent steel plate. Vertical bolts connected the base plates, the concrete beam, and the rubber posts.

The final weight of the concrete and steel rail combined was estimated to be 318 lb/ft (473 kg/m) excluding bolts, nuts, and washers. The nominal flexural strength of the concrete beam was 2,602 kip-in. (294 kN-m). The nominal flexural strength of the concrete beam in the vertical direction was 2,098 kip-in. (237 kN-m). The nominal shear strength of the concrete section at its weakest point (at the circular vertical hole) is 66 kips (294 kN).

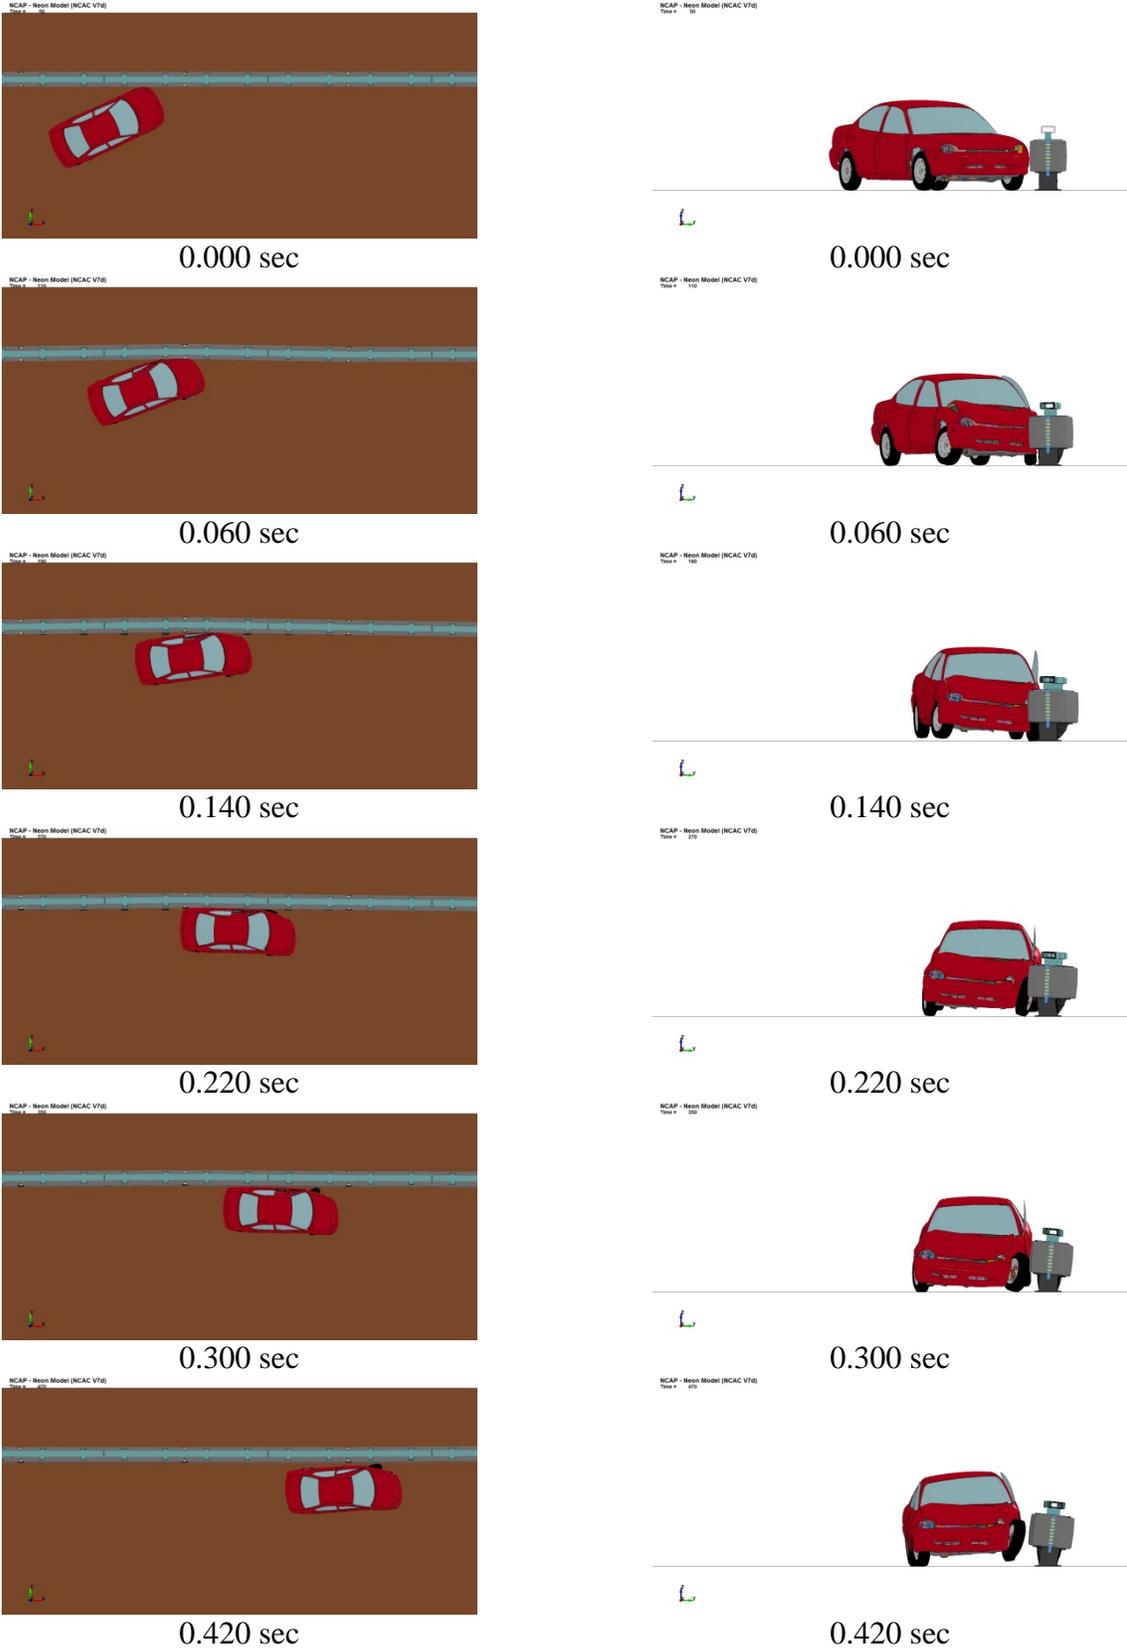
Figure 61. RESTORE Barrier Simulation with MASH Test Designation 4-10 Impact (1100C)

Moderate damage occurred to the front and left sides of the car. The left-front tire slightly contacted the first two posts downstream from the splice between beam segments 5 and 6. The tire then appeared as if it was trying to disengage. The body of the car only contacts the front face of the concrete beams, and no part of the car contacted the upper tube assembly. There system did not appear to have any permanent damage. The system did restore fully; however, the rubber material unloading curve had not been validated, and damping was not enabled in the material.

Accelerations, velocities, and displacements were found at the center of gravity of the 1100C model at every 0.01 ms and filtered using a customized Excel spreadsheet that is used for filtering full-scale crash test data. The lateral and longitudinal occupant impact velocity (OIV) and occupant ridedown acceleration (ORA) for the RESTORE barrier simulation and the baseline simulation are shown in Table 7. The CFC 180 10-ms average lateral acceleration trace is shown in Figure 62, and the peak acceleration is shown in Table 7. The initial peak lateral acceleration was reduced by 17.3 percent in the RESTORE barrier simulation as compared to the baseline simulation into a rigid New Jersey-shaped concrete barrier at the same impact conditions. The lateral OIV was reduced by 20 percent. The longitudinal OIV, lateral ORA, and longitudinal ORA were almost unchanged when compared to the baseline simulation. Note, all of the occupant risk values were below the MASH threshold limits for both the rigid concrete barrier and the RESTORE barrier simulations.

Other parameters (i.e., parallel time and exit time, velocity, and angle) that give an indication of the RESTORE barrier performance were compared to those obtained under simulated impacts with rigid barriers. A comparison of these parameters is shown in Table 8. Parallel and exit times were determined by visual inspection of the simulation. Exit velocity and angle were determined from the nodal output at the center of gravity local node at the exit time. The parallel and exit times were greater and the exit velocity was lower with the RESTORE barrier, which was anticipated since the system deflected and absorbed some of the vehicle's kinetic energy. The vehicle also exited the RESTORE barrier at a lower angle than the rigid barrier.

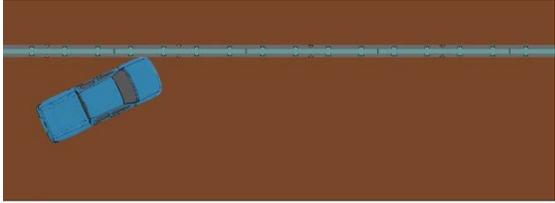
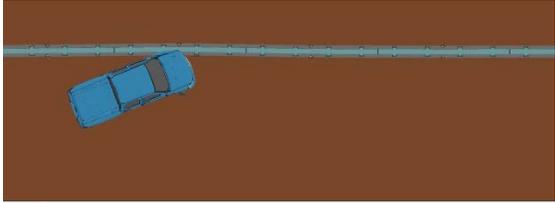
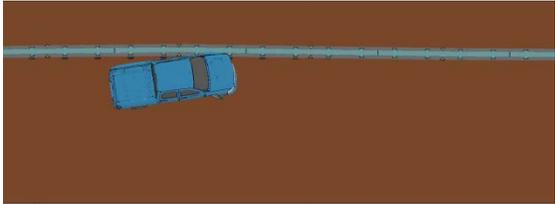
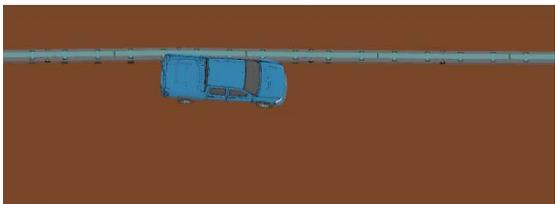
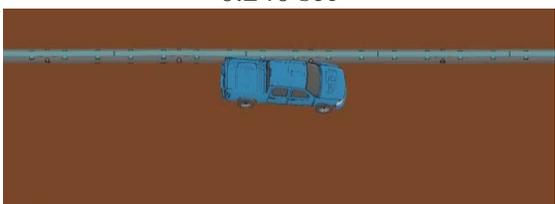
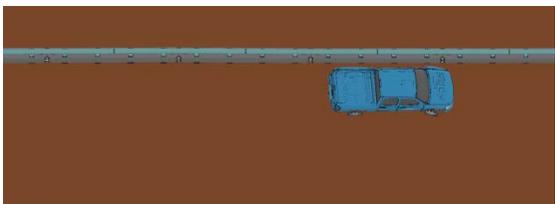
Figure 63. RESTORE Barrier Simulation with MASH Test Designation 4-11 (2270P) Impact

Moderate damage occurred to the front and left sides of the truck. The left-front and left-rear tires both slightly contacted the first post upstream from the splice between beam segments 5 and 6 and the first post downstream from the splice between beam segments 5 and 6. The left-front fender contacted the upper tube assembly upon initial impact and the left-rear quarter panel contacted the upper tube assembly upon the rear-end impact, which caused some slight permanent damage to the upper tube assembly. The rest of the system did not appear to have any permanent damage. The system did restore fully; however, the rubber material unloading curve had not been validated, and damping was not enabled in the material.

Accelerations, velocities, and displacements were found at the center of gravity of the 2270P model at every 0.1 ms and filtered using a customized Excel spreadsheet that is used for filtering full-scale crash test data. The lateral and longitudinal OIV and ORA for the RESTORE barrier simulation and the baseline simulation are shown in Table 9. The CFC 180 10-ms average lateral acceleration trace is shown in Figure 64, and the peak is shown in Table 9. The initial peak lateral acceleration was reduced by 28 percent with the RESTORE barrier simulation as compared to the baseline simulation into a rigid single-slope concrete barrier at the same impact conditions. Lateral OIV was reduced by 26 percent, and lateral ORA was reduced by 12 percent. Longitudinal ORA increased compared to the baseline simulation, but it was still below the MASH safety limit. As shown in previous simulations, the rear of the Silverado vehicle model is overly stiff, which causes tailslap to be overestimated in simulations. Thus, the lateral and longitudinal ORA would be expected to be lower in a full-scale crash test than in the simulation. This behavior may also have contributed to the greater pitch and roll motions of the pickup truck after it exited the system.

Other parameters (i.e., parallel time and exit time, velocity, and angle) that give an indication of the RESTORE barrier performance were compared to those obtained under simulated impacts with rigid barriers. A comparison of these parameters is shown in Table 10. Parallel and exit times were determined by visual inspection of the simulation. Exit velocity and angle were determined from the nodal output at the center of gravity local node at the exit time. The parallel and exit times were greater and the exit velocity was slightly lower with the RESTORE barrier, which was anticipated since the system deflected and absorbed some of the vehicle's kinetic energy. The vehicle also exited the RESTORE barrier at a lower angle than the rigid barrier.

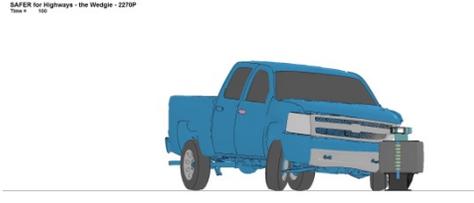
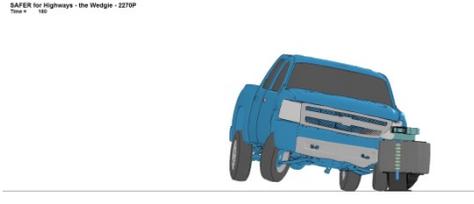
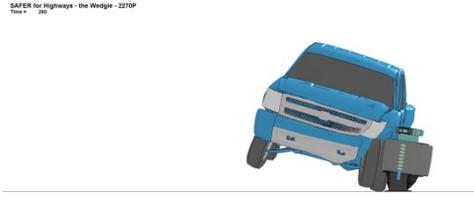
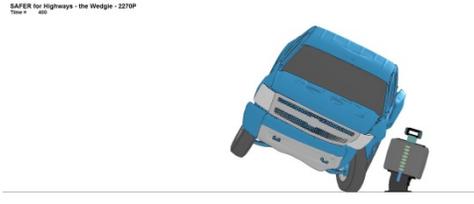
The 2270P Silverado model impacted the RESTORE barrier at a speed of 62 mph (27.8 m/s) and an angle of 25 degrees approximately 64 in. (1,626 mm) upstream from the splice between beam segments 5 and 6. The vehicle was successfully contained and redirected, and the vehicle trajectory is shown in Figure 63. The pickup truck was parallel to the system 180 ms after impact and exited the system 270 ms after impact. The vehicle had some moderate roll and pitch motions once it exited the system.

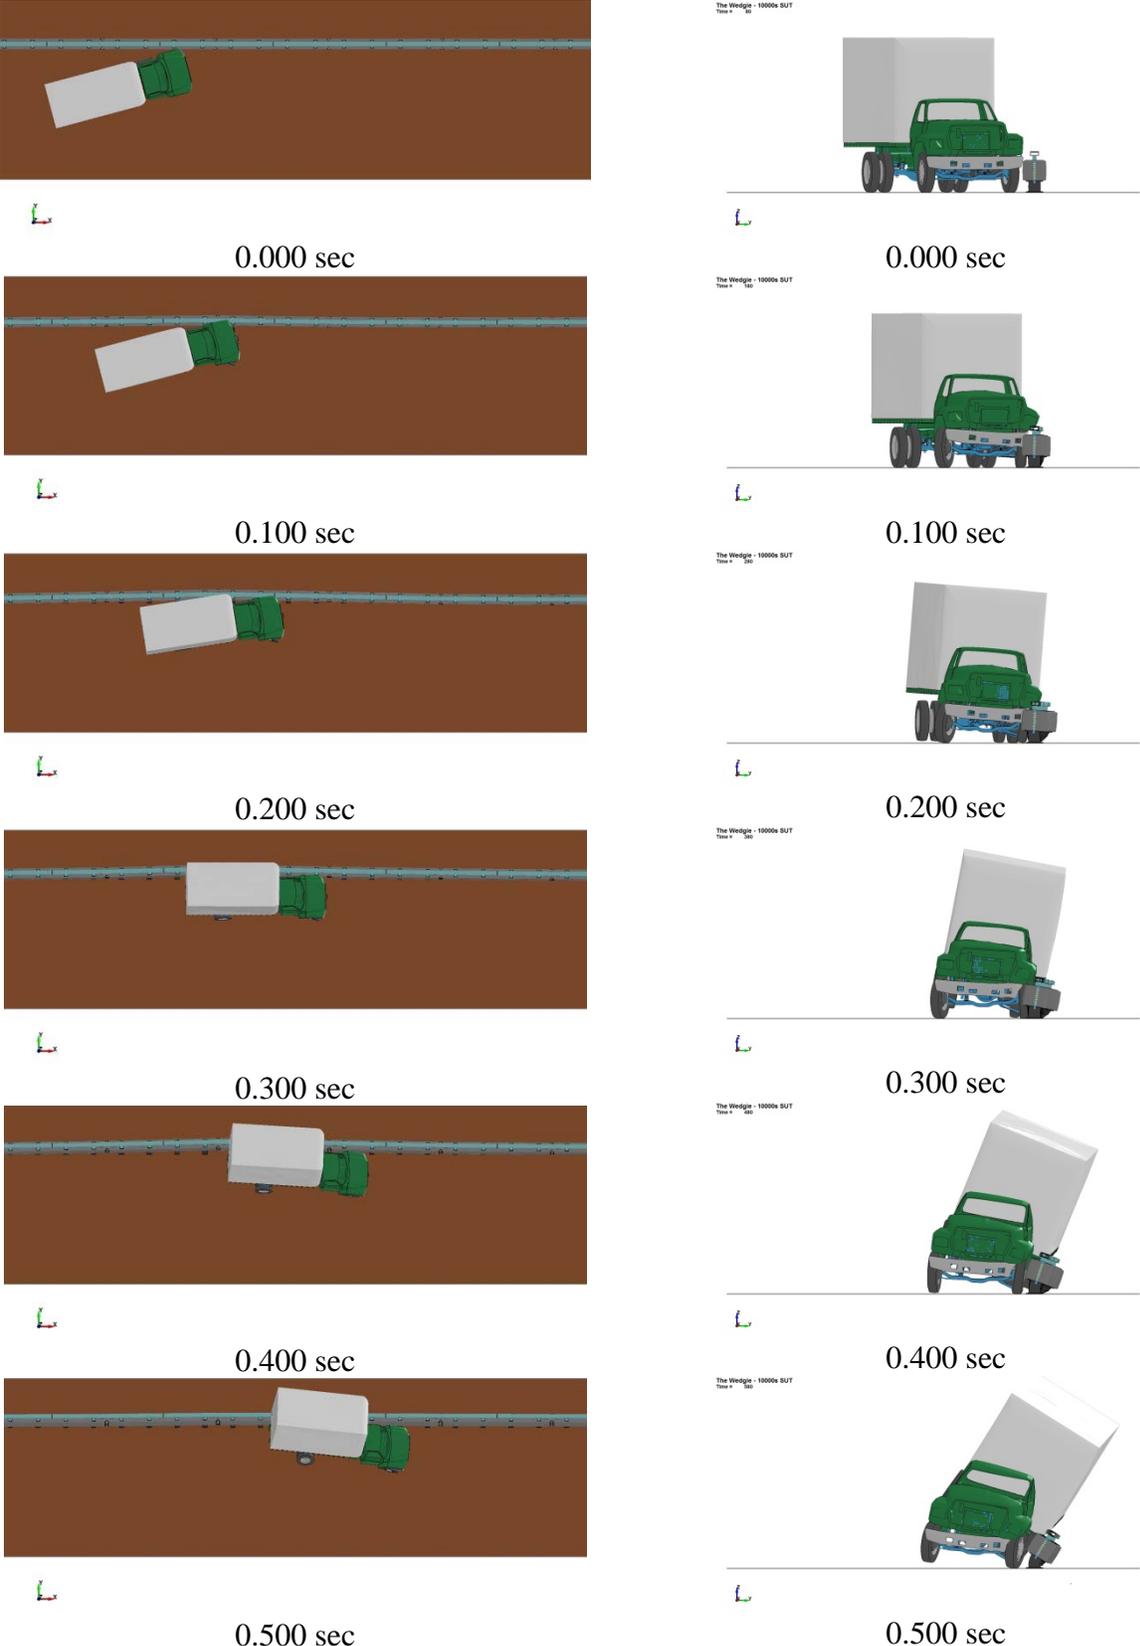
Figure 65. RESTORE Barrier Simulation with MASH Test Designation 4-12 (10000S) Impact

Moderate damage occurred to the front and left sides of the truck. The left-front tire slightly contacted the second, third, and fourth posts downstream from the splice between beam segments 5 and 6. The left-rear tire became airborne after the initial impact and only contacted the front face of the concrete beams. The left-front fender and the box contacted the upper tube assembly, which caused some slight permanent damage to the upper tube assembly. The rest of the system did not appear to have any permanent damage. The posts bent significantly backward during the impact event, and the concrete beams contacted the ground. The system did not restore as the simulation ended in error before the vehicle exited the system.

The system laterally deflected a maximum of 13.5 in. (342 mm) at the top upstream end of concrete beam no. 6. The top of concrete beam no. 6 also vertically deflected a maximum of 7.4 in. (188 mm) due to the cargo box leaning on the top of the barrier and the barrier rotating backward.

The dynamic barrier deflections during the passenger vehicle impacts were in the desired range. However, the barrier rotation backward in the 2270P pickup truck and 10000S single-unit truck simulations was concerning. However, as noted previously, the restoring force of the rubber material had not been validated and damping was enabled in the material. If the barrier rotates excessively in full-scale crash tests and the barrier could not restore, then additional investigation may be needed.

The barrier also experienced over 7 in. (178 mm) of vertical deflection during the single-unit truck simulation. Much of this movement was caused by barrier rotation, but the box leaning on the rail also pushed the barrier lower. This loss in barrier height could lead to an unsuccessful test if the single-unit truck rolls over top of the barrier. This behavior will be explored through full-scale crash testing.

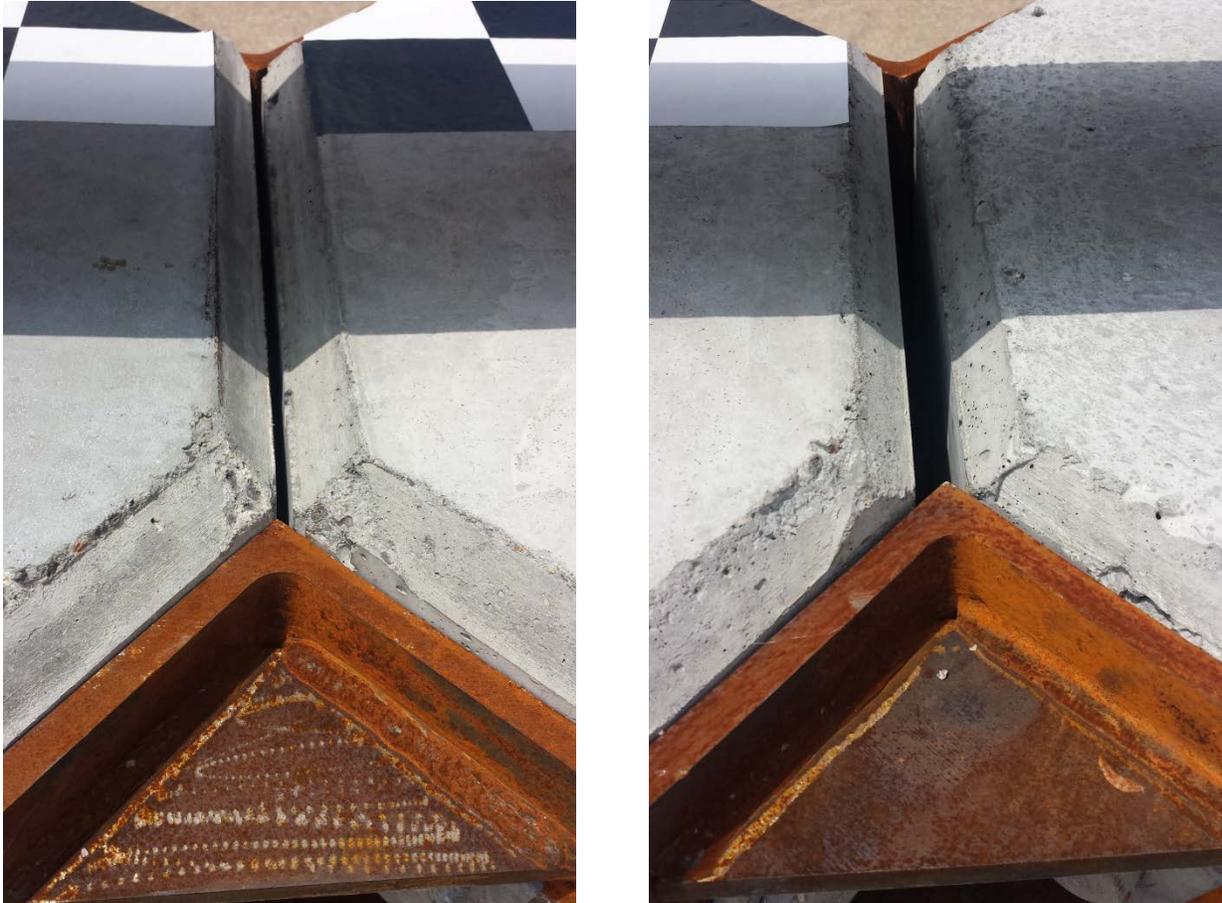
Figure 66. ACJ Variable Gap Width

The ACJ was easy to install, and adjacent barrier segment joints were aligned to form a continuous barrier face. The gap between barrier segments was a nominal $\frac{1}{2}$ in. (13 mm), but the actual installation joint gaps varied, as shown in Figure 66. Due to the ACJ's ability accommodate joint gaps between $\frac{1}{4}$ and $\frac{3}{4}$ in. (6 and 19 mm), these gaps were not an issue. The ACJ also accommodated small variations in gap width on the front and back faces at a joint.
