Design and Evaluation of an Energy-Absorbing, Reusable Roadside/Median Barrier

NDOR Sponsoring Agency Contract No. DPU-STWD (94)

DESIGN AND EVALUATION OF AN ENERGY- ABSORBING, REUSABLE ROADSIDE/MEDIAN BARRIER

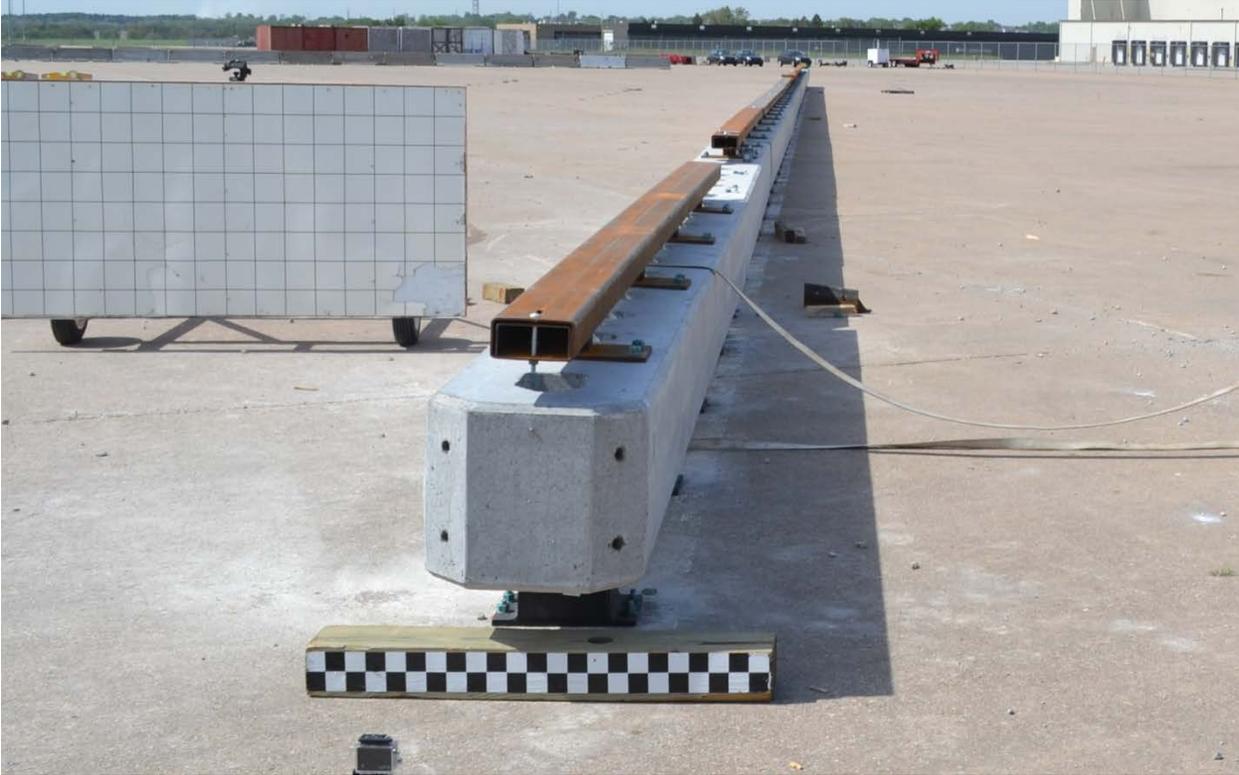
Figure 67. Barrier Stability with Steel Pipe Inserts

A 3½-in. (89-mm) diameter standard steel pipe with a 4-in. (102-mm) outer diameter and a 0.226-in. (5.7-mm) thickness was inserted into the 4-in. (102-mm) diameter hole in each of the four posts. The system was stable and remained upright, as shown in Figure 67. The posts with the steel pipe inserts were dynamically impacted in test nos. SF10P-1 and SF10P-2, as described previously. The steel pipe inserts did not affect the energy absorption of the posts.

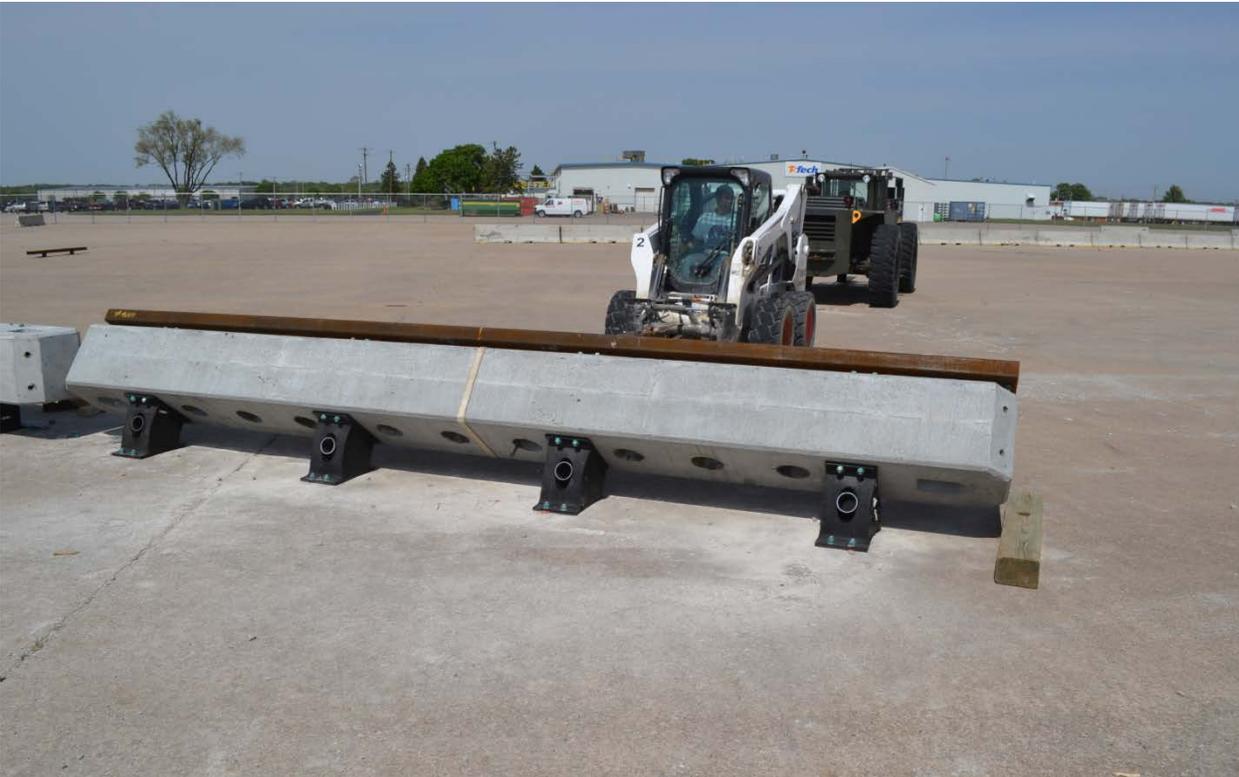
Figure 68. Barrier Deflection with Steel Pipe Inserts

A strap was placed around the concrete beam and pulled slowly. When only a single segment was pulled, the posts did not deform in shear but rather rotated backward. When pulled for approximately 6 in. (152 mm) and then released, the barrier restored to within 0.8 in. (20 mm) of its original position. The barrier was pulled for approximately 12 in. (305 mm) and then released, and the barrier restored to within 3.75 in. (95 mm) of its original position. When pulled for approximately 18 in. (457 mm) and then released, the lower corner of the concrete barrier nearly contacted the ground, and the barrier did not restore, as shown in Figure 68. After the steel pipes were removed from the posts, the barrier could not stand upright due to deformation that occurred from the overloading in the pull tests. The pull tests on the posts with the additional steel pipe in the holes resulted in a barrier system that did not fully restore, so alternative support systems were examined.

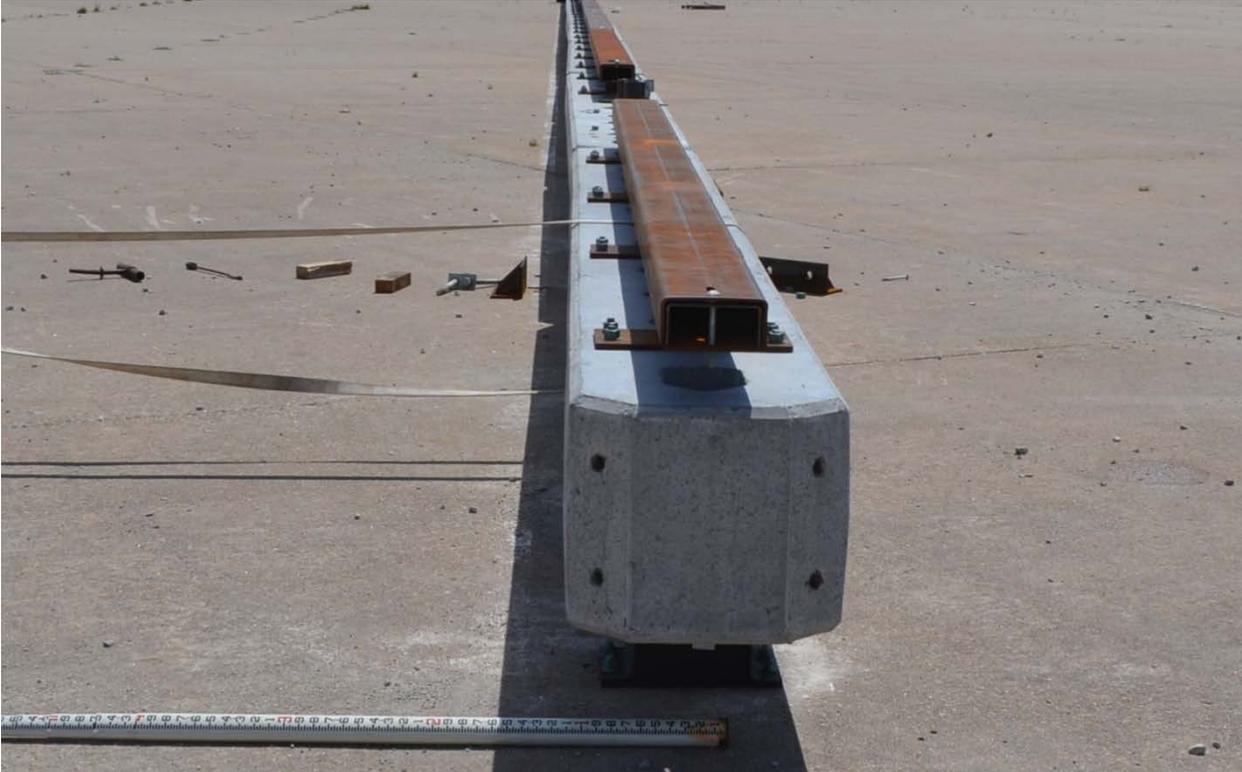
Figure 70. Barrier Stability with Two Support Skids with Shims

The steel plate shims were removed, and the barrier was stable and not leaning. The permanent set that had been noted previously was no longer present, and it was believed to be eliminated by overloading the posts from the opposite direction. The top skid plate was not supporting any weight of the beam as the heights to the bottom of the beam varied from $11\frac{1}{8}$ in. (283 mm) to $11\frac{1}{4}$ in. (286 mm). Thus, with only the posts supporting the beam, the system had a vertical deflection of $\frac{3}{8}$ to $\frac{1}{2}$ in. (9.5 to 12.7 mm) at approximately 70 degrees F (21 degrees C). The system also remained completely upright with only the rubber posts supporting the weight of the rail. However, the barrier did begin to lean after several hours. The steel shims were once again inserted in the gap between the bottom of the concrete beams and the top skid plate, and the system continued to remain completely upright and stable. In lieu of having varying thickness steel shims to stabilize the system on varying terrain, thick rubber sheet shims would allow adjustability more easily without multiple parts. Implementing the skids into the barrier system increased the stability and was further pursued.

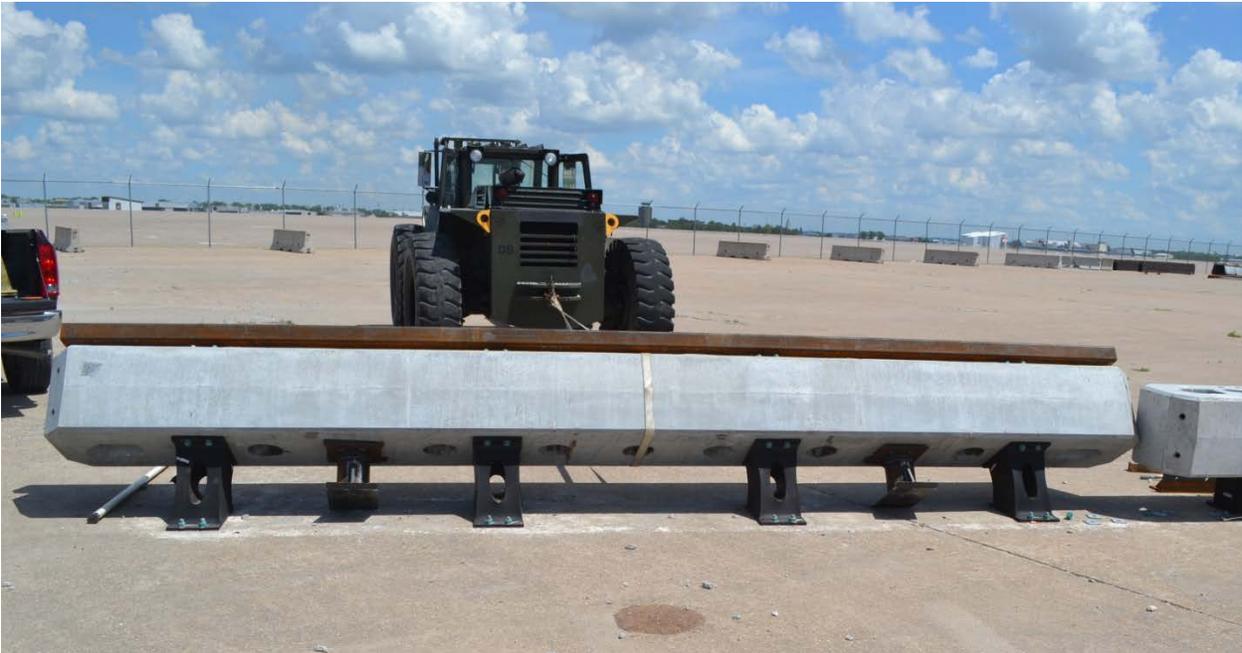
Figure 71. Maximum Barrier Deflection with Two Support Skids with Shims

the concrete beams and the top skid plate was closed. The weight of the rail was taken off of the rubber posts, and the Version 2 skids supported most of the weight of the rail. Since the site terrain was not completely level, a $\frac{3}{8}$ -in. (9.5-mm) shim was installed for one skid and a $\frac{3}{4}$ -in. (19-mm) shim was installed for the second skid. The resulting barrier segment was completely stable and did not lean, as shown in Figure 70. The beam was pulled from the opposite side as the previous pull tests to prevent further permanent set from occurring. The segment was pulled for approximately 18 in. (457 mm), as shown in Figure 71, and then released. The barrier restored completely and no deformation occurred to the skids.

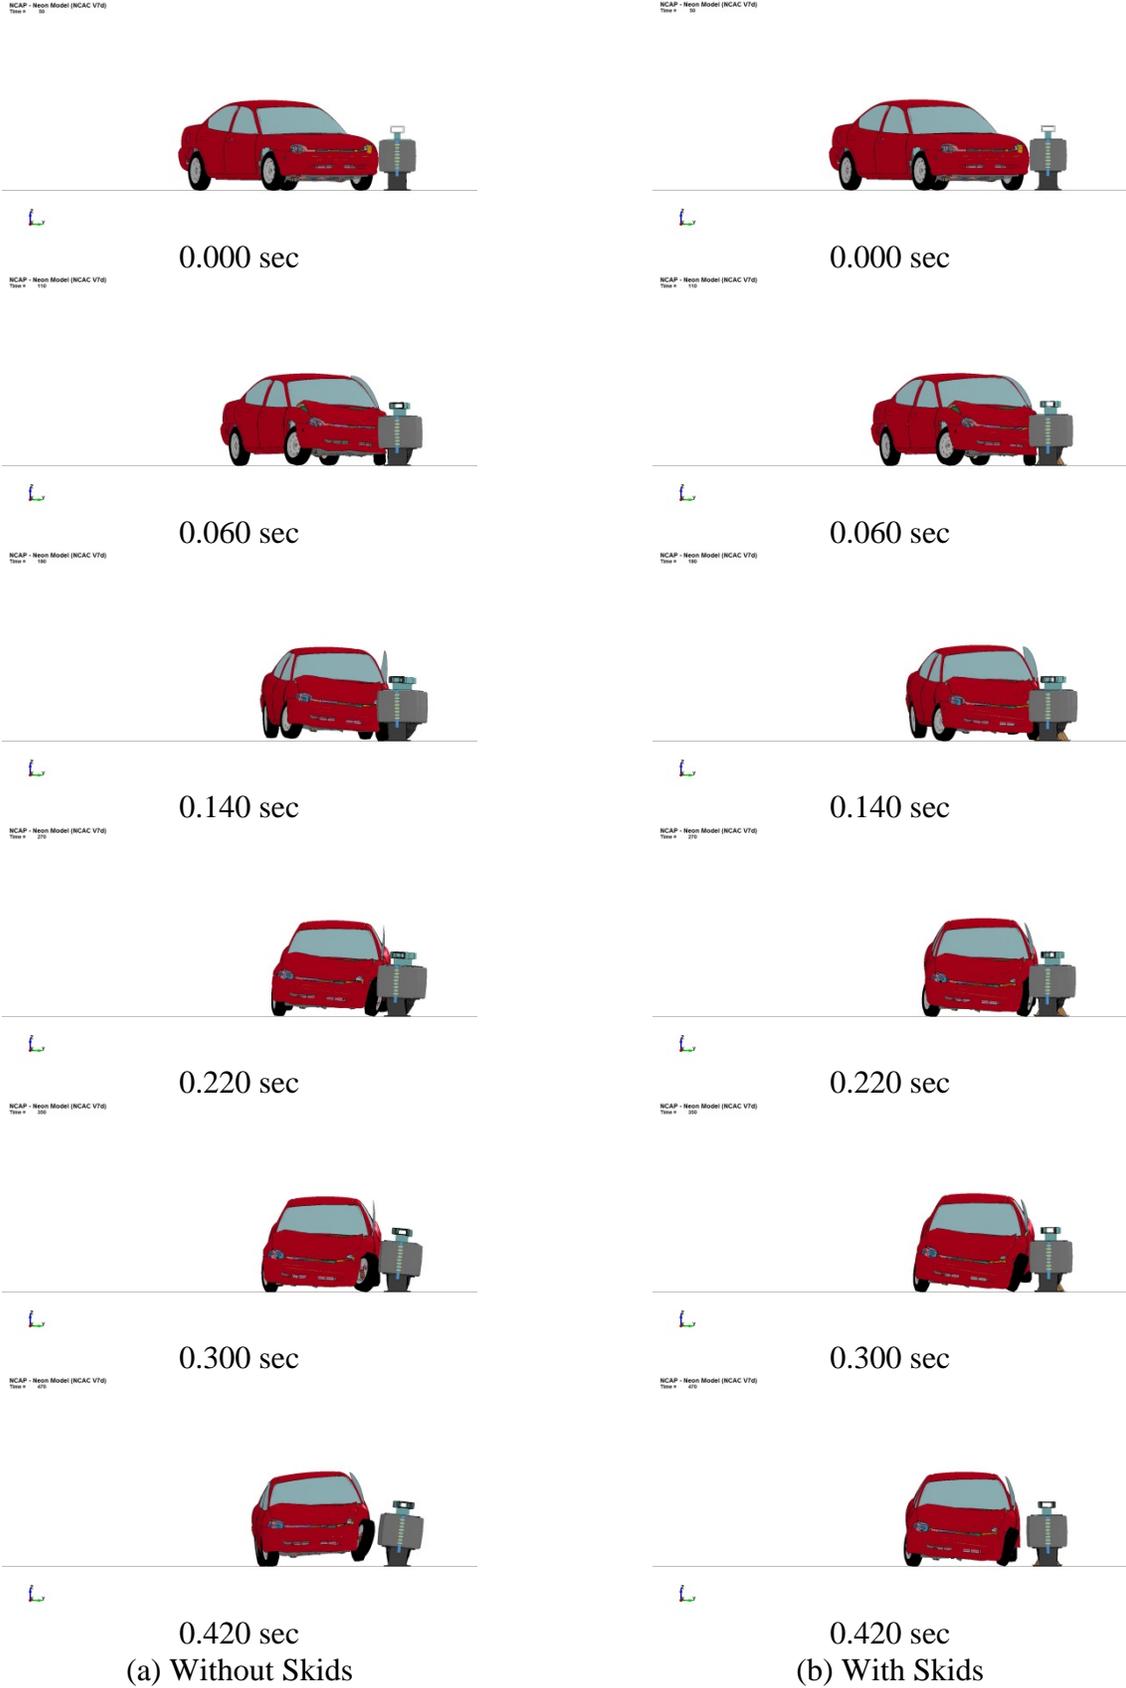
Figure 73. RESTORE Barrier Simulation with Test Designation 4-10 Impacts

Other parameters (i.e., parallel time and exit time, velocity, and angle) that give an indication of the RESTORE barrier performance were compared to those obtained under impacts with rigid barriers. A comparison of these parameters is shown in Table 12 for the 1100C small car impacts and Table 13 for the 2270P pickup truck impacts. The parameters were calculated the same as those used during previous simulations, and overall, the results did not change much between prior RESTORE barrier simulations. The simulation with skids had longer exit times and slightly lower exit velocities and angles.

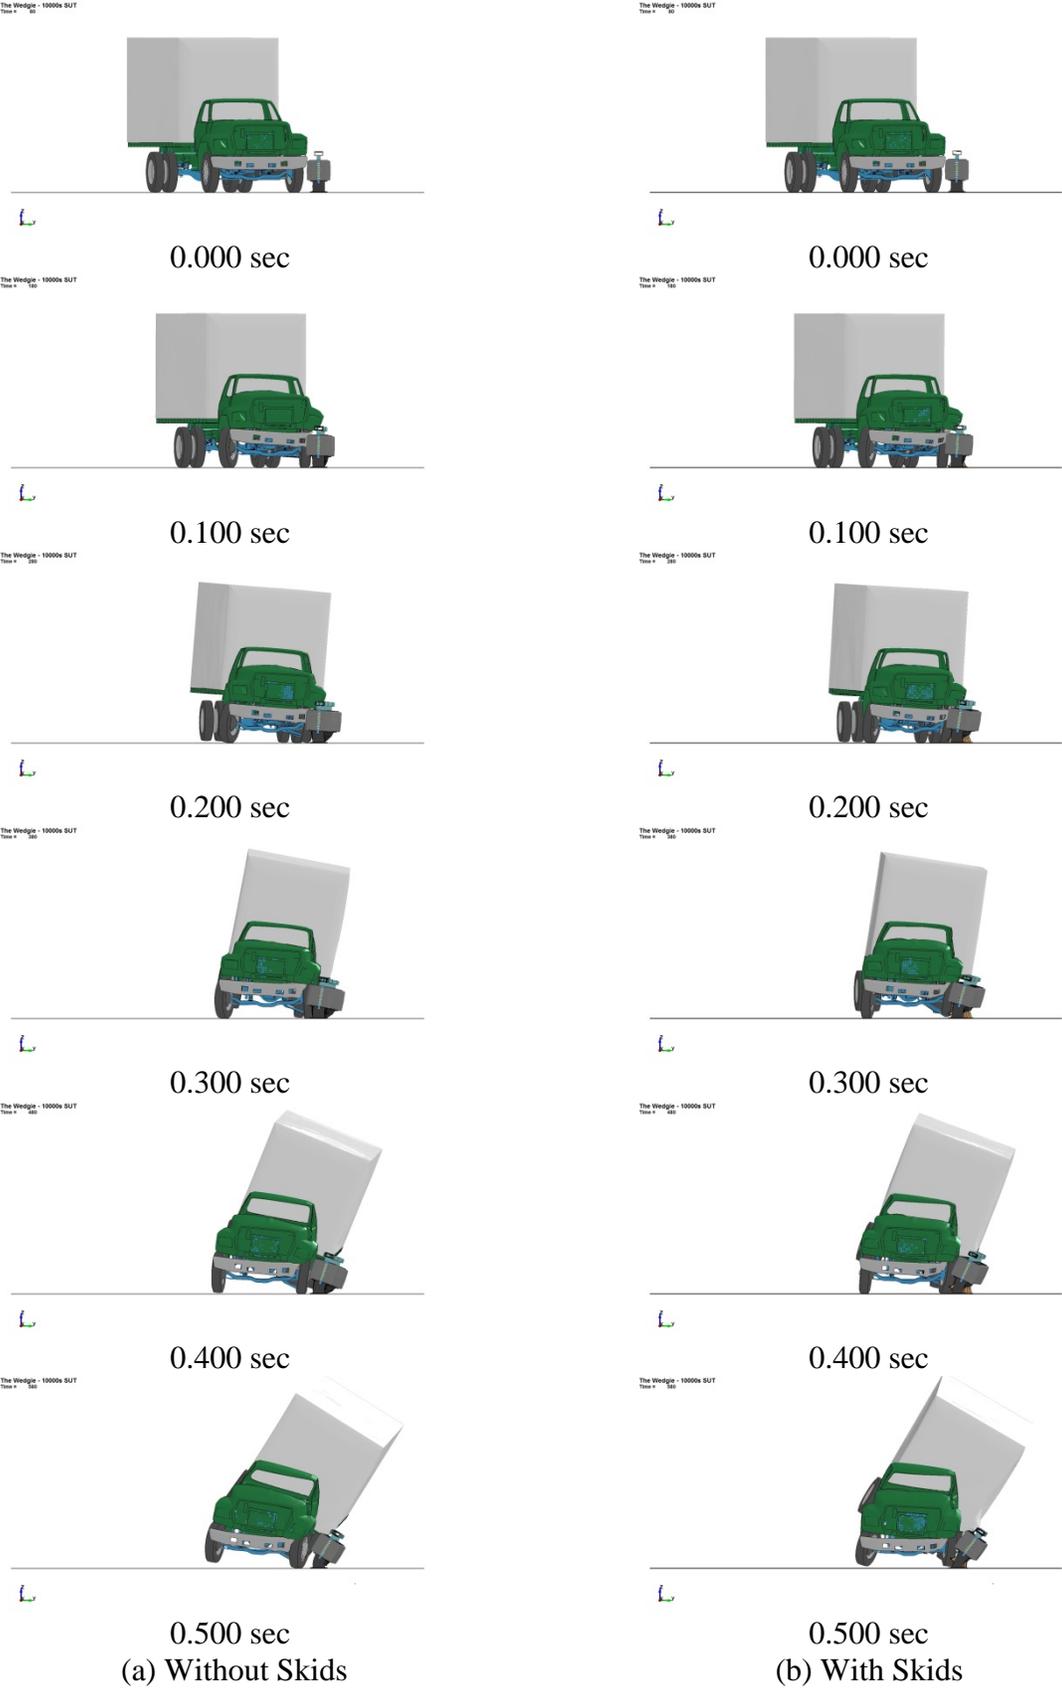
Figure 76. RESTORE Barrier Simulation with Test Designation 4-12 Impacts

The barrier performance is slightly different between the two simulations, but the barrier still has a significant roll motion, which could lead to the barrier not restoring or to potential vehicle rollover. Since there are many parts of the model that have yet to be validated, it is hard to make predictive conclusions as to the performance of the vehicle and barrier. While it is still somewhat subjective if the 10000S impact into the RESTORE barrier will perform acceptably according to MASH TL-4 safety performance criteria, the skids do not appear to be detrimental to the barrier system. Throughout the duration of the project, several simulation issues occurred and are discussed in Appendix C.

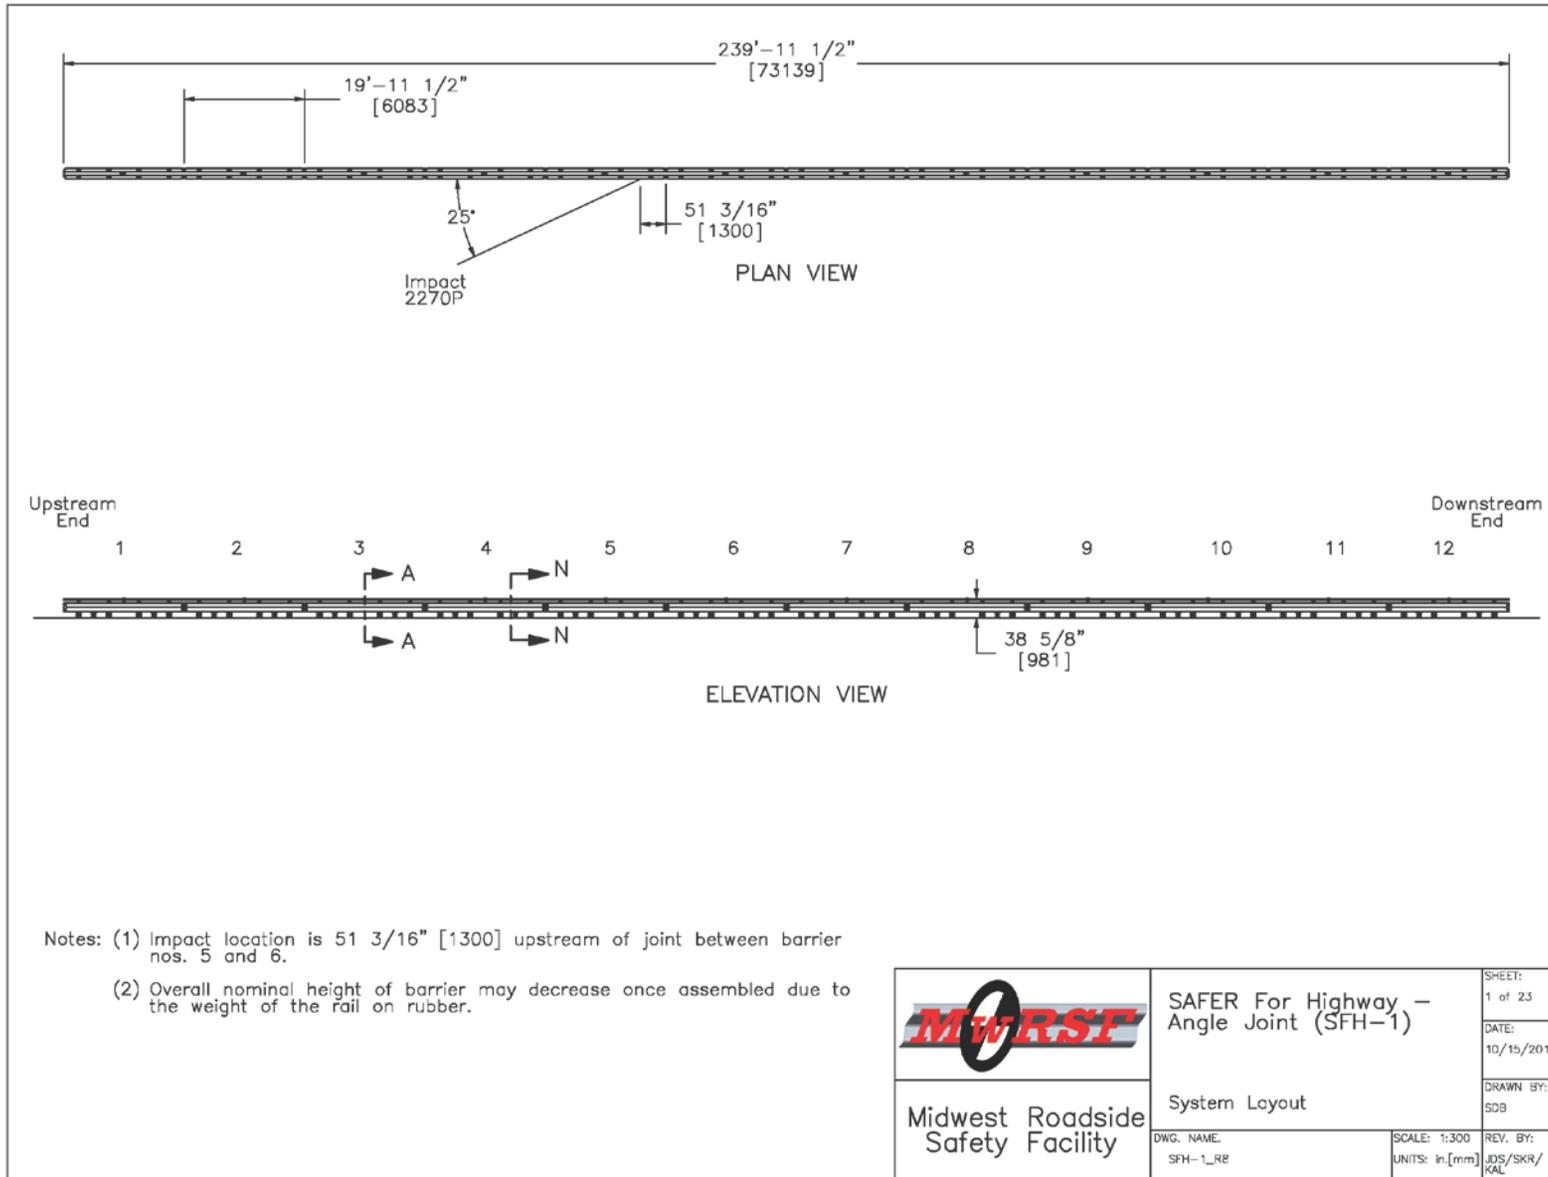
Figure 77. Recommended Barrier Design for Full-Scale Crash Testing, System Layout

Details of the final longitudinal barrier hereby recommended for full-scale crash testing according to MASH TL-4 safety performance criteria are shown are Figures 77 through 99.

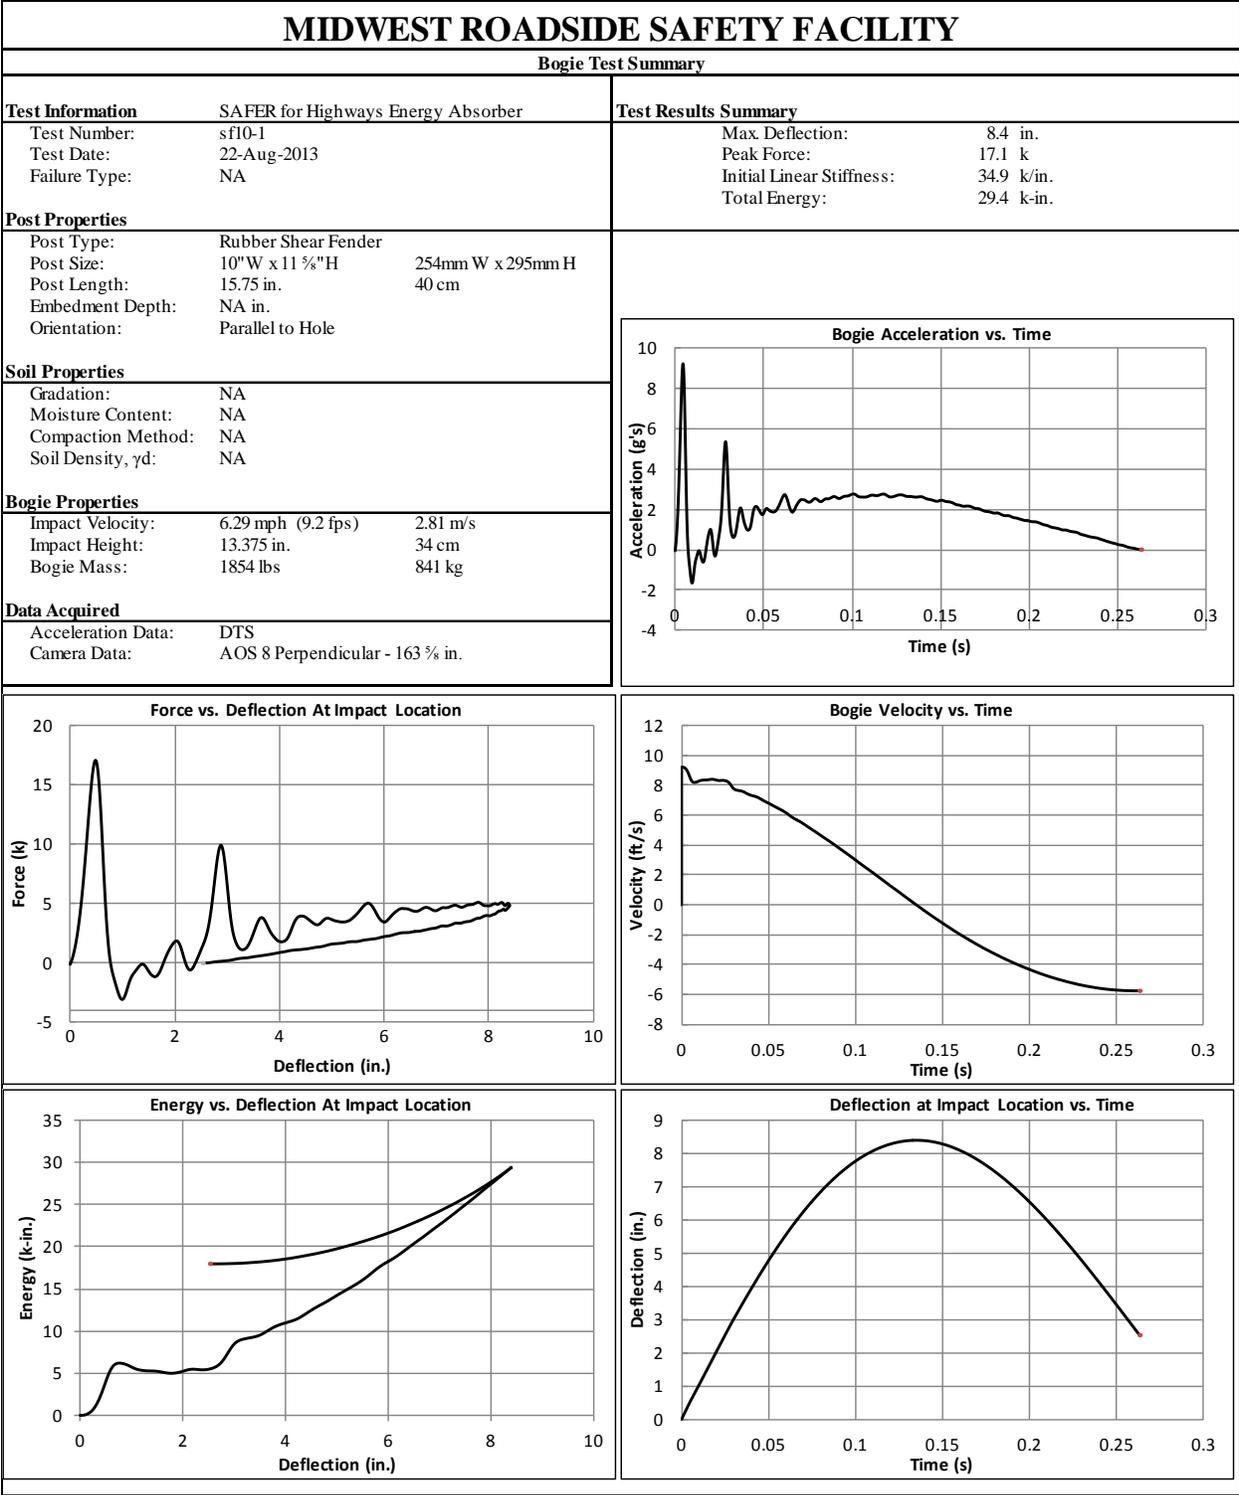
Figure B-1. Test No. SF10-1 Results (DTS)

The results of the recorded data from each accelerometer for every dynamic bogie test are provided in the summary sheets found in this appendix. Summary sheets include acceleration, velocity, and deflection vs. time plots as well, as force vs. deflection and energy vs. deflection plots.
