*Midwest States Regional Pooled Fund Research Program
Fiscal Years 2008-2009 (Years 19 and 20)
Research Project Number TPF-5(091) Supplement #2 and TPF-5(193) Supplement #19
NDOR Sponsoring Agency Code RFPF-09-02 and RFPF-10-CABLE-1*

DEVELOPMENT OF A SOCKETED FOUNDATION FOR THE MIDWEST WEAK POST (MWP) V1

1. Report No. TRP-03-298-14	2.	3. Recipient's Accession No.	
4. Title and Subtitle Development of a Socketed Foundation for the Midwest Weak Post (MWP) V1		5. Report Date July 23, 2014

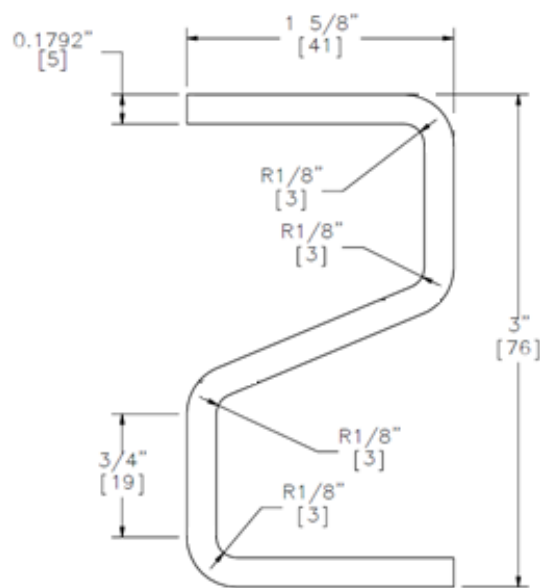
Figure 1. MWP Version No. 1 Cross-Section

For several years, the Midwest Roadside Safety Facility (MwRSF) has been developing a non-proprietary, high-tension, cable barrier system according to the *Manual for Assessing Safety Hardware* (MASH) [3]. As part of the study, the Midwest Weak Post (MWP) Version No. 1 V1, as shown in Figure 1, was developed [4]. The MWP V1 was fabricated from 7-gauge (4.6-mm thick) sheet steel and designed to be significantly weaker under strong axis bending than the previous S3x5.7 (S76x8.5) post. The future Phase II socketed-foundation design guidelines could be used in conjunction with the MWP. However, the resulting foundation would be conservatively designed in terms of cross-section size, embedment depth, and reinforcement. Thus, a need exists to develop an optimized socketed foundation for the MWP V1.

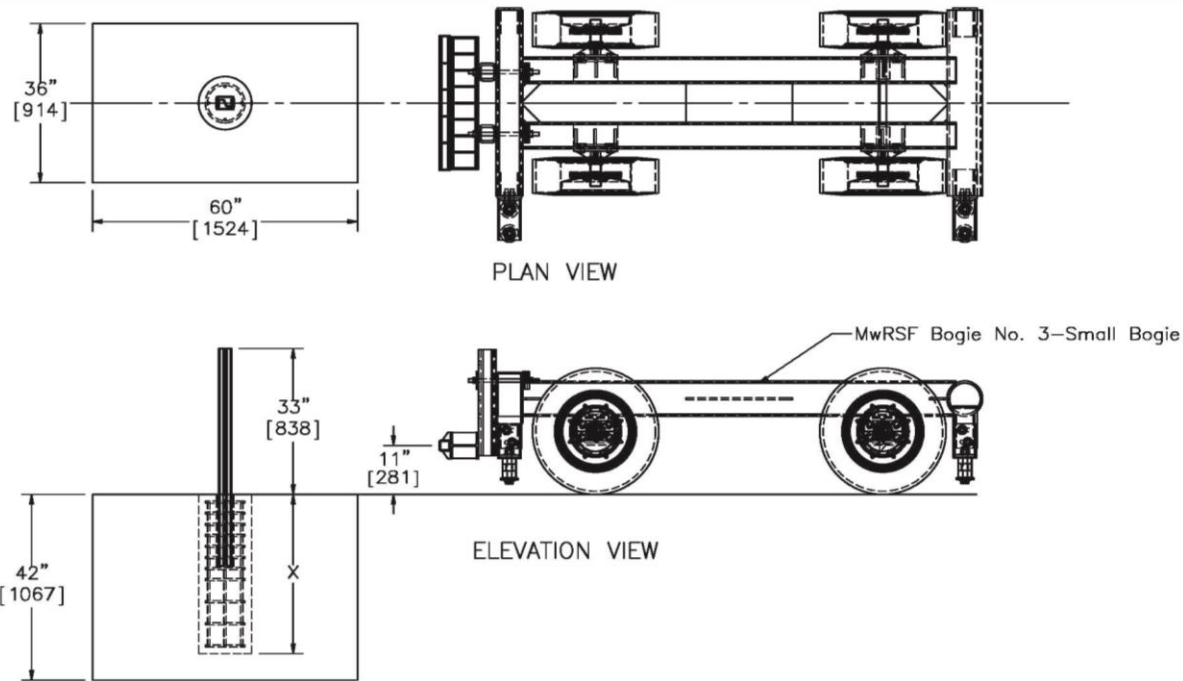
Figure 2. Bogie Testing Matrix and Setup, Test Nos. HTCB-12 through HTCB-16

- Notes: (1) Post assembly is to be placed in the center of a 5' [1524] long x 3' [914] wide x 3'-6" [1067] deep area filled with compacted standard strong soil. After the initial test, ensuing test assemblies can be installed using only a 3' [914] augered hole placed in the center of the 5' [1524] x 3' [914] area.
- (2) Attach a 3/4" [19] thick Neoprene pad to the front of the bogie impact head.
- (3) Initial test is to be conducted with the 36" [914] deep footing with 2 1/2" [64] circular rebar spacing. Subsequent tests will be determined based on results of initial test.
- (4) For test HTCB-16 (Weak soil), use a test pit with a size of 4'x4' [1219x1219], but with the same depth as the strong soil tests.

For test nos. HTCB-12 through HTCB-15, the socketed foundations were placed in a strong soil conforming to American Association of State Highway and Transportation Officials (AASHTO) Grade B material. This soil is considered a strong soil that has been utilized during the evaluation of roadside safety hardware. However, the displacement of a foundation in weaker soils was also desired. Thus, the socketed foundation for test no. HTCB-16 was placed in a soil pit consisting of AASHTO Grade A-3 sand material. The details pertaining to each individual test are shown in Table 1.

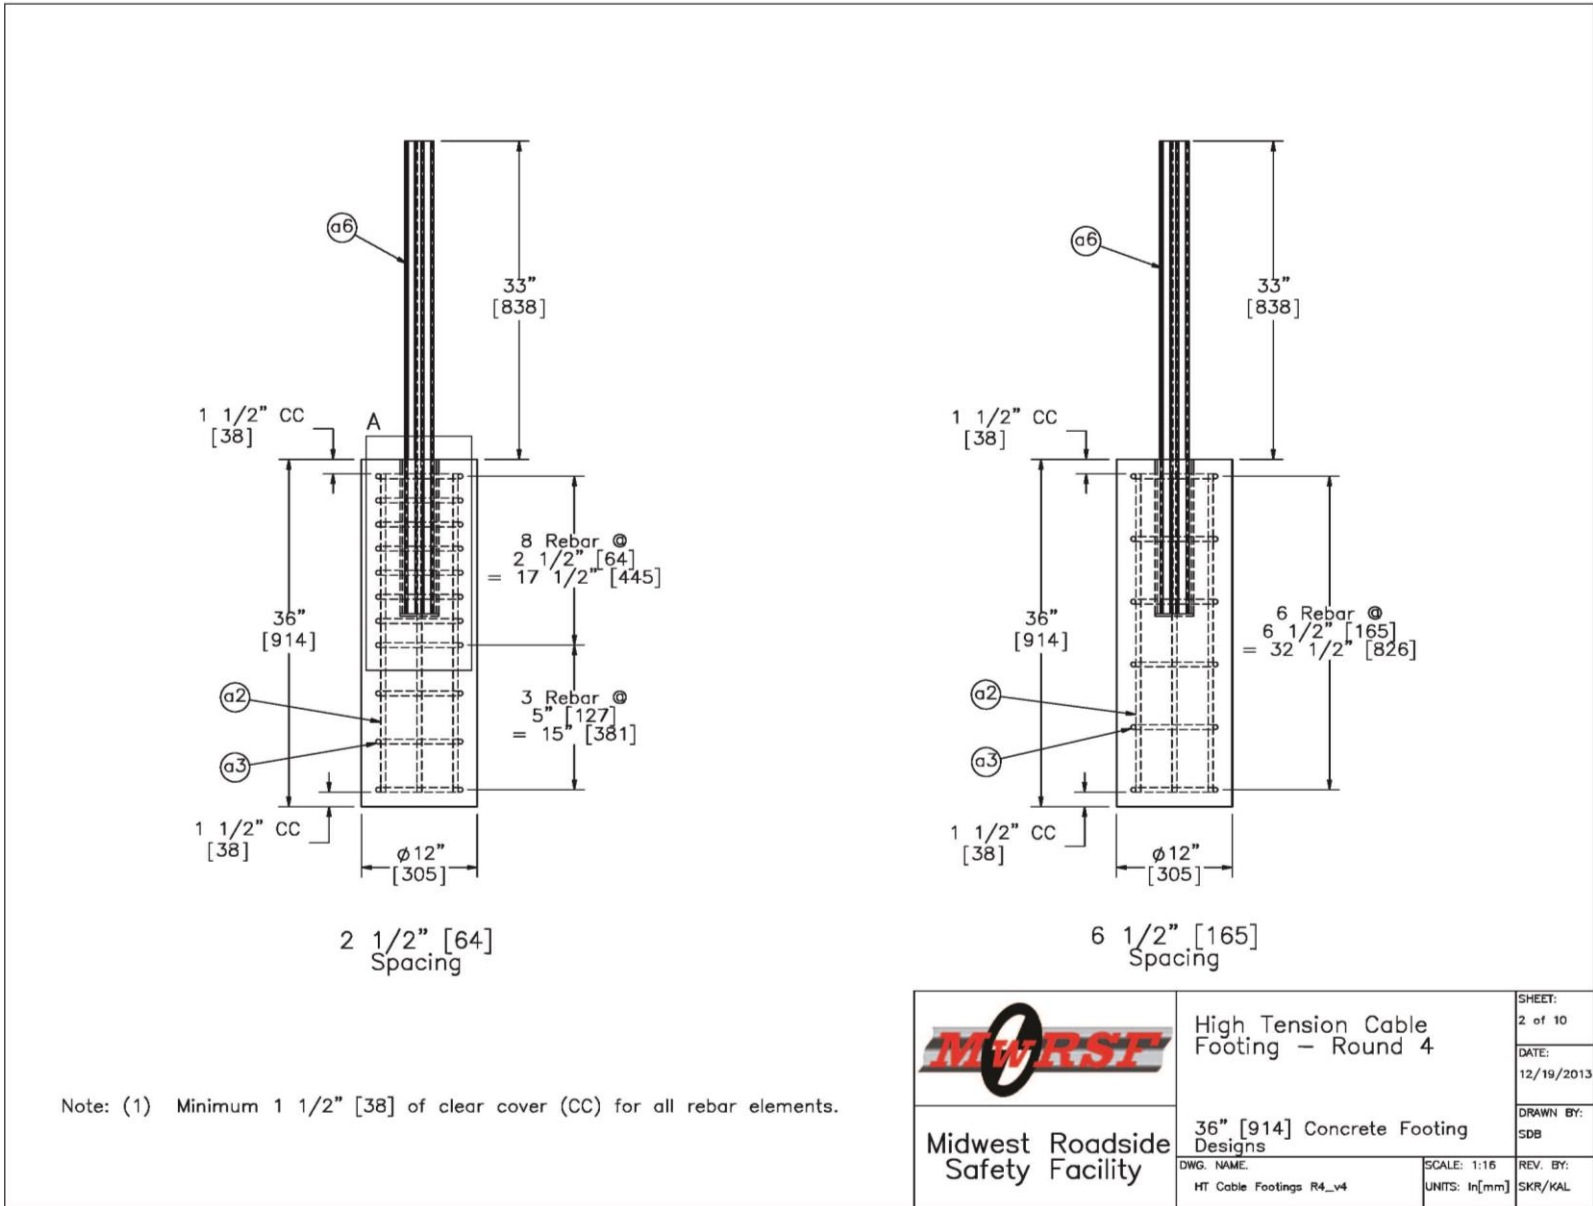
Figure 3. Assemblies and Reinforcement Configurations, Test Nos. HTCB-12 and HTCB-16

Five different socketed foundations were designed and fabricated for evaluation through dynamic component testing. The same cross-section size and reinforcement pattern was utilized for all five configurations, but the embedment depth and the spacing between steel hoop stirrups varied, as shown in Figures 2 through 11. Fabrication and installation photographs are shown in Figure 12. Material specifications, mill certifications, and certificates of conformity for the reinforced concrete socketed foundations are shown in Appendix A.

Each socketed foundation consisted of a 12-in. (305-mm) diameter concrete cylinder. The foundation lengths, or embedment depths, varied between 24 in., 30 in., and 36 in. (610 mm, 762 mm, and 914 mm). The concrete was specified to have a minimum 28-day compressive strength of 3,500 psi (24 MPa).

The socketed foundations were reinforced with both circumferential and vertical Grade 60 steel rebar. The circumferential rebar was No. 4 (12.7 mm) bars bent into a loop with an inner diameter of 8 in. (203 mm). The spacing of the circumferential steel varied between 2½ in. (64 mm) and 6½ in. (165 mm), as shown in Figures 3 through 5. Finally, four No. 4 (12.7 mm) vertical bars were spaced equally around the inside of the circumferential steel.

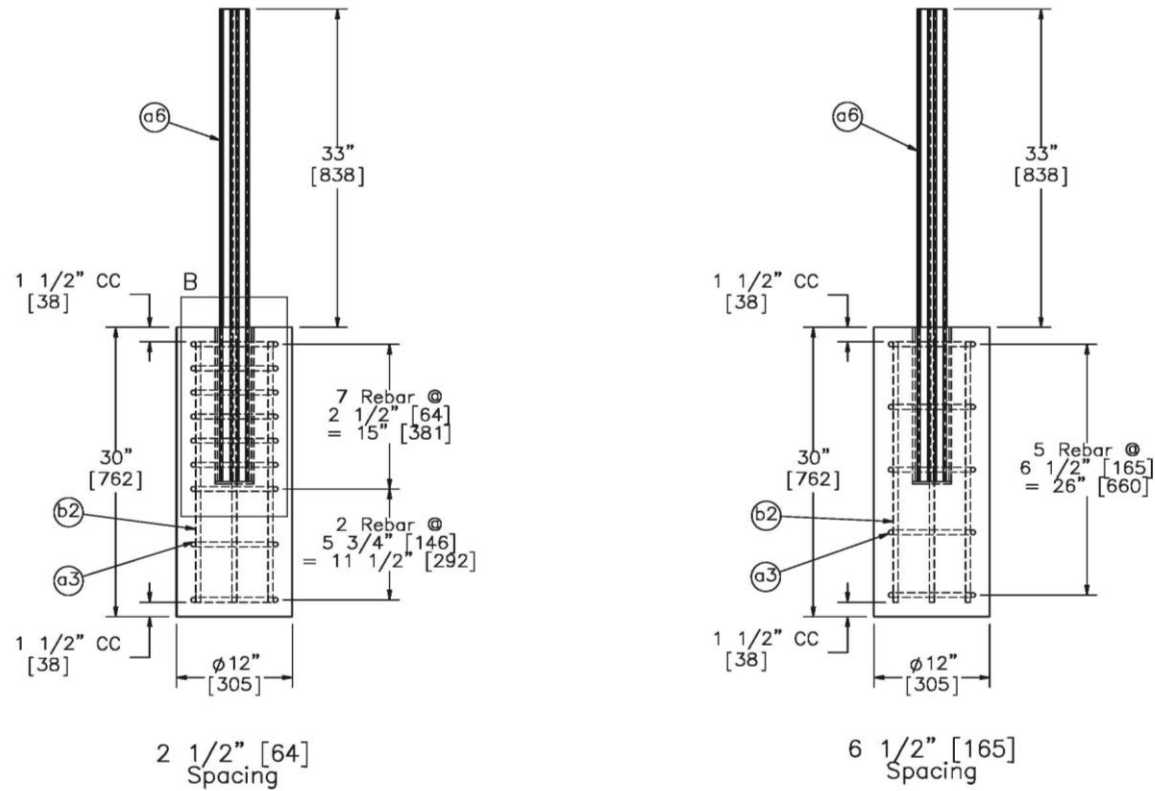
Figure 4. Assemblies and Reinforcement Configurations, Test Nos. HTCB-13 and HTCB-14

Note: (1) Minimum 1 1/2" [38] of clear cover (CC) for all rebar elements.

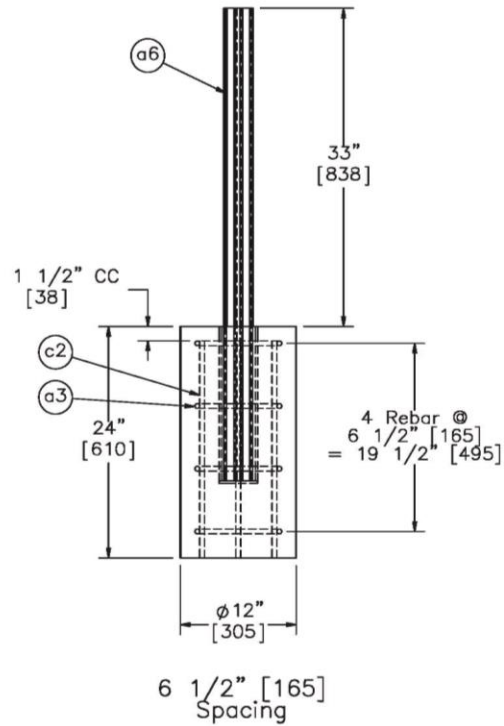
Figure 5. Assembly and Reinforcement Configuration, Test No. HTCB-15

- Notes: (1) Minimum 1 1/2" [38] of clear cover (CC) for all rebar elements.
 (2) Foundation created using the 30" [762] design with 6 1/2" [165] spacing but cut at 24" [610].

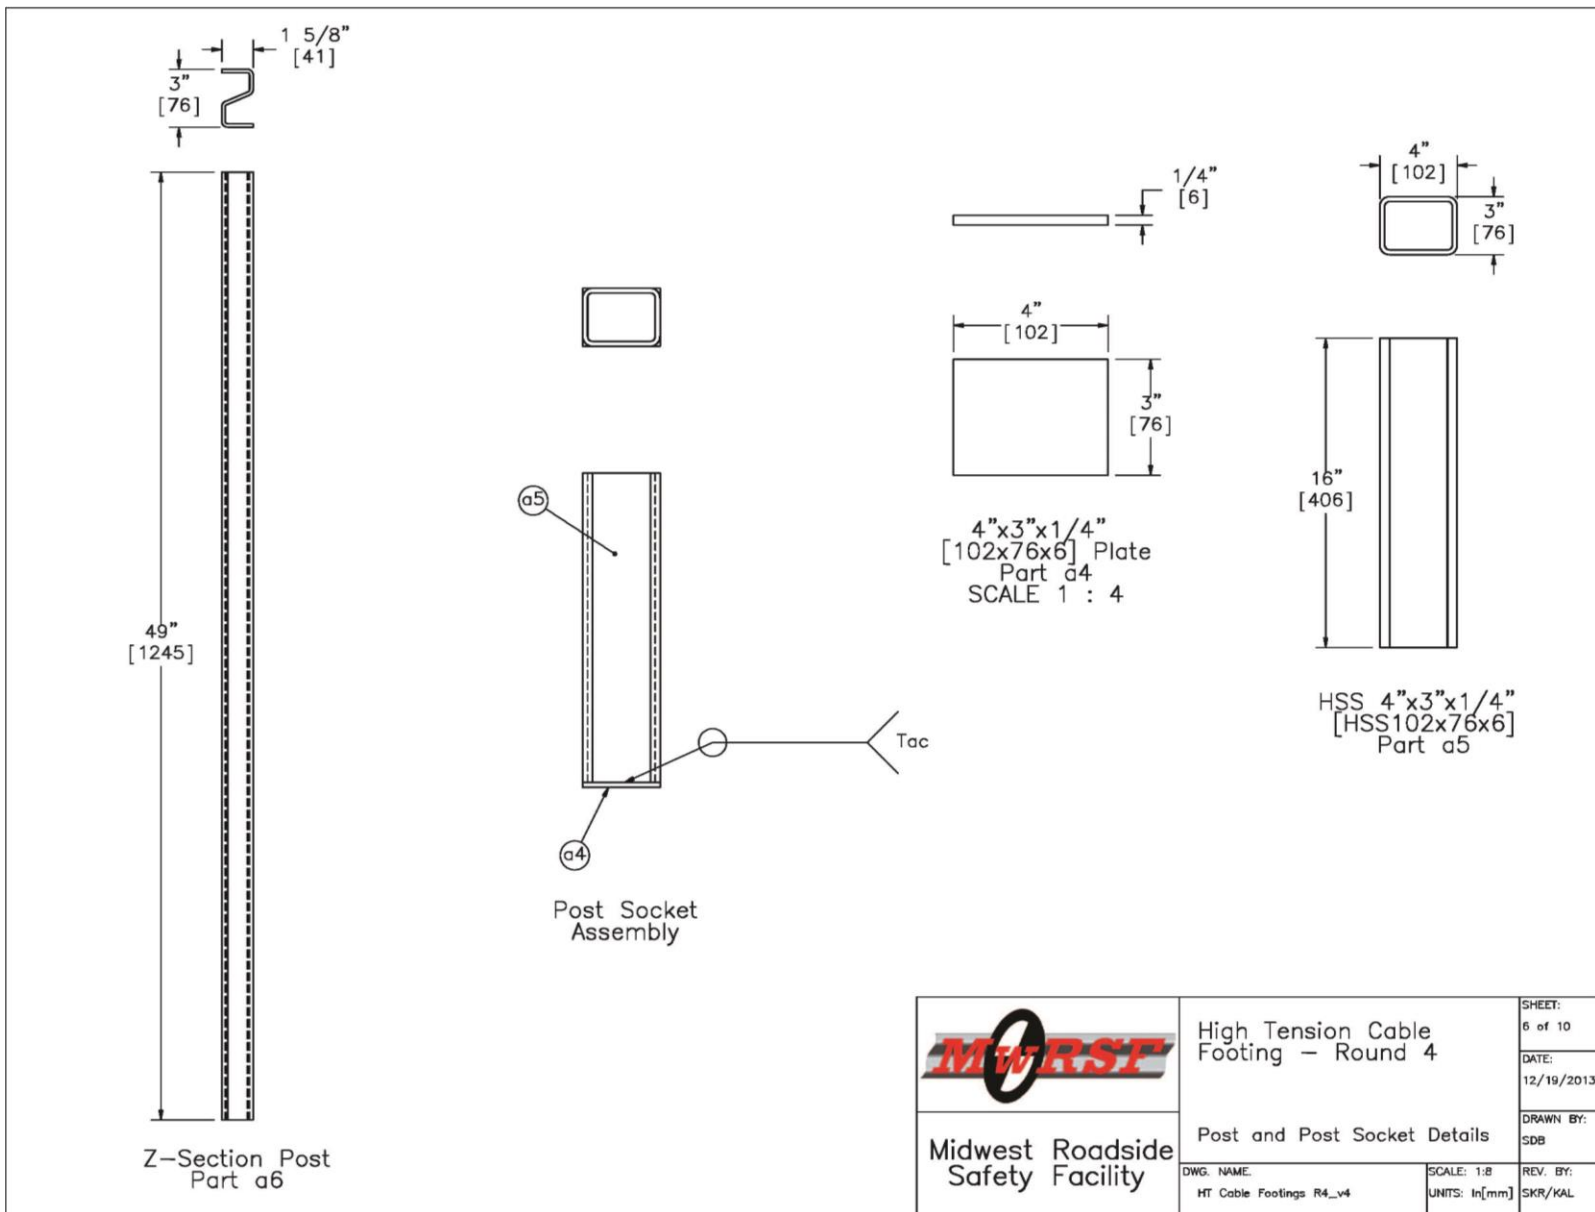
Figure 7. Steel Post and Socket Details, Test Nos. HTCB-12 through HTCB-16

A 16-in. (406-mm) long, 4-in. x 3-in. x ¼-in. (102-mm x 76-mm x 6-mm) steel tube was located at the top-center of each foundation. A 4-in. x 3-in. x ¼-in. (102-mm x 76-mm x 6-mm) steel plate was tack-welded to the bottom of the steel tube to enclose the socket void during concrete casting. The socket sleeve assembly was then cast into the top of the concrete foundation with the open end of the tube flush with the top surface of the post base.

As stated previously, these socketed foundations were designed specifically for use with the new MWP V1. For testing purposes, a 49-in. (1,245-mm) long MWP was placed into each socketed foundation. All posts were fabricated using hot-rolled ASTM A1011 HSLA Gr. 50

steel, a typical sheet steel material. Details concerning the development of the MWP V1 can be found in reference [4], while detailed dimensions for the MWP V1 are shown in Figure 7.

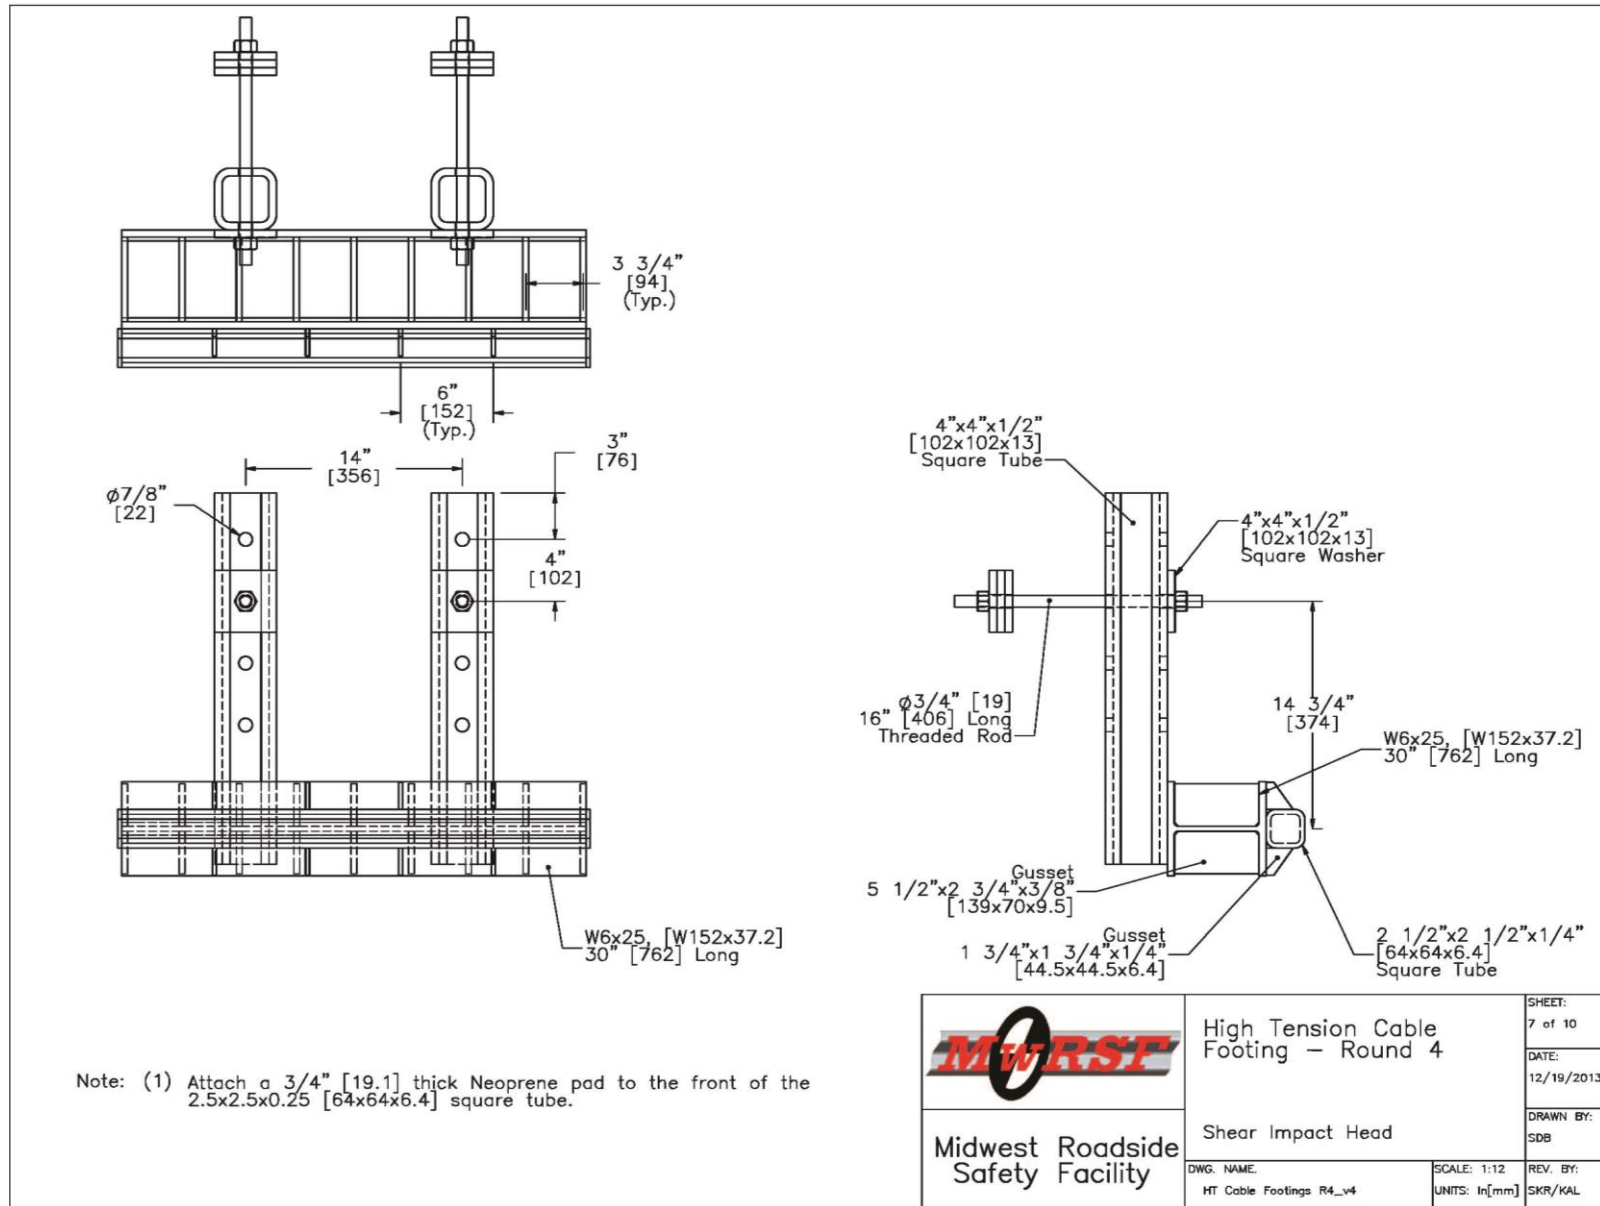
Figure 8. Bogie Head Details, Test Nos. HTCB-12 through HTCB-16

A rigid-frame bogie was used to impact the posts. A variable-height, detachable impact head was used in the testing. The bogie impact head consisted of a 2½-in. x 2½-in. x ¼-in. (64-

mm x 64-mm x 6-mm) square tube mounted onto the outside flange of a W6x25 (W152x37.2) steel beam with reinforcing gussets. A ¾-in. (19-mm) neoprene pad was attached to the front of the square tube to prevent local damage to the post from the impact. The impact head was bolted to the bogie vehicle, creating a rigid frame with an impact height of 11 in. (279 mm) for test nos. HTCB-12 through HTCB-16. The bogie with the impact head is shown in Figure 13. The weight of the bogie with the addition of the mountable impact head and accelerometers was 1,888 lb (856 kg).

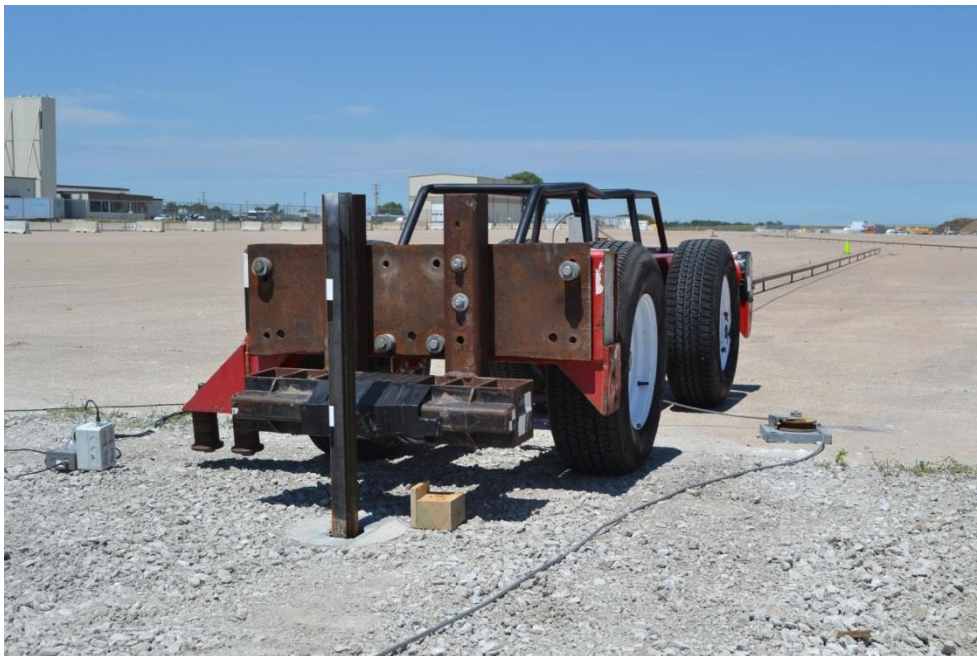
Figure 13. Rigid-Frame Bogie on Guidance Track

A pickup truck with a cable tow system was used to propel the bogie to a target impact speed of 20 mph (32 km/h). When the bogie approached the end of the guidance system, it was released from the tow cable, allowing it to be free rolling when it impacted the post. A remote braking system was installed on the bogie, thus allowing it to be brought safely to rest after the test.

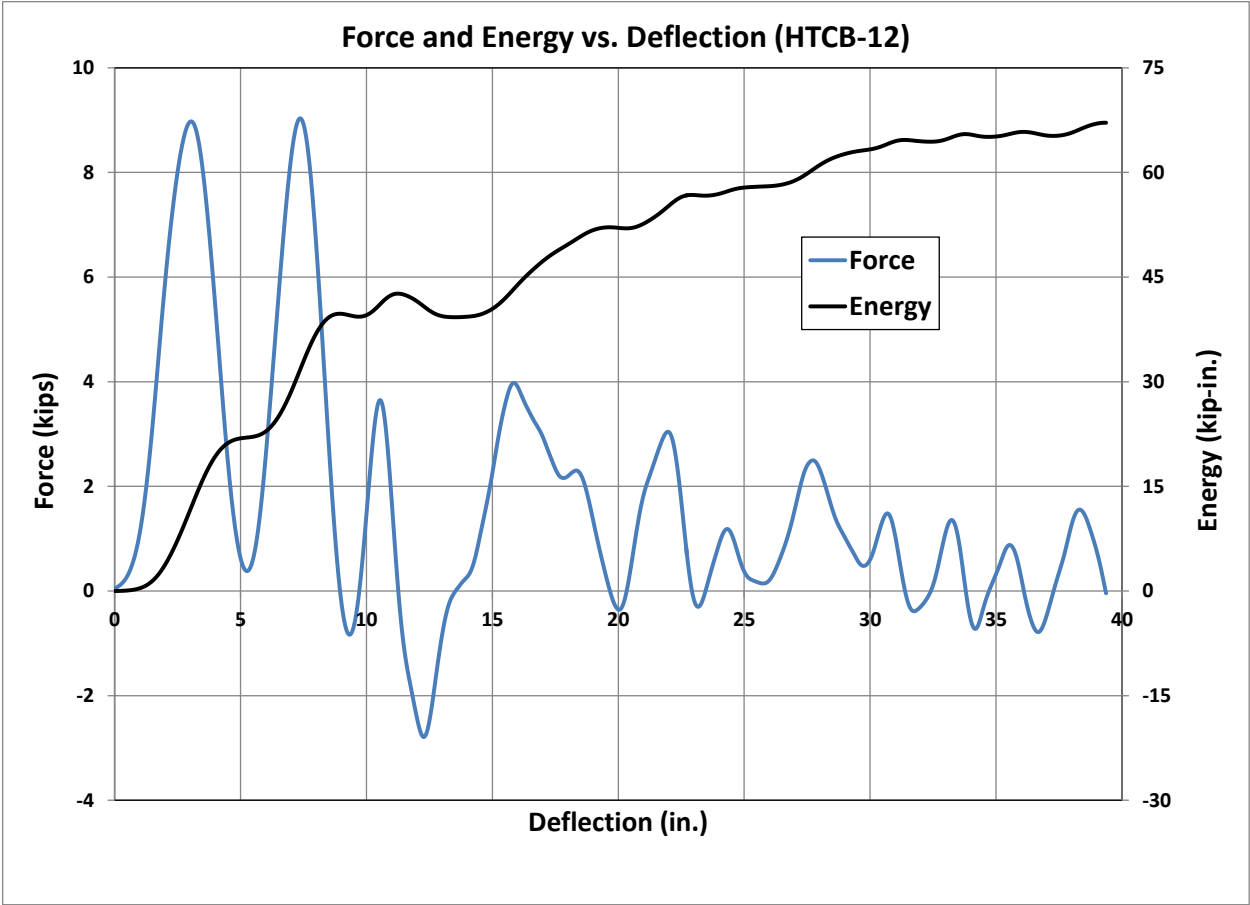
Figure 14. Force vs. Deflection and Energy vs. Deflection, Test No. HTCB-12

During test no. HTC-12, the bogie impacted the post 11 in. (279 mm) above ground line at a speed of 20.6 mph (33.2 km/h), causing strong-axis bending in the post. Upon impact, the foundation experienced 1/8 in. (3 mm) of dynamic deflection, and a plastic hinge formed in the post. The steel post continued to bend over until the bogie overrode the top of the post 0.120 seconds after impact and at a deflection of 39.4 in. (1,001 mm). Field measurements concluded that the top of the concrete foundation had no visible permanent displacement after the impact event.

(17.8 kN) and gradually decreased over the remainder of the impact event. At a maximum deflection of 39.4 in. (1,001 mm), the post assembly had absorbed 67.1 k-in. (7.5 kJ) of energy.

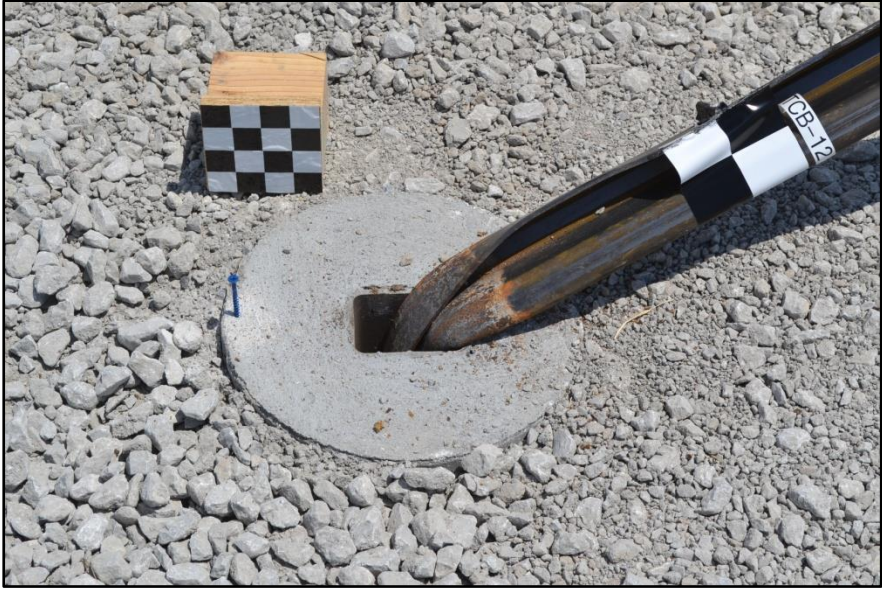
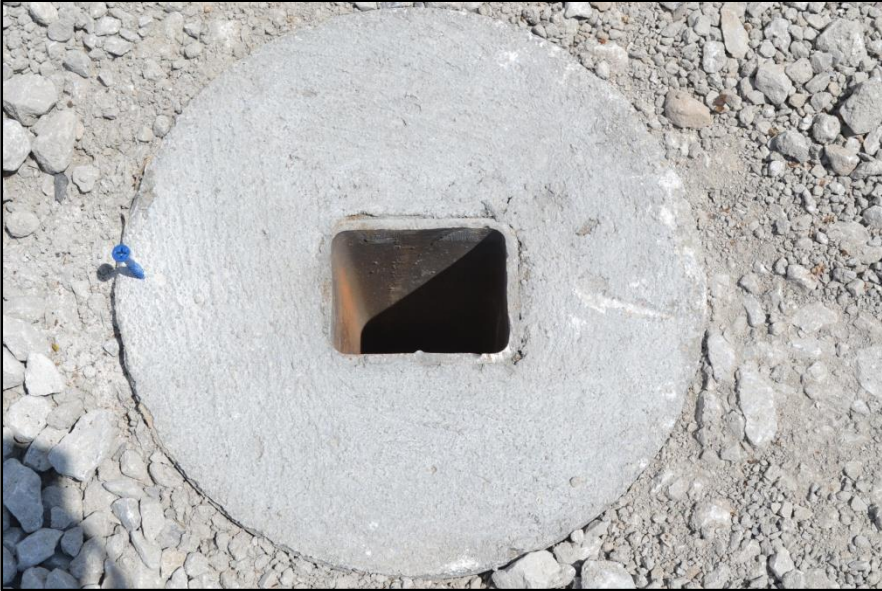
Figure 15. Time-Sequential and Post-Impact Photographs, Test No. HTC B-12

Damage to the test article consisted of plastic deformations to the MWP at ground line. The concrete foundation experienced no significant damage, only minor scrapes on the back side of the socket. Time-sequential and post-impact photographs are shown in Figure 15.

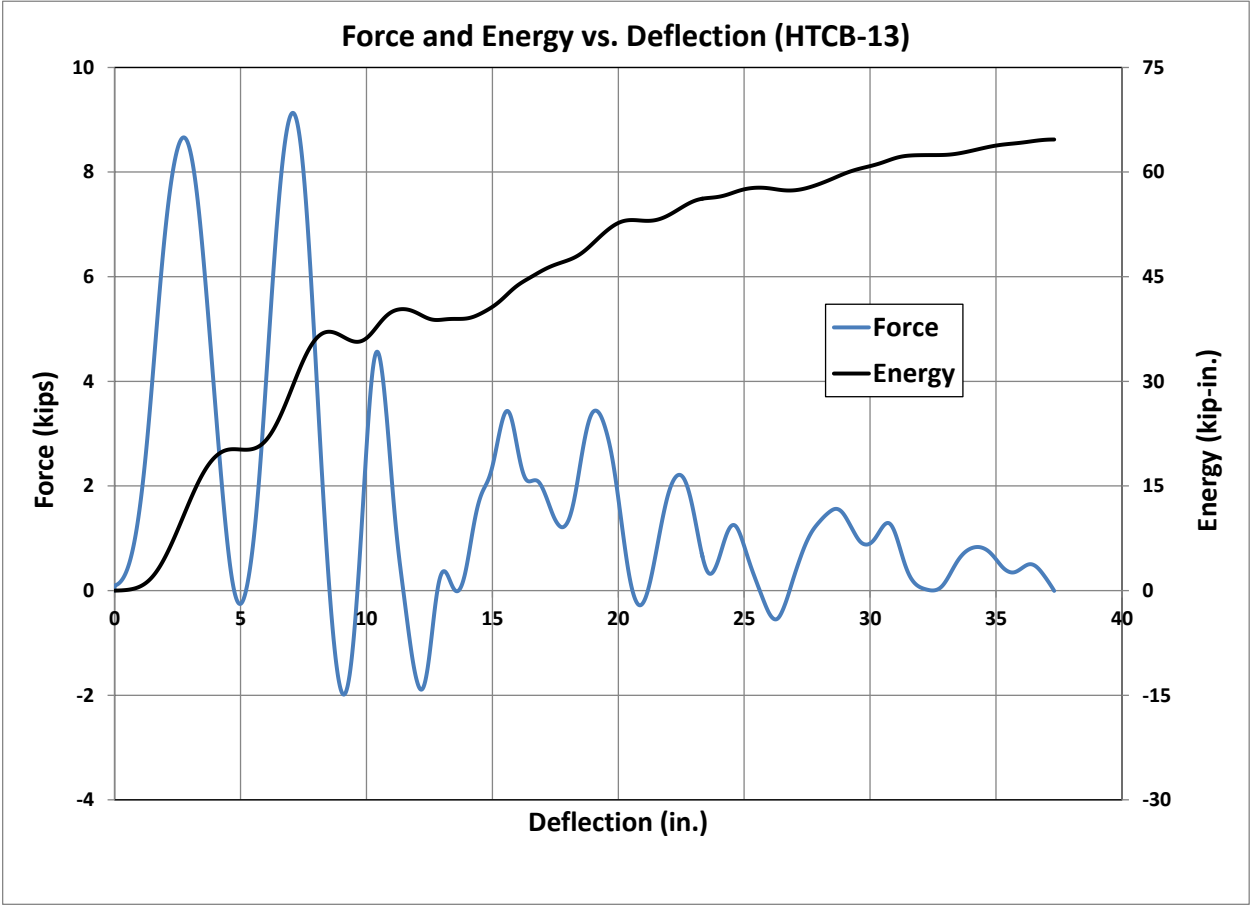
Figure 16. Force vs. Deflection and Energy vs. Deflection, Test No. HTCB-13

Force vs. deflection and energy vs. deflection curves were created from the accelerometer data and are shown in Figure 16. Inertial effects resulted in a high peak force over the first few inches of deflection. After a brief decrease, the force rebounded to a peak of 9.1 kips (40.5 kN) at 7.1 in. (180 mm) of deflection. Following this second peak, the forces quickly decreased and remained below 4.5 kips (20.0 kN) for the remainder of the impact event. At a deflection of 37.3 in. (947 mm), the post assembly had absorbed 64.7 k-in. (7.3 kJ) of energy.

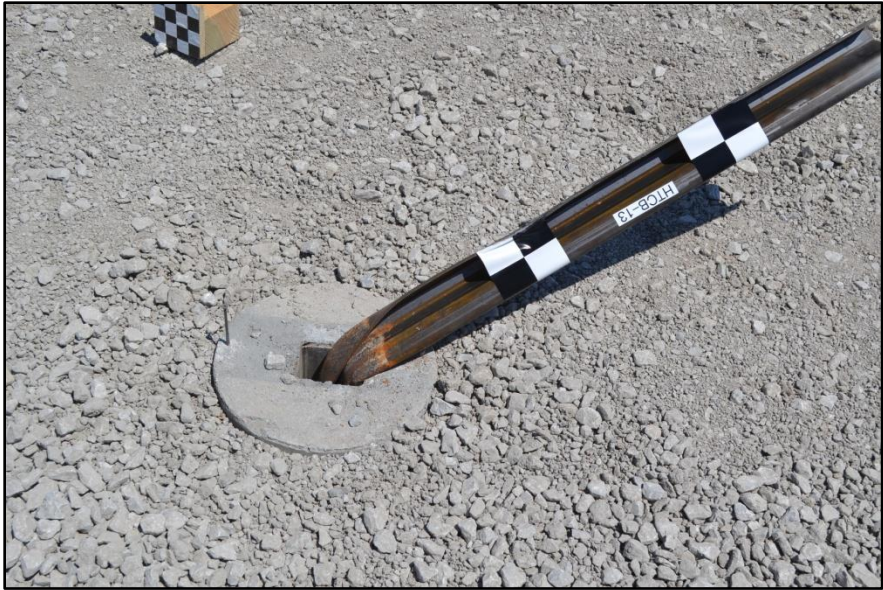
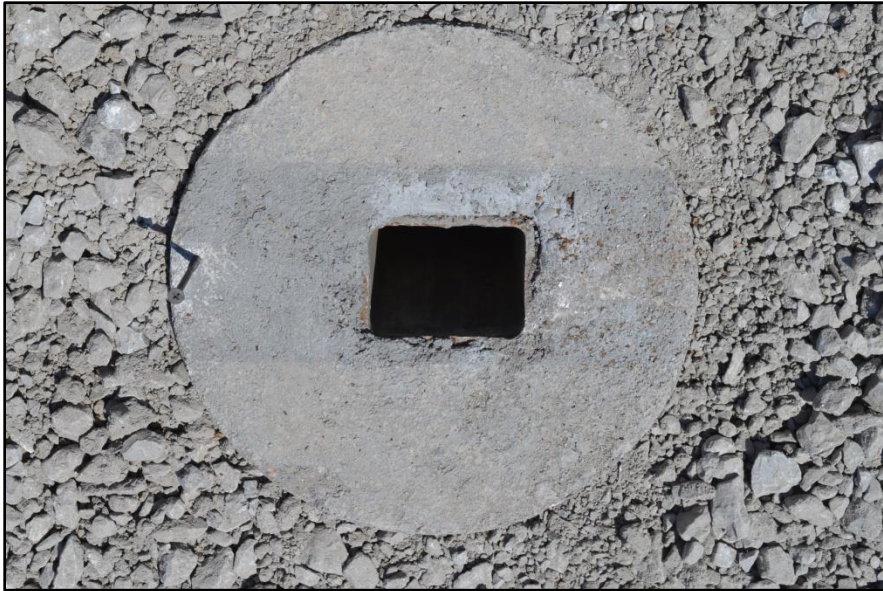
Figure 17. Time-Sequential and Post-Impact Photographs, Test No. HTCB-13

Damage to the test article was confined to plastic deformations in the post at ground line. The concrete foundation experienced no significant damage, only minor scrapes on the back side of the socket. Time-sequential and post-impact photographs are shown in Figure 17.

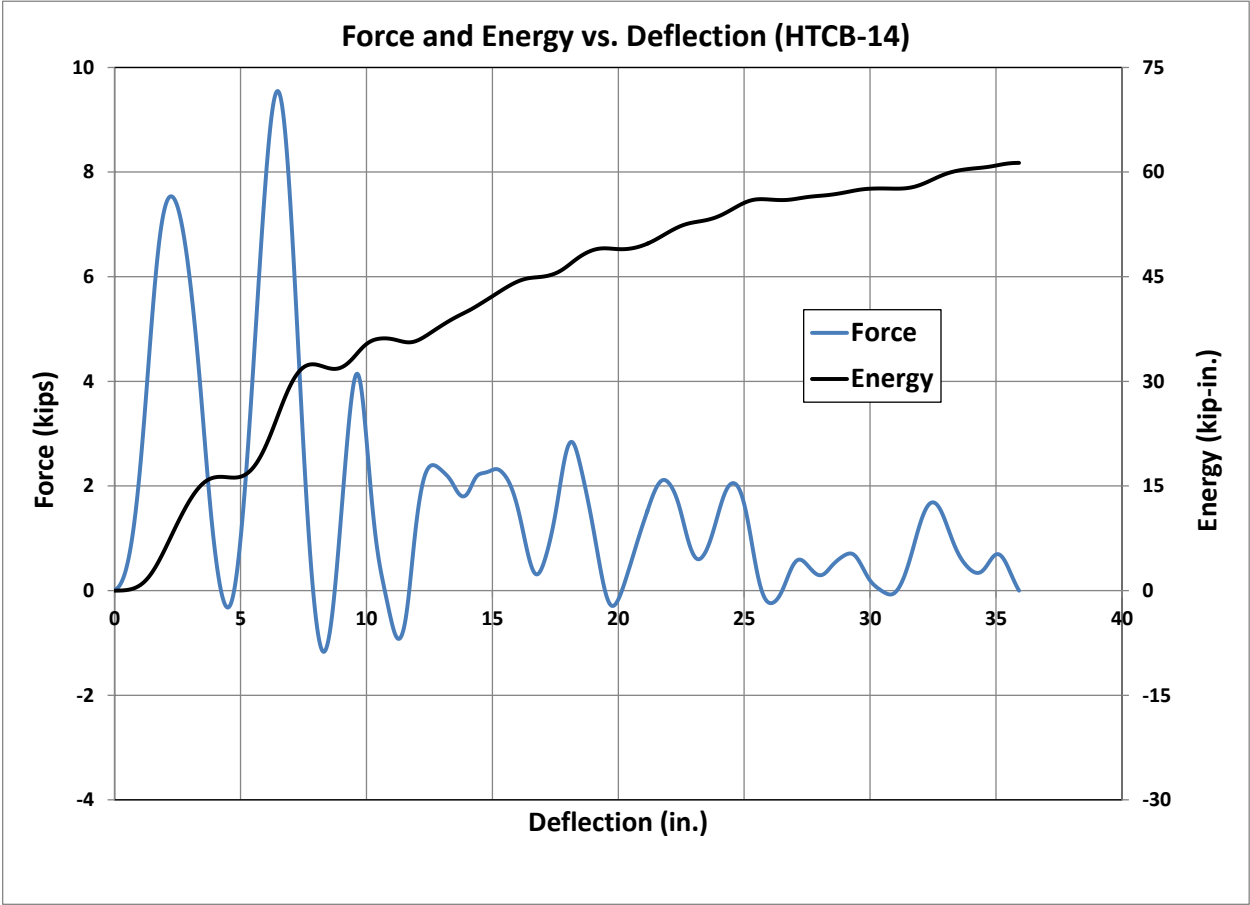
Figure 18. Force vs. Deflection and Energy vs. Deflection, Test No. HTCB-14

Force vs. deflection and energy vs. deflection curves were created from the accelerometer data and are shown in Figure 18. Inertial effects resulted in a high peak force over the first few inches of deflection. After a brief decrease, the force rebounded to a peak of 9.5 kips (42.3 kN) at 6.5 in. (165 mm) of deflection. Following this second peak, the force decreased quickly and remained below 4.1 kips (18.2 kN) for the remainder of the impact event. At a deflection of 35.9 in. (912 mm), the post assembly had absorbed 61.3 k-in. (6.9 kJ) of energy.

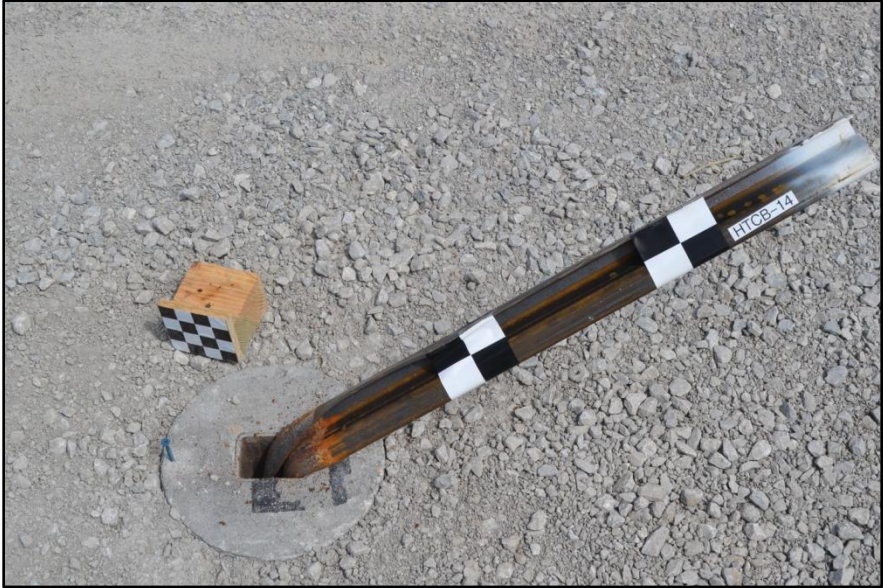
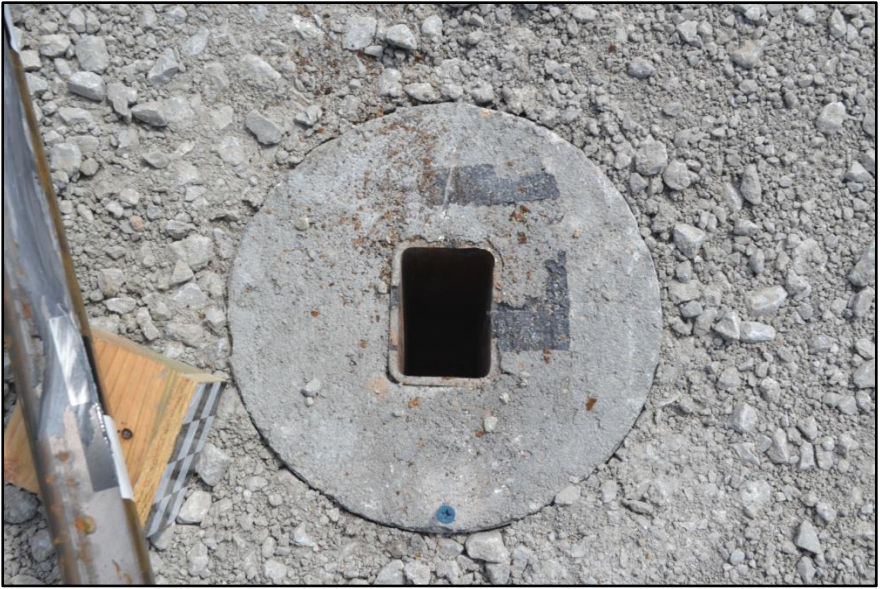
Figure 19. Time-Sequential and Post-Impact Photographs, Test No. HTCB-14

Damage to the test article was confined to plastic deformations of the post near ground line. The concrete foundation experienced only minor scrapes on the back side of the socket. Time-sequential and post-impact photographs are shown in Figure 19.

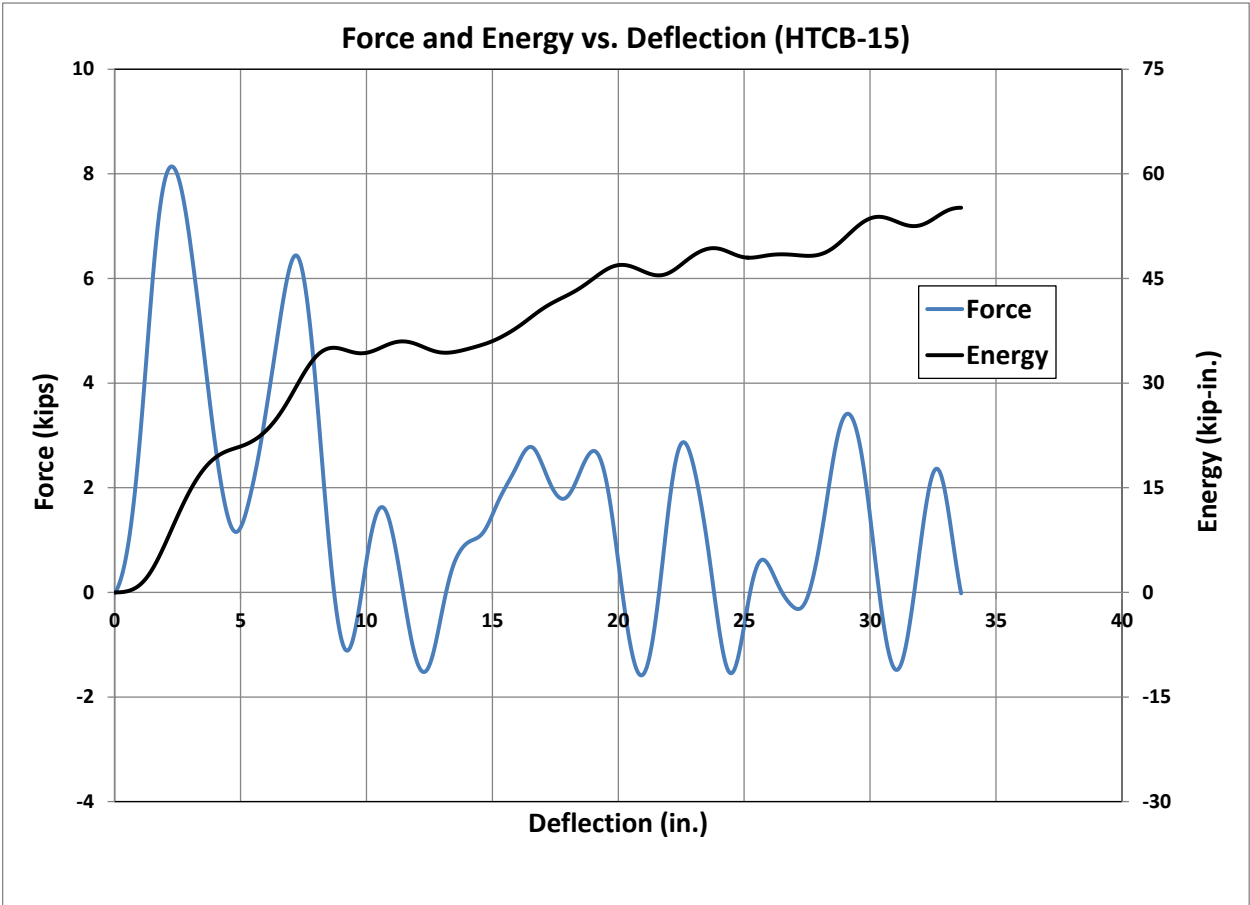
Figure 20. Force vs. Deflection and Energy vs. Deflection, Test No. HTCB-15

(15.6 kN) for the remainder of the test. At a deflection of 33.6 in. (853 mm), the post assembly had absorbed 55.1 k-in. (6.2 kJ) of energy.

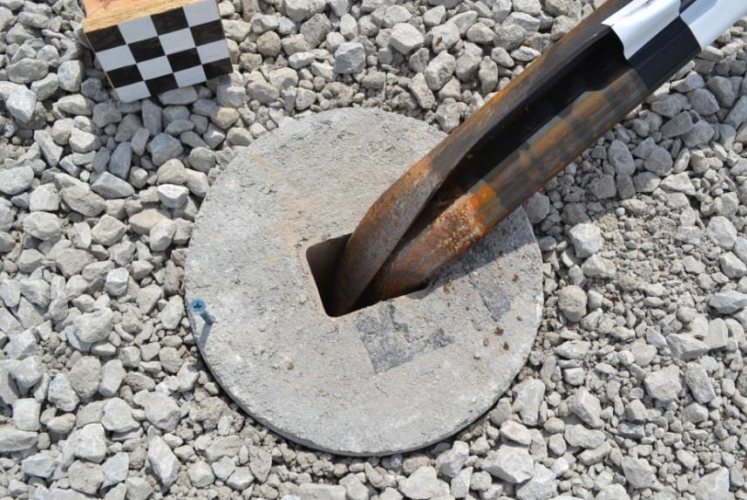
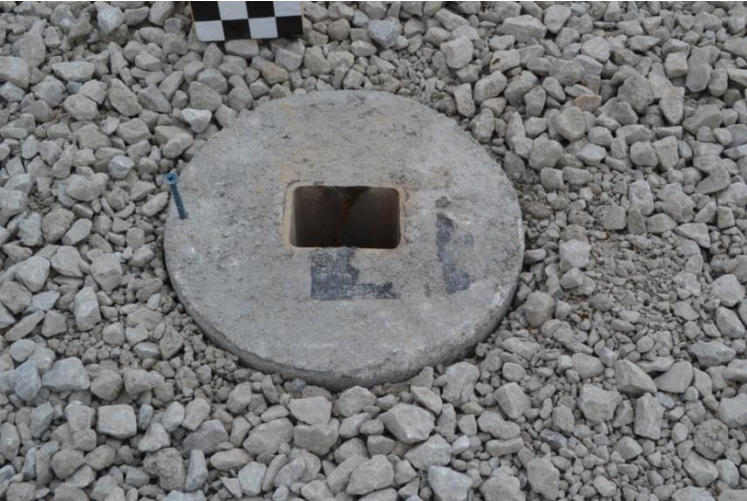
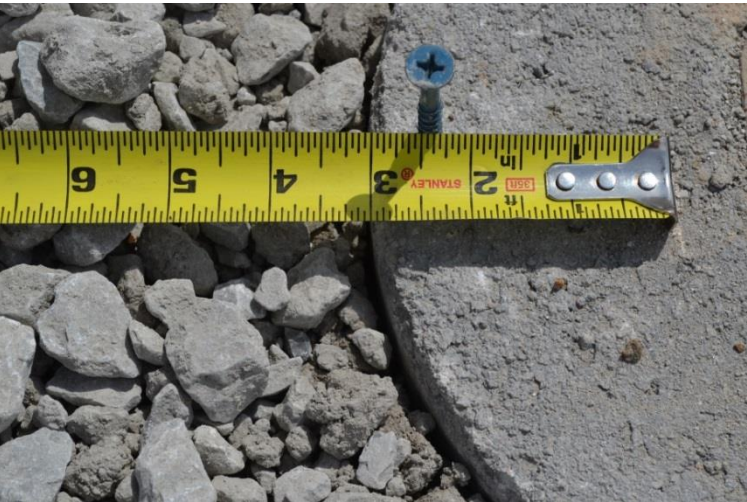
Figure 21. Post-Impact Photographs, Test No. HTC B-15

Damage to the test article was confined to plastic deformations of the post at ground line. The concrete foundation experienced no significant damage. Time-sequential and post-impact photographs are shown in Figure 21. Due to technical difficulties with the high-speed camera, time-sequential photographs were taken from the JVC digital camera.

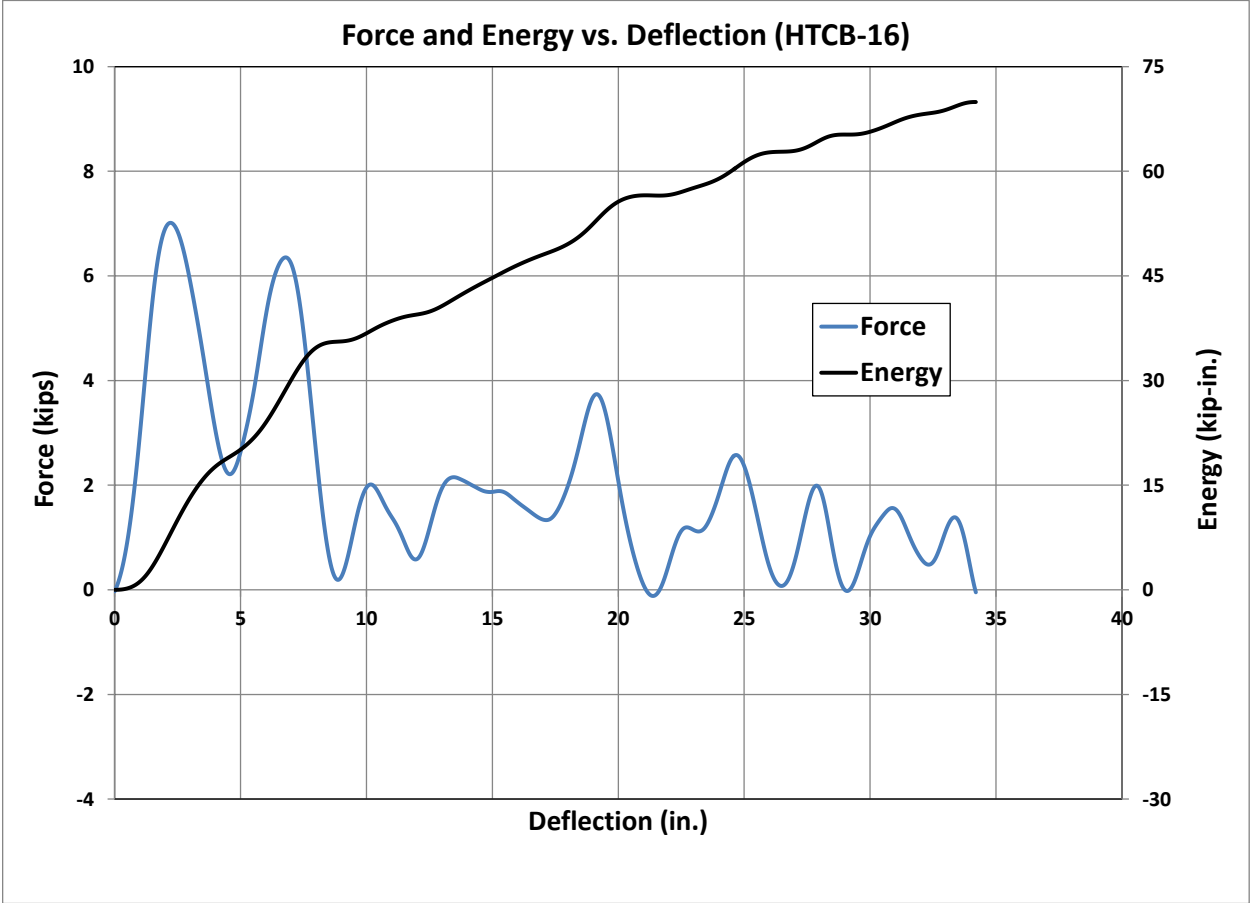
Figure 22. Force vs. Deflection and Energy vs. Deflection, Test No. HTCB-16

Force vs. deflection and energy vs. deflection curves were created from the accelerometer data and are shown in Figure 22. Inertial effects resulted in a high force over the first few inches of deflection. After a brief decrease, the force rebounded to a peak of 6.4 kips (28.5 kN) at 6.8 in. (173 mm) of deflection. Following this second peak, the force remained below 4 kips (17.8 kN) for the remainder of the test. At a deflection of 34.2 in. (869 mm), the post assembly had absorbed 69.9 k-in. (7.9 kJ) of energy.

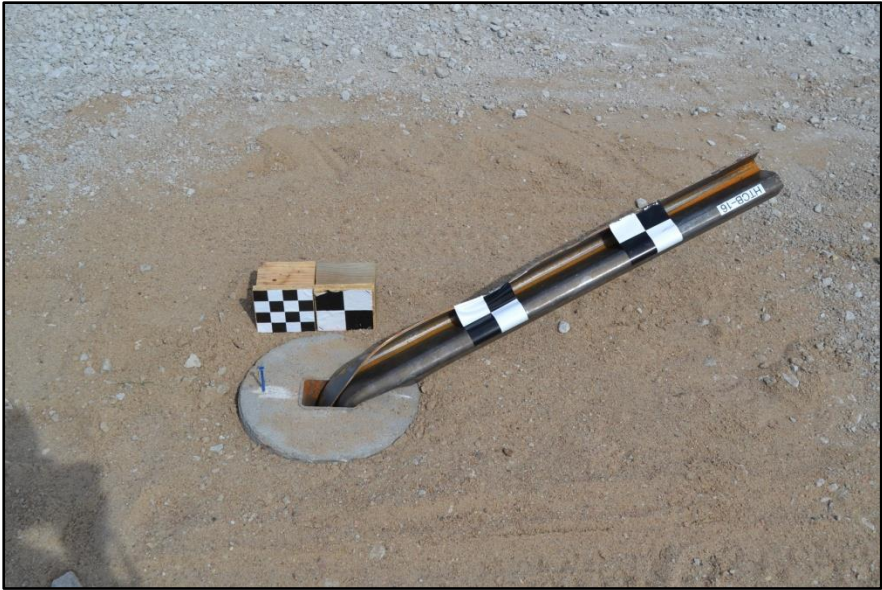
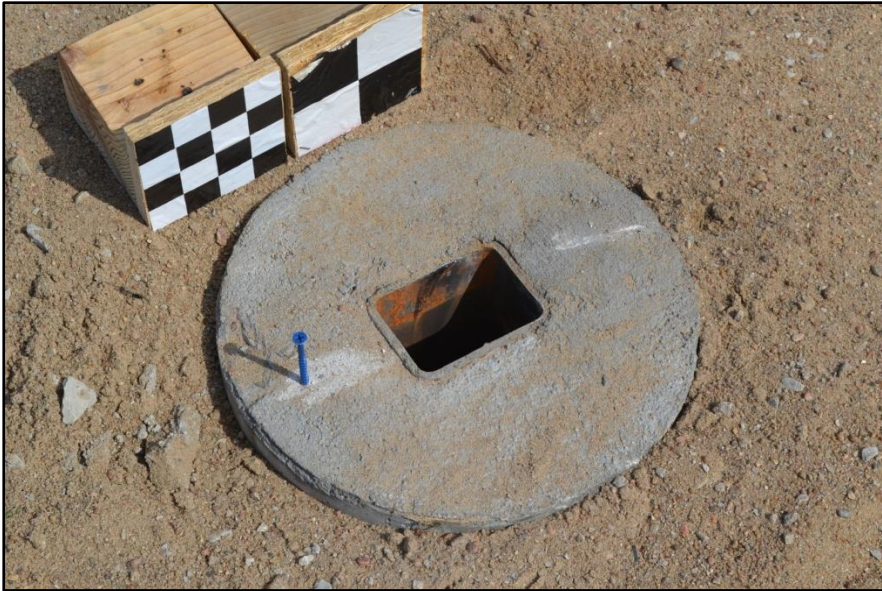
Figure 23. Time-Sequential and Post-Impact Photographs, Test No. HTC B-16

Damage to the test article was confined to plastic deformations of the MWP at ground line. The concrete foundation experienced only minor scrapes. Time-sequential and post-impact photographs are shown in Figure 23.
