*Midwest States Regional Pooled Fund Research Program
Fiscal Years 2008-2009 (Years 19 and 20)
Research Project Number TPF-5(091) Supplement #2 and TPF-5(193) Supplement #19
NDOR Sponsoring Agency Code RFPF-09-02 and RFPF-10-CABLE-1*

DEVELOPMENT OF A SOCKETED FOUNDATION FOR THE MIDWEST WEAK POST (MWP) V1

1. Report No. TRP-03-298-14	2.	3. Recipient's Accession No.	
4. Title and Subtitle Development of a Socketed Foundation for the Midwest Weak Post (MWP) V1		5. Report Date July 23, 2014

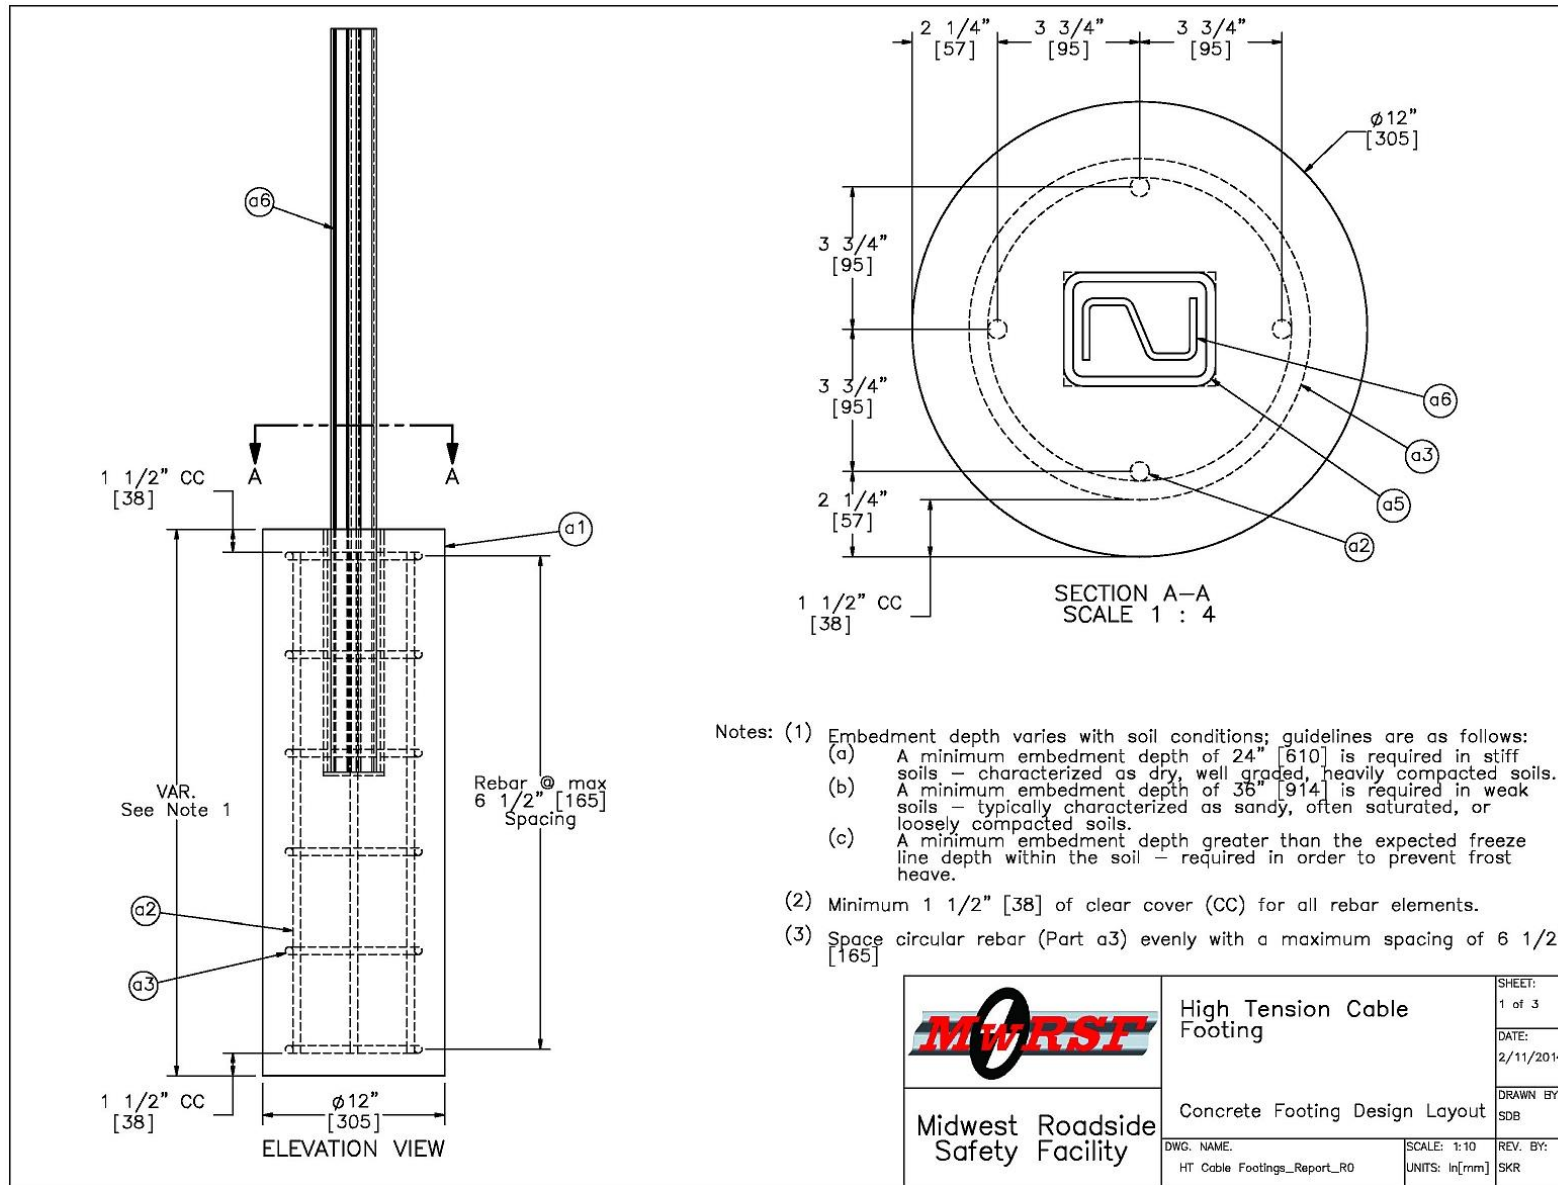
Figure 26. Socketed Foundation for MWPs, Design Details

1. A minimum embedment depth of 24 in. (610 mm) for socketed foundations installed in stiff soils, characterized as dry, well graded, heavily compacted soils.
2. A minimum embedment depth of 36 in. (914 mm) for socketed foundations installed in weak soils, typically characterized as sandy, often saturated, or loosely compacted soils.
3. A minimum embedment depth greater than the expected freeze line within the soil in order to prevent frost heave.

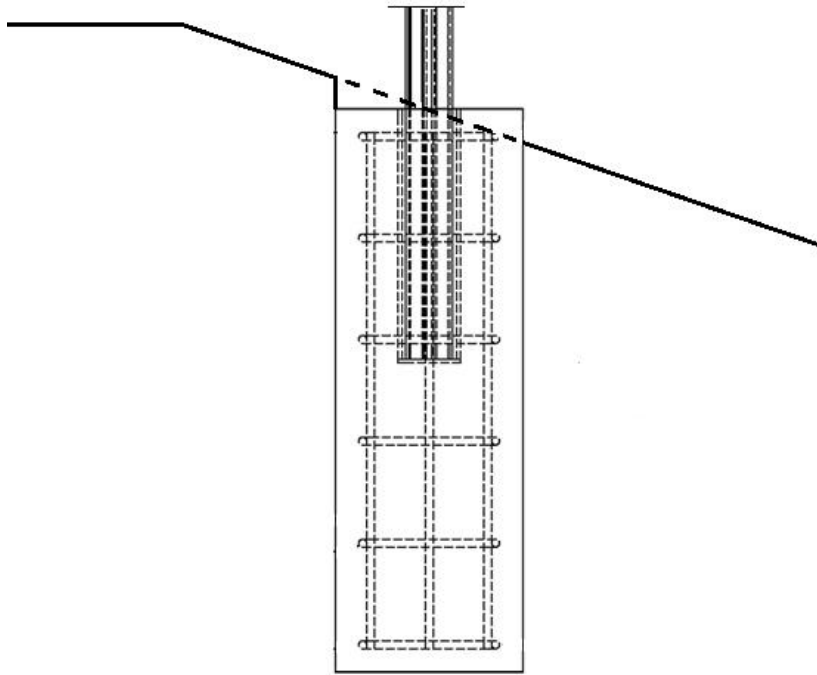
Figure 29. Placement of Foundation on Slope

Cable guardrail systems are regularly installed within medians and on roadsides with cross slopes. Under these circumstances, the top of the socketed foundation would not lay flush with the surrounding terrain, and may result in the downslope side of the foundation protruding above ground line. To minimize the extent of this protrusion, it is recommended to install the top-center of the foundation level with the surrounding slope, as shown in Figure 29. Additionally, this configuration ensures that the post and cables remain at the correct height.
