## Corrosion Studies on the USS Arizona with Application to a Japanese Midget Submarine

The assessment of corrosion on the USS Arizona included the pioneering development of a minimum-impact cost-effective technique to determine the corrosion rate of steel-hulled shipwrecks in seawater. The technique, with potential application worldwide, is illustrated in this paper with the application to a World War II Japanese midget submarine submerged in deep waters off the Oahu, Hawaii, coast.

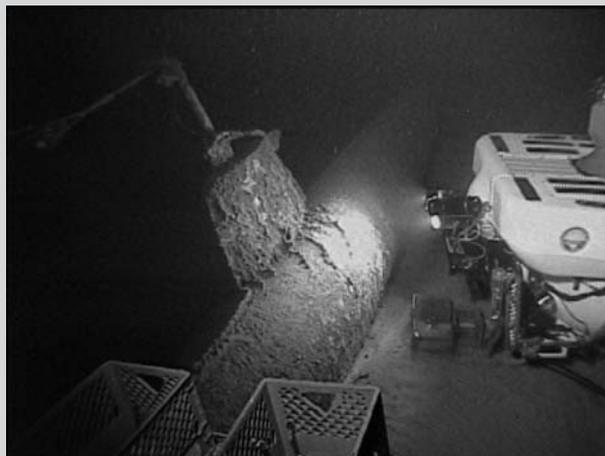
Figure 3. The aft end of the Japanese midget submarine during collection of concretion samples. Photo courtesy of the National Oceanic and Atmospheric Administration/Hawaiian Undersea Research Laboratory.

water. In a later submersible descent, several small segments of marine concretion were recovered from the aft end of the midget sub by the robotic arm of HURL's *Pisces* submersible (Figure 3). These samples were analyzed in metallurgical and chemistry laboratories at the University of Nebraska–Lincoln, and x-ray diffraction measurements were conducted at the Air Force Research Laboratory, Eglin Air Force Base, Florida. The purpose of this paper is to review Corrosion Equivalent Corrosion Rate (CECR) methodology,<sup>2</sup> a minimum impact technique pioneered on *Arizona*, and its application to estimate the average corrosion rate of the external hull of the midget submarine. A second purpose is to present the results of x-ray diffraction studies on the concretion samples and to relate these results to physical and chemical properties of the submarine's concretion.

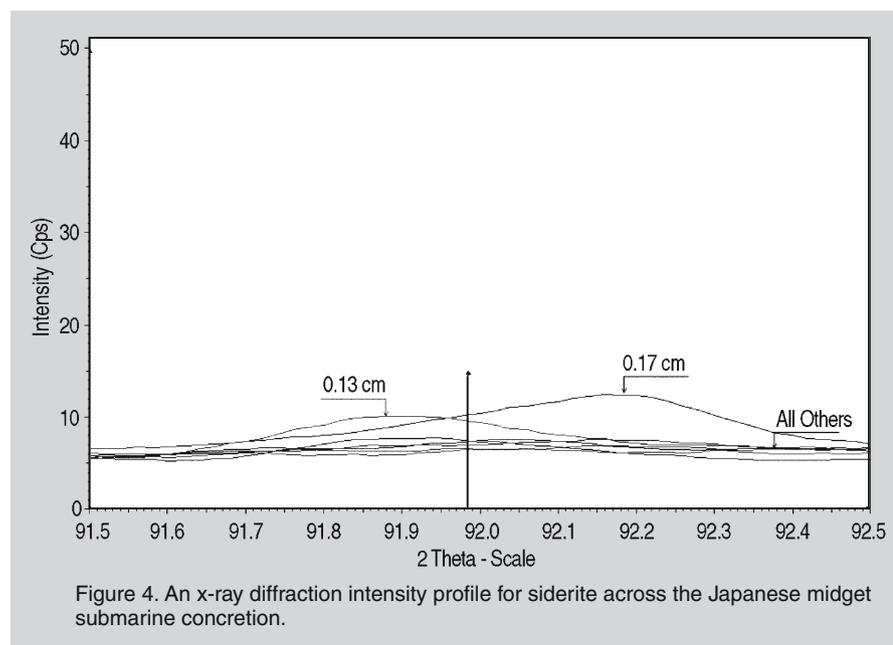
Figure 4. An x-ray diffraction intensity profile for siderite across the Japanese midget submarine concretion.

Maximum siderite toward seaside (Figure 4) suggests that iron diffusion through the concretion is fast relative to siderite formation kinetics. The exact mechanism by which siderite forms is unknown, but it is probably related to iron exchange with calcium in calcium carbonate.<sup>12</sup> North reported that the original aragonite skeletal material was converted into various iron compounds with siderite being the most common. Maximum goethite and magnetite toward

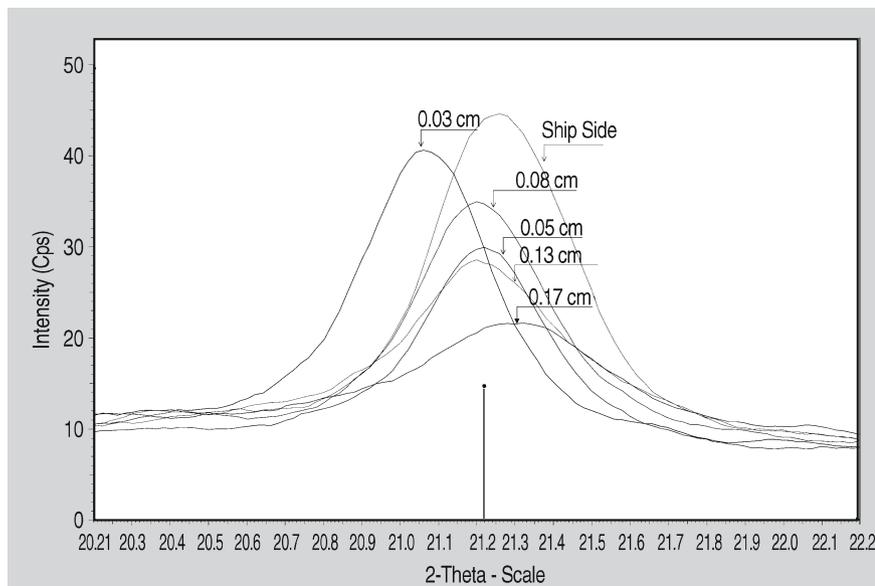
Figure 5. X-ray diffraction intensity profiles for goethite across the Japanese midget submarine concretion.

shipside (Figures 5 and 6, respectively) suggests that oxygen diffusion is fast relative to iron oxide formation kinetics. The presence of goethite in the concretion rather than at the metal/concretion interface, as in the case of *Arizona*, may explain the higher iron content in the midget submarine concretion than in *Arizona* concretion. Although a chloride-containing oxide, akaganeite, appears in *Arizona* scale, no chloride containing oxides appear in the midget submarine concretion. Other research indicates that akaganeite forms after the concretion is exposed to air,<sup>13</sup> which may explain the presence of this mineral in *Arizona* concretion, but it does not explain its absence in the midget submarine concretion.

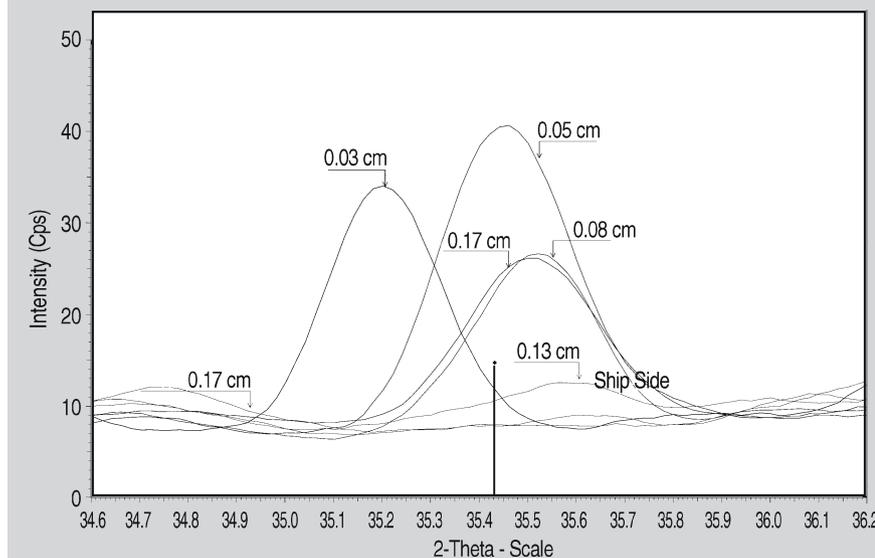
Figure 6. X-ray diffraction intensity profiles for magnetite across the Japanese midget submarine concretion. The double peaks at 0.17 cm result from heterogeneity in the concretion.
