Investigation of rapid remote sensing techniques for forensic wind analyses

Perishable damage data resulting from severe windstorms require efficient and rapid field collection techniques. Such datasets permit forensic damage investigations and characterization of civil infrastructure. Ultimately, observed structural damage serves as a proxy approach to estimate wind speeds for storms that include hurricanes, tornadoes, straight-line winds, etc. One of the more common methods to collect, preserve, and reconstruct three-dimensional damage scenes is the use of an unmanned aerial system (UAS), commonly known as a drone. Onboard photographic payloads permit scene reconstruction via structure-from-motion; however, such approaches often require direct site access and survey points for accurate results, which limit its efficiency. In this presentation, the use of UAS platforms with and without surveyed ground control points is investigated to understand the accuracy if site access is not possible. UAS datasets will be compared to lidar data of various structures collected following the 2017 Hurricane Harvey near Rockport, TX.

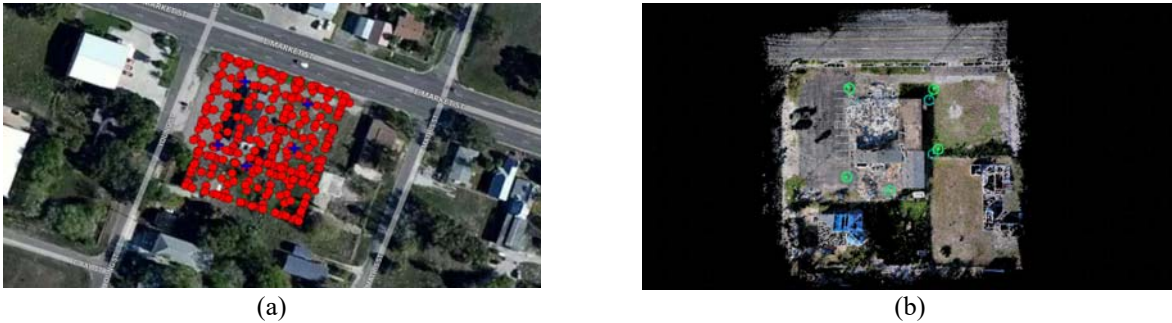
Figure 1. VFW flight details: (a) image locations in red and (b) GCPs shown in green

The available equipment for the aerial surveys was a DJI Inspire 2 UAS with an onboard Zenmuse X5 camera and mounted 15 mm lens. Flight paths were autonomously controlled with the Pix4dcapture application on a handheld android-based tablet, using perpendicular “lawn-mower” like passes due to the various changes in height in the scenes (Figure 1). At Rockport VFW, three flights were performed with an 85% overlap at an above-ground-level (AGL) altitude of 25 meters. Similarly, two flights were conducted at the Aransas Pass Storage Center with 85% overlap and an AGL altitude of 28 meters. This produced a total of 302 and 639 images, for the VFW and storage center locations. The resultant ground sampling distance was between 0.55 – 0.61 cm. Ground control points (GCP) were well distributed to scale the SfM resultant point cloud.

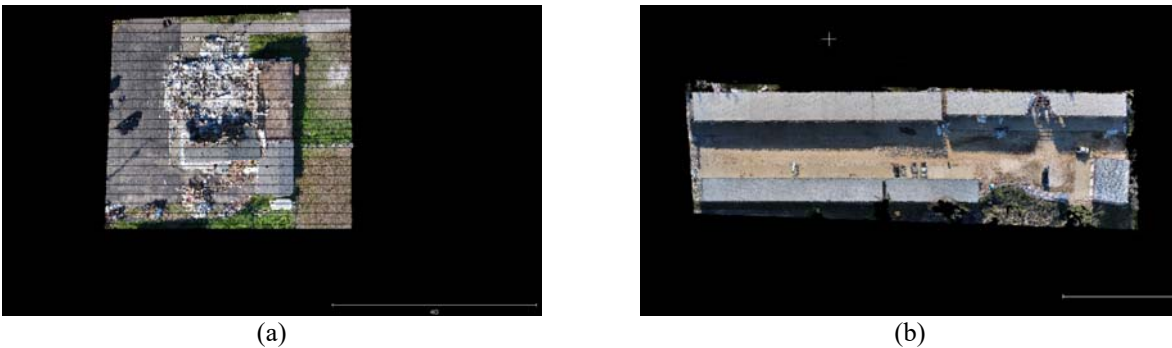
Figure 2. SfM derived point clouds: (a) VFW and (b) Aransas Pass storage facility

Pix4d is a commercial software commonly utilized for UAS processing, which utilizes high resolution images and form them to produce accurate deliverables, including digital models, point clouds, etc. The processing template for data processing is selected as 3D maps, image scale at one-half, point density of optimal, and the minimum number of matches of 3. The SfM point clouds of Rockport VFW and Aransas Pass storage are displayed in Figure 2. The total number of points in each cloud are 143 and 460 million, respectively.
